TEST REPORT ON SEALED SILVER OXIDE-ZINC SECONDARY CELLS

TECHNICAL REPORT ASD-TR-61-636

FLIGHT ACCESSORIES LABORATORY
AERONAUTICAL SYSTEMS DIVISION
AIR FORCE SYSTEMS COMMAND
WRIGHT-PATTERSON AIR FORCE BASE, OHIO

(Prepared under Contract No. AF 33(600)-41600
by Delco-Remy, Division of General Motors Corporation,
Anderson, Indiana.
Author: J. A. Keralla)

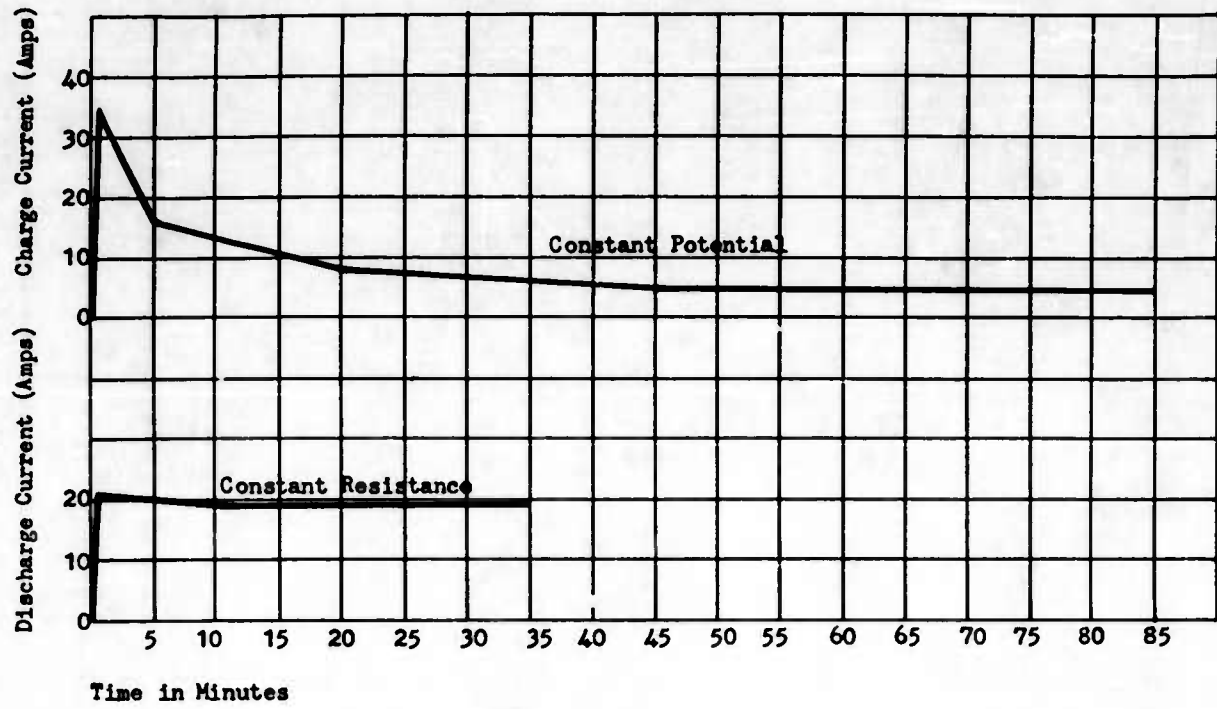
FIGURE 6
 TYPICAL CHARGE AND DISCHARGE CURVES OF CFL OPERATING
 FOR 1760 CYCLES

The negative plate material did not grow in any direction and remained encapsulated in one wrapping of separator material. There was no evidence of washing of negative material from the grid. The material itself appeared coarse and gritty to the touch, but it is estimated that if the positive lugs had not corroded, this battery would have continued cycling well over 2000 cycles. Fig. 6 shows typical charge and discharge current-time curves over 1760 cycles.

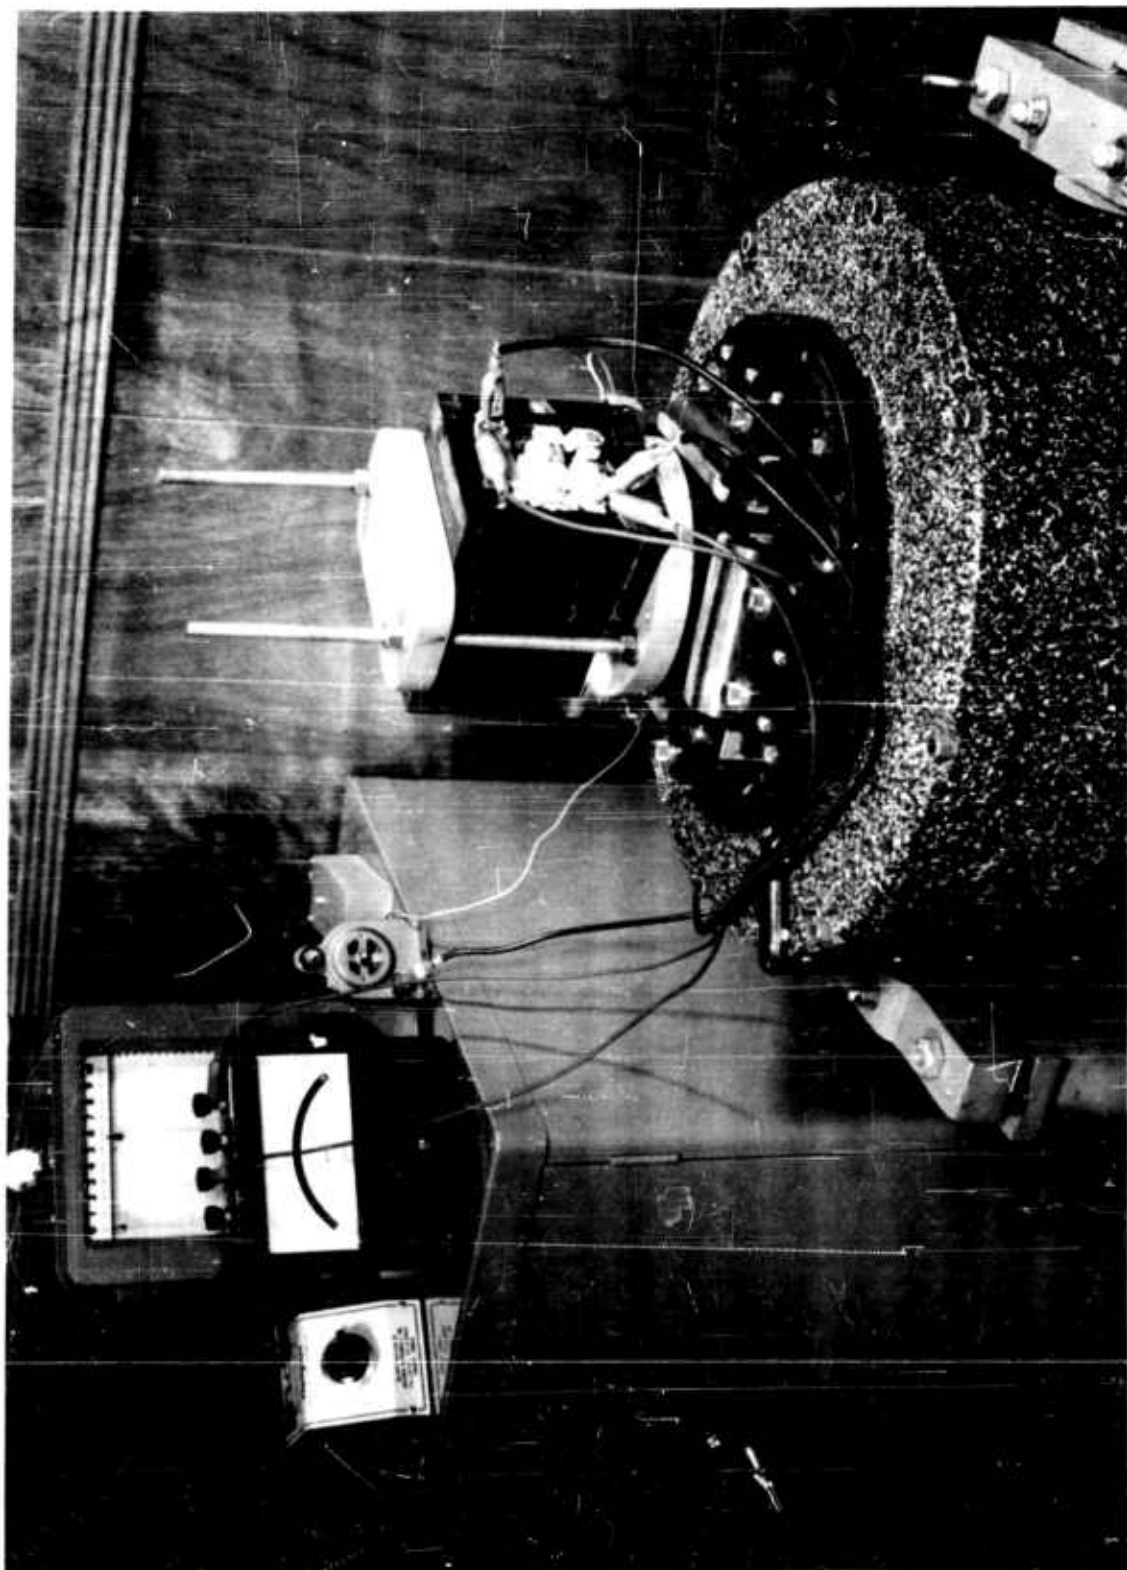
FIGURE 34
VIBRATION OF PLANE #1 OF 3-SEALED CELLS

FIGURE 35
VIBRATION OF PLANE #2 OF 3-SEALED CELLS

FIGURE 36
VIBRATION OF PLANE #3 OF 3-SEALED CELLS

There was no apparent damage to the battery during or after the vibration test as determined by the fact that the cell voltages returned to normal open circuit readings. There were no resonant frequencies noted during the scan for resonance in any axis. Fig. 33 shows the charge, discharge curves during the vibration test. Figures 34, 35 and 36 show positions of sample during test.

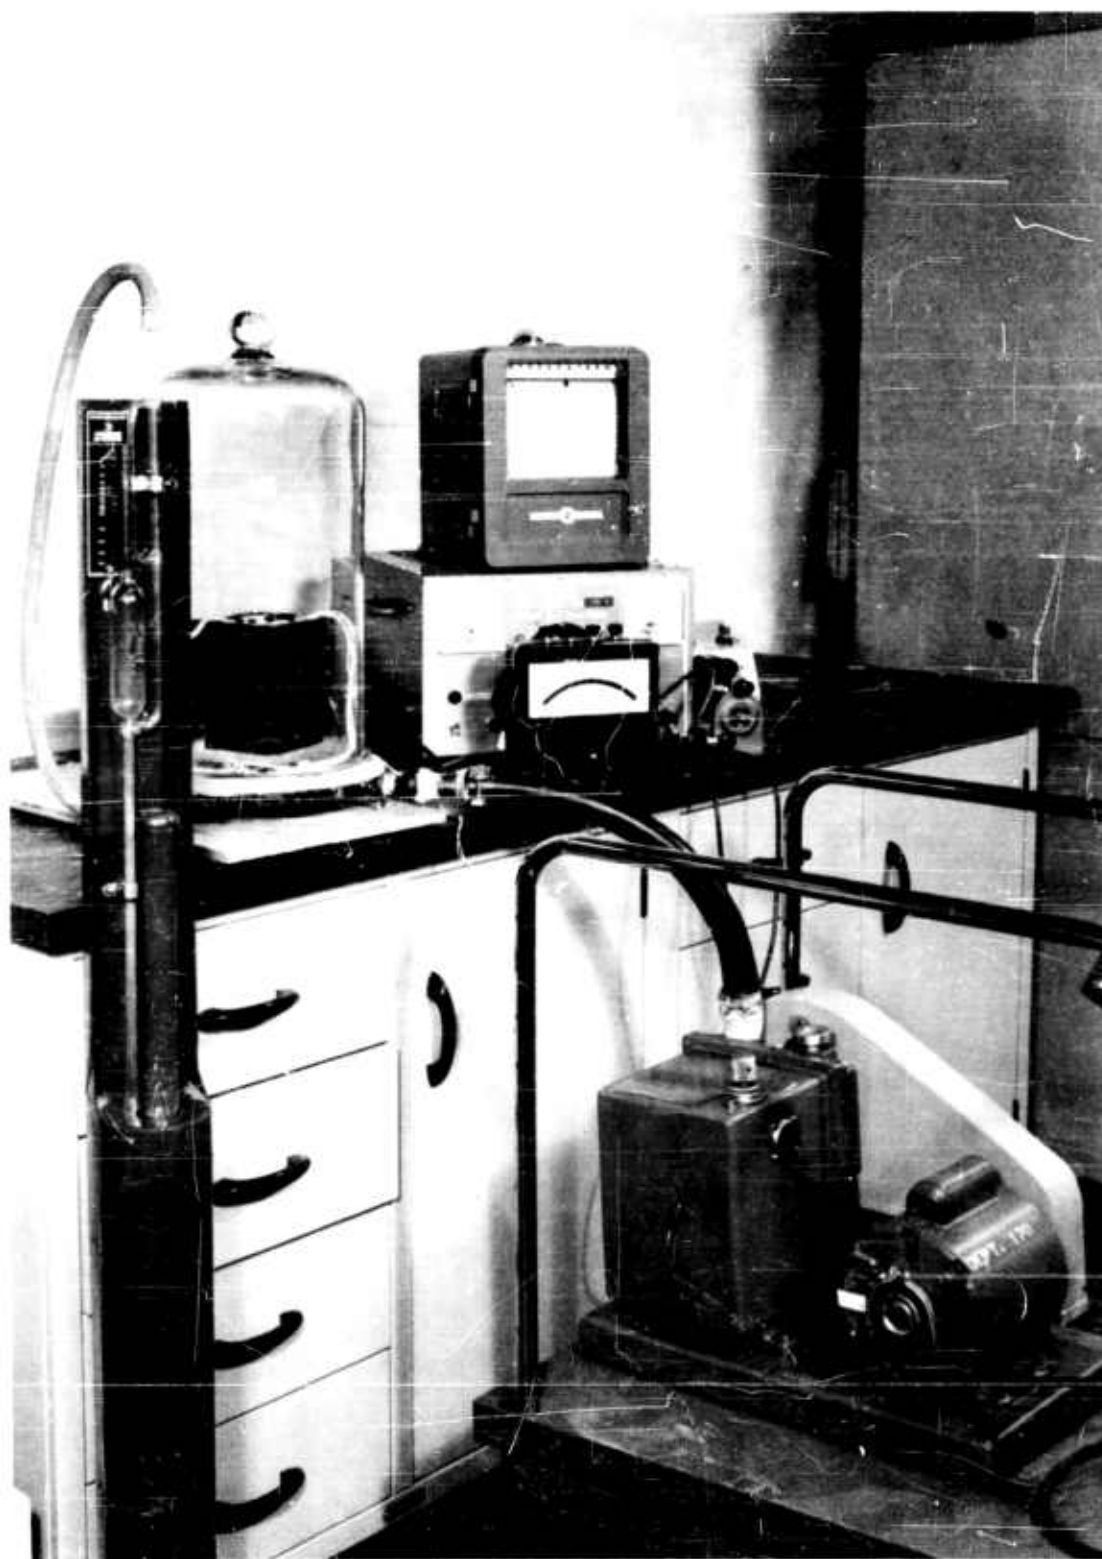
FIGURE 45
PRESSURE TEST OF 3-SEALED CELLS
