FRANKFORD ARSENAL  
Research and Development Group  
Pitman-Dunn Laboratories  
Philadelphia 37, Pa.

TECHNICAL REPORT R-1635

DEVELOPMENT OF THRUSTER, CARTRIDGE ACTUATED, XM14

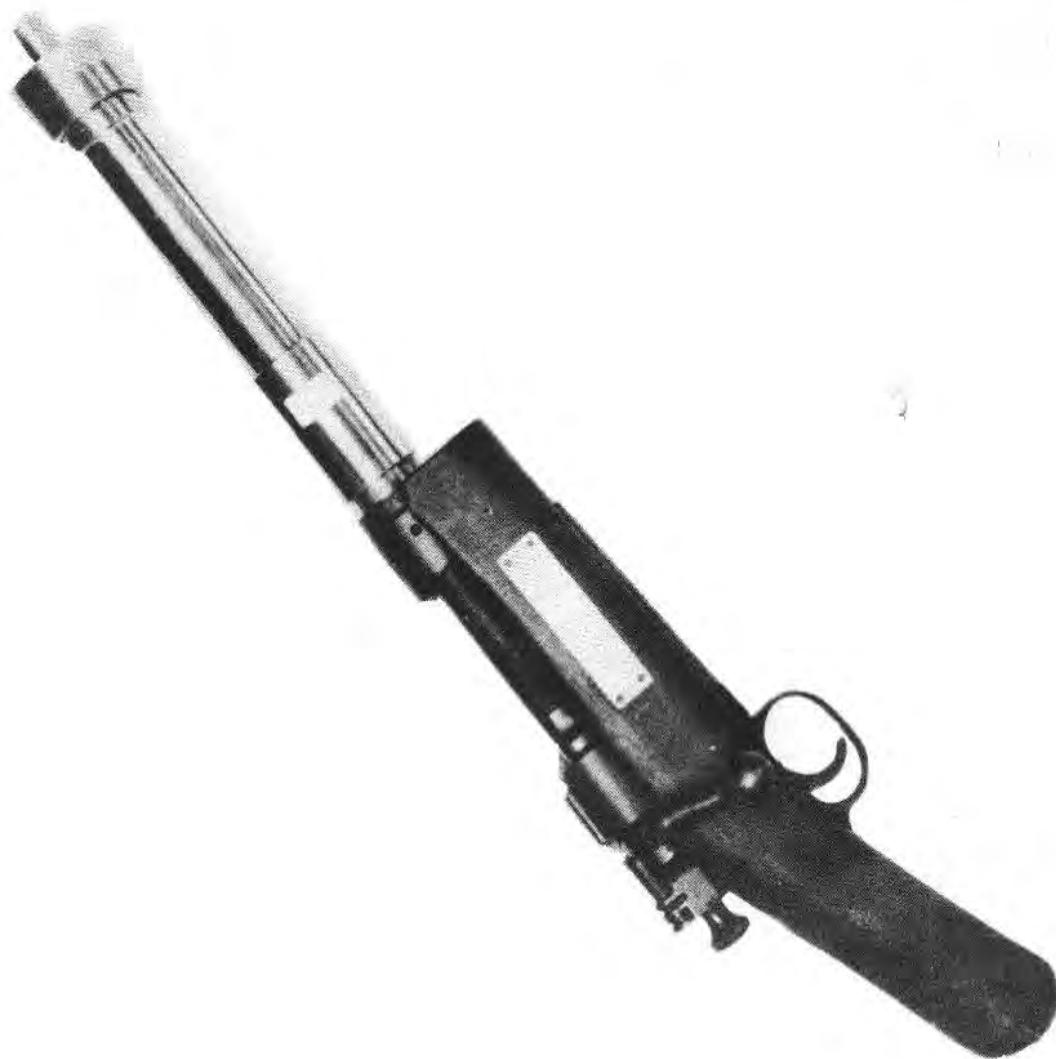
Figure 1. XM14 Thruster

seals had to be replaced and the unit thoroughly cleaned after each firing, it was felt that the modified thruster, designated XM14 (Figure 1), would provide enough data in test firings to give a firm basis for design of the final unit. The thruster was mounted in the test rig shown in Figures 2 and 3. Test instrumentation is shown in Figure 4. A 95-pound mass, representing the projectile, was propelled vertically in the test rig by firing a .30 caliber M3 rifle grenade cartridge (Figure 5) in a standard 1903-A3 bolt-action rifle receiver fitted to the thruster. Table I list results recorded in six test firings.

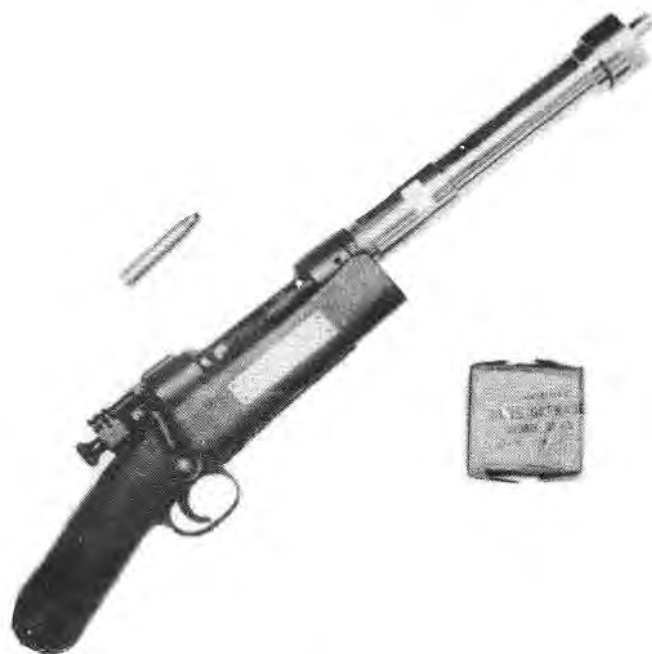
Figure 13. XM14 Thruster and Rifle Grenade Cartridge

A conventional bolt-action receiver is used to contain and fire the rifle grenade cartridge. Loading and firing procedures are identical to those used with a conventional rifle. When the rifle grenade cartridge is fired, it generates a high-pressure gas which exerts pressure against the piston, causing it to move forward. The gas escapes through ports in the piston (refer to Figure 16), fills the void ahead of the piston, and thus tends to slow down piston operation. As the gas travels toward the end of the body, it passes through annular rings (buffering chambers) and in doing so further slows piston operation. The buffered piston stroke of approximately 3.25 inches imparts to the 95-pound projectile sufficient velocity to travel a distance of 61 inches from the rammer tray (details shown in Figures 17 through 20) to seat firmly into the breech of the 155 mm howitzer. With a tray elevation of  $6^{\circ}$  at a tank elevation of  $0^{\circ}$ , the projectile ramming velocity is 15.7 feet per second. After the projectile is chambered, the piston is manually repositioned.

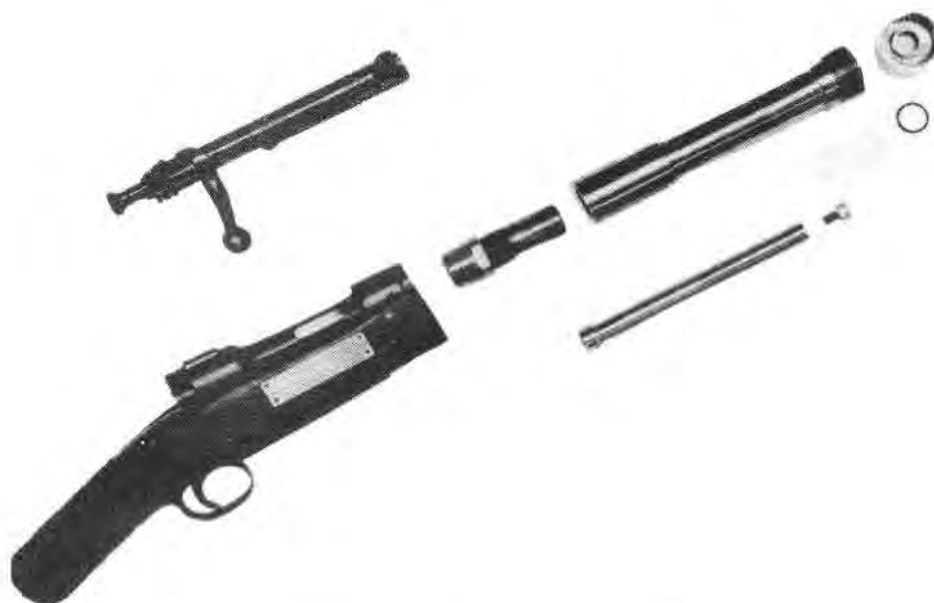
Figure 14. XM14 Thruster, Exploded View
