NAVWEPS REPORT 7904  
NOTS TP 2910  
COPY 98

## TEMPERATURE ENVIRONMENTS OF JET FIGHTER AND ATTACK BOMBER AIRCRAFT INSTRUMENTATION

Howard C. Schafer

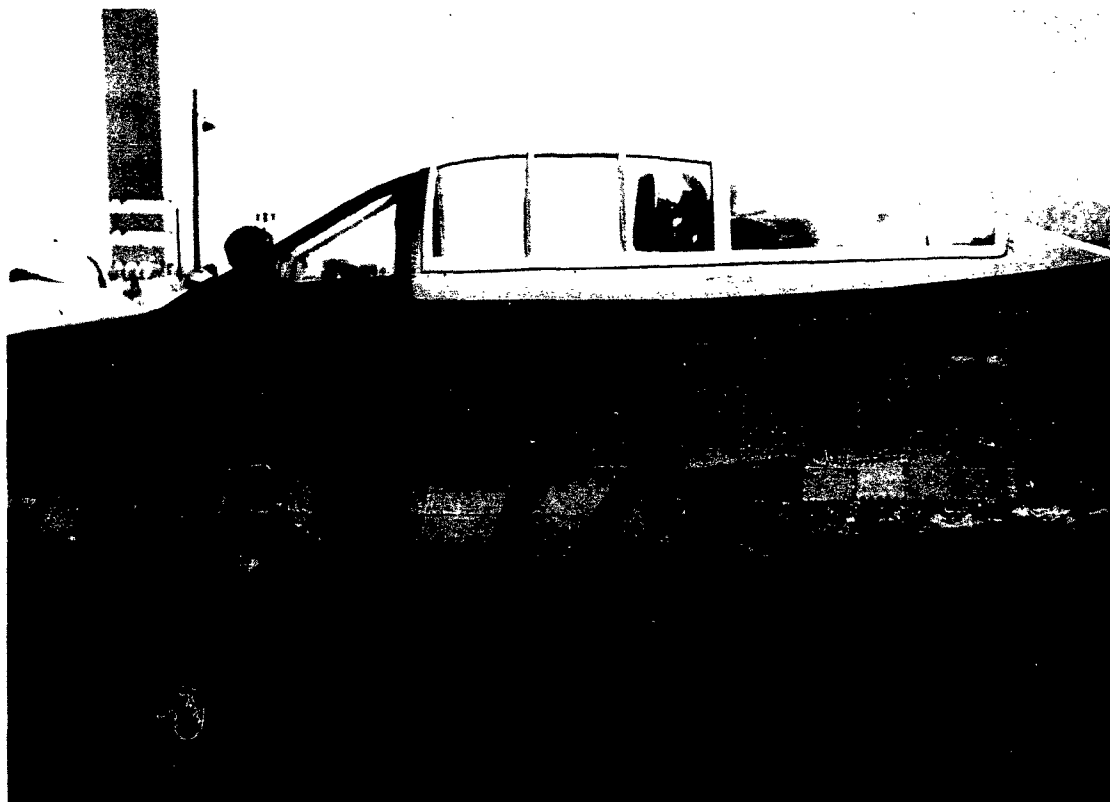
FIG. 1. F-84 Test Vehicle at NOTS.

An A4D light attack bomber was used for Phase II because of the aircraft's half-bubble canopy as opposed to the F-84's full-bubble canopy. Available for use as a test vehicle was an A4D cockpit that had been used in tests at the NOTS Supersonic Naval Ordnance Research Track for the Mk 1 Mod 0 Rocket Catapult Qualification Program. A nonoperational (struck) A4D aircraft was also available.
