**Air Force Surveys in Geophysics  
No. 145**

**Summary Report—Project Ice Way**

W. D. KINGERY, EDITOR

TERRESTRIAL SCIENCES LABORATORY PROJECT 7628

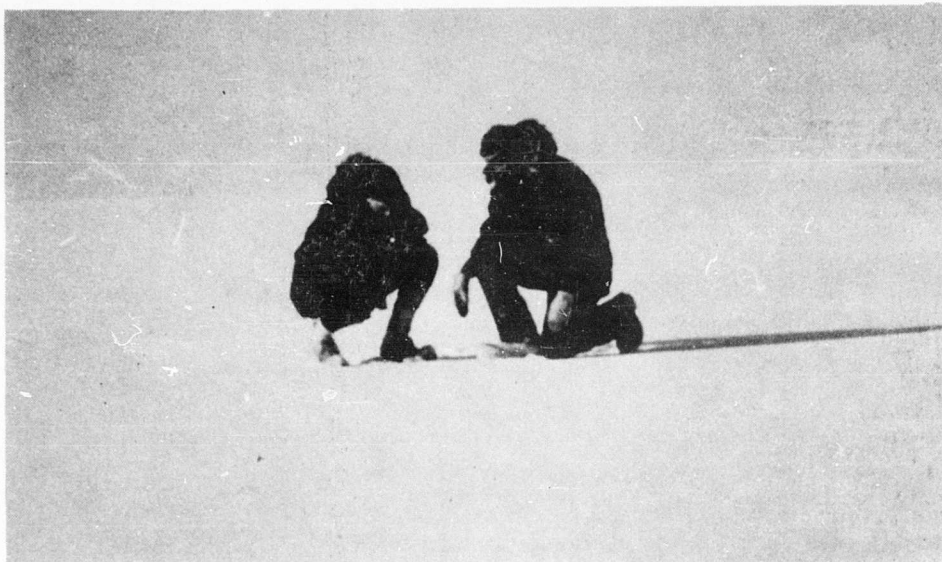
FIG. 3.4. Natural surface condition on bay showing smooth snow cover over ice; view west

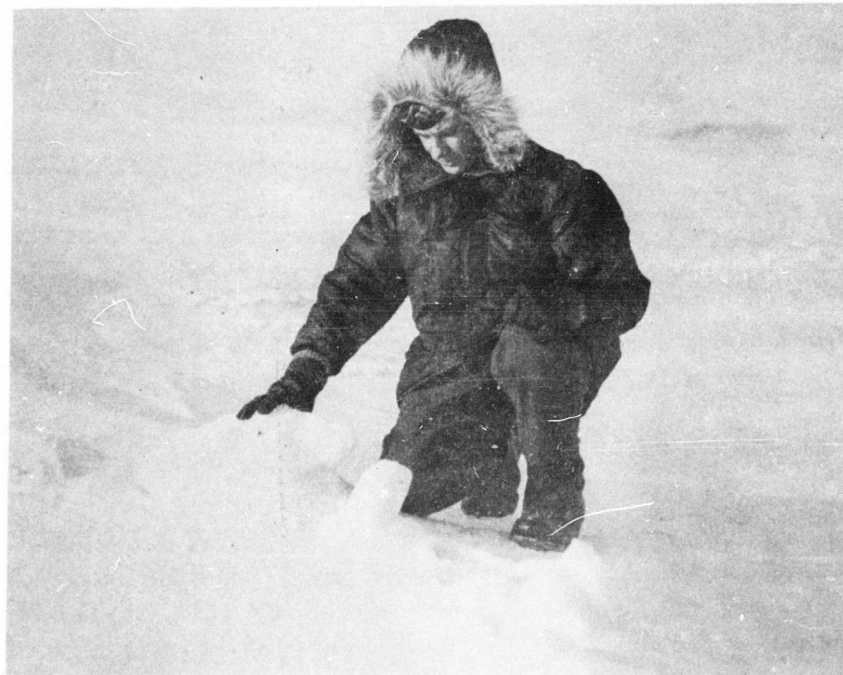
FIG. 3.5. Portion of rough area in vicinity of runway; ice chunks frozen into surface; small areas like this were scattered throughout bay; view northwest

Around the east end of the runway and at several spots along the runway the generally smooth snow surface was marred by the protrusion of small bits of ice which had frozen in the surface (Figure 3. 5). These areas were not sufficiently large to hinder the location of the pads and the camp in smooth areas, and they were graded down along the runway. It is assumed that such areas existed throughout the entire bay since they were undoubtedly caused by the freezing, breaking up, and refreezing of those areas during freeze-up the previous fall.

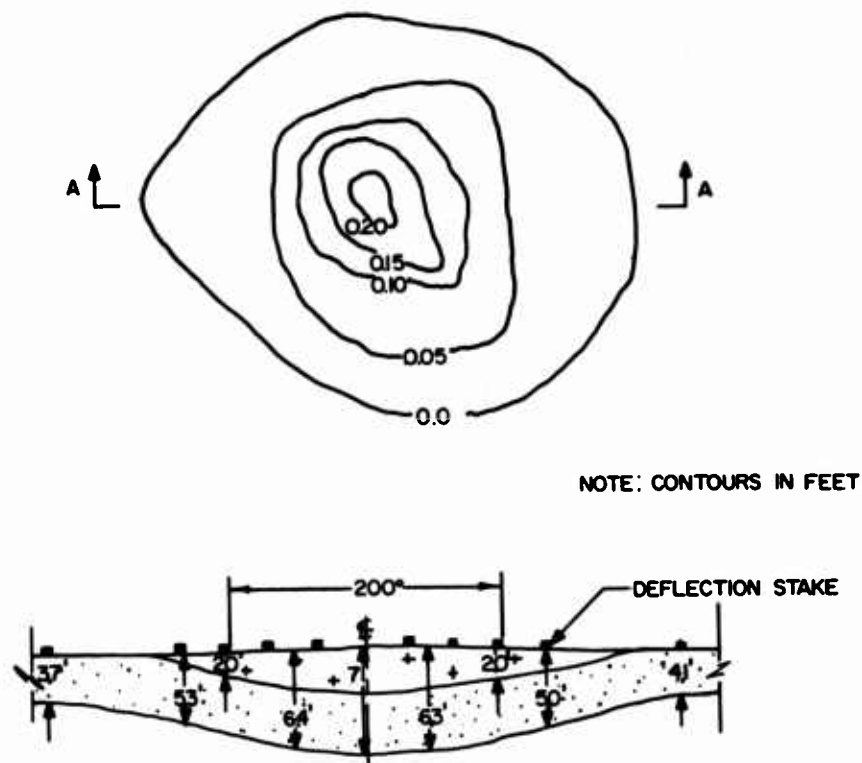
FIG. 4.12. Surface contours and vertical profile of Parking Apron No. 2

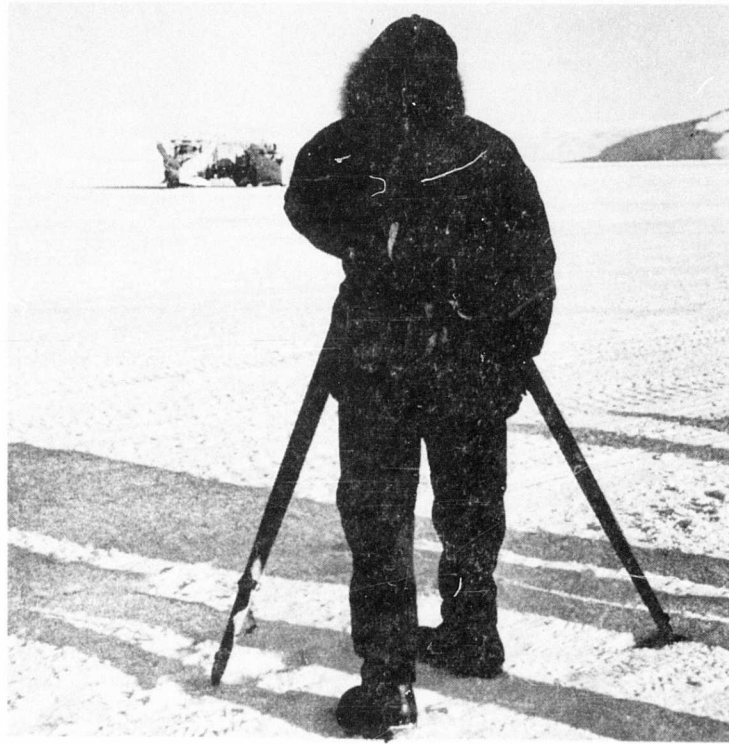
FIG. 7.1(a) General view and (b) close-ups of ice deflection measurement with a load of five V-plows

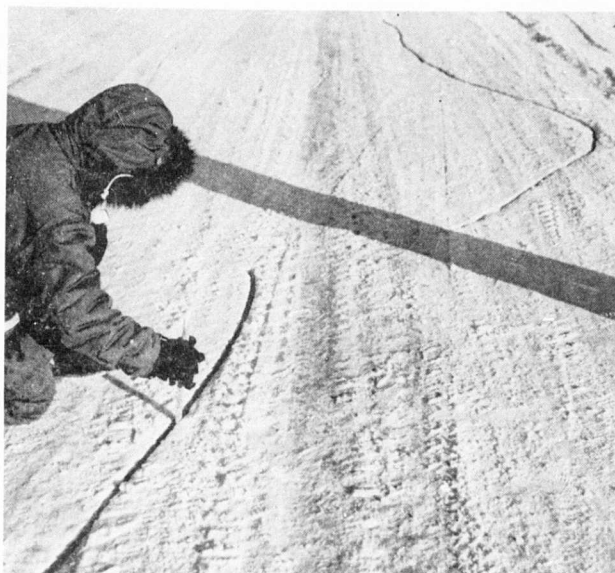
FIG. 8.1 Runway crack at North Star Bay runway

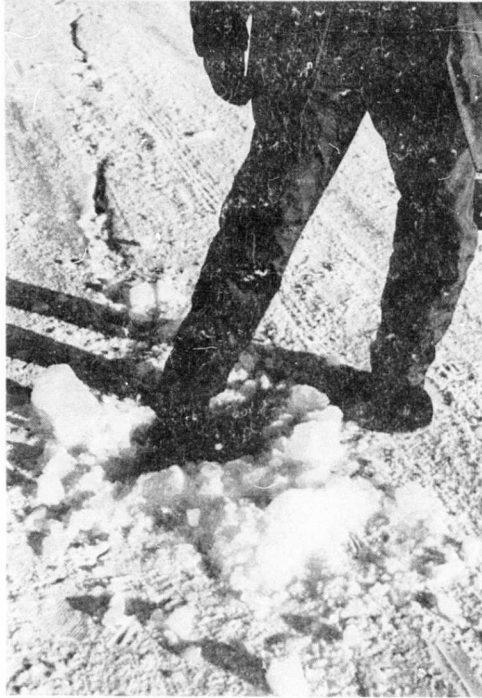
FIG. 8.5 Block of ice lifted from crack and broken by overnight "working" of ice

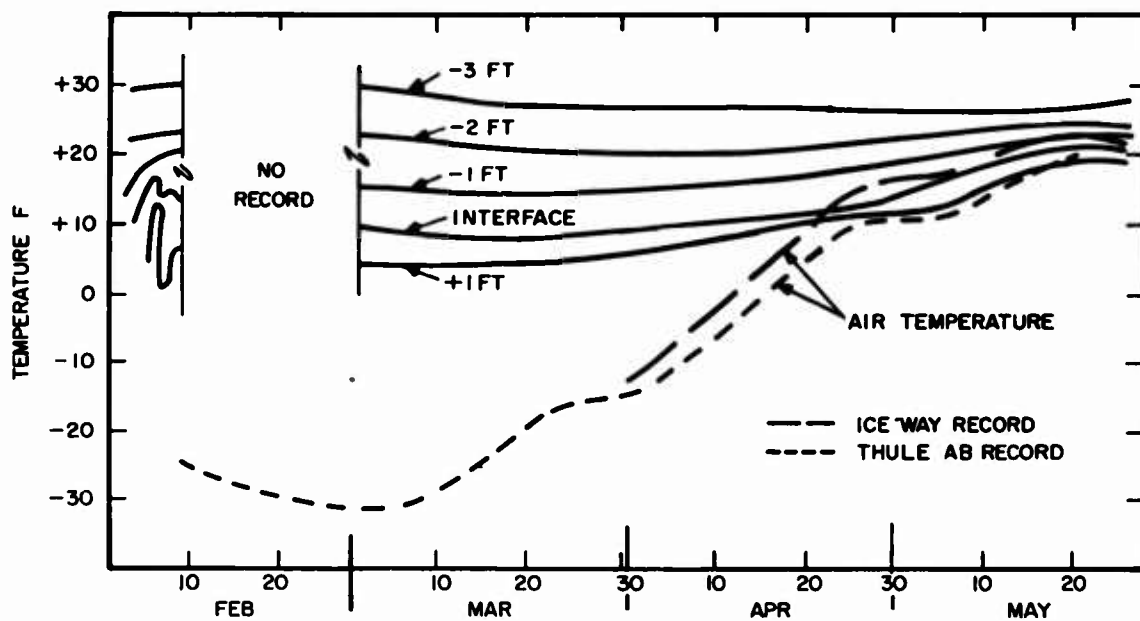
FIG. 9.4 Ice temperature profiles by stratum in the free-flooded parking apron (Parking Apron No. 1)

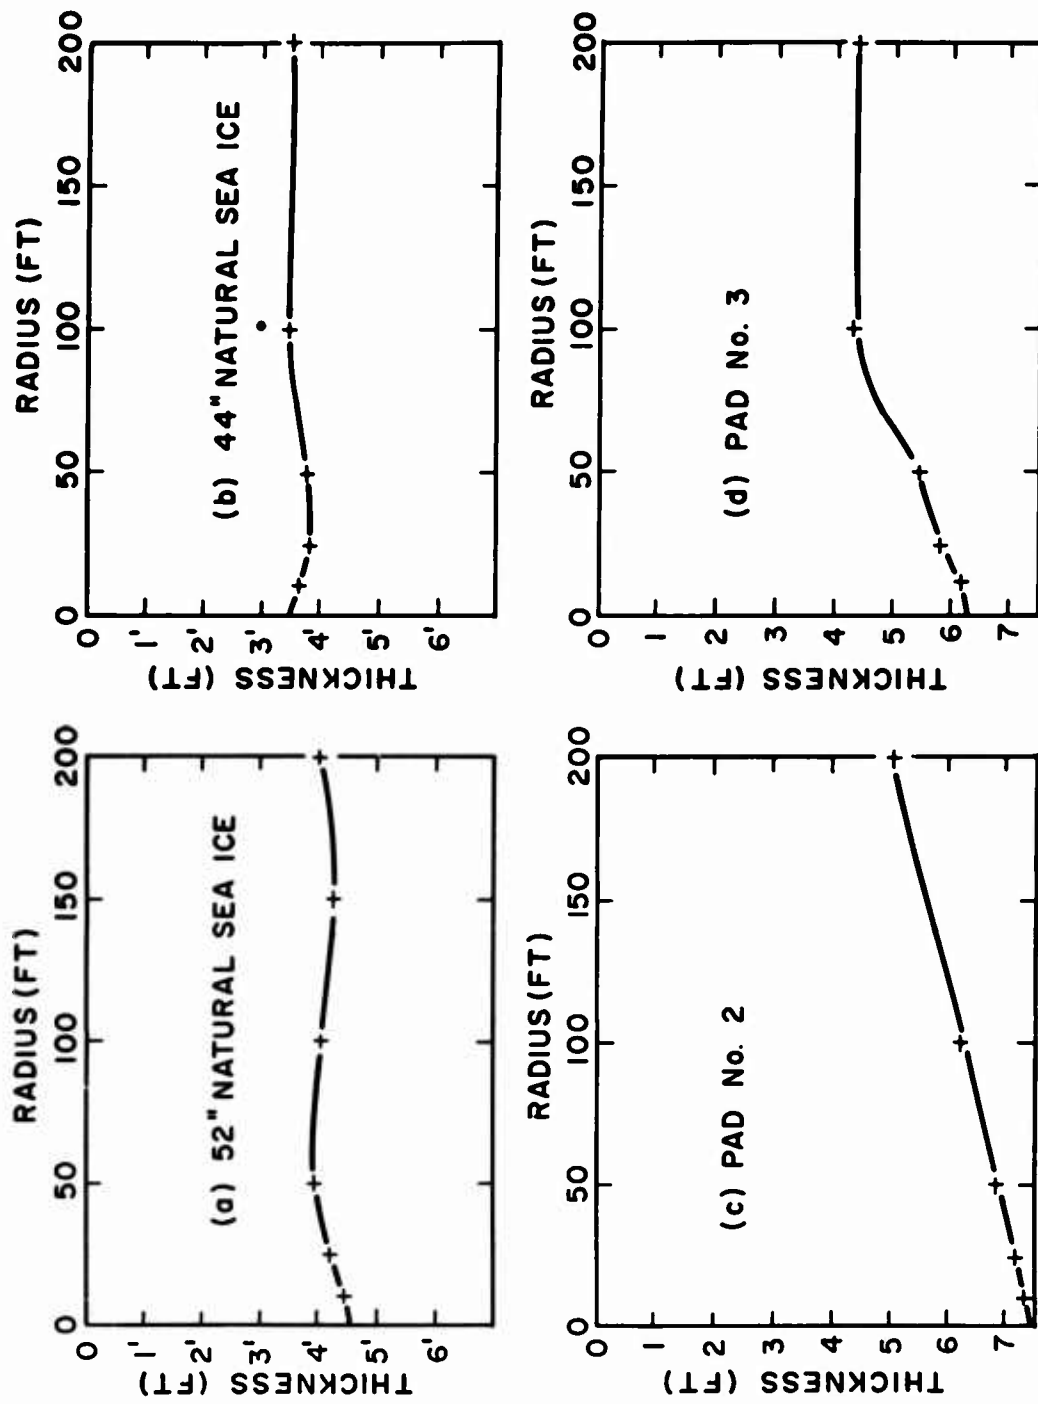
FIG. 13.2. Ice thickness profiles of the test areas studied

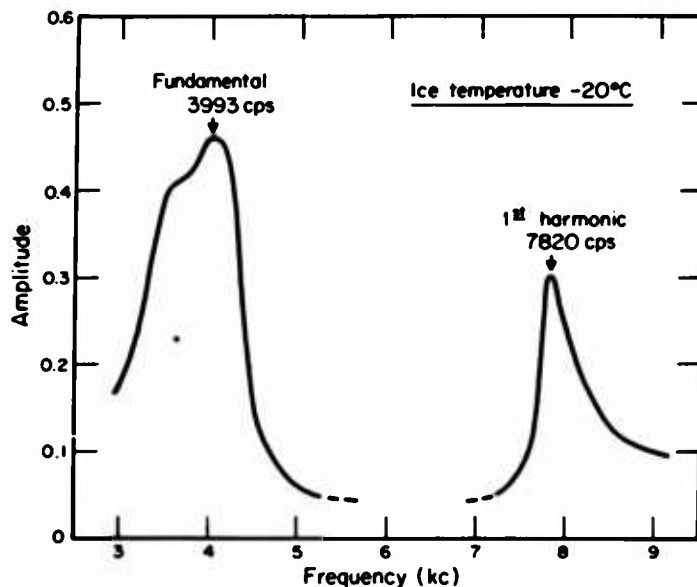
FIG. 14.3 Ice core longitudinal resonance; Sample No. 7
