# FATIGUE TESTS AND CRACK DETECTION ON SOME TYPES OF AXIAL-FLOW COMPRESSOR ROTOR BLADES

von Kármán Gas Dynamics Facility  
ARO, Inc.

TECHNICAL DOCUMENTARY REPORT NO. AEDC-TDR-62-168

October 1962

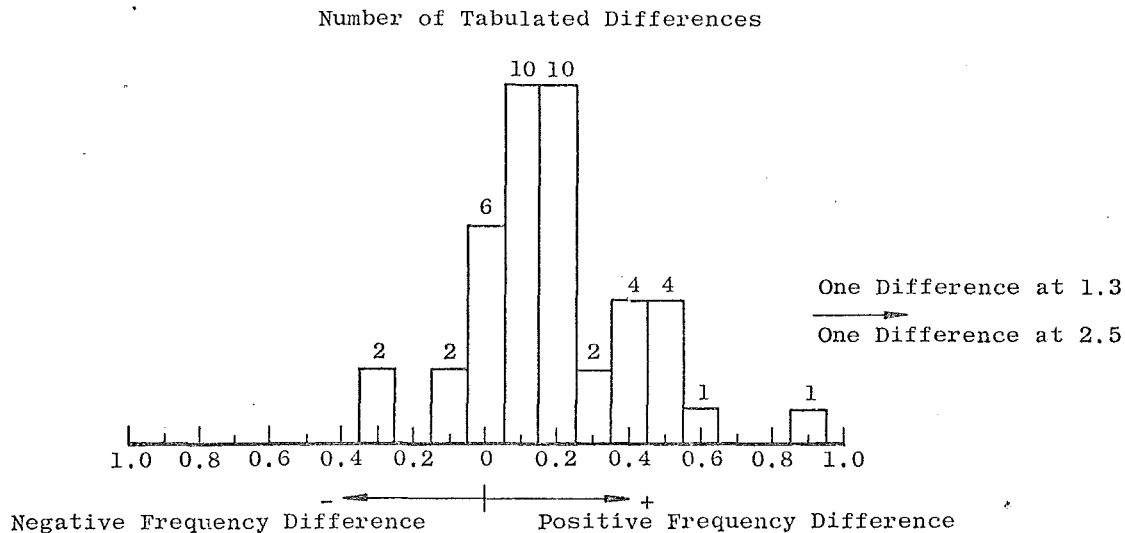
When all 50 blades in row 1 were so tabulated, the differences were grouped numerically as in the following example:

This graph represents only 44 blades because six of the blades had recently been changed to type-403 steel for reasons not connected to this illustration. The grouping of this range of differences is between  $-0.1$  cps and  $+0.6$  cps, and since the grouping is not concentrated about 0 cps, we assume that some or all reasons that may cause the natural frequency of a blade to change have influenced a general increase in frequency. This assumption includes a shift of instrumentation zero as well as natural changes to the blade. The three frequencies to the right of the grouping probably can be explained as an error in determining or recording the frequencies; it is discussed under section 4.5 of this report how these errors are eliminated by successive frequency determinations. In any event we have no basis for suspecting a defective blade by the indication of an increasing (positive) frequency change, and the 1.3-cps and 2.5-cps differences were ignored until future determinations could locate the error.

The two blade frequencies shown on the graph at  $-0.3$  cps apparently exhibit decreasing frequencies outside the normal grouping, so we assume that the decreasing frequency change greater than all others in the row being considered may represent a cracked blade. Or in fact, these two blades should be inspected with all means available such as the MPT to determine if crack indications or other detrimental factors are present. In this actual case the two blades were pulled and subjected to MPT, X-ray inspection, and fatigue test in an attempt to locate cracks. One of the two blades was determined to be defective by fatigue tests, the

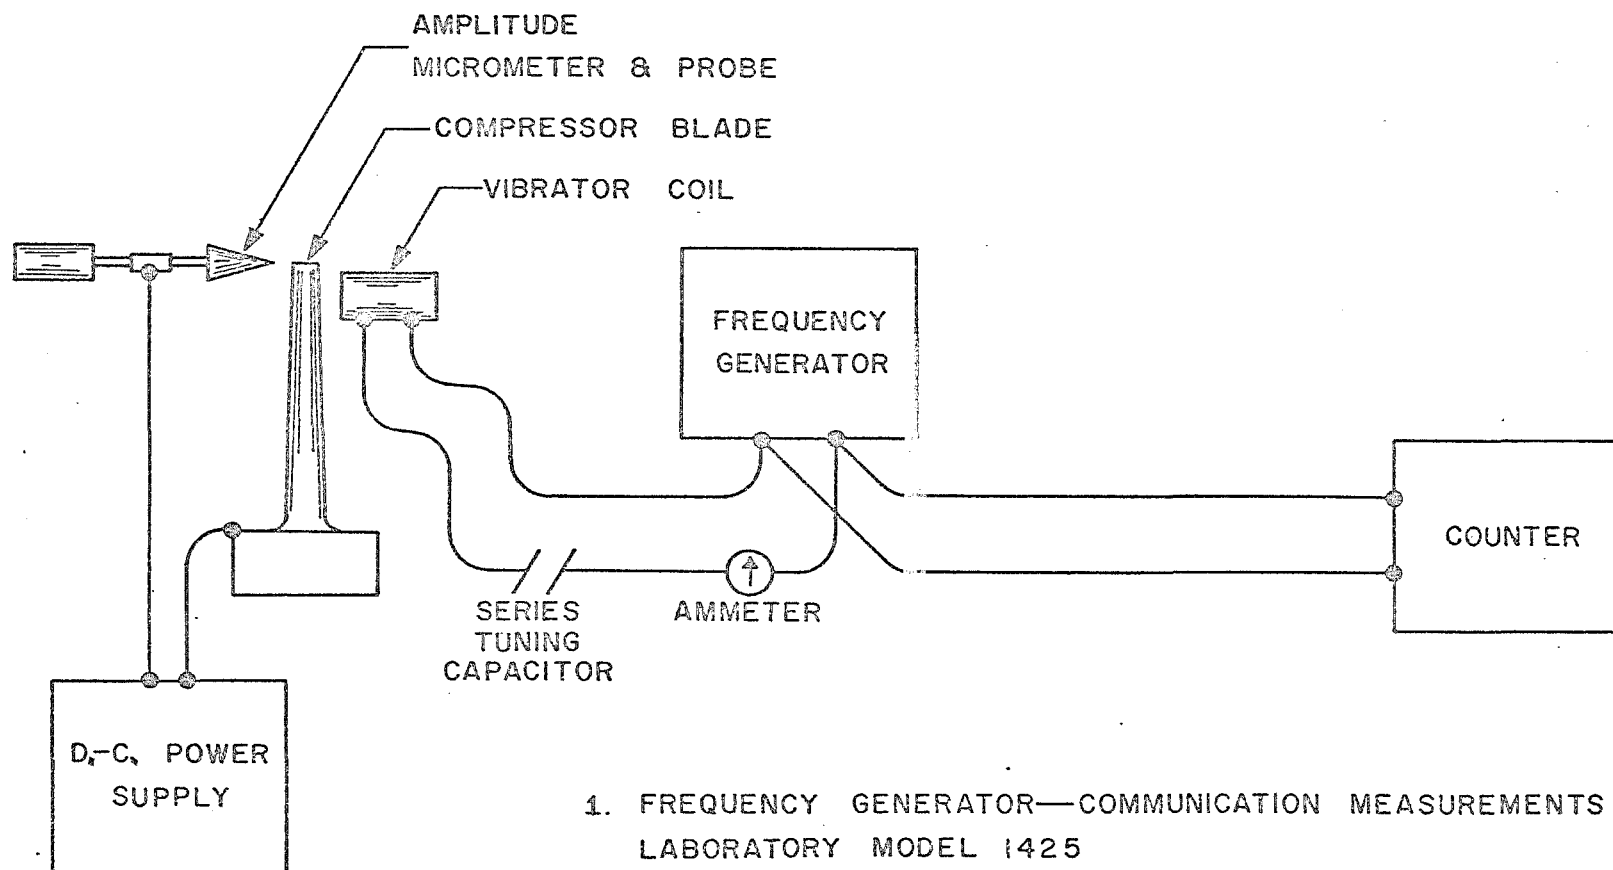
Fig. 2 Apparatus for Fatigue Testing Compressor Blades

Components and connections for the fatigue tests are shown in Fig. 2. The apparatus and connections used to obtain natural frequency data of installed rotor blades are shown in Fig. 3.

To vibrate the blade, the coil was positioned as close to the blade as possible, yet far enough away to provide a clearance between the blade and coil when the blade was vibrating. Approximately two microfarads were connected in series with the coil to approximate series resonance. The test components and connections are given in Figs. 2 and 3.

To avoid the difficulties associated with strain gages, the spark gap apparatus, shown by Figs. 1 and 2, was developed from ideas presented in Ref. 1. Blade tip amplitude was established by setting the output of the power supply to 500 volts, advancing the probe to the vicinity of the blade until an electric arc occurred, and then setting a value on the micrometer corresponding to the tip deflection desired. The blade was then excited by raising the output power of the frequency generator until an arc was produced. It is reported in Ref. 1 that the arc so produced is approximately 1/100 millimeter. The method used to compute the tip deflection for a given reference stress is given in the appendix.

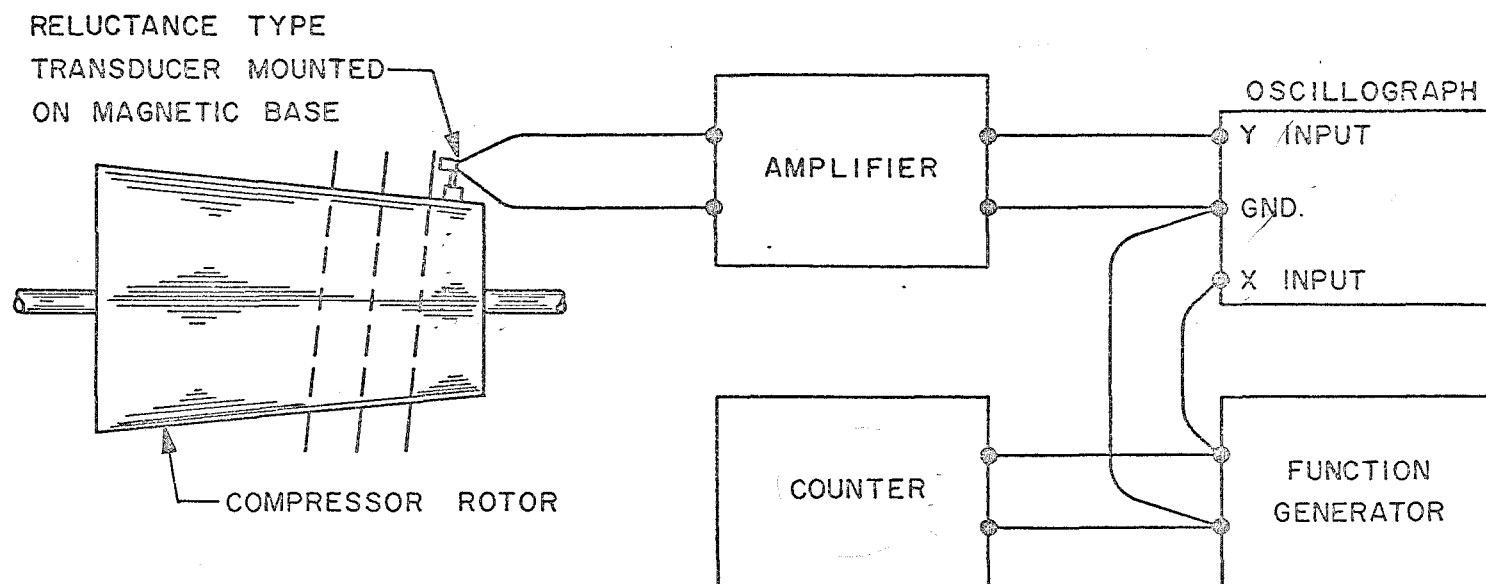
Fig. 3 Apparatus Used to Determine Frequency of Compressor Blades

Figure 3 indicates schematically the method used to determine the fundamental frequency of blades while they were installed in the compressor rotor. The same method was employed in the laboratory.

1. FUNCTION GENERATOR—HEWLETT-PACKARD MODEL 202A
2. COUNTER—BERKELEY EPUT METER MODEL 554A
3. AMPLIFIER—HEWLETT-PACKARD MODEL 450A
4. OSCILLOGRAPH—DUMONT TYPE 304A

The blade was struck with a plastic hammer, and the vibrations produced were detected by the transducer, amplified, and applied to the y-axis input of the oscillograph. While the blade was vibrating,

the output frequency of the function generator, which was applied to the x-axis input of the oscillograph, was adjusted to obtain a Lissajous circle on the oscillograph. A Lissajous circle was produced as a result of blade frequency being equal to the function generator frequency. The function generator frequency was displayed by the counter, and this value was recorded as the fundamental frequency of the blade.

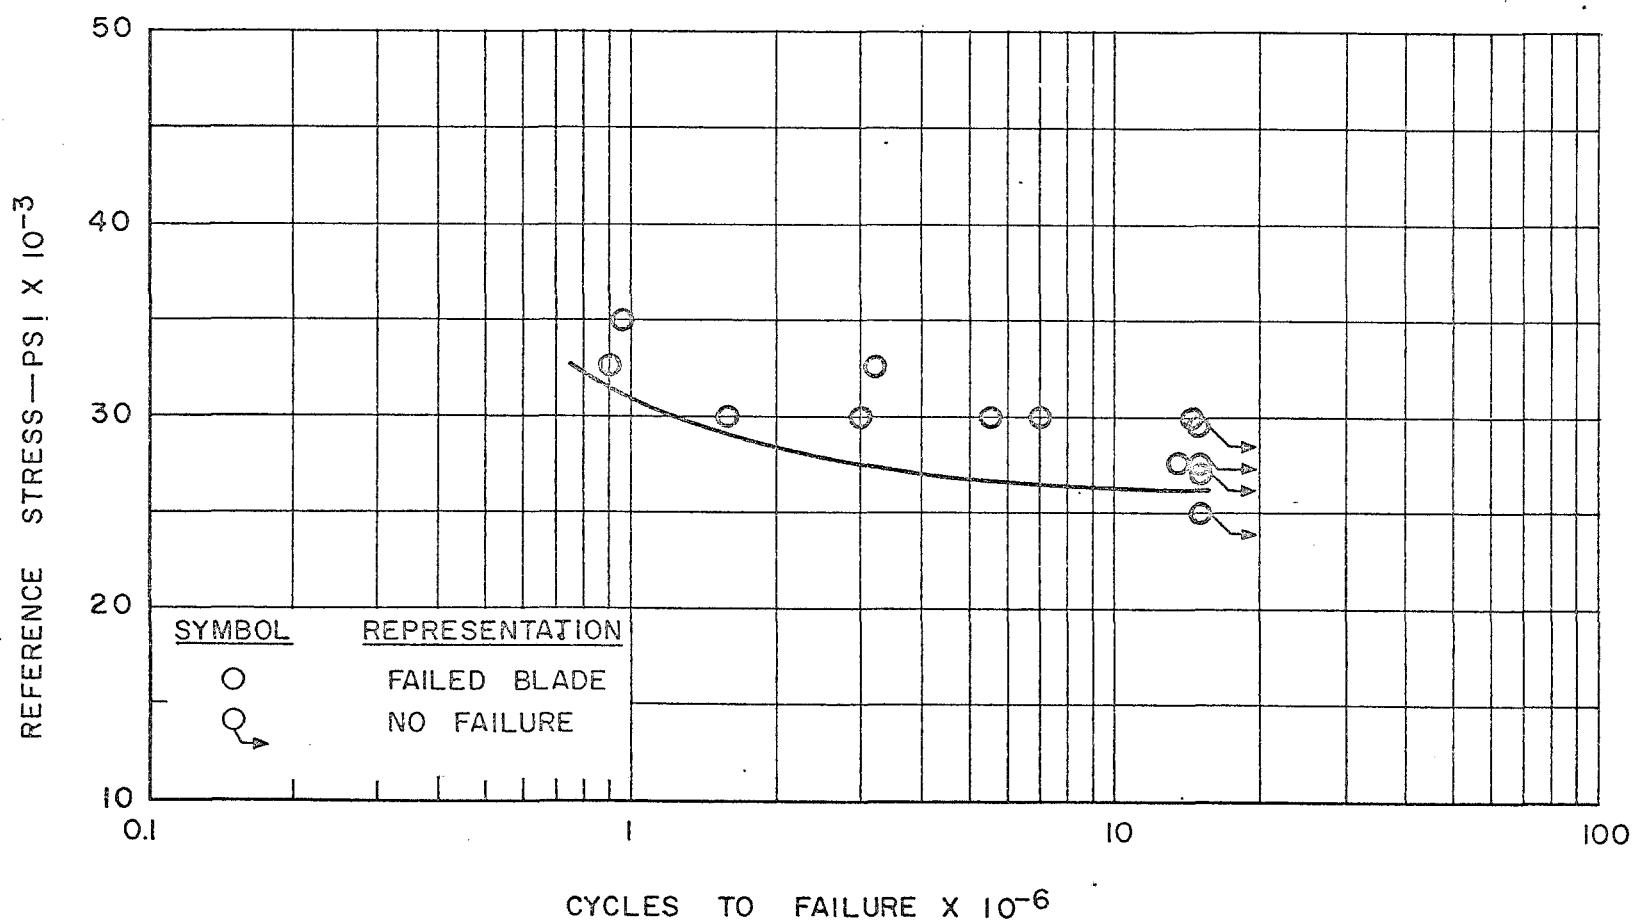
Fig. 4 Variation of Cycles to Failure under Completely Reversed Stress for Type-8630 Compressor Blades

Stress versus cycles to failure data are presented for each type of blade that has been used in VKF (Figs. 4, 5, and 6). The three curves were obtained to provide a comparison of the operating endurance limits of the blades and to form a basis for verification of failures when used blades were fatigue tested.

The data obtained indicates that the type-403 and type-8630 shot-peened blades have higher fatigue strengths than the original type-8630 blades. The most significant improvement is shown to be in the type-403 blade which has an indicated endurance limit of 44,000 psi as compared to an indicated endurance limit of 27,000 psi for the type-8630 blade.

It was considered that the S-N curves of Figs. 4, 5, and 6 represent the fatigue life of a normal compressor blade as used in VKF. If a suspected blade failed to exhibit a fatigue life comparable to the curve, it was considered to have been in the process of failing when removed from the compressor. Conversely, when the fatigue life of a suspected blade compared favorably with the curve, it was considered to be a sound blade if other methods could detect no failure.

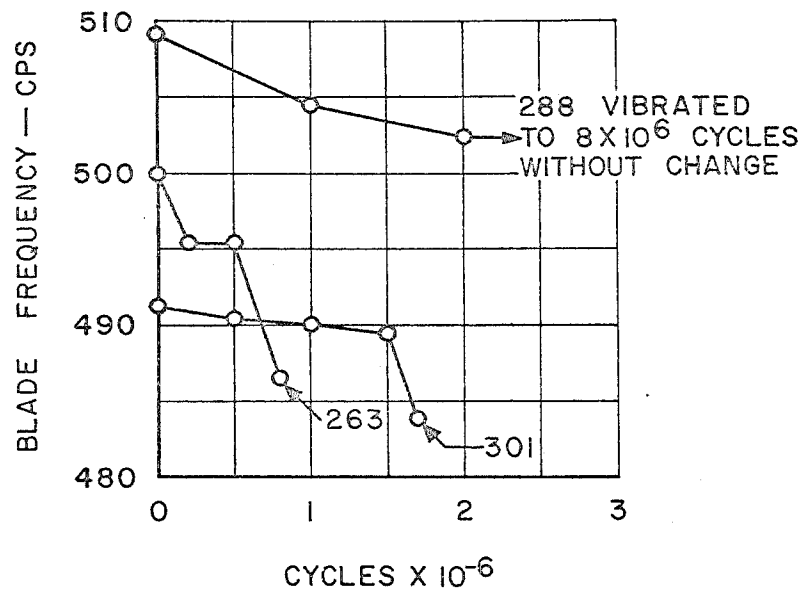
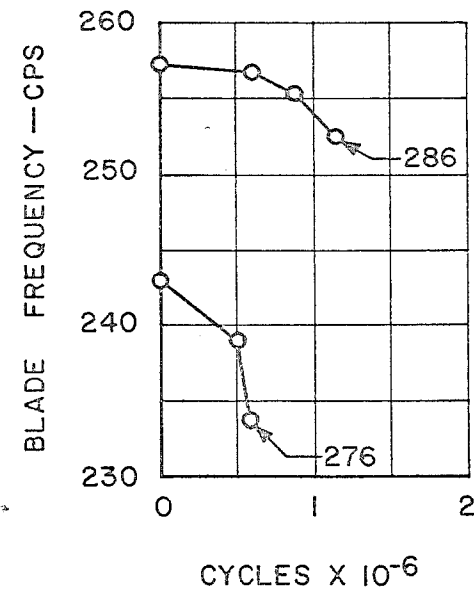
Fig. 7 Variation of Blade Frequency with Cycles of Vibration at 32,500-psi Stress

The degree of agreement between the fatigue life of a suspected blade and the controlling S-N curve may be seen by comparing Fig. 7 with the proper S-N curve. Figure 7 shows the fatigue test history of some representative type-8630 blades, all of which cracked during the test (with the exception of blade no. 288), and the crack was positively detected at the terminus of the frequency versus cycles to failure curve. When a blade such as no. 263 was compared to the S-N curve of Fig. 4, it was expected from the S-N curve that a failure should occur at better than 800,000 cycles at the stress level of 32,500 psi, whereas the history plot of Fig. 7 shows that the frequency of the blade decreased 5 cps during the first 300,000 cycles of testing. Since the S-N curve of Fig. 4 was compiled by plotting the point at which the blade made a sharp decrease in frequency rather than when the crack was discovered by conventional means, the comparison shows that the test blade was failing as soon as the fatigue test started. The failure point of all the blades of Fig. 7 (except 288) was considered to be at the start of the test. This is verified by the rates of frequency decrease at the beginning of the test which are greater than expected as a result of temperature increases.

Blade no. 286 of Fig. 7 does not show a rapidly decreasing frequency initially, but the rate of frequency change became larger as the test proceeded and did not become stable in frequency after warm-up as with sound blades. This blade gives the impression that failures were occurring slowly at the start of the test and most certainly between 600,000 and 800,000 cycles.

The other blades shown in Fig. 7 follow the characteristics of blade no. 263 initially, which is an indication of when the failures started; however, the manner in which the frequency decreased, and during certain periods did not decrease, may be an indication of the rate of growth of fatigue cracks. For example, blade no. 263 exhibited a stable frequency between 300,000 and 500,000 cycles and there after decreased until a large surface crack was detected. As a comparison, blade no. 276 never exhibited a stable frequency while being tested. The stable frequency periods of the plots may be periods when cracks are not growing, and the remaining section of the blade is being fatigued as if it were a blade of reduced cross section.

Included in Fig. 7 is the history of blade no. 288 which has a compressor history of a decreasing frequency and fatigue test of a decreasing frequency until at two million cycles the frequency became fixed and did not change even to eight million cycles. A crack was not found on this blade by the MPT. X-ray inspection revealed inclusions near the tip of the blade, which is not uncommon for the type-8630 blades and is not necessarily a proof of internal cracking. Although blade no. 288 is the only case of its kind ~~that was not cracked~~ during this test, its history is included to show what may be one limitation to the frequency method. This blade has shown a severe decrease from the initial frequency, yet its frequency became stabilized and the expected life was not decreased.

Another limitation of the frequency method is shown by the shape of curves 263 and 285 of Fig. 7. Here the frequency starts decreasing, becomes constant for a period of time, and then continues to decrease. If two comparative frequency data were taken during the time the frequency was constant, no differences would be noted, and yet the blade would be cracked. Under these circumstances, the blade would not be detected by the frequency method. However, this limitation would not apply where periodic frequency readings are started with installation of the blade.

The effect of temperature was necessarily considered when interpreting the curves of Fig. 7. For rows 1 through 6 blades, an approximate 1-cps decrease in frequency during the first million cycles was attributed directly to the increasing temperature of the vibrating blade. For rows 7 through 9 blades, the temperature of the blade increased more during the first million cycles, and according to observation, the frequency decrease was approximately 2 cps. After the first million cycles, the blade temperature would stabilize, as would the frequency. A crack was detected by noting a frequency decrease rate greater than could be attributed to the temperature effect.

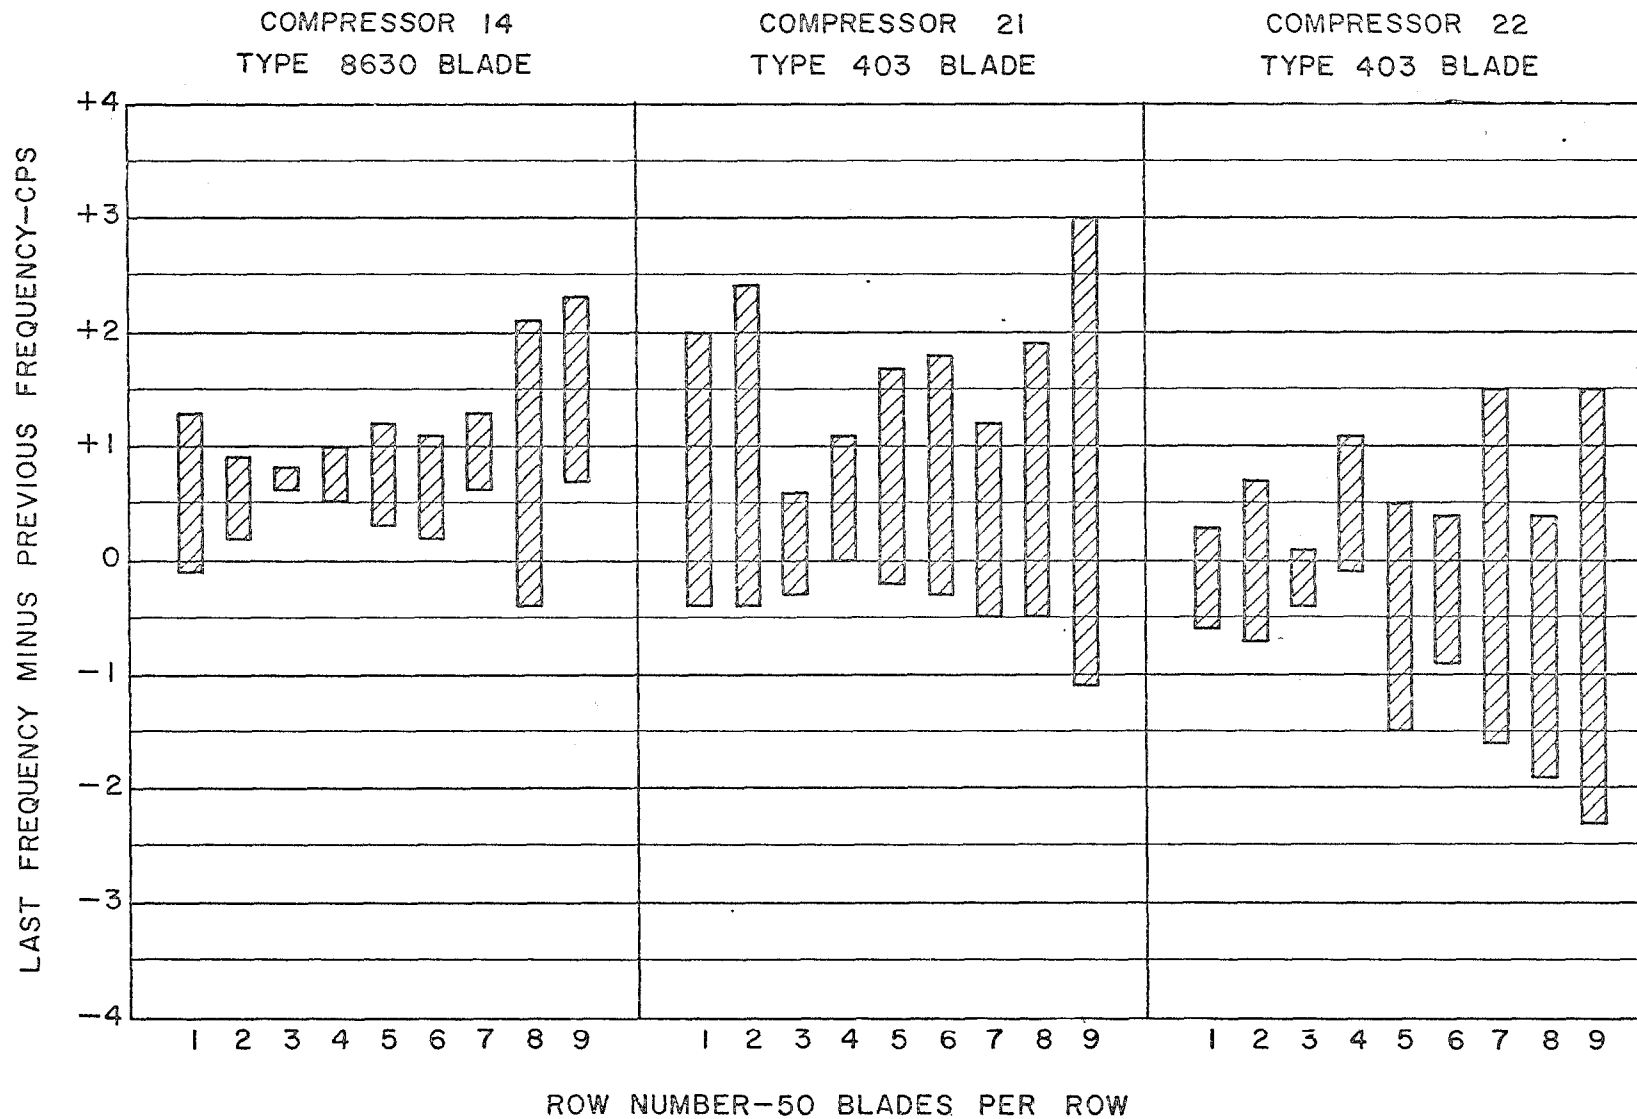
Fig. 8 Range of Differences between Two Rotor Blade Frequency Data

This example is given for row 1 of compressor no. 14 and is further represented as the first bar of the graph of Fig. 8. Figure 8 also shows a bar for the range of frequency differences of every row of each axial compressor in VKF. The graph of Fig. 8 shows such random behavior of frequency differences between row numbers that it appears impossible to fix any universal frequency change as a criteria for suspecting a defective blade.

The success of such detection depended on controlling or accounting for all factors which would naturally change the frequency of the blades. Practically, such factors as ambient temperature could not be controlled. Therefore, the frequency differences were considered statistically so a normal variation of differences could account for the uncontrolled effects of temperature, accuracy, etc. With a normal grouping of frequency differences, a blade which was in the process of failing or undergoing an undesirable change, such as loosening of the fastening nut, the frequency decrease between successive investigations would be significantly outside the grouping of the distribution. Blades removed during the March 1961 maintenance period exhibited frequency decreases greater than the negative values of Fig. 8.

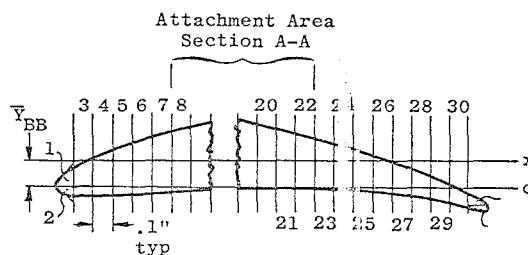
Section B-B (Not to scale)

$$A_{BB} = \frac{\sum_{1}^{32} A}{5^2} = \frac{19.50875}{25} = 0.78 \text{ in.}^2$$

$$I_{BB} = \frac{\sum_{1}^{32} I_{cg} + \sum_{1}^{32} Ad_1^2}{5^4} = \frac{3.864282 + 1.52749}{625} = 0.008627 \text{ in.}^4$$

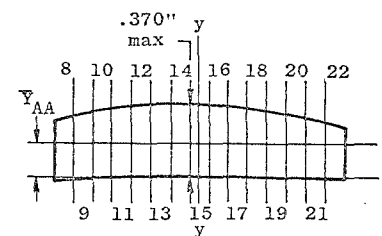
Section A-A (Not to scale)

$$A_{AA} = \frac{\sum_{8}^{22} A}{5^2} = \frac{12.8575}{25} = 0.514 \text{ in.}^2$$

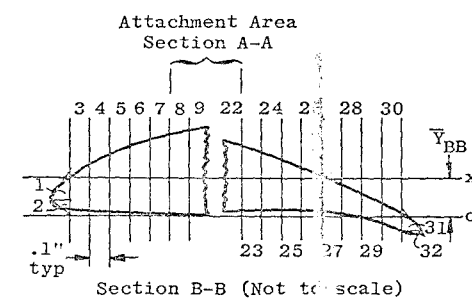
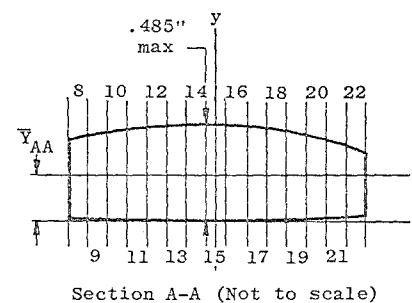
DETERMINATION OF AREA, MOMENT OF INERTIA, AND LOCATION OF THE X-X CENTROIDAL AXIS OF A TYPICAL ROW 1 ROTOR BLADE OF 403 FORGED STAINLESS STEEL

$$A_{BB} = \sum_0^{32} A \times 5^{-2} = \frac{24.7715}{25} = 0.99 \text{ in.}^2$$

$$\bar{Y}_{BB} = \frac{\sum_0^{32} A\bar{Y}}{5 \sum_0^{32} A} = \frac{25.4874}{5 \times 24.7715} = 0.206 \text{ in.}$$

$$I_{AA} = \frac{\sum_8^{22} I_{cg} + \sum_8^{22} Ad_2^2}{5^4} = \frac{6.9961 + .08371}{625} = 0.01133 \text{ in.}^4$$
