Subject: ULTRASONIC WELDING OF REFRACTORY METALS  
Progress Report No. 9  
For the Period 1 June through 31 July, 1962  
Navy Contract No. NOW 61-0410-c

WELDING D-31

Table I  
SUMMARY OF COMPARATIVE TENSILE-SHEAR STRENGTH DATA  
OF ULTRASONICALLY WELDED 0.005-INCH D-31 ALLOY FOIL  
WITH DIFFERENT WELDING PARAMETERS

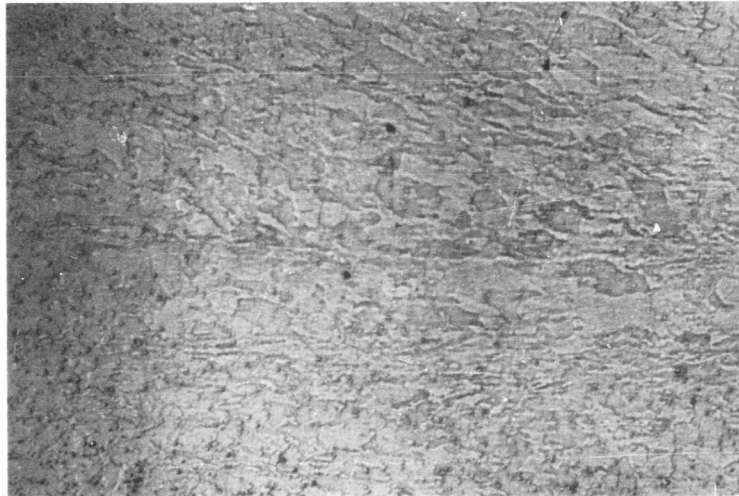
Figure 3

DETAIL A FROM FIGURE 2

Magnification: 500X

- a. "New" D-31 possesses good ultrasonic weldability. Crack-free welds with good tensile-shear consistency can be made, at least with the foil size under study. Figures 3 and 6, for instance, show weld interfaces with complete bonding and lack of surface-film residues.

- f. Welding slightly below minimum clamping force yields poor results (Studies No. 7, 8, Table I; Figures 2, 4; Table II). Some welds made with low clamping force are good (Figures 2, 3) but strength inconsistency exists, with the majority of specimens showing a lack of bonding. Little cracking has been observed. Cracks would be anticipated with the use of low clamping force and the lower-quality material which the specimen stock in Study 7, Table I apparently is.
