Final Report on a Program to  
Develop a System for the Inspection  
of Soldered Electrical Joints  
Under Contract DA-30-069-507-ORD-3252  
Covering the Period  
March 4, 1961 through June 30, 1962

Eastman Kodak Company  
Apparatus and Optical Division, Lincoln Plant  
Rochester, New York

This document is the final report on a project to develop a method and apparatus for the rapid inspection of soldered joints in electrical assemblies. The information contained is divided into two major sections: (1) a summary of the entire program and (2) a detailed discussion of the efforts accomplished during the final report period. The work was performed by the Eastman Kodak Company under the direction of Frankford Arsenal and in accordance with Contract DA-30-069-507-ORD-3252.

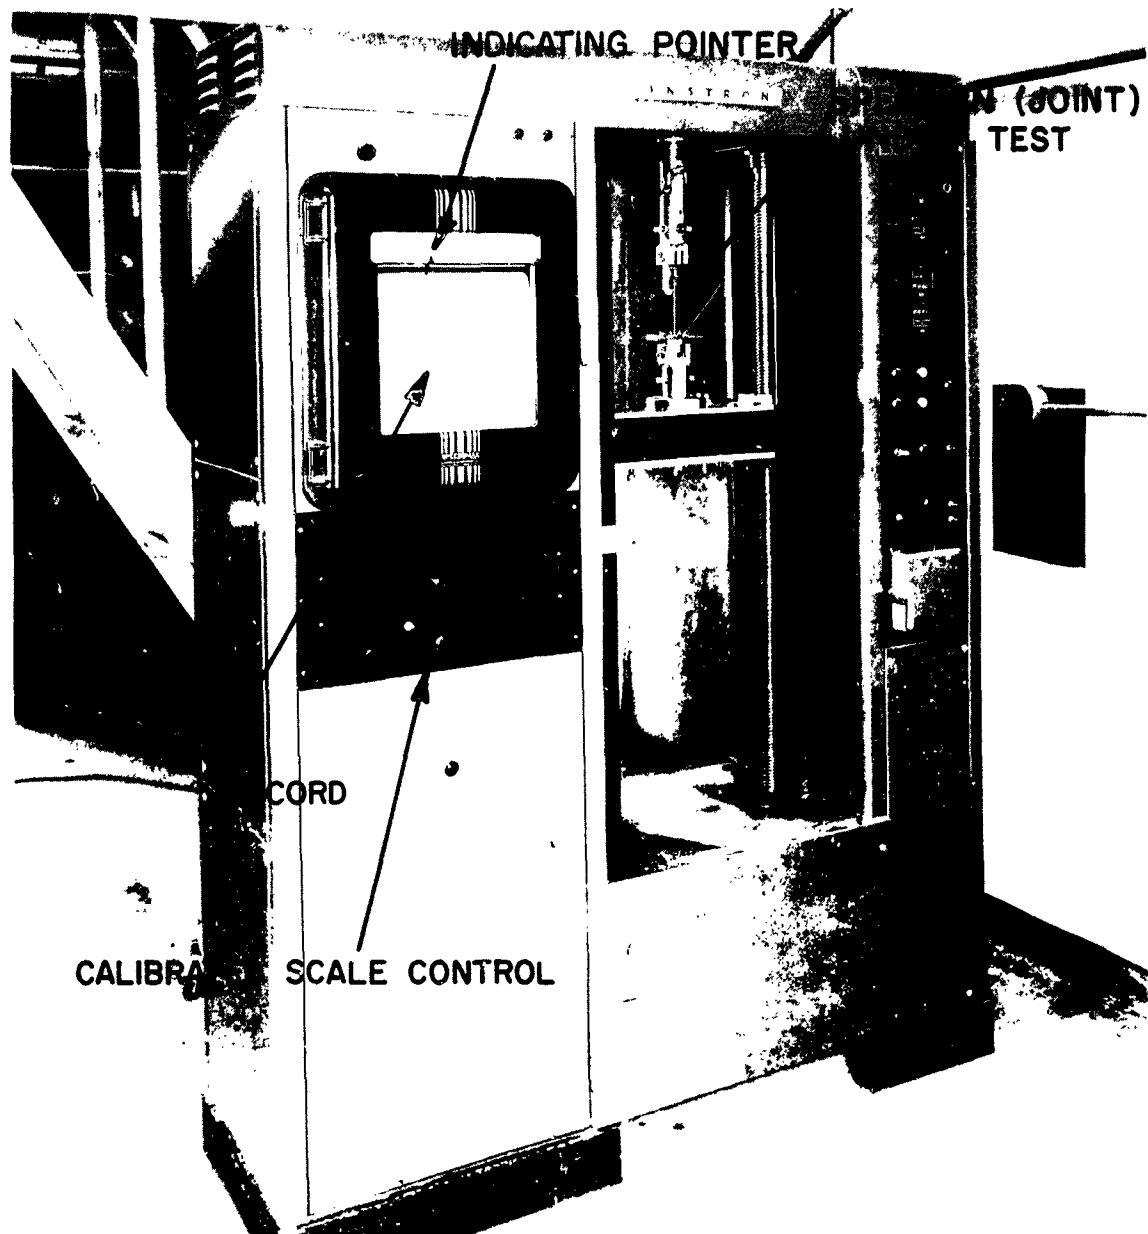
Figure A6. INSTRON WIRE TESTING TENSILE MACHINE

| <u>Parameter</u> | <u>Specification</u> | <u>Identification Code*</u> |
|---|---|---|
| c. Method | a. Pull from insulation side and record force in pounds required to cause joint failure, using apparatus and fixtures shown in Figures A 6 and A 7. | None |

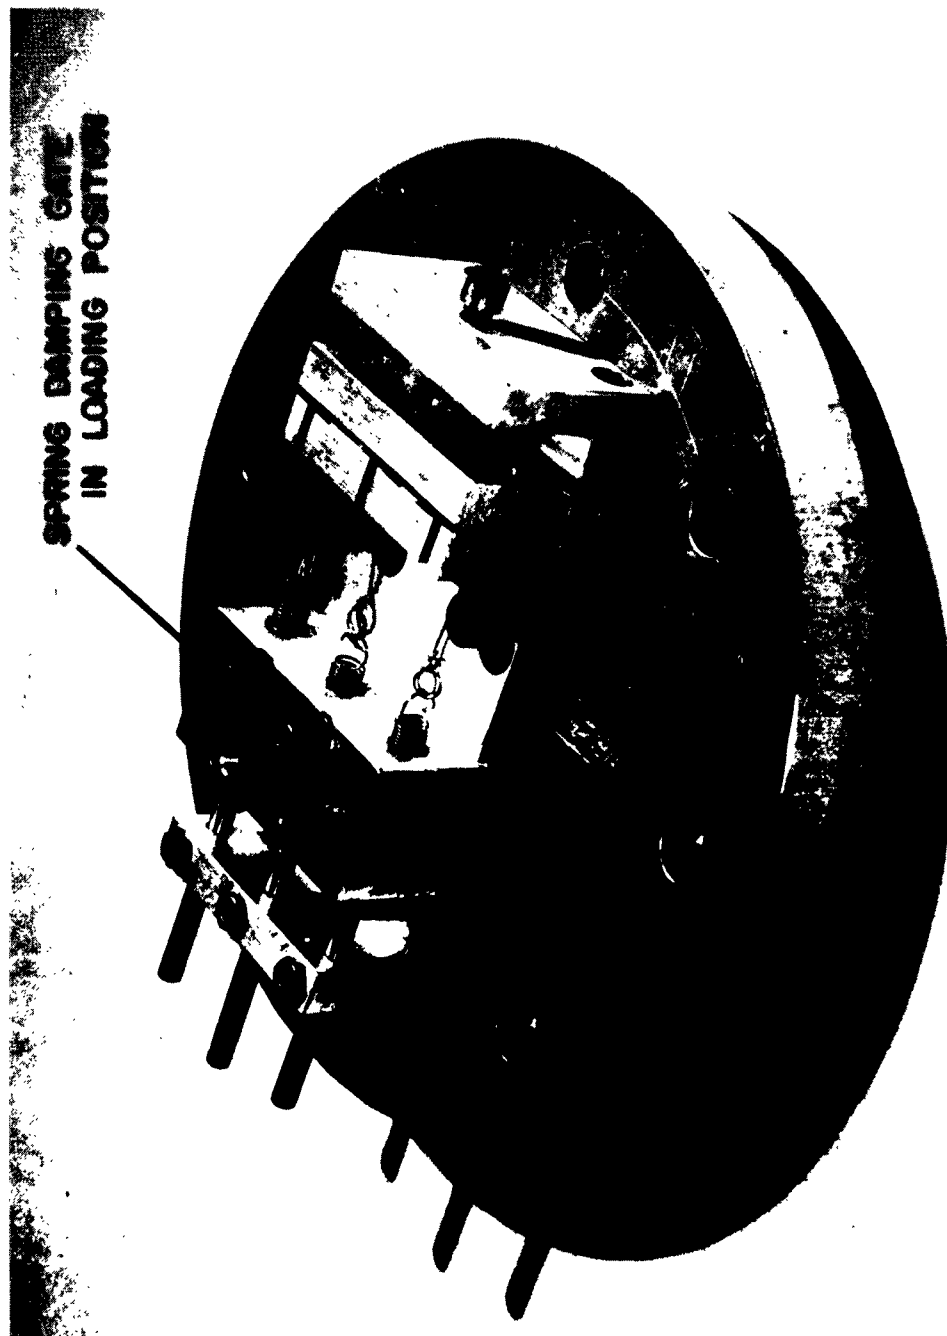
Figure A 11. VIBRATION FIXTURE, GATE OPEN
