Report No. 0162-01TN-62-18

HIGH- AND LOW-TEMPERATURE TESTS  
OF THE AEROJET UTILITY VAN

AFBSD Technical Note BSD-TDR-62-331

**AEROJET-GENERAL CORPORATION**

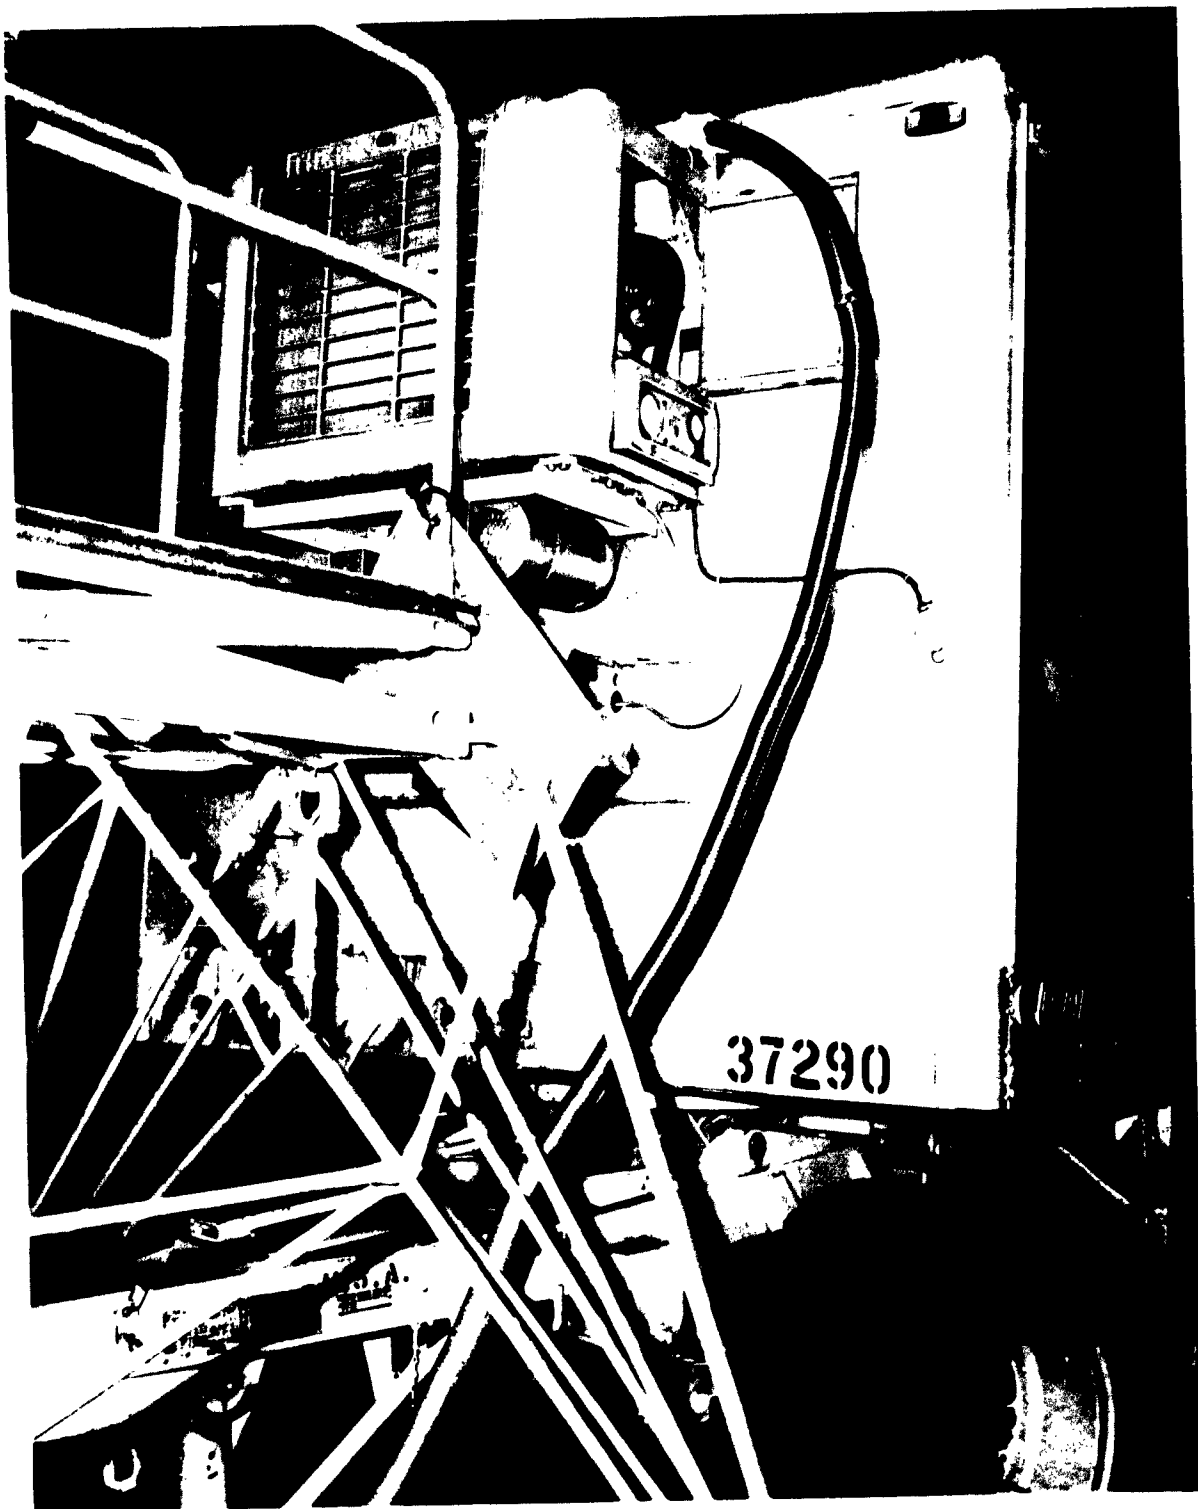
Figure 2

Thermo-King Temperature-Control Unit Installed on Aerojet Utility Van  
(View of Right-Forward Corner of Van)

The interior temperature of the van was regulated by a Thermo-King temperature-control unit, Model K30A. The unit, installed on the exterior forward wall of the van (Figure 2), provided heat from three heater strips powered by

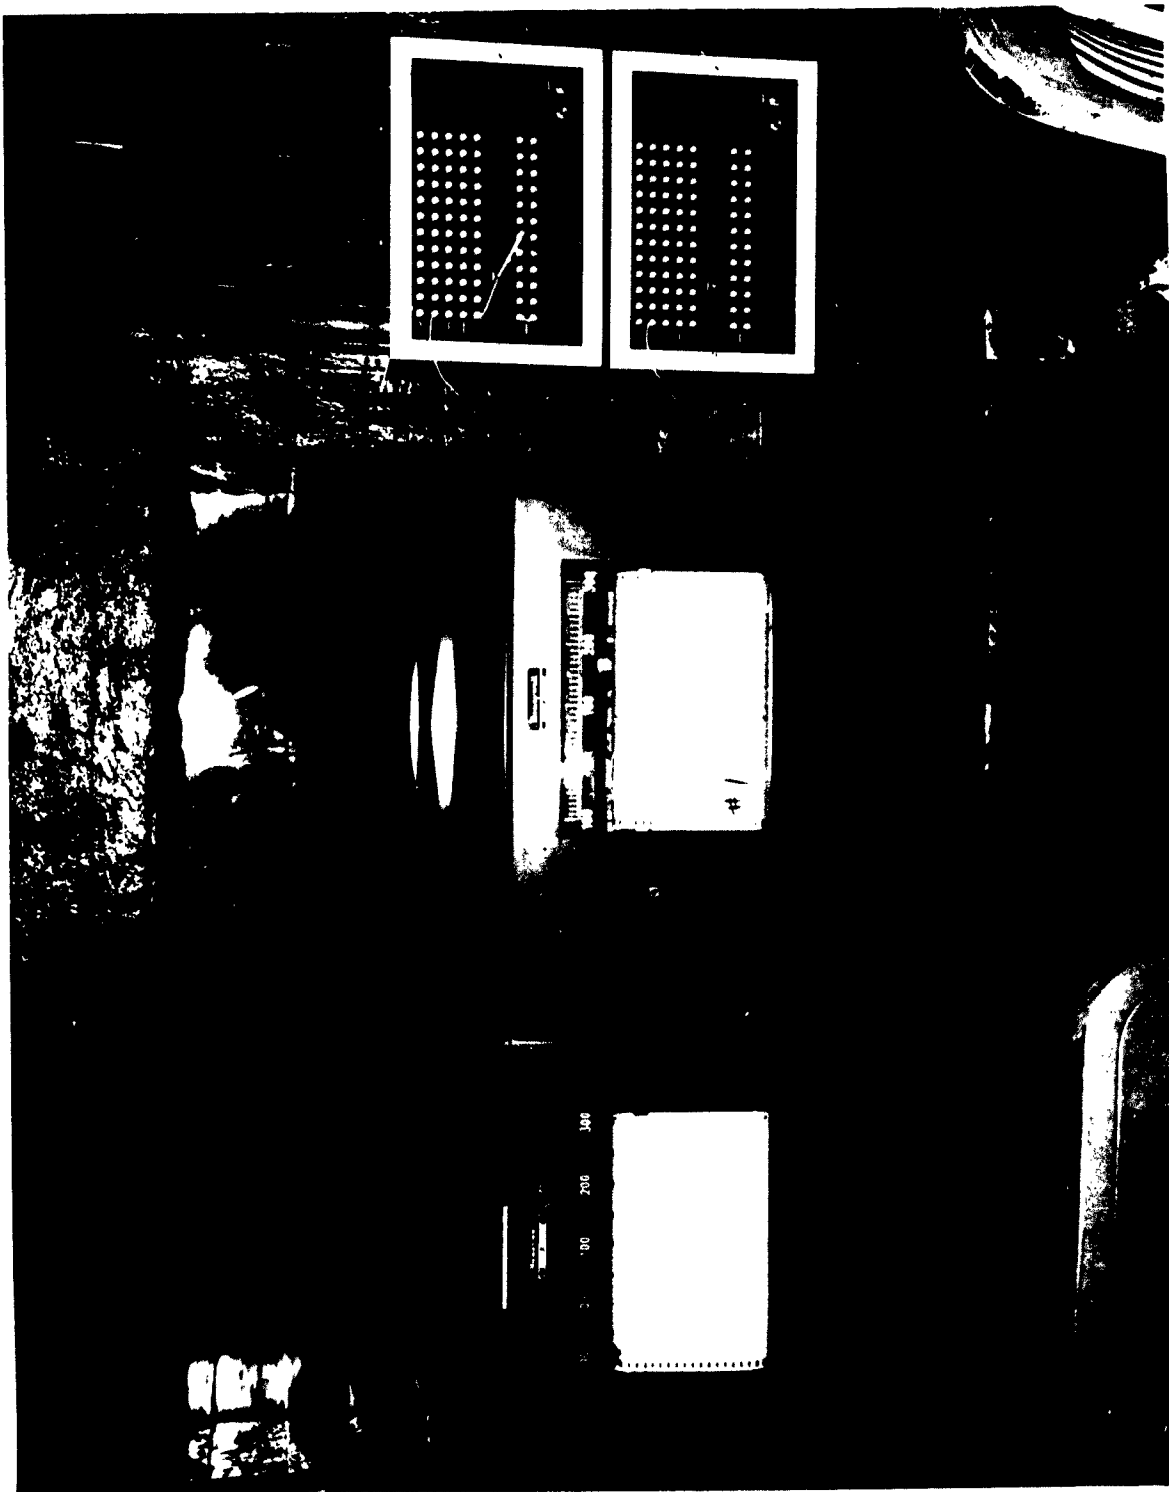
Figure 4

Minneapolis-Honeywell Brown Print-Out Recorder and Standard  
Reference Junction

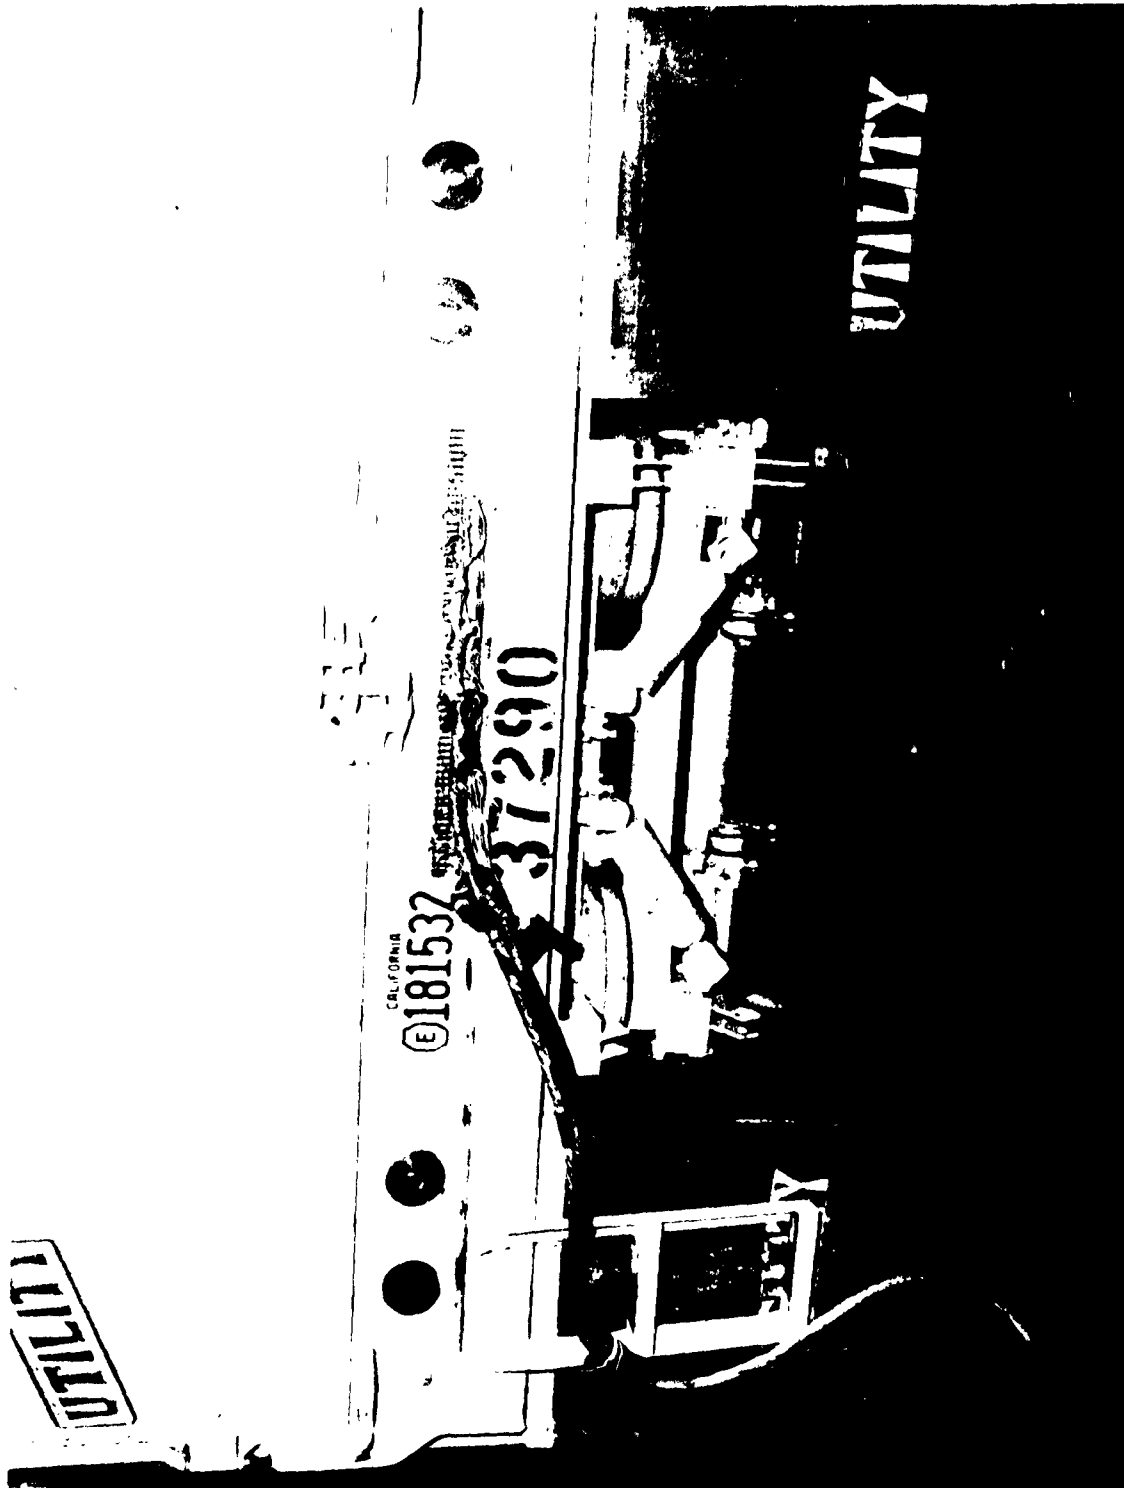
Thermocouple Termination at Aft End of Utility Van

The motor and interior of the van was instrumented with 26 iron-constantan thermocouples (Figure 3) to determine motor-surface and van-interior temperature gradients. All temperature data were continuously recorded on two Minneapolis-Honeywell Brown print-out recorders, Model No. RY153X82-C-II-III (13), serial numbers 322005 and 314315 (shown in Figure 4 with standard reference junction). Calibration input voltage for each  $10^{\circ}\text{F}$  from  $-50$  to  $+200^{\circ}\text{F}$  was applied to each channel by a Leeds-Northrup potentiometer, Model K-2. A plot of this calibration is shown in Figure 5. A continuous  $+150^{\circ}\text{F}$  reference point was provided on each recorder by a standard reference junction manufactured by Pace Engineering Company. Figures 6 through 9 show the instrumentation of the motor. Figure 10 shows the thermocouple termination at the aft end of the Utility van.
