**QUARTERLY PROGRESS REPORT NO. 3  
SEGMENTED ROCKET MOTOR CASE PROGRAM**

**DOUGLAS REPORT SM-42911**

**MISSILE & SPACE SYSTEMS DIVISION  
DOUGLAS AIRCRAFT COMPANY, INC.  
SANTA MONICA CALIFORNIA**

Contract No. AF 04(611)-8184  
AFSC Project No. 3059  
AFSC Task No. 305909  
Program Structure No. 750G

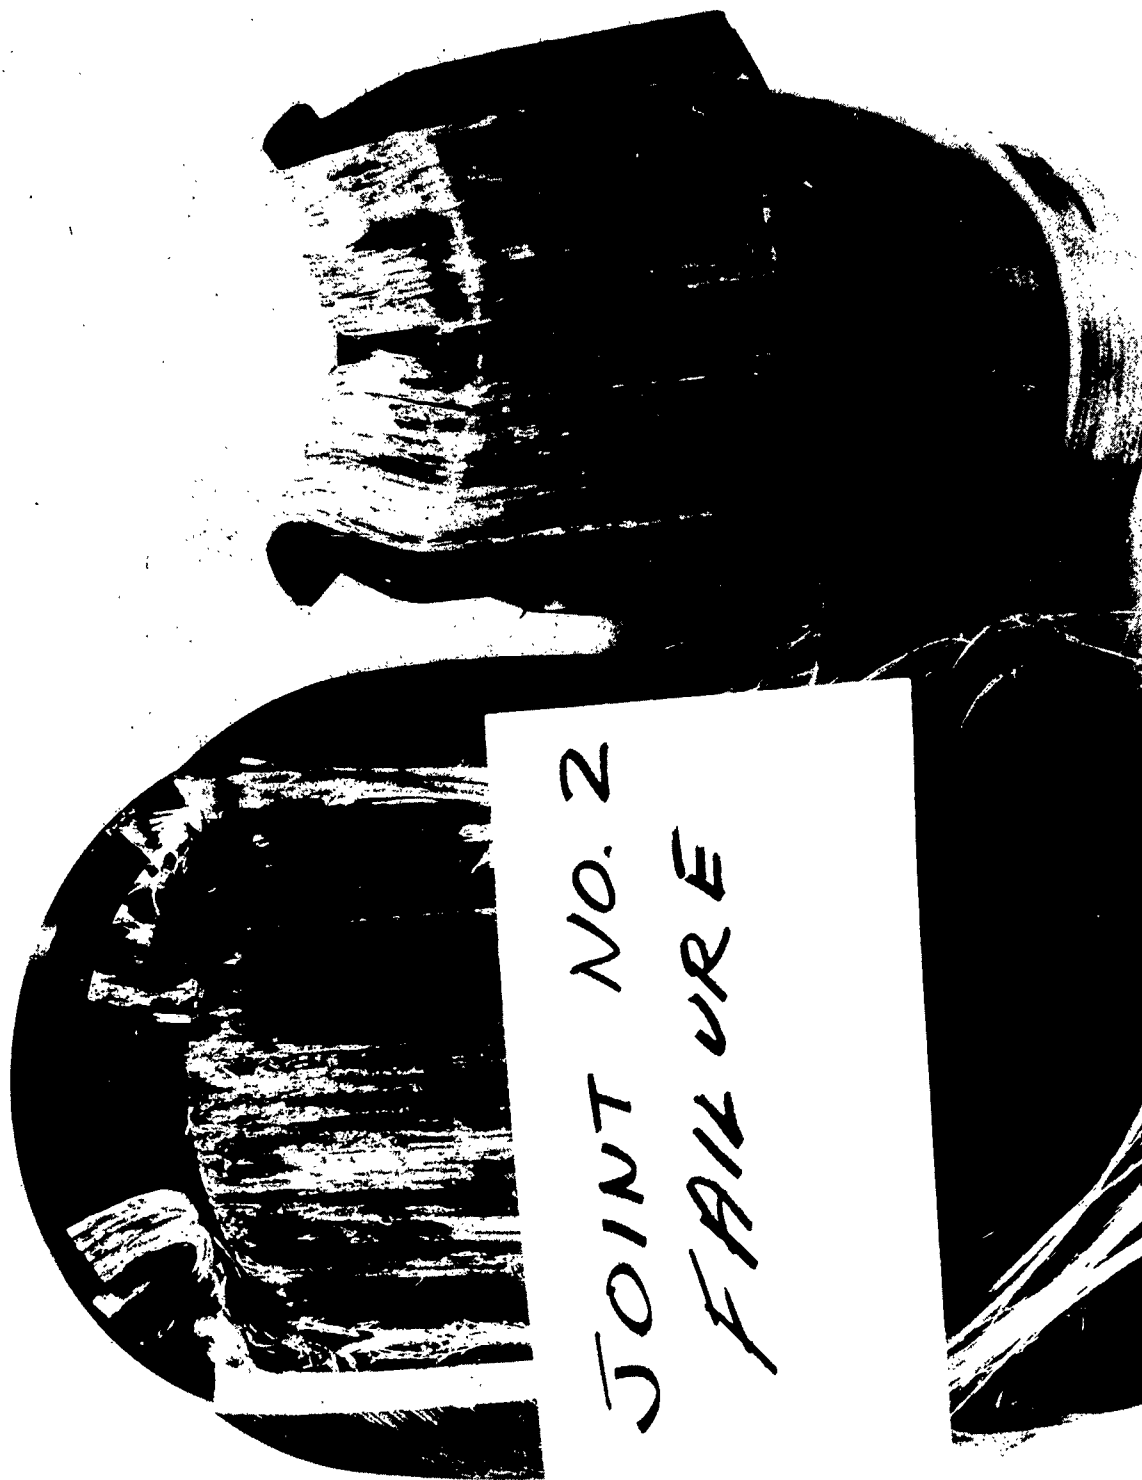
FIGURE 3

NUMBER 2 SEGMENTED JOINT TEST SPECIMEN AFTER FAILURE

The specimen was tested in a 400,000 lb. Baldwin compression-tension machine. It was loaded in tension until it failed. Failure occurred at 181,000 lbs. load due to failure of the fiberglass-to-metal bond (Lefkowied No. 157) which allowed the staves to pull out of the joint (see Figure 3). Failure of the bond at this low load was probably due to diffusion of the adhesive into the fiberglass during cure.

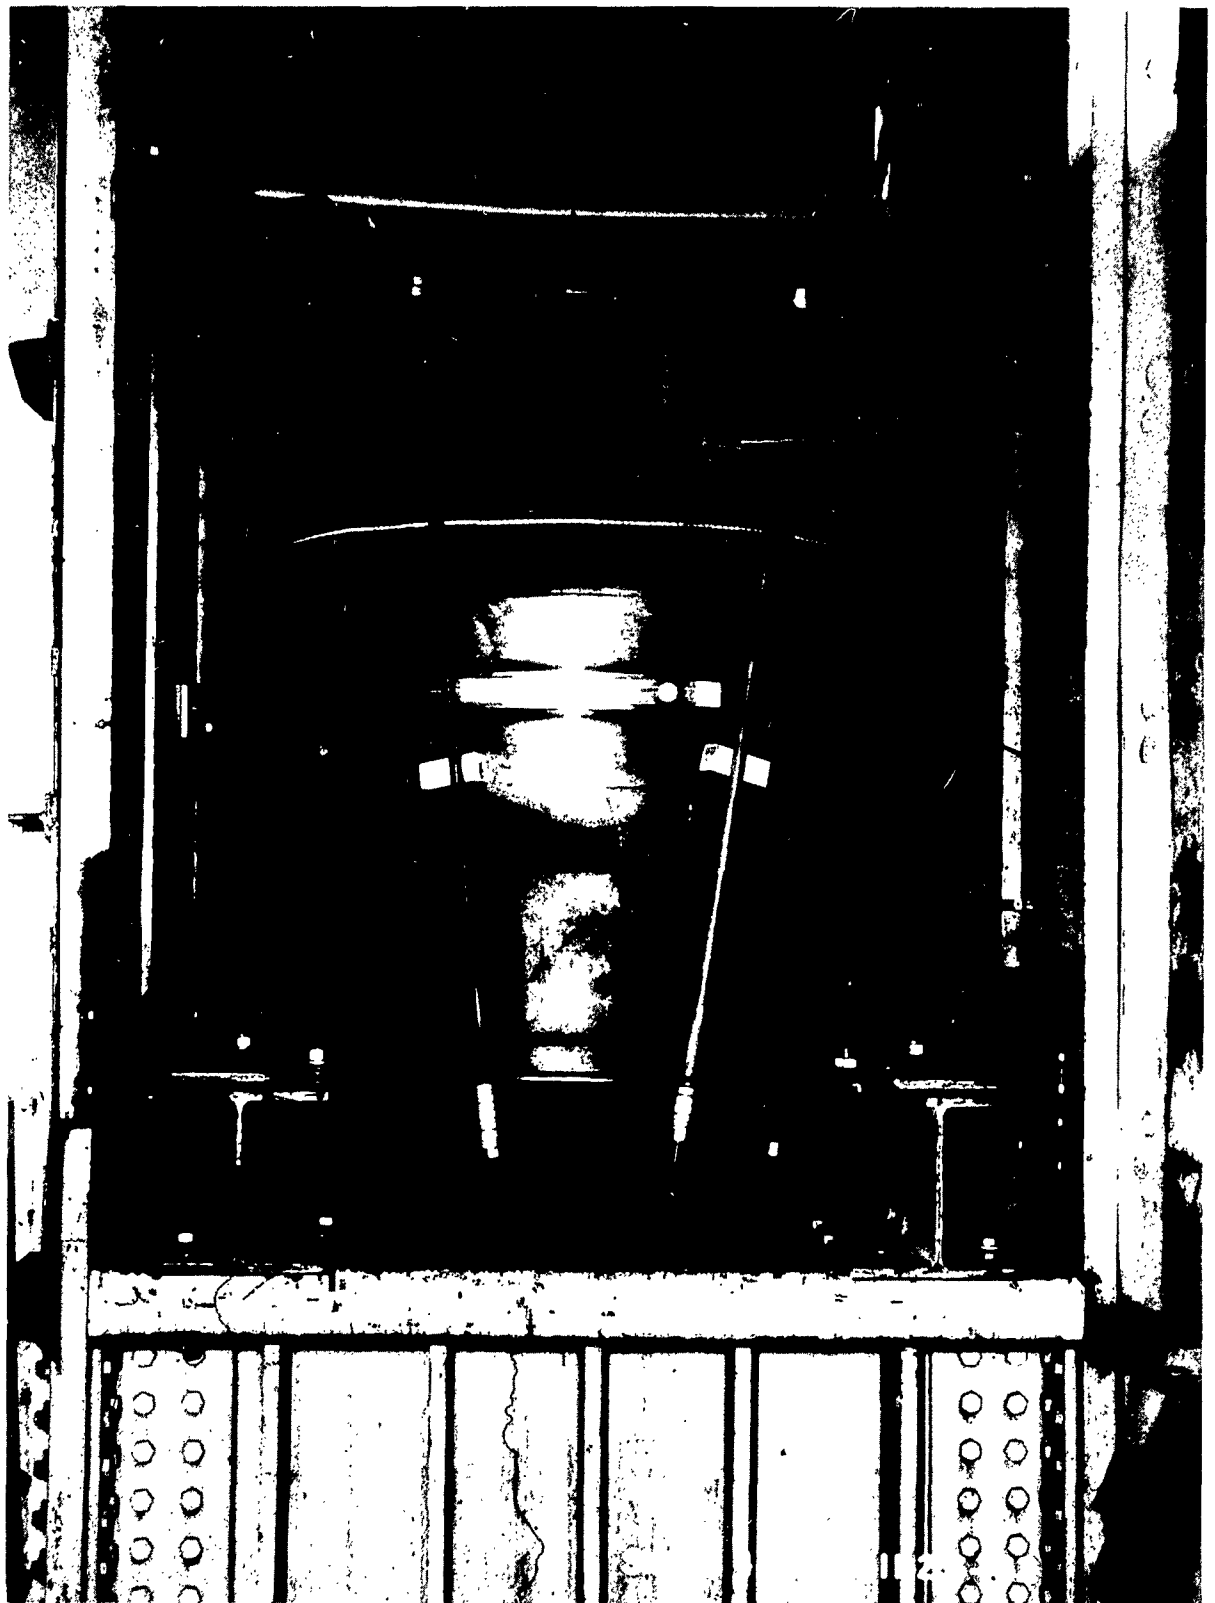
**FIGURE 20**

PROOF TEST SET-UP FOR 43-INCH DIAMETER TEST CLOSURES

Two of the 43-in. dia. test closures were assembled "back-to-back" and production clamps and bands were used to hold them together (see Figure 20). The closure assembly was pressurized, but several of the clamps "rotated" off at 250 psi, allowing the closures to separate and the "O" ring to extrude (see Figure 21). A dimensional inspection of the clamps showed that they had been machined out of engineering tolerance. The closures will be proof-tested again within two weeks. A stronger clamp retaining band has been completed for this second proof test. Also, the clamps have been re-machined within tolerance.
