Report No. 0162-01TN-62-20

STRUCTURAL VERIFICATION TESTS  
OF THE AEROJET  
UTILITY VAN

AFBSD TECHNICAL NOTE BSD-TDR-62-330

Prepared by  
W. D. Hulse  
Mechanical Environment Group

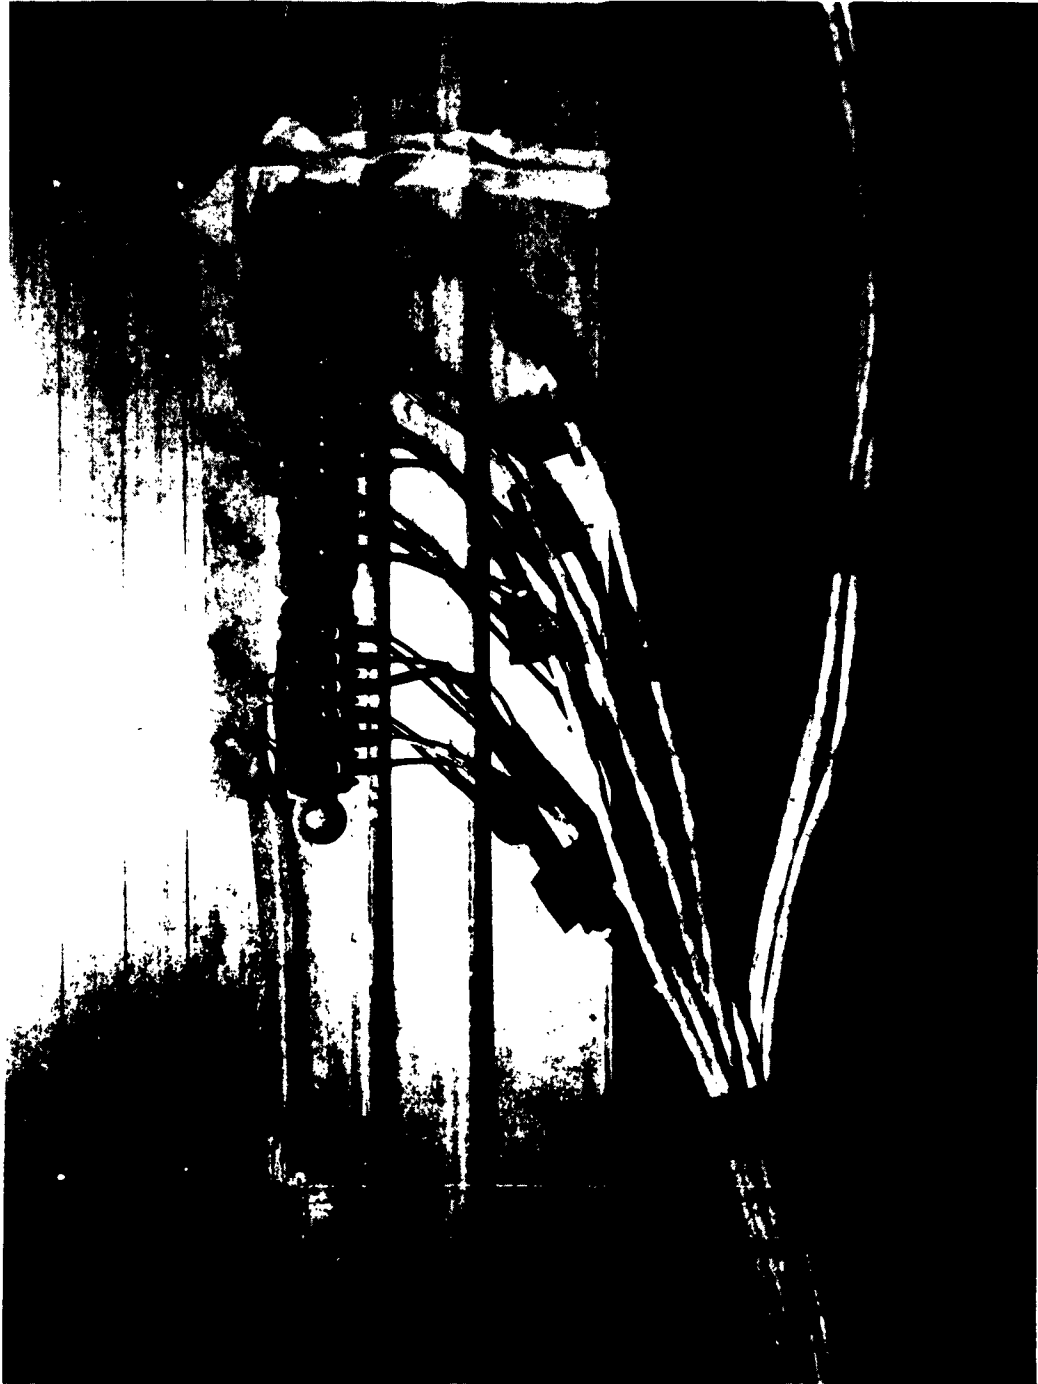
Figure 5

Wiring Detail of Six Strain-Gage Locations

1. Eleven biaxial strain gages were located at critical van load points to determine stress levels (Figures 3 through 5). The strain gages were Baldwin-Lima-Hamilton type AX-5 gages designed to register strain to 20,000 microin/in.

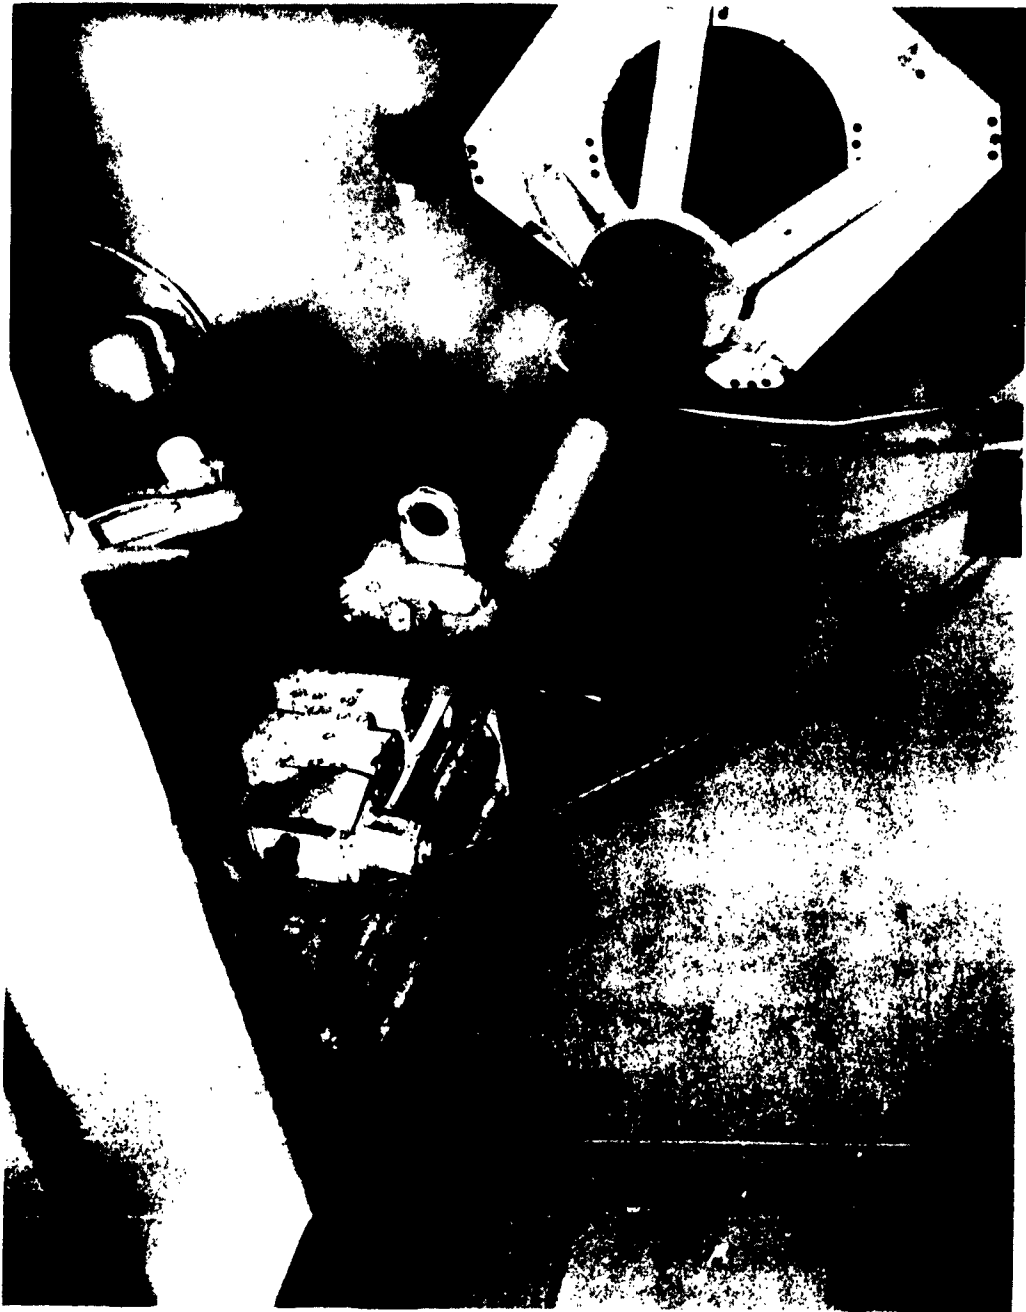
Method of Applying Forward and Aft Loads

With the motor and harness secured in the van to provide a downward vertical load factor of 1.0, additional forward and aft loads of 2.0 were applied and maintained for 5 min. Figure 8 shows the method of applying forward and aft loads. Strain-gage measurements were recorded during this test phase.

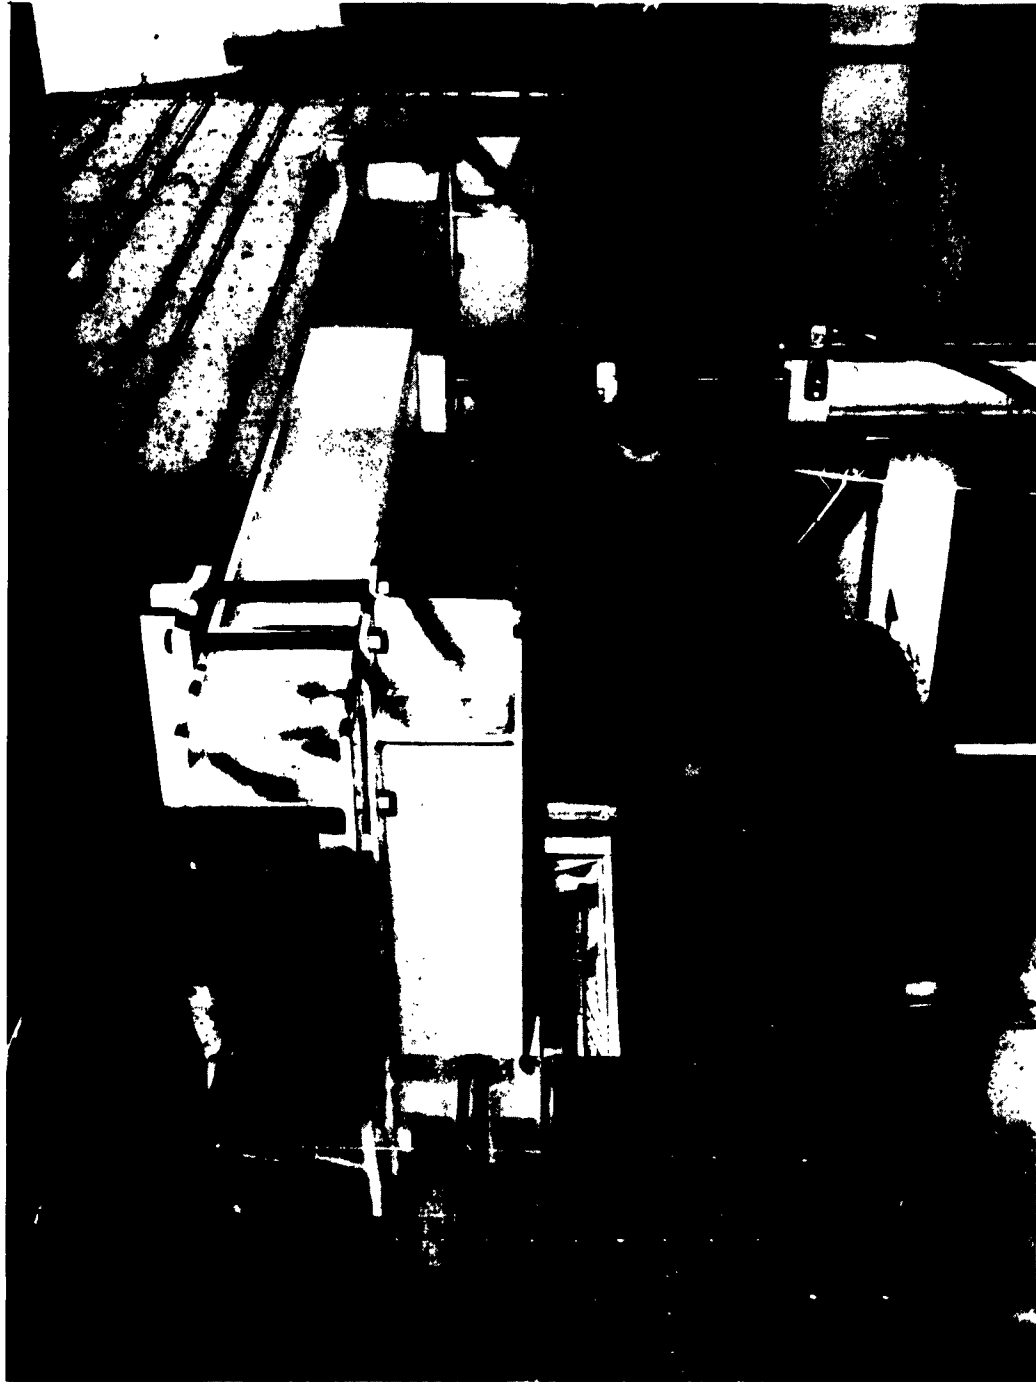
Figure 9

Cross Beams Extending Through Van Access Doors,  
Downward-Load Test

With the van emptied of the motor and harness, a downward load of 3.0 was applied at the areas of harness wheel contact with the van rails. The load was applied evenly and simultaneously to the four points of contact by the hydraulic actuators acting against two beams extending through the side access doors of the van. The load was maintained for 5 min. Both strain-gage and deflection measurements were recorded during this test phase. Figures 9 and 10 show the downward-load test setup.

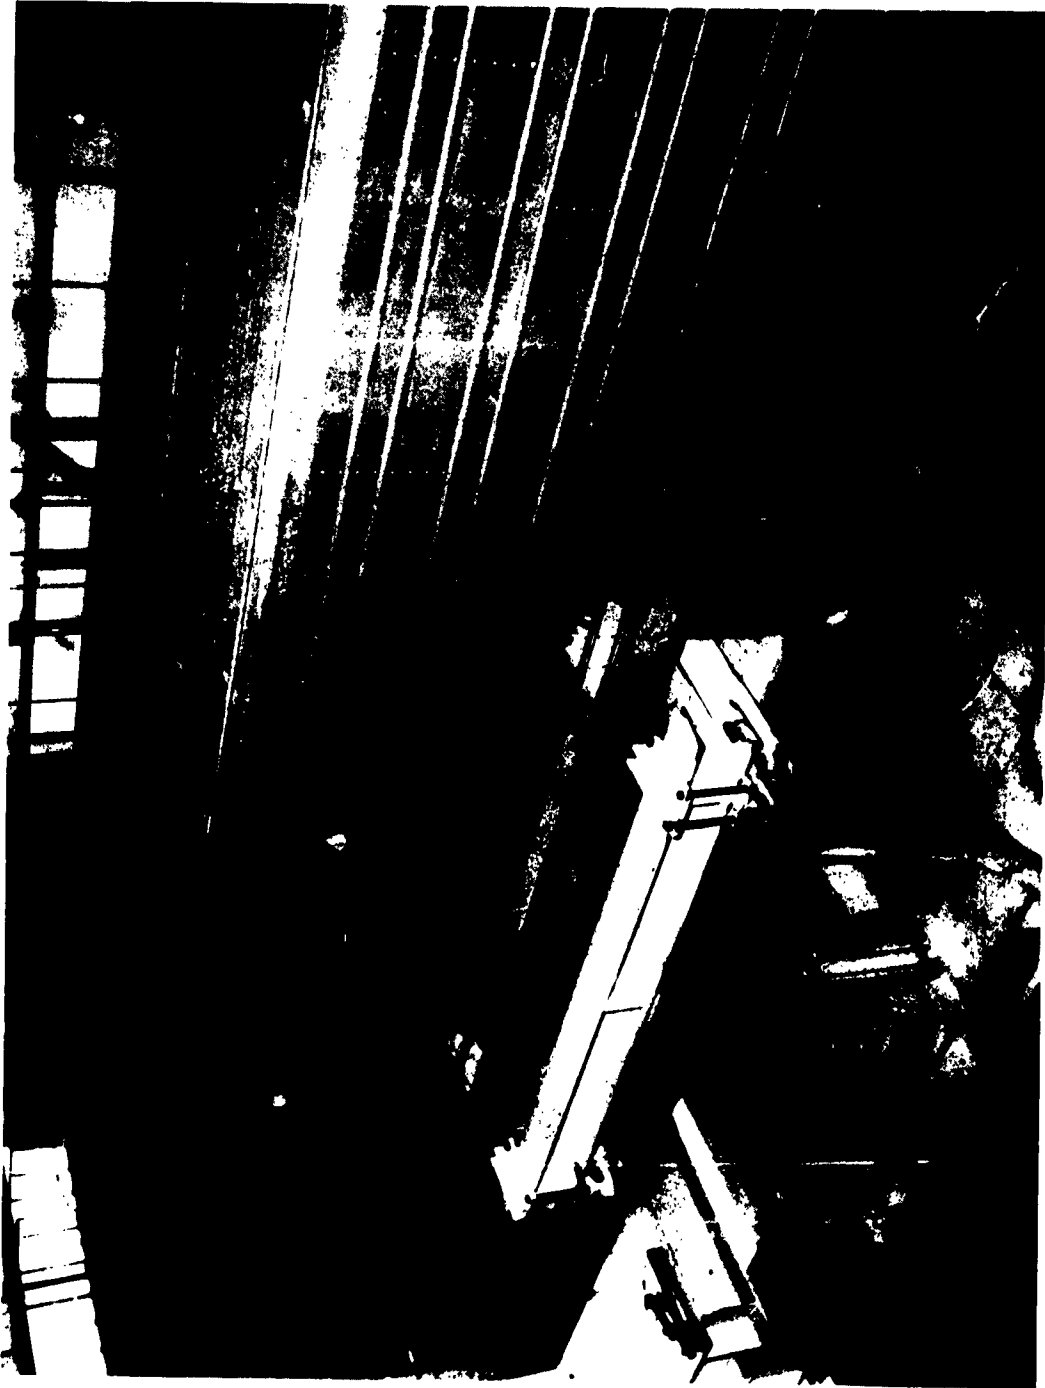
Figure 10

Side View of Test Setup, Downward-Load Test
