Technical Report 1730-TR

DEMOLITION OF CONCRETE LOCKS ON THE OHIO RIVER  
(RESEARCH PHASE)

Project 8F07-10-002

20 November 1962

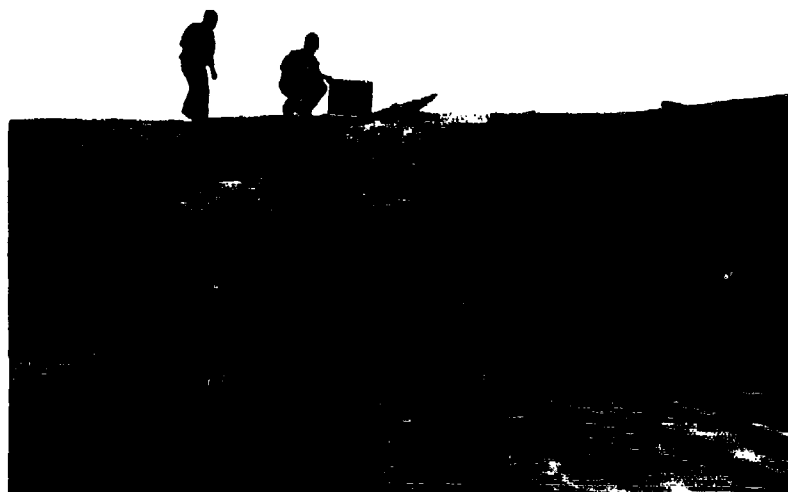
Fig. 4. Crater produced by 50-pound charge on charge side of wall (top) and spall produced on side of wall opposite 50-pound charge (bottom).

b. Results. The first 50-pound charge produced a clear breach of the wall. The crater was 82 inches wide and 55 inches high. The spall was 187 inches wide by 82 inches high (Fig. 4). The second 50-pound charge did not quite breach the wall. The crater was  $20\frac{1}{2}$  inches deep by  $93\frac{1}{2}$  inches wide by 59 inches high, and the spall was 26 inches deep by 166 inches wide by  $61\frac{1}{2}$  inches high.

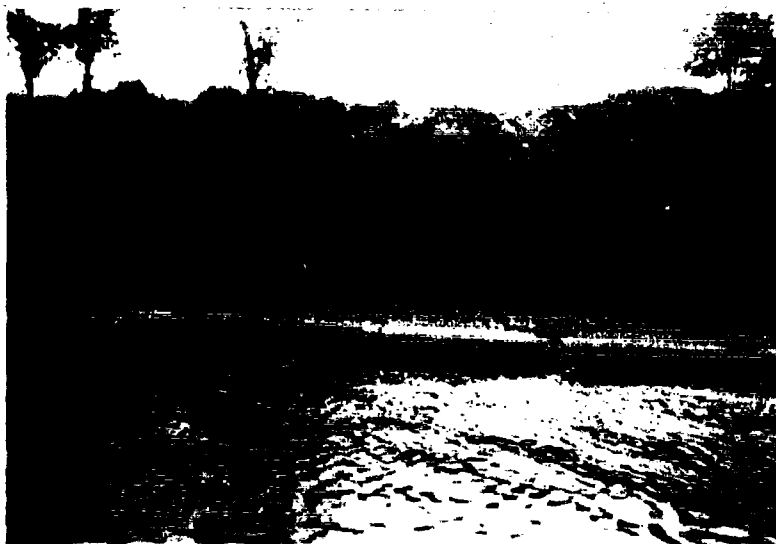
H7694  
Fig. 18. Results of 30-pound charge which had been placed 5 feet under water. Wall was breached at point where charge was placed.

broke off about 10 feet of concrete 4 to 5 feet deep and toppled it back into the water behind the charge (Fig. 17). The next 30-pound charge produced a clean breach but did not topple the wall. The wall was pushed back, however, and a portion of the wall was spalled out from the top rear down as far as could be probed in the silt behind the wall (Fig. 18).

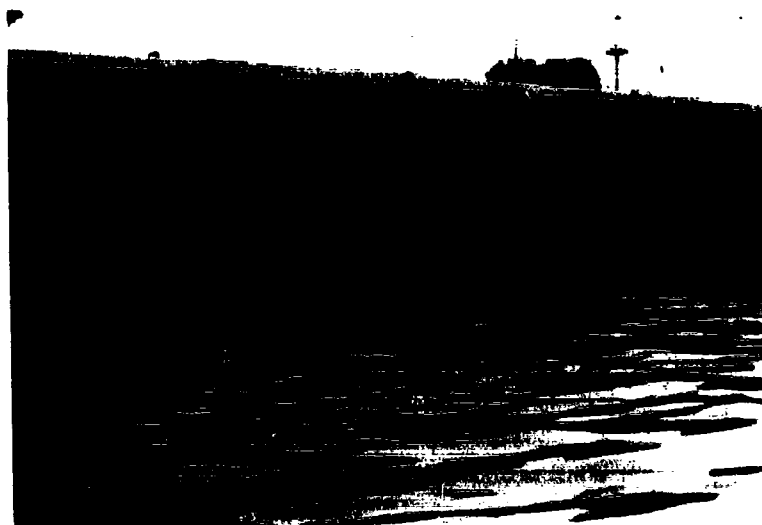
Fig. 21. Crater produced by 45-pound charge fired  $2\frac{1}{2}$  feet under water (top) and spall produced by same charge (bottom).

The 45-pound charge fired  $2\frac{1}{2}$  feet under water produced a good breach, but the spall and the crater were somewhat smaller than the previous shot (Fig. 21).

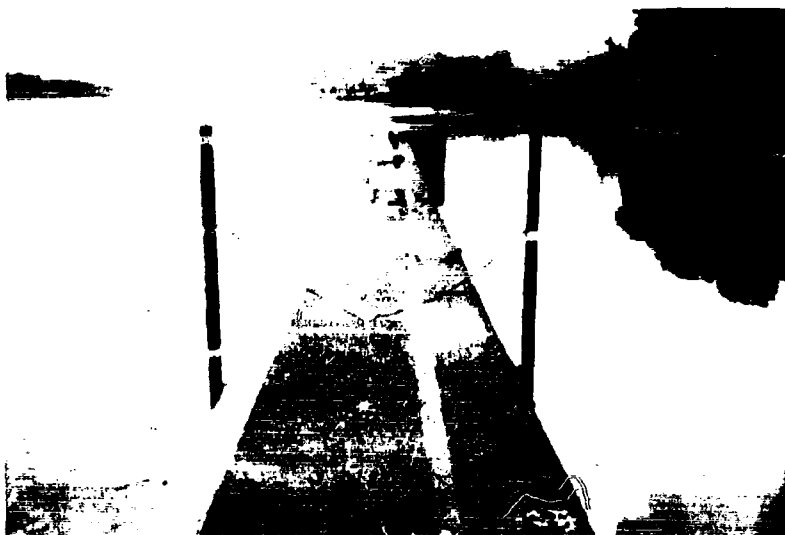
Fig. 24. Underwater opposed charges prepared for simultaneous detonation.
