**ROYAL AIRCRAFT ESTABLISHMENT  
(FARNBOROUGH)**

TECHNICAL NOTE No: MECH. ENG. 297

**CONTINUOUS ROD WARHEAD LETHALITY  
TRIALS AGAINST B.29 AIRCRAFT WINGS  
(3/16, 1/4 AND 5/16 inch SQUARE-SECTION RODS)**

JULY, 1959

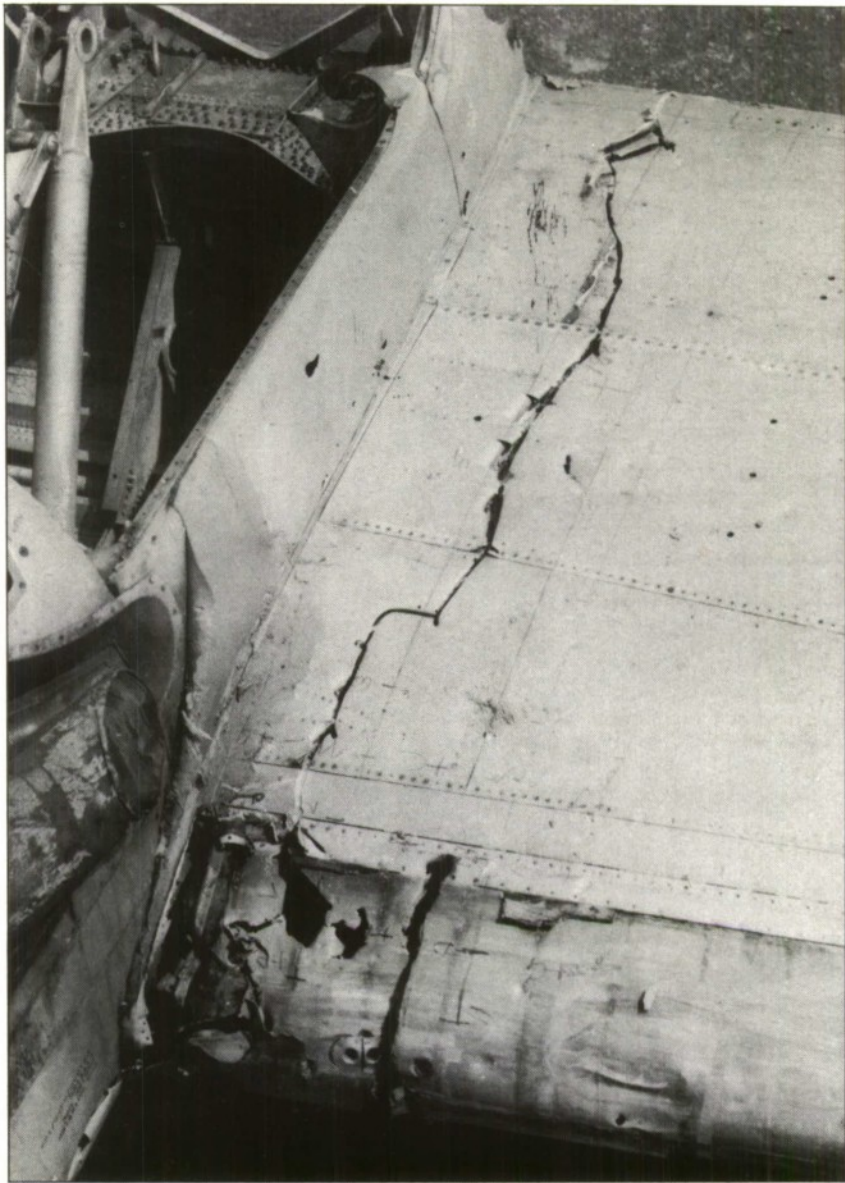
FIG.7a. FIRING 2. ROD DAMAGE TO LOADED STARBOARD WING (3/16 inch ROD, STATION 225)

Firing No.	Trial conditions	Details of damage
1	3/16 in. rod against Stn.225 of unloaded B29 port wing. (45° below and off ahead)	Continuous chordwise cut across wing lower surface. All top-hat section stringers (13) severed. Forward spanwise joint stringer 50% severed. Groove in front spar lower boom $\frac{1}{4}$ in. deep and in rear spar lower boom $\frac{1}{8}$ in. deep. Leading edge completely severed. No trailing edge present. <u>Wing remained in position. Figs.6A &amp; B</u>
2	3/16 in. rod against Stn.225 of loaded B29 starboard wing. (45° below and off ahead)	Continuous chordwise cut across wing lower surface 8 ft 3 in. long. 10 top-hat section stringers severed 3 top-hat section stringers 75% severed. Forward I-beam 50% severed. Cut in rear I-beam 3/16 in. deep. Groove in front spar lower boom $\frac{1}{4}$ in. deep. Groove in rear spar lower boom $\frac{1}{8}$ in. deep. <u>Wing continued to support load. Figs.7A &amp; B</u>

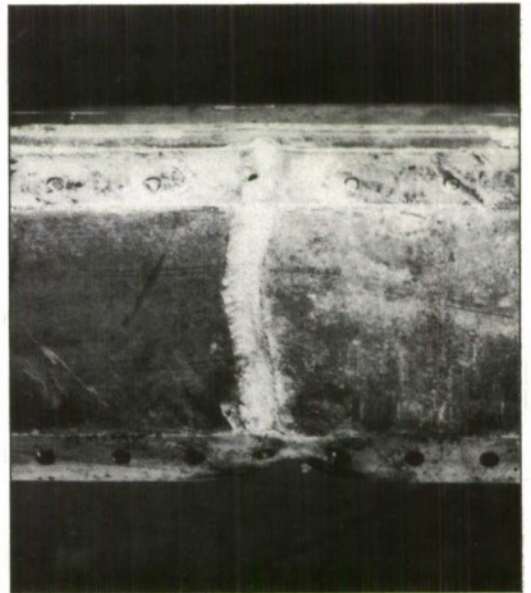
FIG.7b. FIRING 2. ROD DAMAGE TO LOADED STARBOARD WING (3/16 inch ROD, STATION 225)

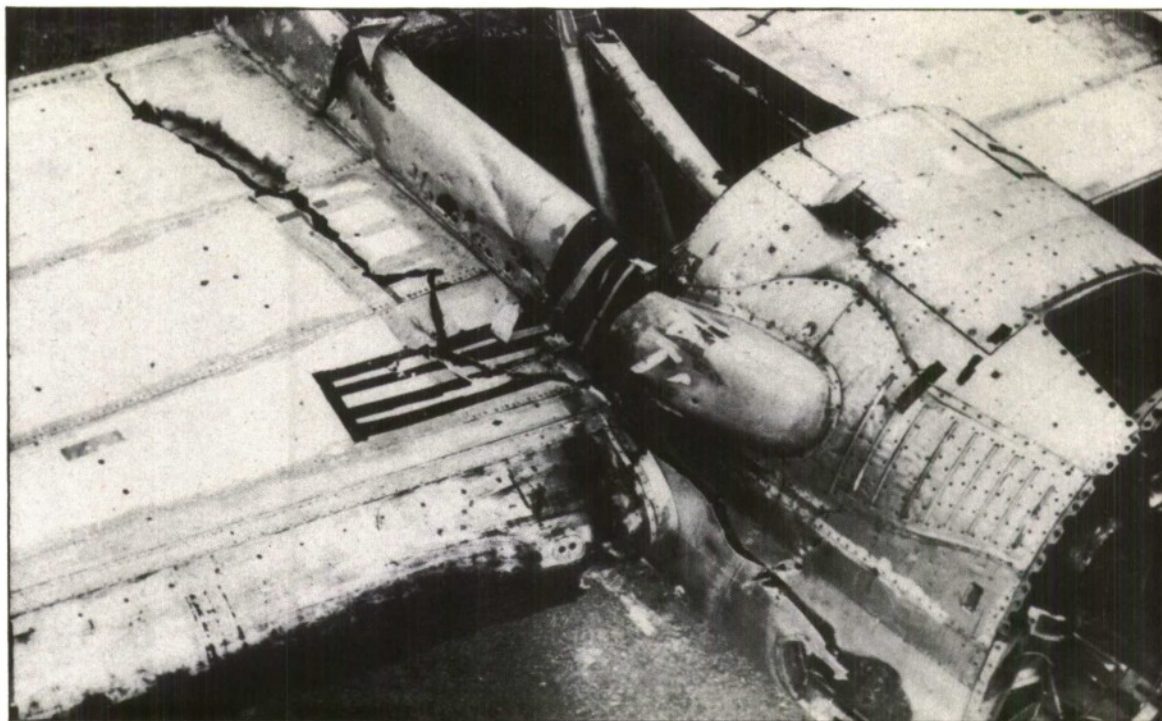
FIG.9a. FIRING 4. ROD DAMAGE TO LOADED PORT WING  
(1/4 inch ROD, STATION 225, 1½ g FLIGHT LOADS)

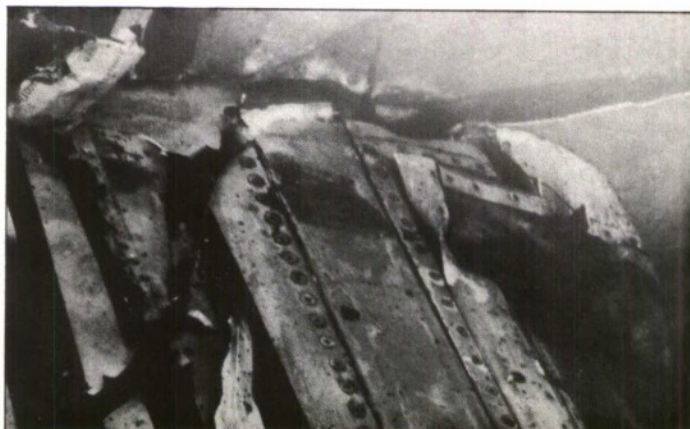
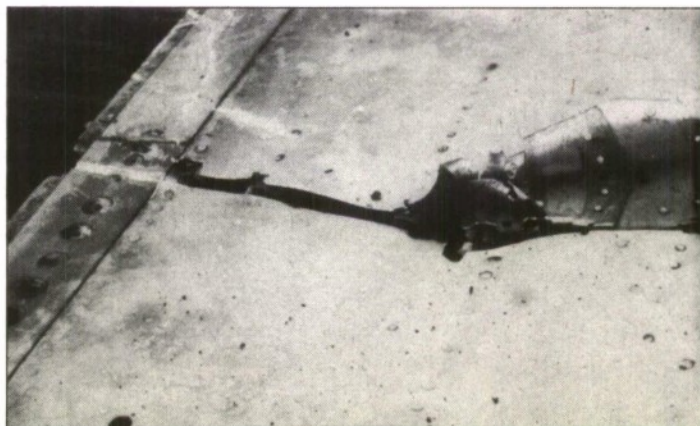
FIG.9b. FIRING 4. ROD DAMAGE TO SPAR BOOMS  
(1/4 inch ROD, STATION 225, 1½ g FLIGHT LOADS)

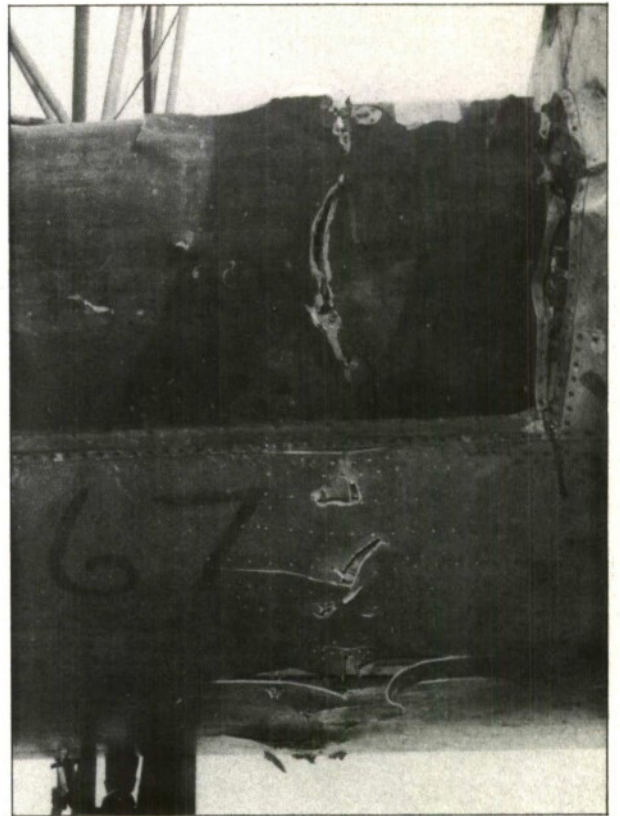
FIG. 11a. FIRING 8. DAMAGE TO LOADED PORT WING  
(5/16 inch ROD, STATION 225, NORMAL ATTACK)

10.4 Neglecting the possible effects of differences in the methods of target loading, it might appear that the U.K. Firing No.8 and the U.S. Firing No.1 would be comparable. However, in the U.S. Firing, the rod projector was located close to the wing surface to be attacked and, as a projector of this type might contain 30 to 40 lb of H.E., some considerable damage from blast would be expected. This, together with possible effects of the simultaneous detonations in the U.S. trial, may account for the fact that the U.S.  $\frac{1}{4}$  inch rod firing resulted in wing failure, whilst the U.K.  $\frac{5}{16}$  inch rod did not.

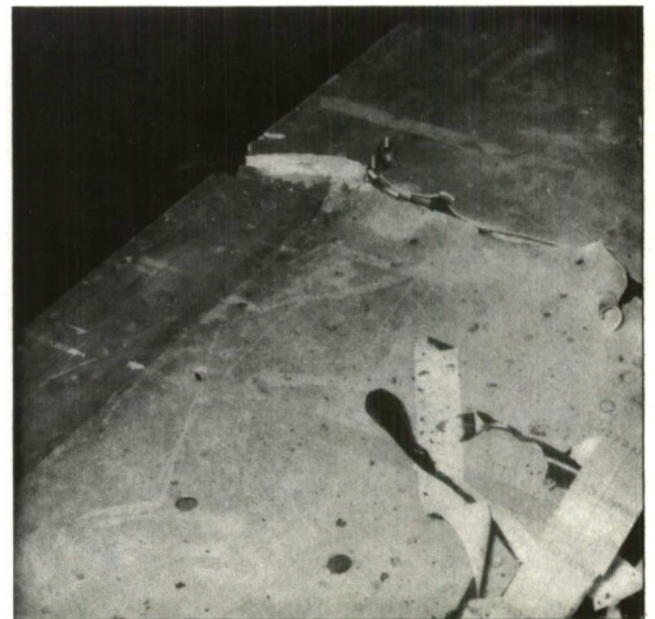
FIG. 11b. FIRING 8. ROD DAMAGE TO SPAR BOOMS  
(5/16 inch ROD, STATION 225, NORMAL ATTACK)

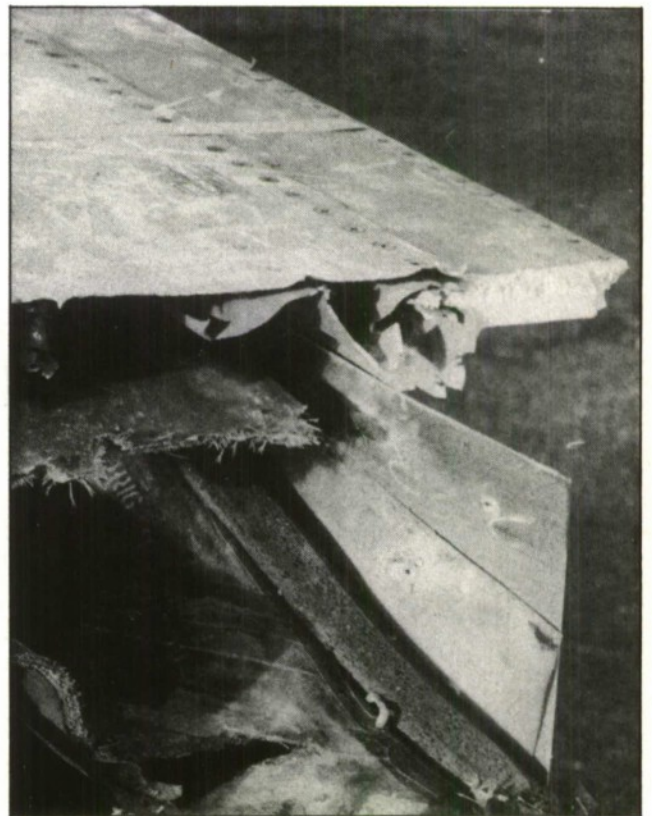
FIG.12b. FIRING 9. SEVERED SPAR BOOMS (3/16 inch ROD, STATION 442)

9.4 The results of Firings Nos.5, 6 and 9 showed that both the 3/16 inch and 1/4 inch continuous rods, at striking velocities of approximately 3300 f.p.s., were capable of causing complete structural failure of the B29 wing at Stn.442 and outboard, from a typical direction of attack. In this section of the wing the spar lower booms are of relatively small depth and failed in all three firings.

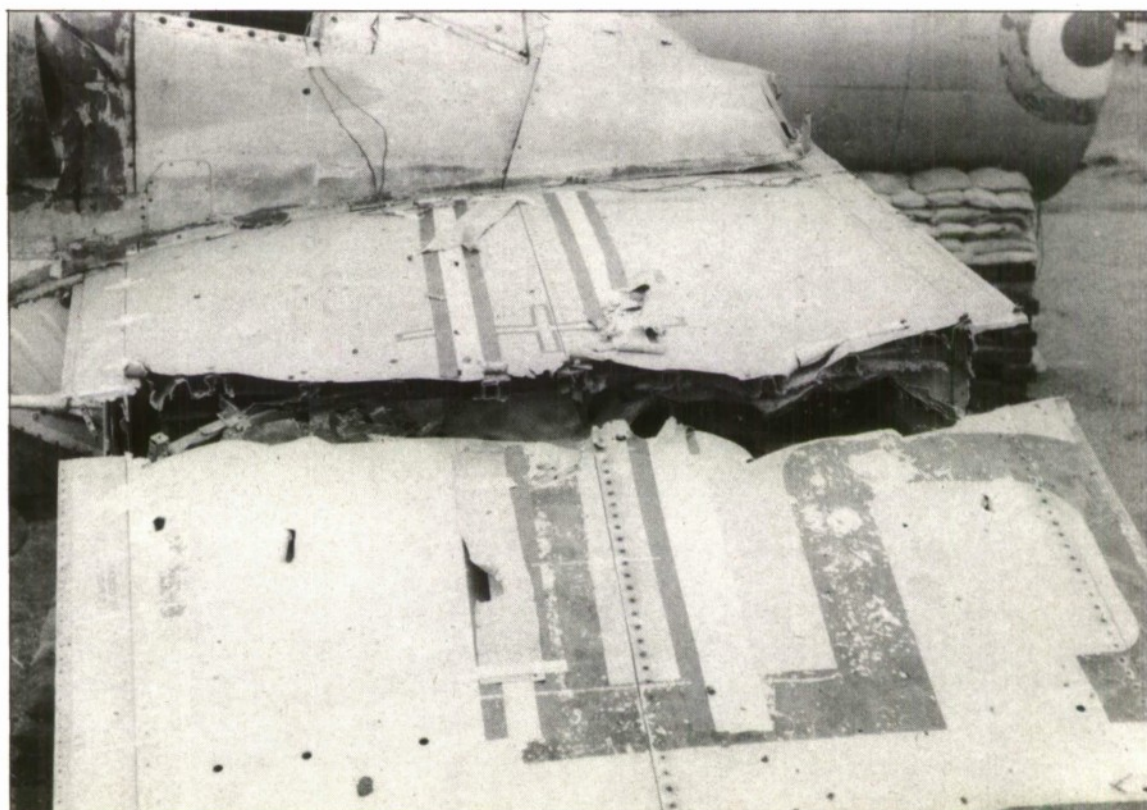
FIG.13b. FIRING 6. DAMAGE TO WING LOWER SURFACE LOOKING INBOARD (1/4 inch ROD, STATION 442)

Firing No.	Trial conditions	Details of damage
8	5/16 in. rod against Stn.225 of loaded B29 port wing. (Normal below attack)	Continuous chordwise cut across wing lower surface. All stringers and I-beams severed except 1 stringer 75% severed. Groove in front spar lower boom $\frac{1}{2}$ in. deep. Groove in rear spar lower boom 0.4 in. deep. Numerous rod exit holes and tears in upper surface interspar skinning pulling 17 rows of rivets over 2 ft span. <u>Wing continued to support load.</u> Figs.11A & B
9	3/16 in. rod against Stn.442 of loaded B29 starboard wing (45° below and off ahead)	Continuous chordwise cut across wing lower surface. All structure severed or failed except for part of upper surface interspar skinning. <u>Wing failed completely.</u> Figs.12A & B
6	$\frac{1}{4}$ in. rod against Stn.442 of loaded B29 starboard wing (45° below and off ahead)	Continuous chordwise cut across wing lower surface. All structure severed or failed except for 2 ft length of upper interspar skin. <u>Wing failed completely.</u> Figs.13A,B,C & D

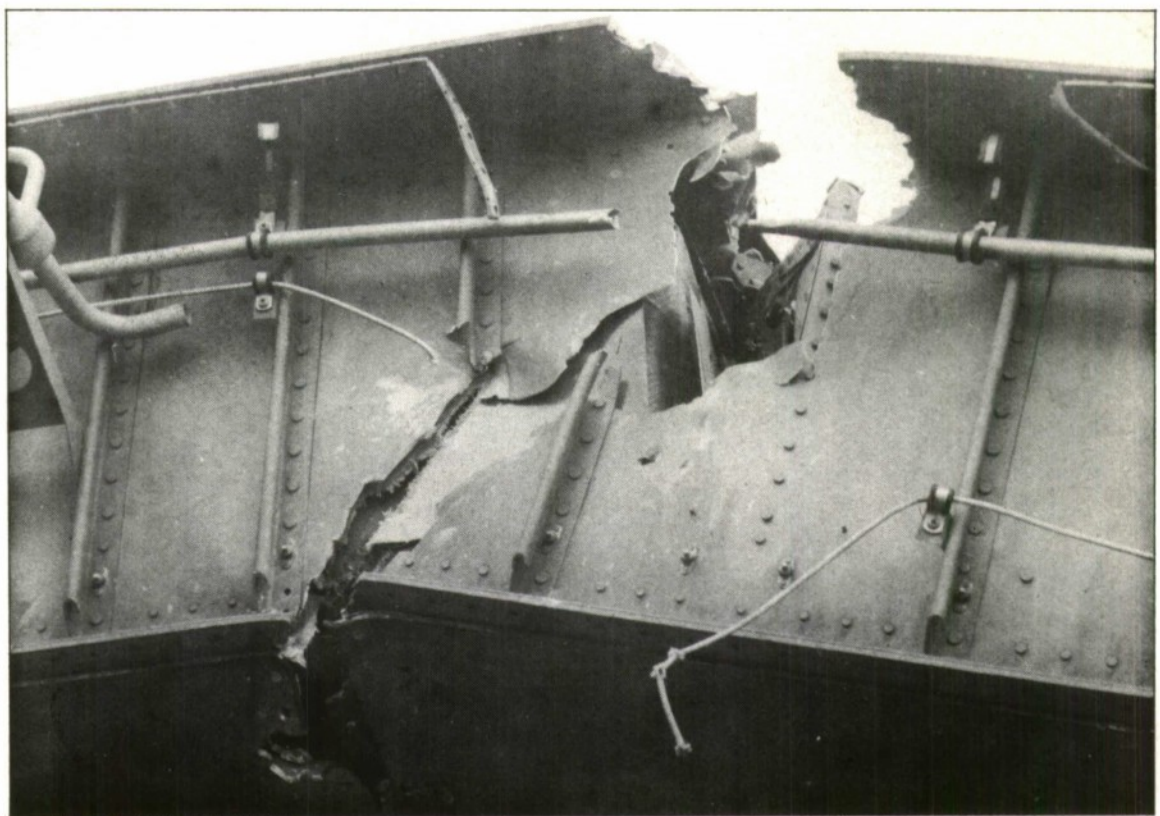
FIG.13c. FIRING 6. SEVERED REAR SPAR  
(1/4 inch ROD, STATION 442)

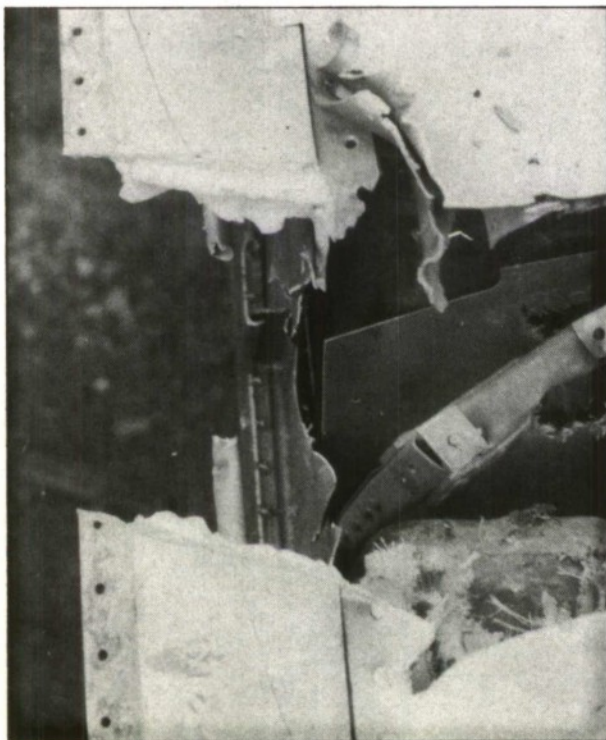
FIG13d. FIRING 6. SEVERED LOWER SPAR BOOMS  
(1/4 inch ROD, STATION 442)

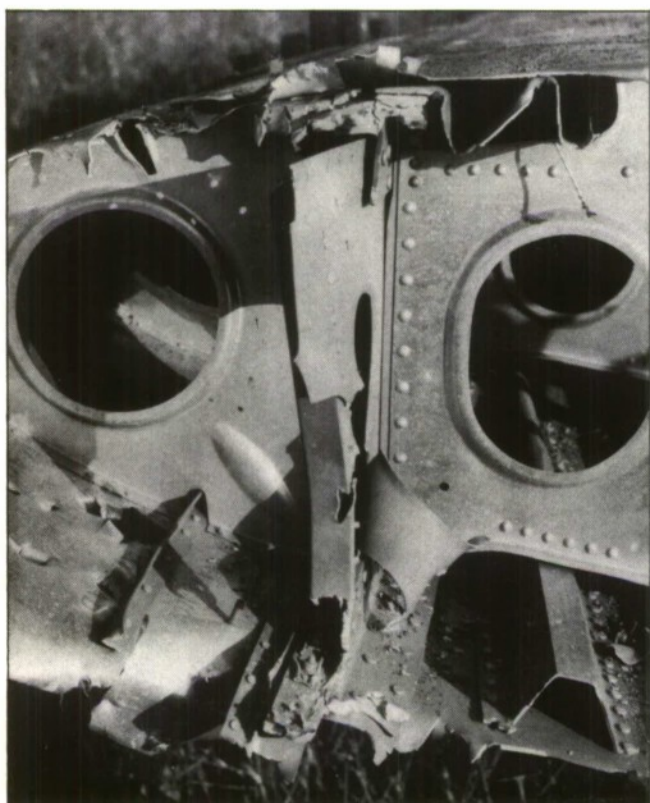
FIG.14d. FIRING 5. DAMAGE TO SEVERED SPARS  
(3/16 inch ROD, STATION 603)

5	3/16 in. rod against Stn.603 of loaded B29 port wing. (45° below and off ahead)	Continuous chordwise cut across wing lower surface. All stringers cut or failed in tension. <u>Wing completely severed.</u> Figs.14A,B,C & D
