STRUCTURAL HEATING EXPERIENCES ON THE X-15 AIRPLANE

## TECHNICAL MEMORANDUM X-711

## STRUCTURAL HEATING EXPERIENCES ON THE X-15 AIRPLANE\* \*\*

By Eldon E. Kordes, Robert D. Reed, and Alpha L. Dawdy

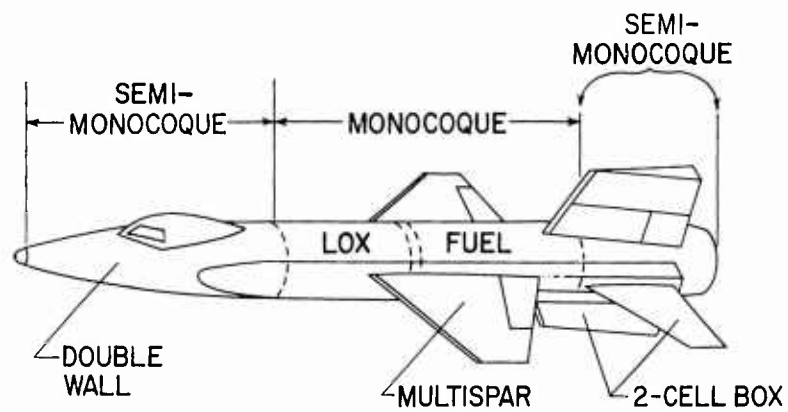
Figure 1

## X-15 STRUCTURE

The X-15 fuselage structure is basically monocoque or semimonocoque as indicated in figures 1 and 2. The external surface is Inconel X, and titanium is used extensively for the internal structure. The forward-fuselage section contains the double-walled pressure compartments for the pilot and instruments. The center-fuselage section is formed by the oxidizer tank ahead of the wing and the fuel tank with frames for supporting the wing. The rearward fuselage structure supports the empennage, main landing gear, and engine. The wing is of multispar construction of taper-milled Inconel X skin with titanium substructure. The horizontal and vertical tails are two-cell box structures with stabilizing ribs. The wing, horizontal tail, and vertical tail have segmented leading-edge heat sinks of Inconel X. A tunnel along each side of the fuselage for housing control cables, hydraulic lines, and instrument wiring is formed by removable panels. Throughout the structure, extensive use has been made of corrugations and beading to minimize thermal stress.

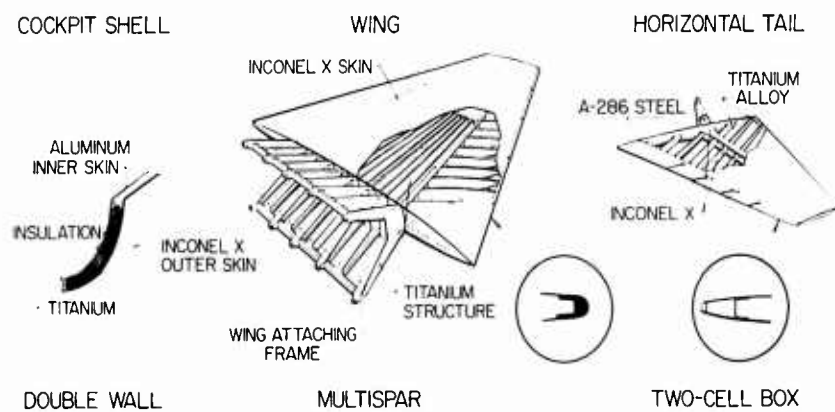
Figure 2

## STRUCTURAL DETAILS

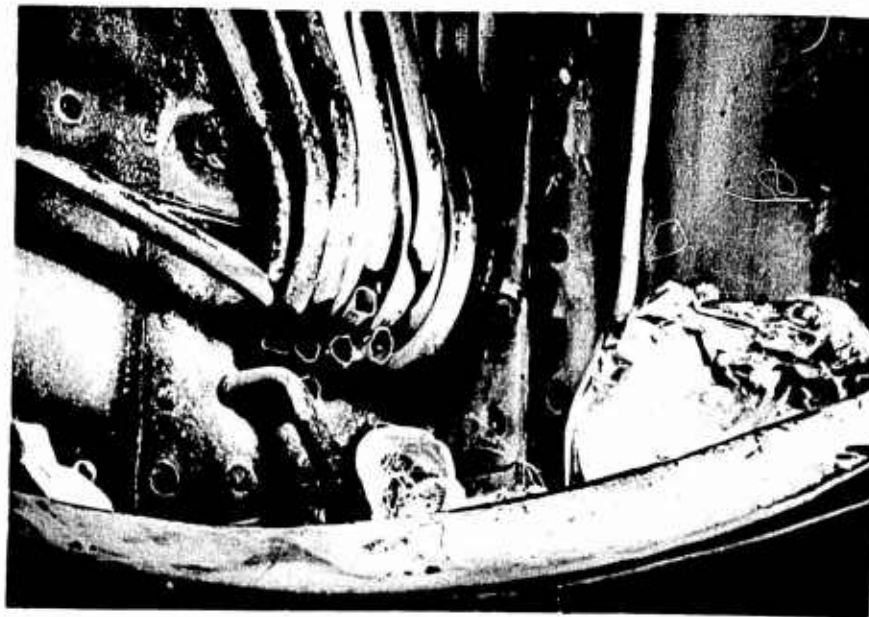
Figure 10

### HEAT DAMAGE TO ALUMINUM TUBING

Damage from airflow into the structure.- Another heating problem that has developed on the X-15 is caused by airflow into the interior of the structure. This flow has resulted in unexpected high temperatures around the speed-brake actuators, and loss of instrumentation wires at the roots of the wing and tail surfaces. On the forward fuselage, the seal of the canopy has been damaged because of a slight raising of the front edge by cabin pressure, which allowed hot air to flow against the seal. This problem has been solved by attaching a shingle-type strip to the fuselage just ahead of the canopy joint to prevent airflow under the edge of the canopy. A similar problem has developed in the nose-gear compartment. The small gap at the rear end of the nose-gear door was sufficiently large to allow the airstream to enter the compartment and strike the bulkhead between the nose-gear compartment and the cockpit. This stream caused a local hot spot. Aluminum tubing, for the pressure-measuring system, is attached to this bulkhead in the nose-gear compartment, and during a flight to a Mach number of 5.2, portions of the tubing melted away. A photograph of this damage is shown in figure 10. Pictured are the aluminum tubing with the damaged area and the titanium bulkhead between the nose gear and pilot compartment. The bulkhead was heated to about 530° F, which was sufficiently high to scorch the paint on the bulkhead in the pilot's compartment and cause smoke in the cockpit. Since this flight, an Inconel compression seal has been added to the rear end of the nose-gear door and additional protection has been provided by placing a baffle plate across the compartment just behind the door opening.

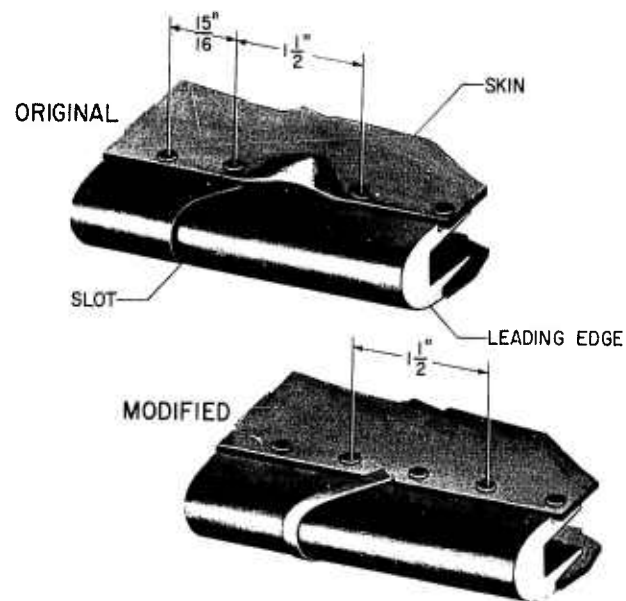
Figure 15

WING SKIN BUCKLE FOLLOWING FLIGHT  
FLIGHT TO MACH NUMBER OF 5.28

On this flight, permanent interrivet buckles were formed directly behind the three outboard slots of the leading edge. The type of buckle

and the location are illustrated by the upper sketch in figure 15. This sketch shows a portion of the leading-edge heat sink, the expansion slot, the external skin with the buckle, and the fastener location. Note that the fastener spacing directly behind the slot is wider than the spacing along the solid portion of the leading edge. Subsequent analysis of the leading-edge structure has indicated that several factors contributed to the permanent buckling of the skin. One factor is the thermal stresses in the skin caused by the high gradients around the local hot spot. Another factor is the wide fastener spacing through the leading edge at the slot. A third reason for the buckles is the fact that the original segmentation of the leading-edge heat sink did not adequately relieve the thermal-induced compression loads. The skins at the slots acted as a splice plate for the heat-sink bar and thus were buckled in compression.

In order to minimize this buckling problem, three design changes have been made. Two of the changes are shown in the lower sketch. An 0.008-inch-thick Inconel tab welded along one edge was installed over each slot to prevent tripping the boundary layer, and thus to minimize the local hot spots, as explained in reference 1. A fastener was added at the slot to decrease the fastener spacing and to increase the allowable skin buckling stress. In order to reduce the load that the skin splice must carry at each slot, the third change was to add expansion slots with cover tabs in three of the outboard segments of the leading edge.
