NAVWEPS REPORT 7763  
NOTS TP 2739  
COPY 87

# EVALUATION OF THE EXPERIMENTAL MODEL OF THE RADAR SET GROUP OA-2003(XN-1)/ASB

**ABSTRACT.** This report discusses the results of the flight testing and evaluation of the experimental model of the Radar Set Group OA-2003(XN-1)/ASB. The characteristics and performance of this equipment are detailed, and certain improvements in design that were suggested for the developmental model are discussed.  
(UNCLASSIFIED)

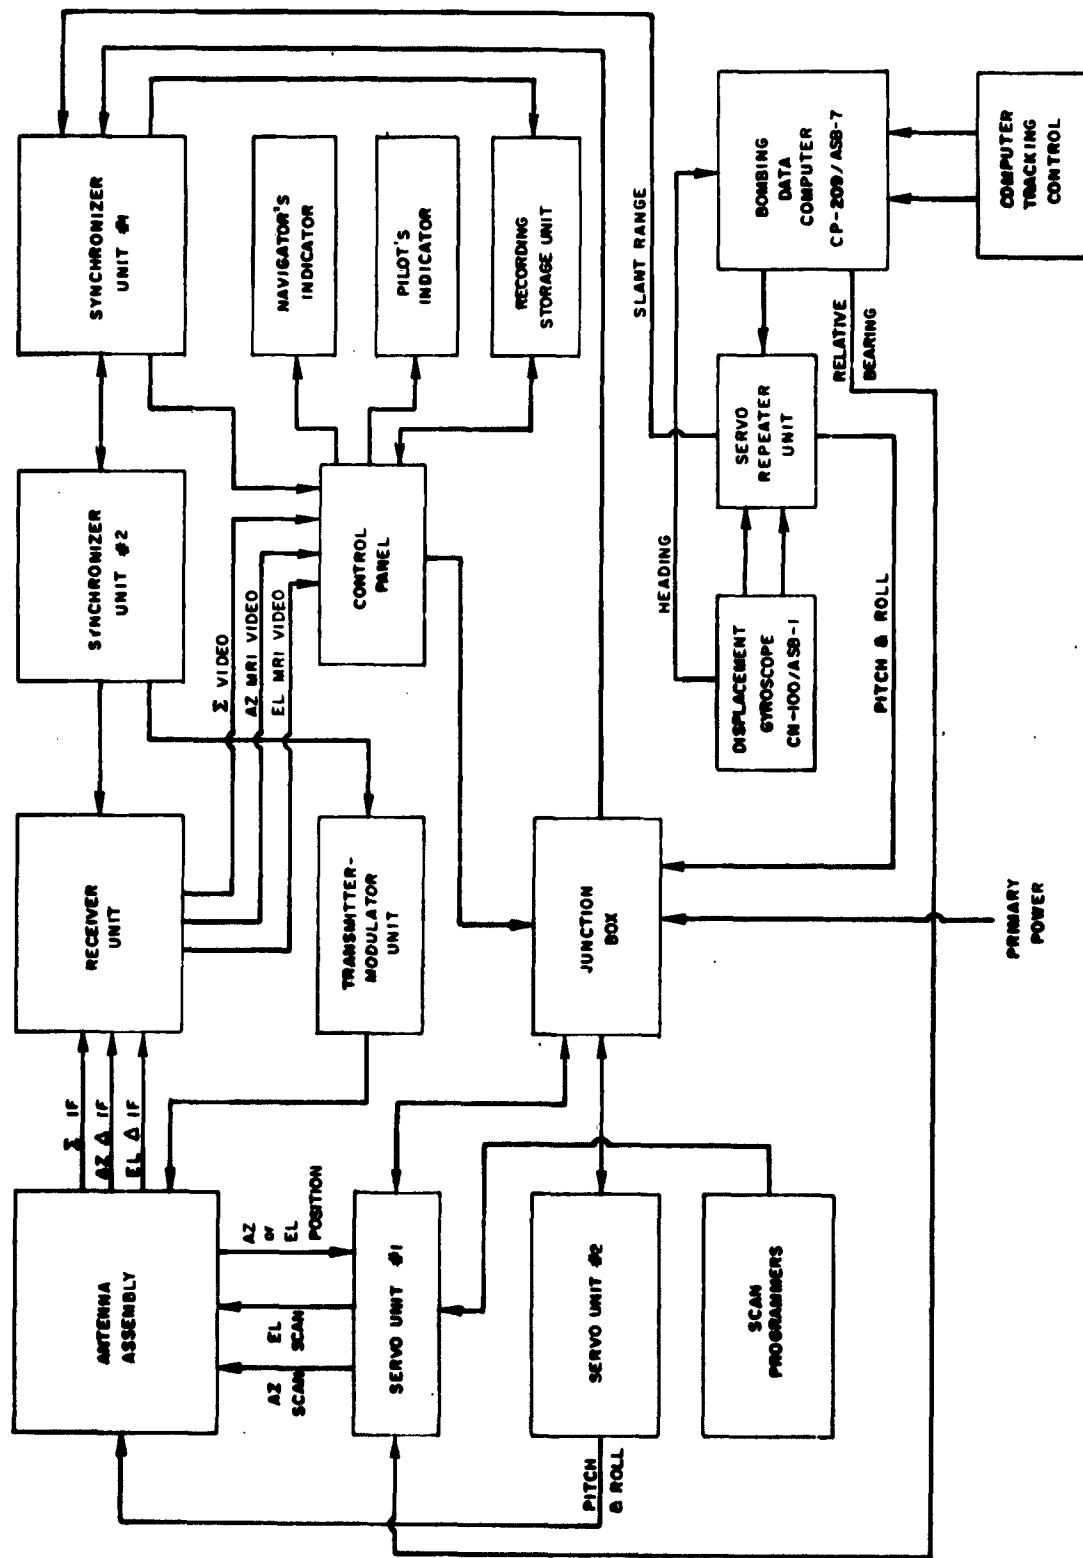
FIG. 4. Radar Set Group OA-2003/ASB Block Diagram

The Radar Set Group OA-2003/ASB (Fig. 1, 2, 3, and 4) is a four-horn monopulse  $K_u$ -band radar, tunable over the range of 16 to 17 gigacycles (gc), with a rated peak power output of 60 kilowatts (kw). The four-gimballed antenna is stabilized in roll and pitch to the vertical; in azimuth to the aircraft datum line (ADL), the aircraft drift angle, or the horizontal line of sight (LOS); and in elevation to the angle of attack, the horizontal, or the elevation LOS. The radiated beam is either pencil or fan shaped (cosecant-squared) in the vertical plane, and pencil shaped in the horizontal plane.

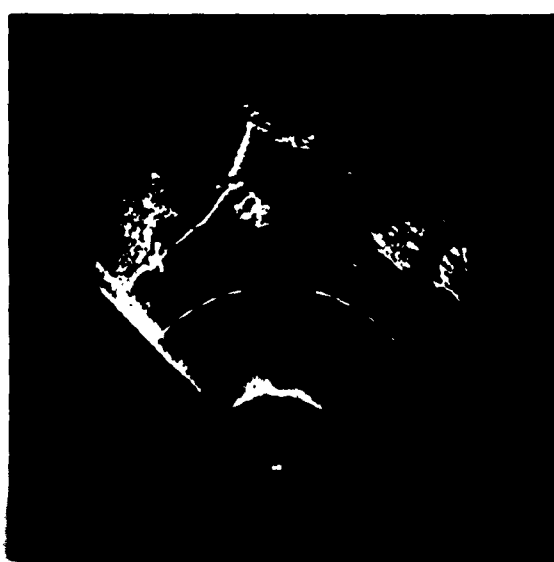
(a)  $\Sigma$  only.

(b) MRI.

FIG. 10. Comparison of  $\Sigma$  Only and MRI Operation, San Francisco Bay Bridge. Note improvement of distortion.

The presentation displayed on the navigator's indicator, conventional cathode-ray tube (CRT), showed a combination of video distortion, 400-cycle noise, inadequate contrast, and initially insufficient gain to permit the display of receiver noise (Fig. 7, 8, 17, 18, and 31). Figure 9 illustrates the undesirable characteristics of noise in the display when sufficient gain was provided and the variation in the noise level with the change in pulse repetition frequency (PRF). The video distortion and the noise problems were largely associated with poor grounds and inadequate shielding of the wiring within the indicator. The noise problem was never completely eliminated, but was improved in time. The inadequate contrast and receiver noise problems were found to have been caused by the video processing circuit where the video, markers, and the unblanking pedestal were mixed, and were attributed to poor direct-current (d.c.) restoration. In time, the contractor provided a newly designed circuit that greatly improved the problem (Fig. 10, 11, 12, 15, 16, 19, and 20).

It was evident from the outset that MRI operation in azimuth was totally inadequate. This was considered the major design deficiency of the radar set. The trouble was pinpointed to the sum ( $\Sigma$ ) and difference ( $\Delta$ ) video processing circuits. Throughout the flight-test program, considerable effort was expended by both NOTS and contractor personnel in designing suitable circuitry to achieve the desired results. A circuit design that could adequately improve resolution in azimuth could not be made compatible with the receiver as designed. Figures 10, 11, 12, 15, 16, 23, 24, 25, and 26 show various MRI displays.

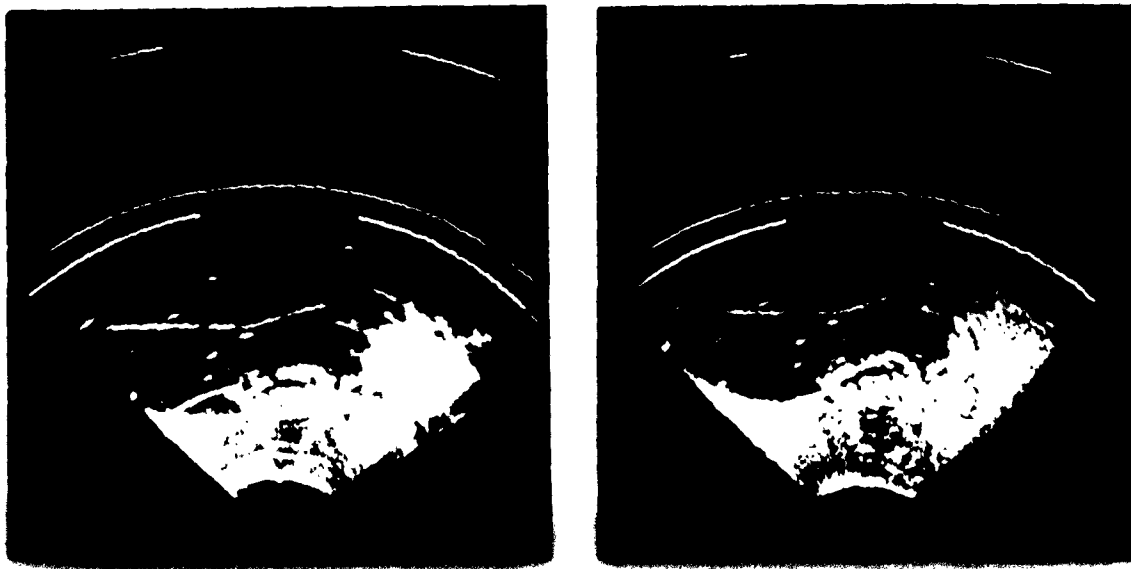
(a)  $\Sigma$  only.

(b) MRI.

FIG. 12. Comparison of  $\Sigma$  Only and MRI Operation, Los Angeles Area (Long Beach). Narrow pulse; fan beam; 5-mile markers.

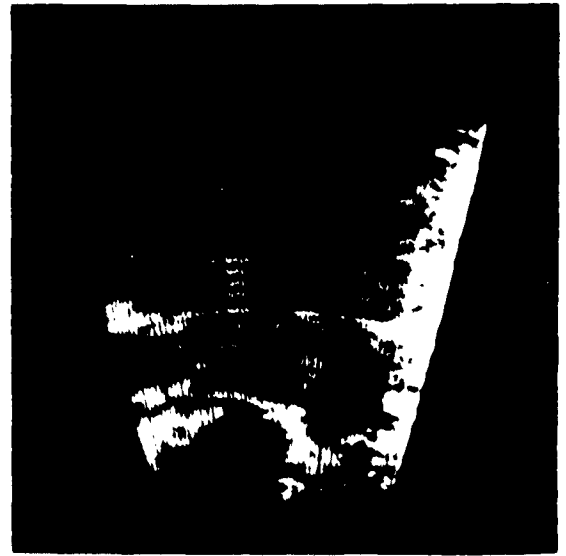
(a) Narrow pulse.

(b) Expanded display; narrow pulse.

FIG. 18. Displays Showing Distortion, Mothball Fleet, San Suisun Bay.

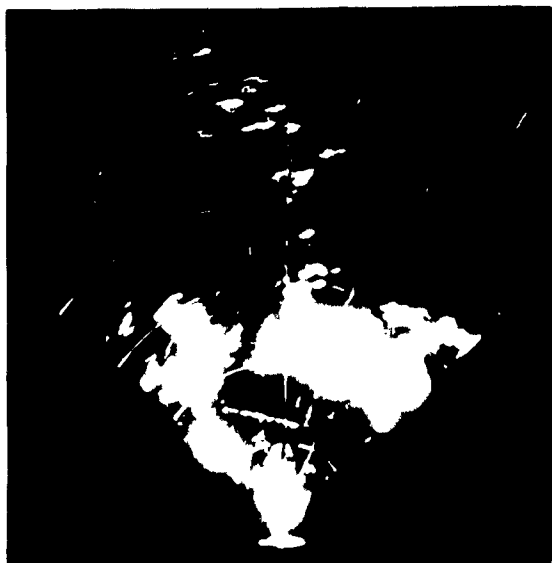
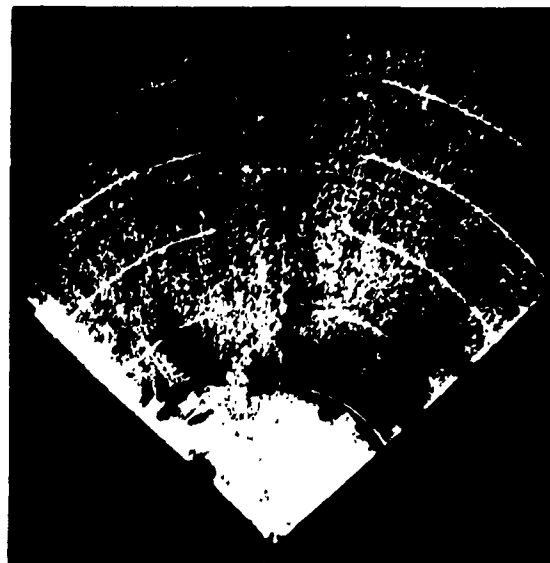
FIG. 23. Comparison of Ground-Test Displays Before Changes to MRI Circuitry.

The MRI circuit originally installed in the radar was purely a summing device without provisions for d.c. restoration or adequate clipping, and it caused (1) variations in the baseline level and (2) large amounts of noise from the  $\Delta$  channel to appear on the navigator's indicator. Several modifications were made to the circuitry, and ground-test results are presented in Fig. 23, 24, 25, and 26.

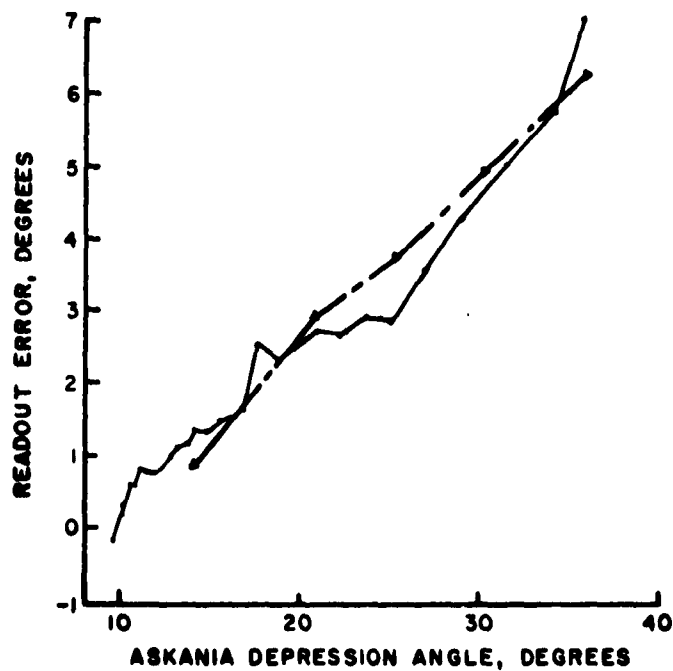
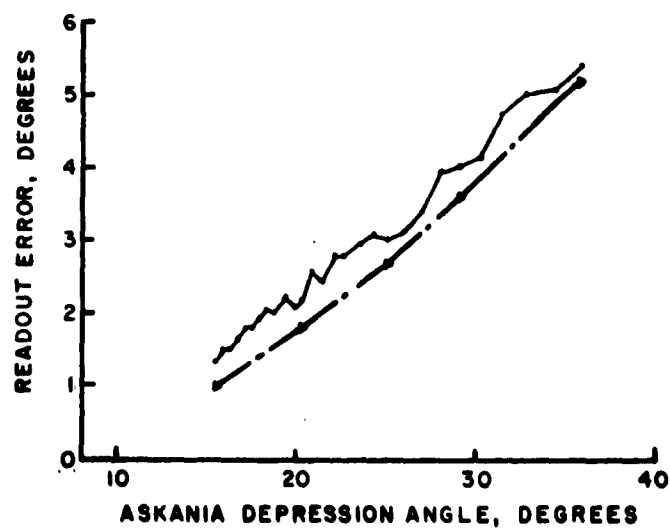
(a) Flight 26, Run 4.

(b) Flight 26, Run 7.

— Actual radar depression-angle error.  
- - - Computed curve for target 2,000 feet north.

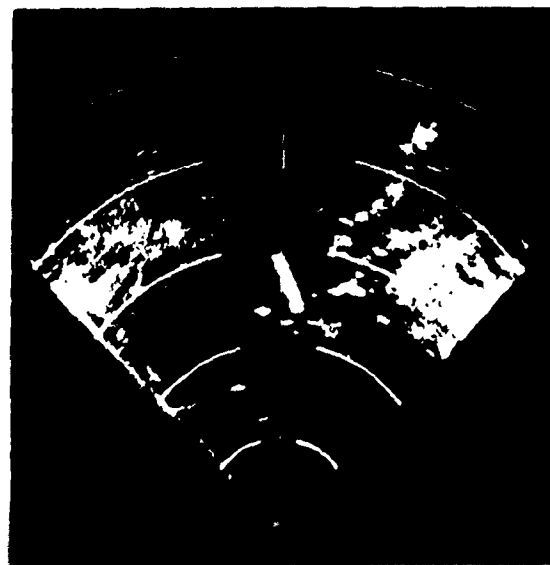
FIG. 30. Displays from 20,000 Feet. Mothball fleet; fan beam; narrow pulse; 5-mile markers.

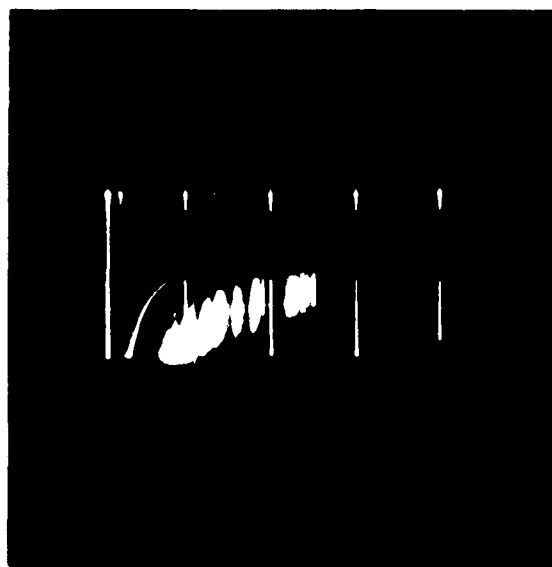
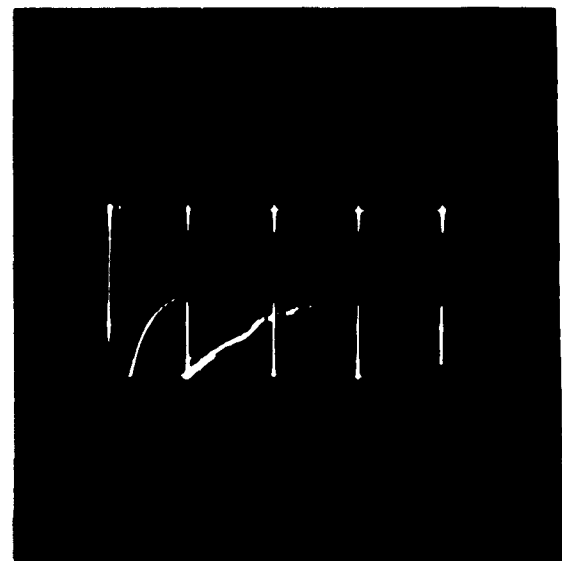
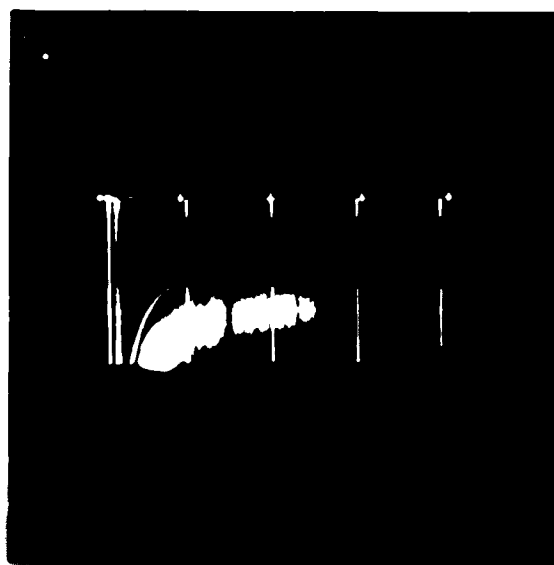
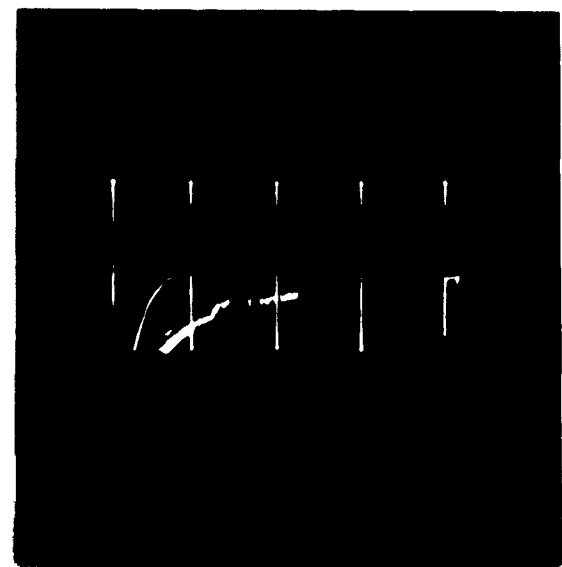
FIG. 36. Terrain Clearance, E-Scan, Mono Lake Area. Five-mile markers.

Two types of false targets appeared when the elevation MRI circuitry was used in the Terrain Clearance mode. These are termed "shadows" and "wings", and examples are shown in Fig. 32b, 33 and 34. Double targets were caused by negative overshoots in the elevation video circuits, and wings were caused by interaction between the sum and elevation difference channels. Figures 35 and 36 show the results when these effects were minimized.
