⑥ Mechanized Rifle Troop (M113)

⑦ MONTHLY TEST REPORT, NUMBER 2,

1-31 March 1963.

SUBJECT: Monthly Test Report Number 2 -- Mechanized Rifle Troop (M13)
(1-31 March 1963) (U)

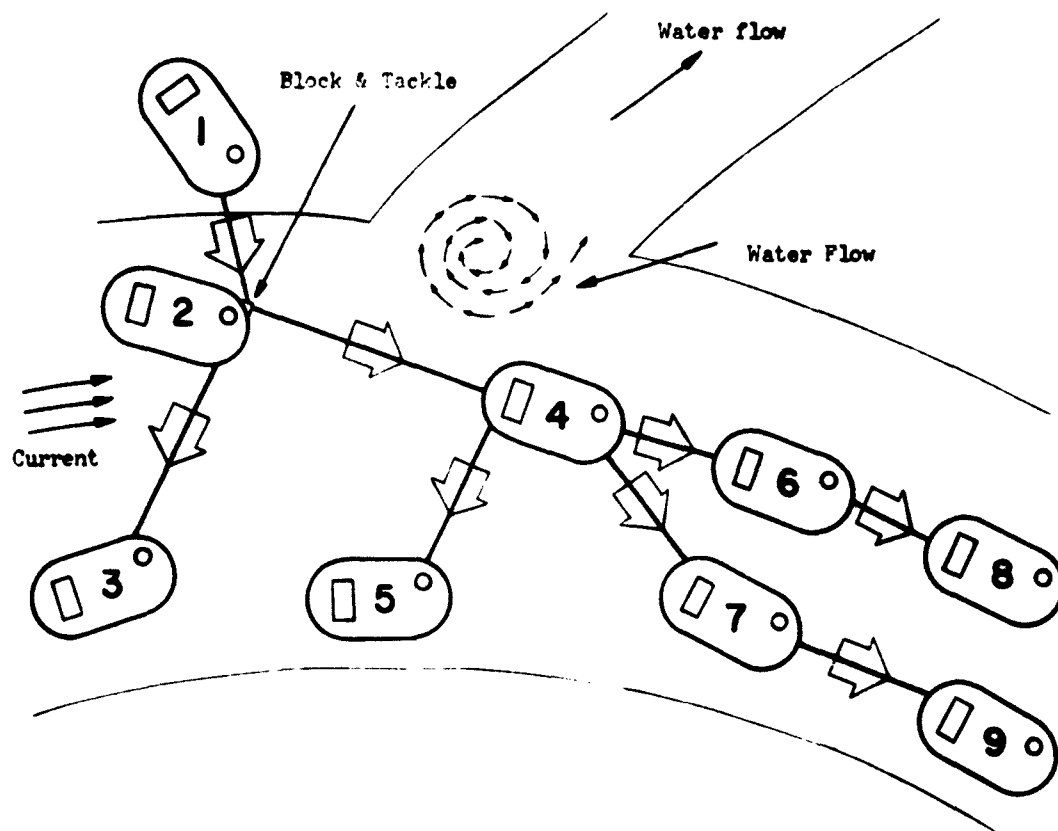
RECOVERY OF M113, 28 MARCH 1963

Vehicle mired in mud is number 1.
