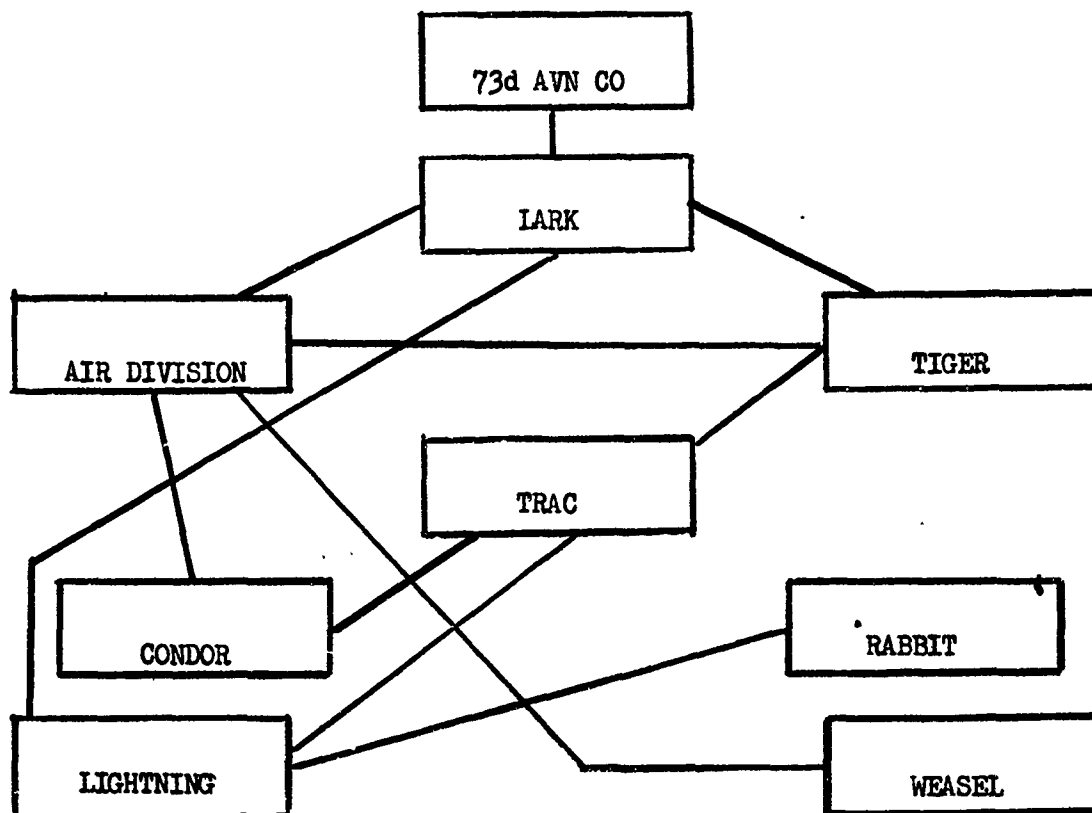
(U) FIGURE 5. Telephone traffic diagram.

The two AN/GRC-46 radio teletype sets provided for communications between the company and the supported units were inadequate during the evaluation. Distances between the 73d Avn Co and flight teams at Qui Nhon was 260 miles, well beyond the range of these radios. As a result, the telephone was used for communication even though much difficulty was experienced. A telephone traffic diagram is shown in figure 5.

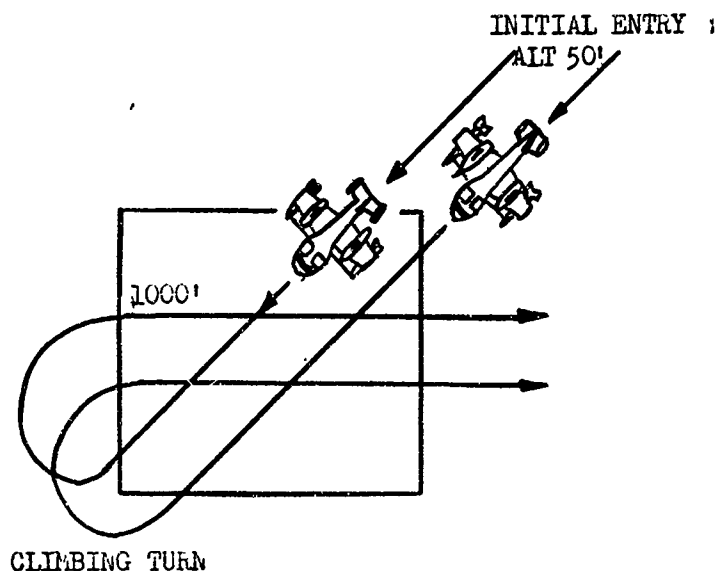
(U) FIGURE B-1. Visual technique 1.

Figure B-1 illustrates a flight maneuver frequently employed by the Visual/Photo Platoon in surveying point targets. The initial

entry was conducted at high cruise speed at an altitude of 50 feet. After passing the target area, a climbing turn to the right was executed and the aircraft leveled off at 1000 feet. At level-off the speed of the aircraft was much slower for the high-altitude flyby. Turns were generally made to the right to allow the observer continuous sighting of the target area.

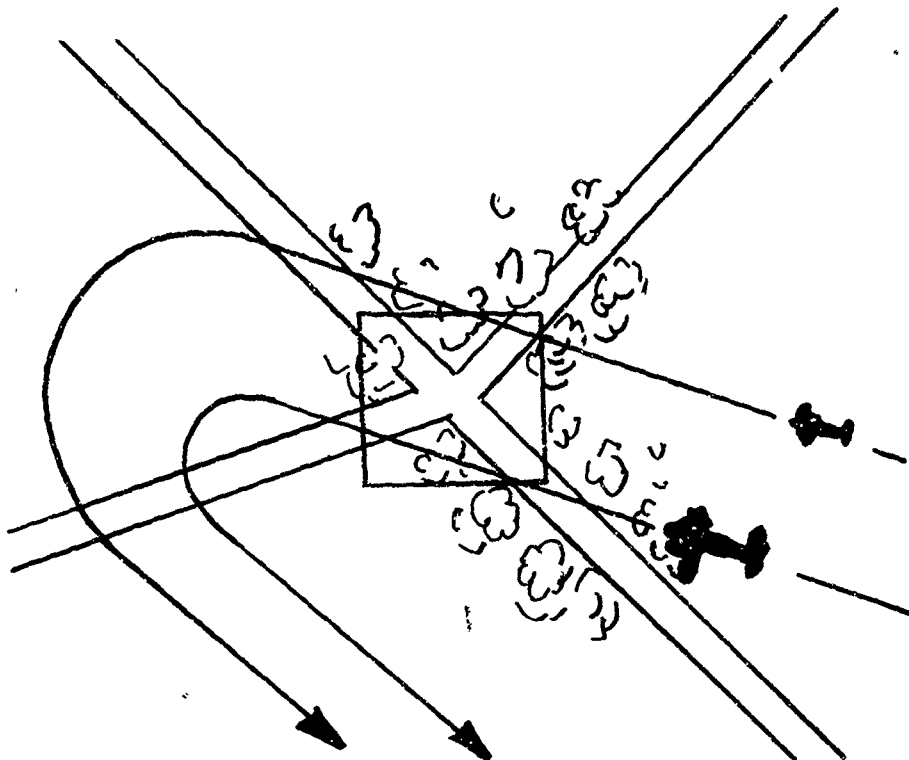
(U) FIGURE B-3. Visual/photo point target surveillance.

Figure B-3 illustrates photo surveillance of a point target. A single pass was used when the Viet Cong had a good air defense capability or when it was desired not to draw the attention of the Viet Cong to the area of interest. The altitude flown depended upon the requested scale factor, lens cone used, and the weather. One aircraft photographed the target while the observers in the other one visually searched for targets.

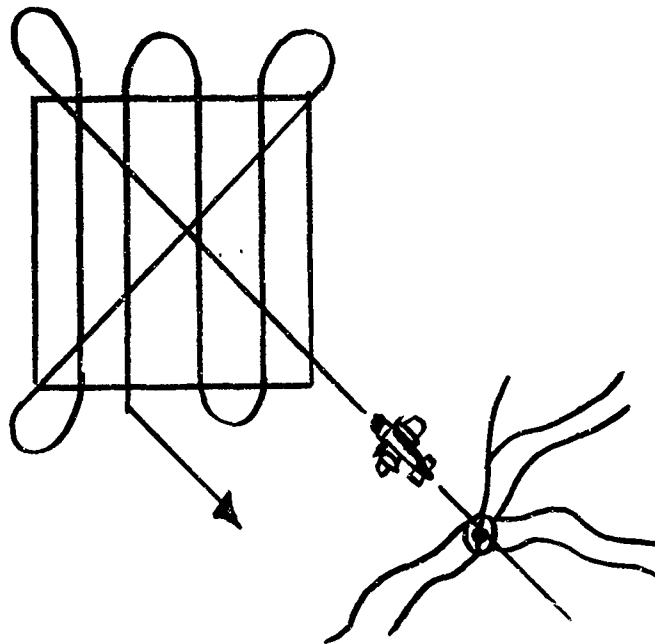
(U) FIGURE B-9. IR area search, technique 1.

Figure B-9 illustrates a small area search pattern using IR surveillance. This pattern was flown at about 1500 feet absolute altitude and an attempt was made to eliminate multiple parallel passes as much as possible to preclude enemy anticipation of future positions. In this sketch the tip of the island in the river is used as an identifiable checkpoint that would be seen in the terrain display scopes as the aircraft passes overhead. Knowing the doppler coordinates of this checkpoint allowed the aviator to up-date his computer, thus eliminating any errors. This mission was flown with the aircraft blacked out and the aviator relying solely on his doppler navigator for navigation.

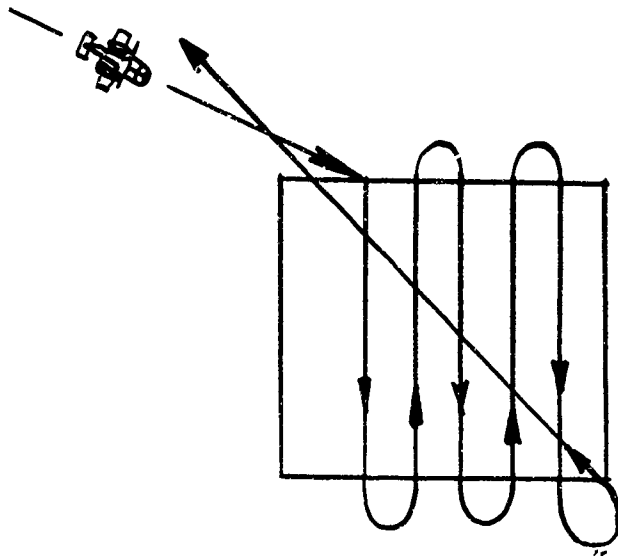
(U) FIGURE B-10. IR area search, technique 2.

Figure B-10 shows the small area search pattern most frequently used to insure a high percentage of coverage while flying IR surveillance missions. Multiple parallel passes were made over the area at an altitude of about 1500 feet absolute.

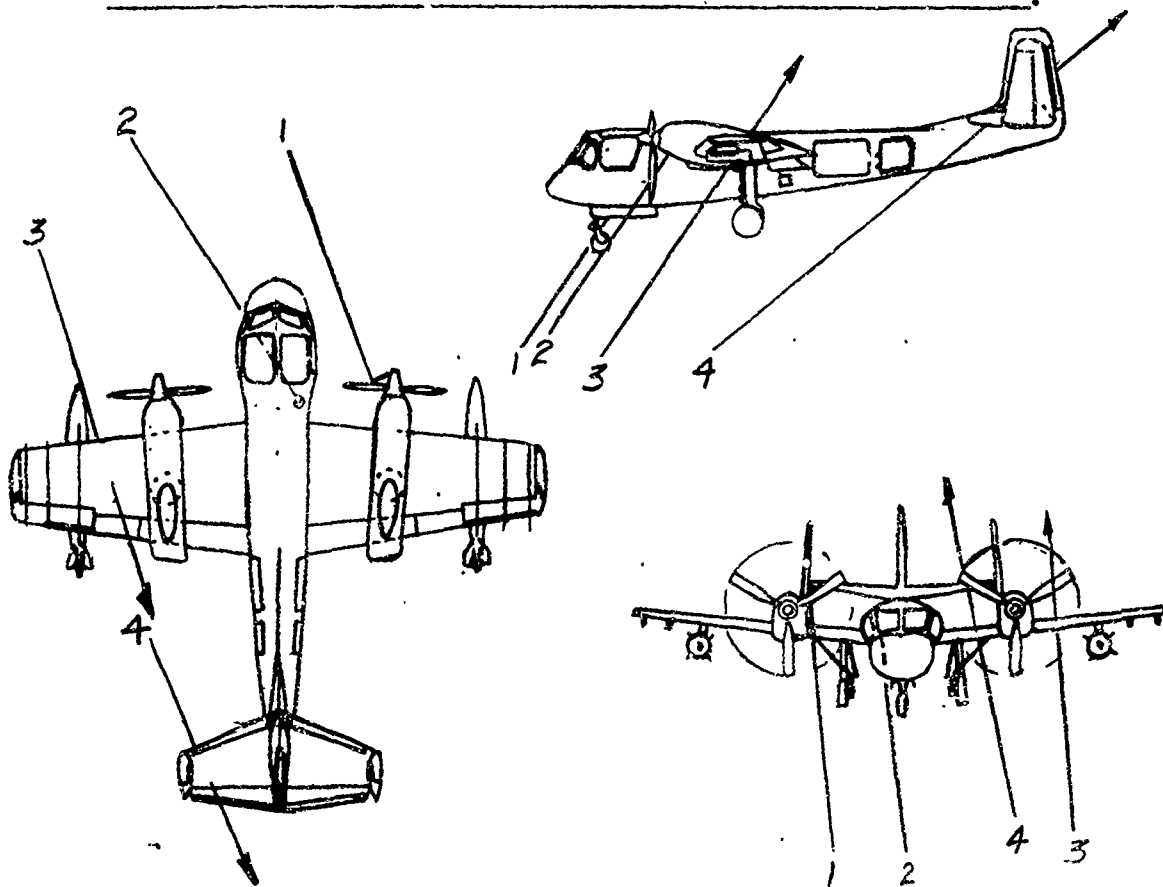
DESCRIPTION OF HIT(S) 1. One projectile struck one blade of the right propeller. The projectile broke into several pieces which damaged the crinner. 2. A projectile punctured the nose wheel well door and continued up and aft, striking the right elevator bell crank and support bracket. 3. A projectile punctured the left wing outer panel. One rib and two stringers were damaged. An aileron push rod was slightly damaged. 4. A projectile penetrated the left elevator damaging the aircraft skin and one rib.

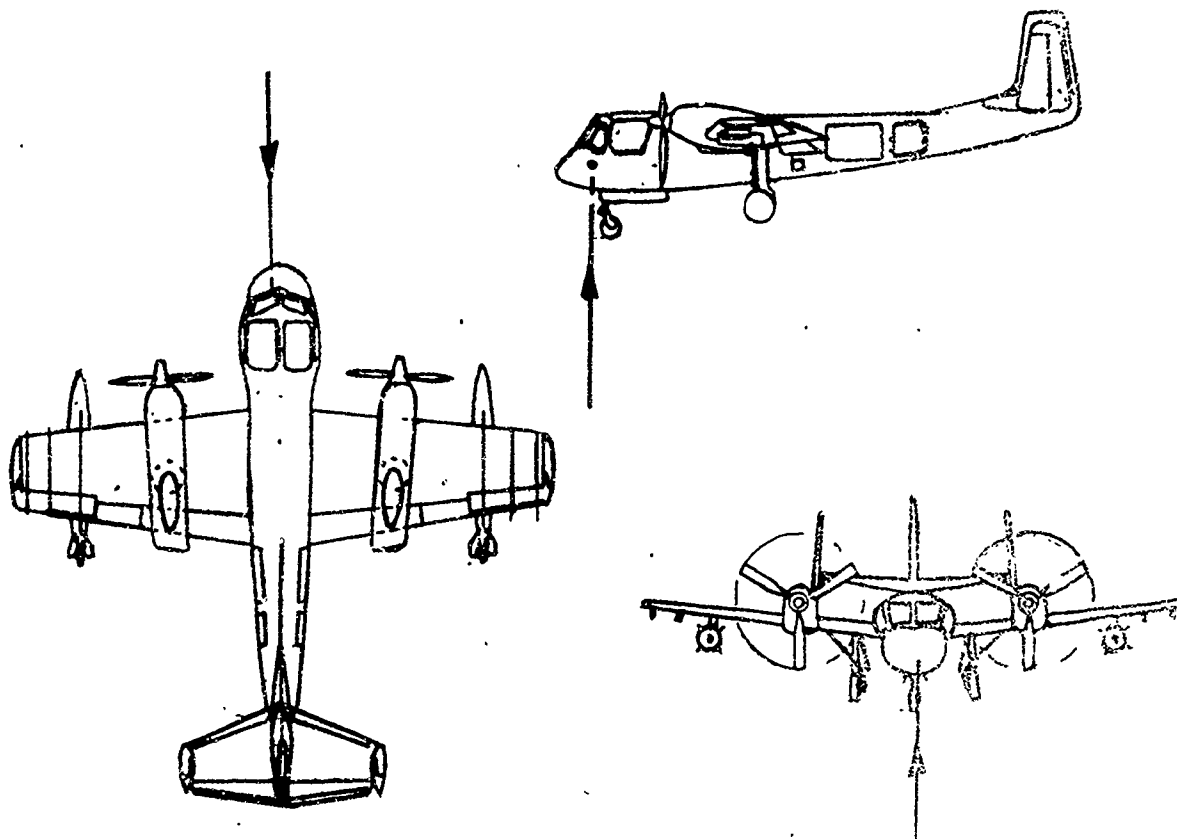
DATE TIME GROUP 271545 April . OV-1 SERIES A  
MISSIONS Visual . ALTITUDE 1000 feet  
NUMBER OF HITS 1 . CALIBER OF PROJECTILE(S) .30 (Est) .  
INJURIES None .  
WEATHER 3000 feet scattered - Visibility 15 miles .  
DESCRIPTION OF HIT(S) Estimated .30 caliber projectile entered aircraft  
through forward inboard cover of right nose wheel well door, damaged the  
forward frame of the nose wheel well, dented a line, cut a wire, cut  
through 60 percent of the aileron tube (co-pilot's). Floor was dented  
slightly.

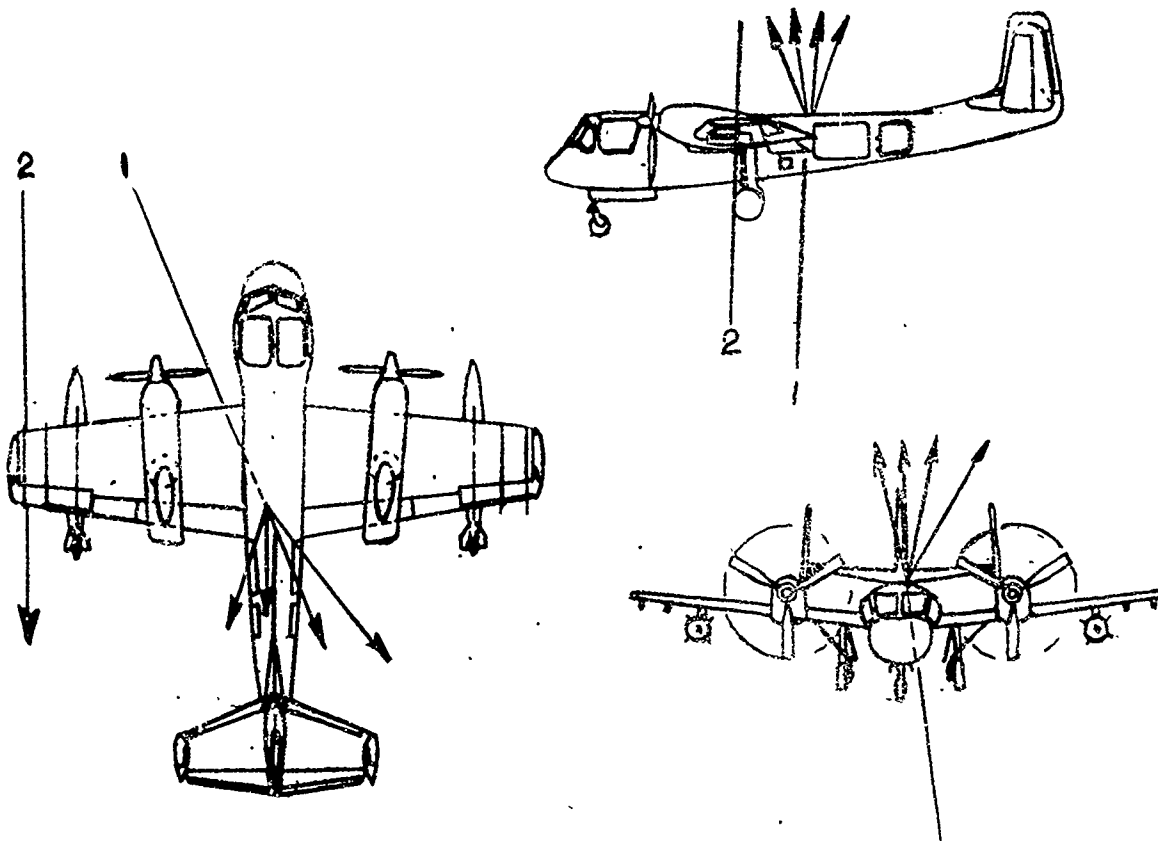
DESCRIPTION OF HIT(S) 1. First round went up and aft, penetrating left radio junction panel fiber glass cover. Terminals 1 and 2 of terminal strip 125 and terminals 1 through 7 of terminal strip 126 (all unused) were shot away. The round then struck the left control bellcrank bracket, inflicting no damage to the bellcrank. Four holes were in the top of fuselage. The elevator trim tab cable was partially covered. 2. Disintegrated .30 caliber round entered left wing of aircraft through landing light. One stringer was damaged.

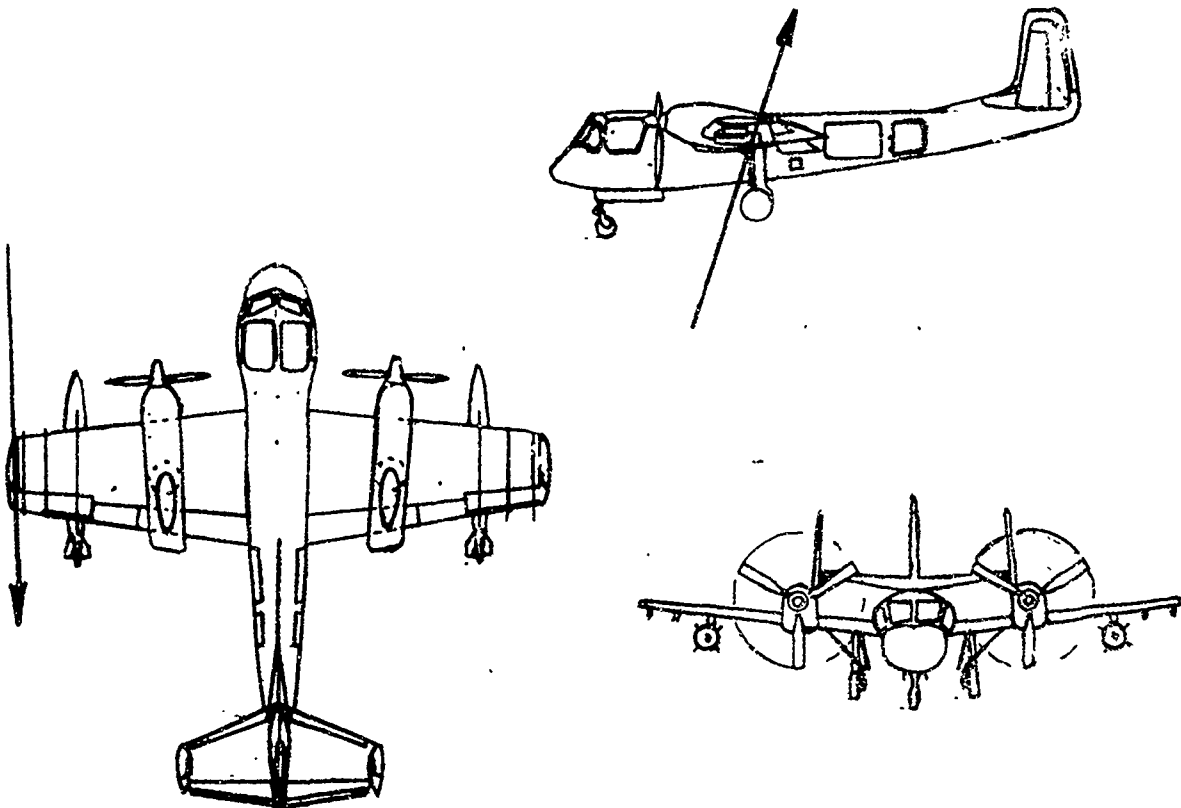
DATE TIME GROUP 171800 May 65 . OV-1 SERIES A .  
MISSIONS Photo . ALTITUDE 1000 feet  
NUMBER OF HITS 1 . CALIBER OF PROJECTILE(S) .30 .  
INJURIES None .  
WEATHER 2000 feet variable - Visibility 15 miles .  
DESCRIPTION OF HIT(S) 1 bullet hit the rocket pod and tumbled through the  
wing tip. Minor damage to stringer.  
\_\_\_\_\_  
\_\_\_\_\_  
\_\_\_\_\_

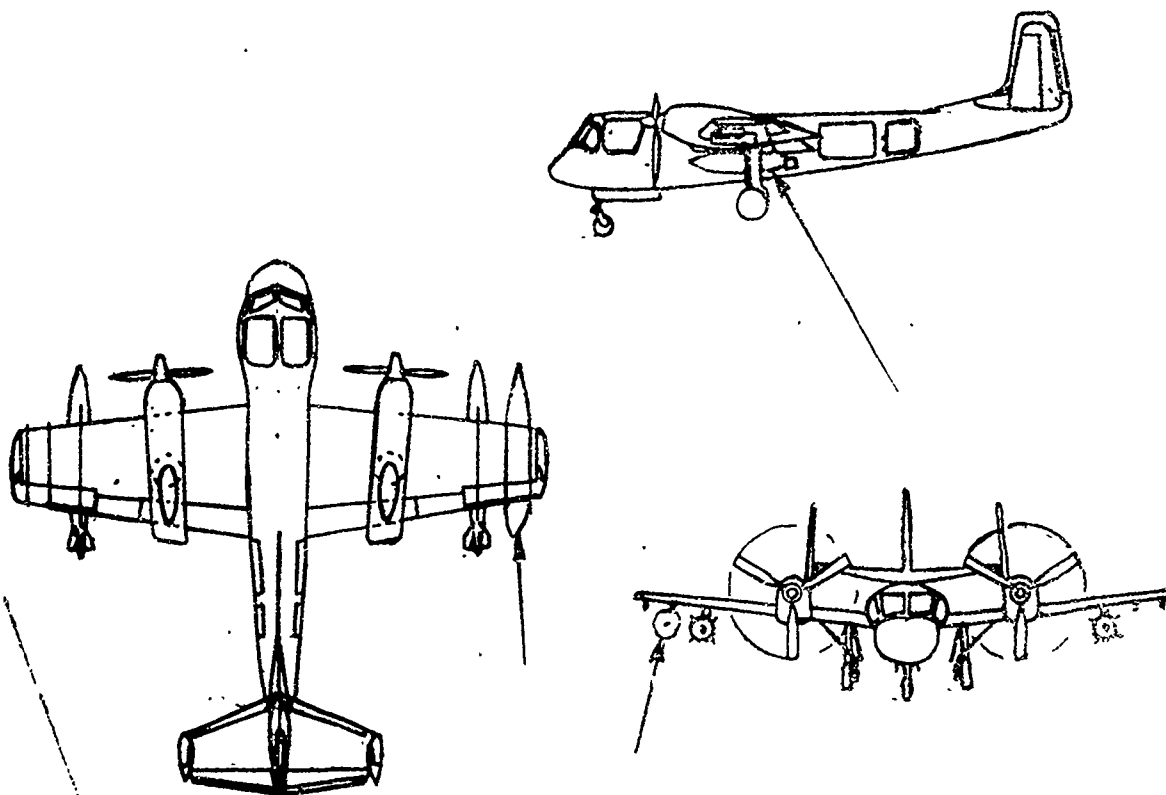
DATE TIME GROUP 19 May 1965 . OV-1 SERIES A .  
MISSIONS Visual Photo . ALTITUDE 1200 feet  
NUMBER OF HITS 2 . CALIBER OF PROJECTILE(S) .30 .  
INJURIES None .  
WEATHER Clear .  
DESCRIPTION OF HIT(S) Two projectiles found in right OE 750-round .50  
caliber pod. Both rounds entered same hole, cutting .50 caliber cartridge  
cases. Powder was ignited but there was no secondary explosion.

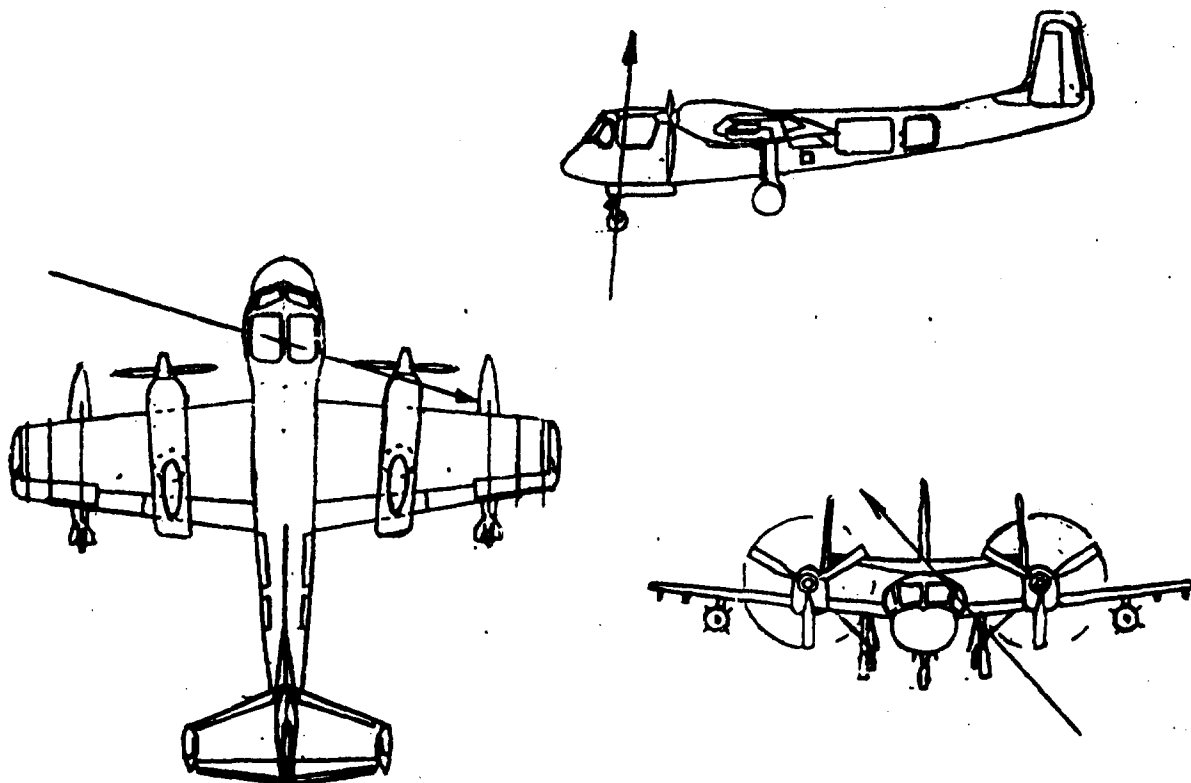
DATE TIME GROUP 210630 May 65 . OV-1 SERIES A .  
MISSIONS Photo . ALTITUDE 2000 feet .  
NUMBER OF HITS 1 . CALIBER OF PROJECTILE(S) .30 (Est.) .  
INJURIES Small cut on aviator's cheek from plexiglass .  
WEATHER Clear .  
DESCRIPTION OF HIT(S) Left side latch and through left side of top  
canopy. Plexiglass damaged.  
\_\_\_\_\_  
\_\_\_\_\_  
\_\_\_\_\_

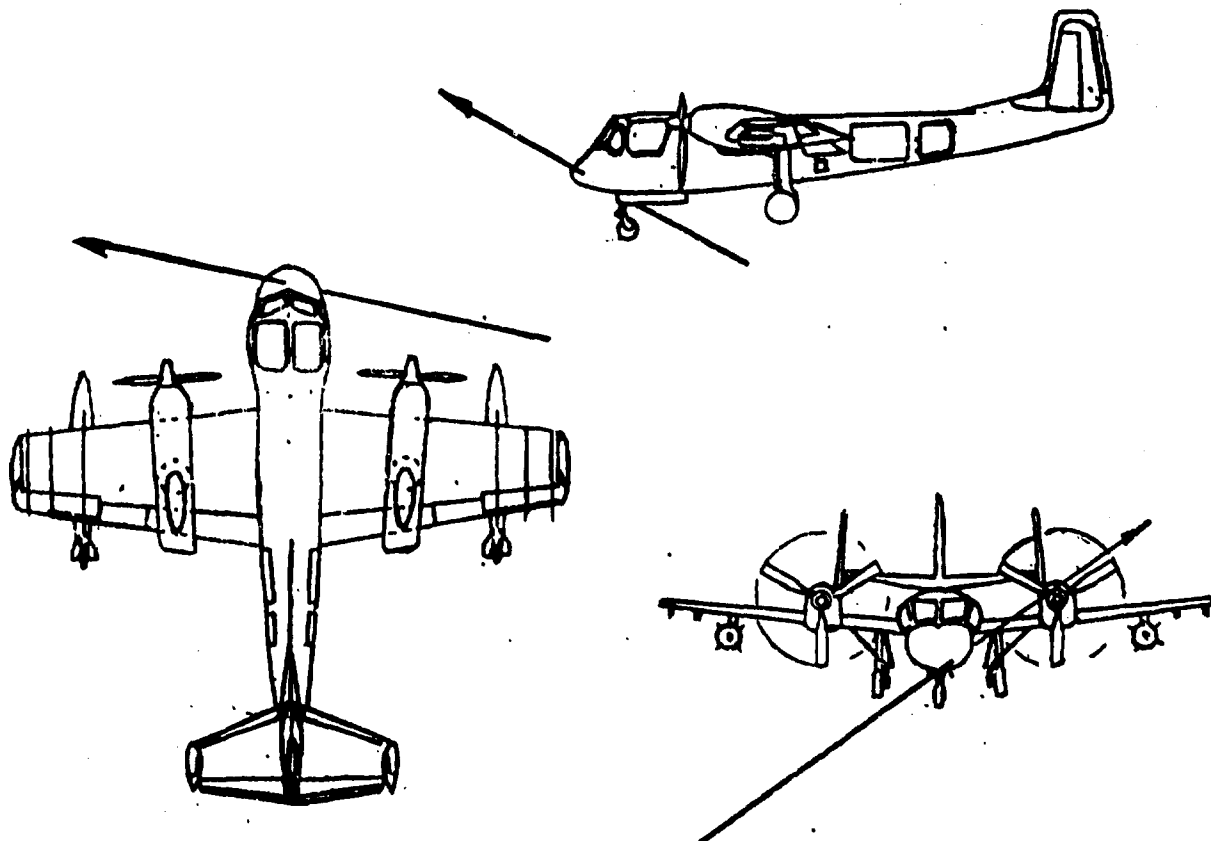
DATE TIME GROUP 210930 May 65. OV-1 SERIES A.  
MISSIONS Visual. ALTITUDE 1000 feet.  
NUMBER OF HITS 1. CALIBER OF PROJECTILE(S) .30 (B&C).  
INJURIES None.  
WEATHER Clear.  
DESCRIPTION OF HIT(S) Estimated .30 caliber bullet entered the aircraft  
through the bottom of the nose section. It passed through the J&P re-  
flector and the airframe and skin. Damage to a stiffener brace mechanism,  
push rod assembly, and crank tube.

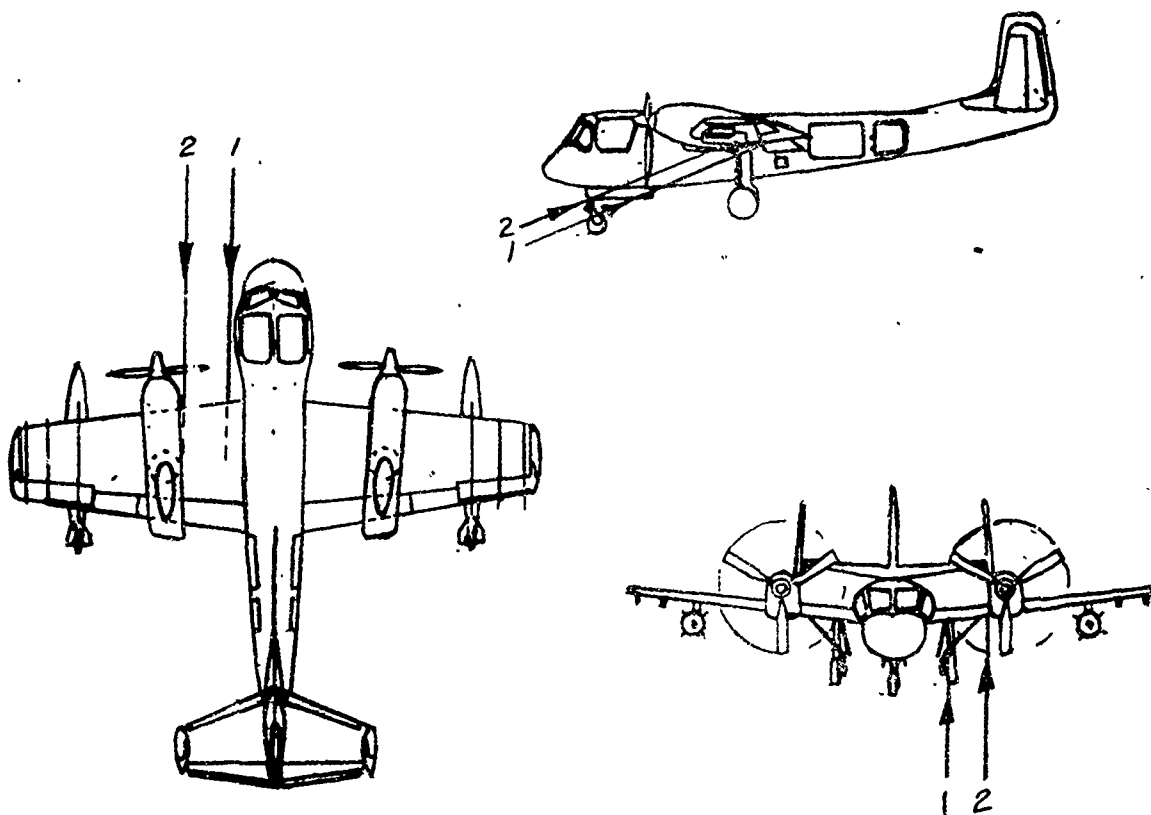
DATE TIME GROUP 231250 May 65 . OV-1 SERIES C  
MISSIONS IR . ALTITUDE 2000 feet  
NUMBER OF HITS 2 . CALIBER OF PROJECTILE(S) 50 .  
INJURIES None .  
WEATHER 3000 feet scattered .  
DESCRIPTION OF HIT(S) Two rounds damaged landing gear door fairing, forward  
trunion support member, bottom landing gear scissor, tire, top wing skin,  
brackets, and stringers.

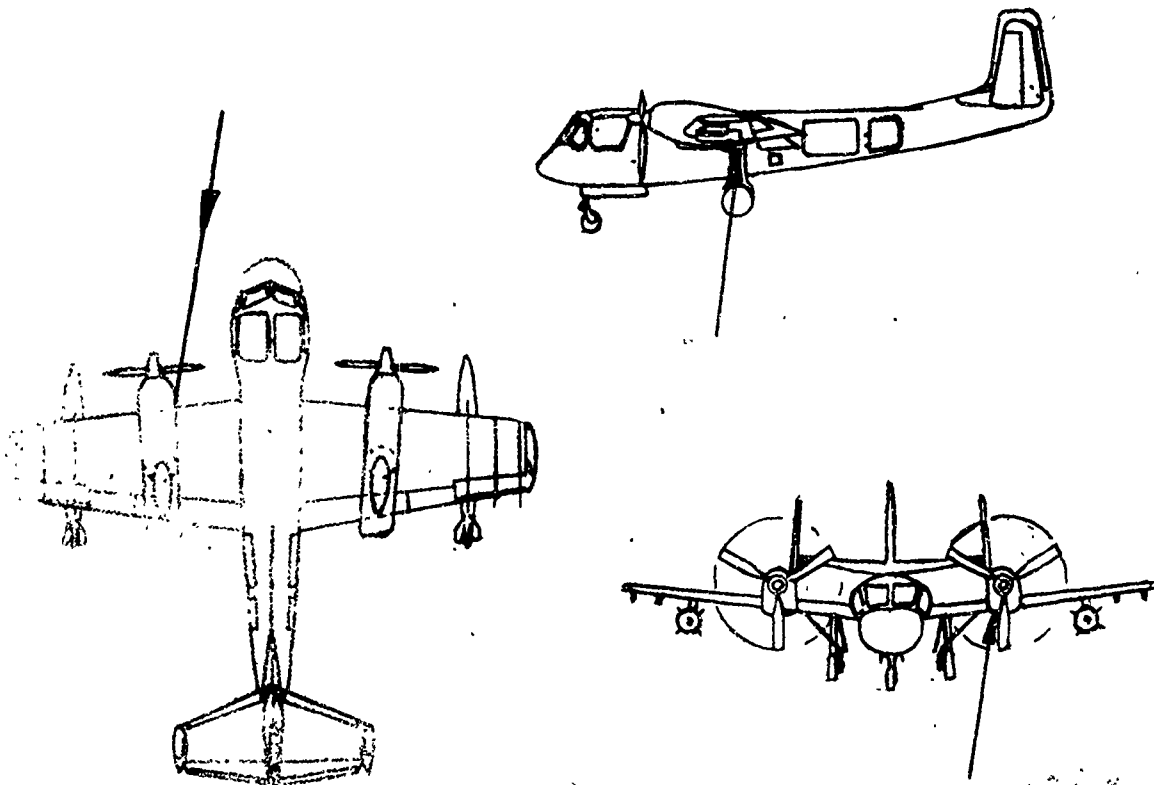
DATE TIME GROUP 190715 Jun 66 . OV-1 SERIES A .  
MISSIONS Visual . ALTITUDE 1000 feet .  
NUMBER OF HITS 1 . CALIBER OF PROJECTILE(S) .30 .  
INJURIES None .  
WEATHER Clear .  
DESCRIPTION OF HIT(S) Round entered aircraft through the left main landing  
gear nacelle fairing assembly, continued up into the wheel well and severed  
the hydraulic line to the brake assembly. The round then entered the engine  
exhaust tube where it terminated.
