This report is an excellent documentation of the initial employment of airboats in combat. The report is a reminder of the patience required of test and evaluation personnel during the initial employment of weapons or equipment. The results of the airboat evaluation conducted during the rainy season of 1964 were quite discouraging, and left unanswered the question of tactical effectiveness of the airboats for Republic of Vietnam operations. A much more aggressive program was instituted during 1965. During the months of August through November 1965 the airboats were used in 104 operations, and Viet Cong were contacted during 84 of these missions. The airboats were particularly effective when used as a flank security element during coordinated offensive operations or as a pursuit force. The airboats were used in these roles on fifteen operations, and during these operations accounted for 81 Viet Cong killed in action. Only five Viet Cong were killed in action during the other 89 operations, principally reconnaissance patrols. The performance of the airboats during the 1965 evaluation clearly demonstrated that they are a valuable vehicle for ground forces operating in the Mekong Delta

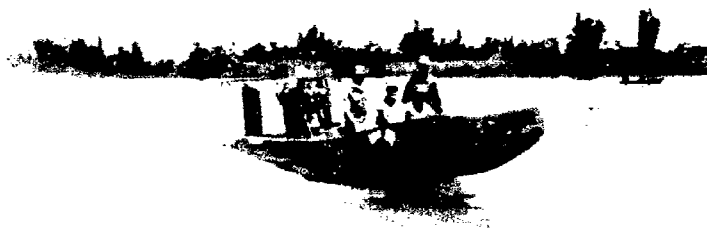
(U) FIGURE B-3. Modified Hurricane Aircat.
