BUREAU OF SHIPS GROUP TECHNICAL INSPECTION REPORT

Operation Crossroads, U.S.S. SARATOGA (CV 3)

TEST BAKER

TECHNICAL INSPECTION REPORT

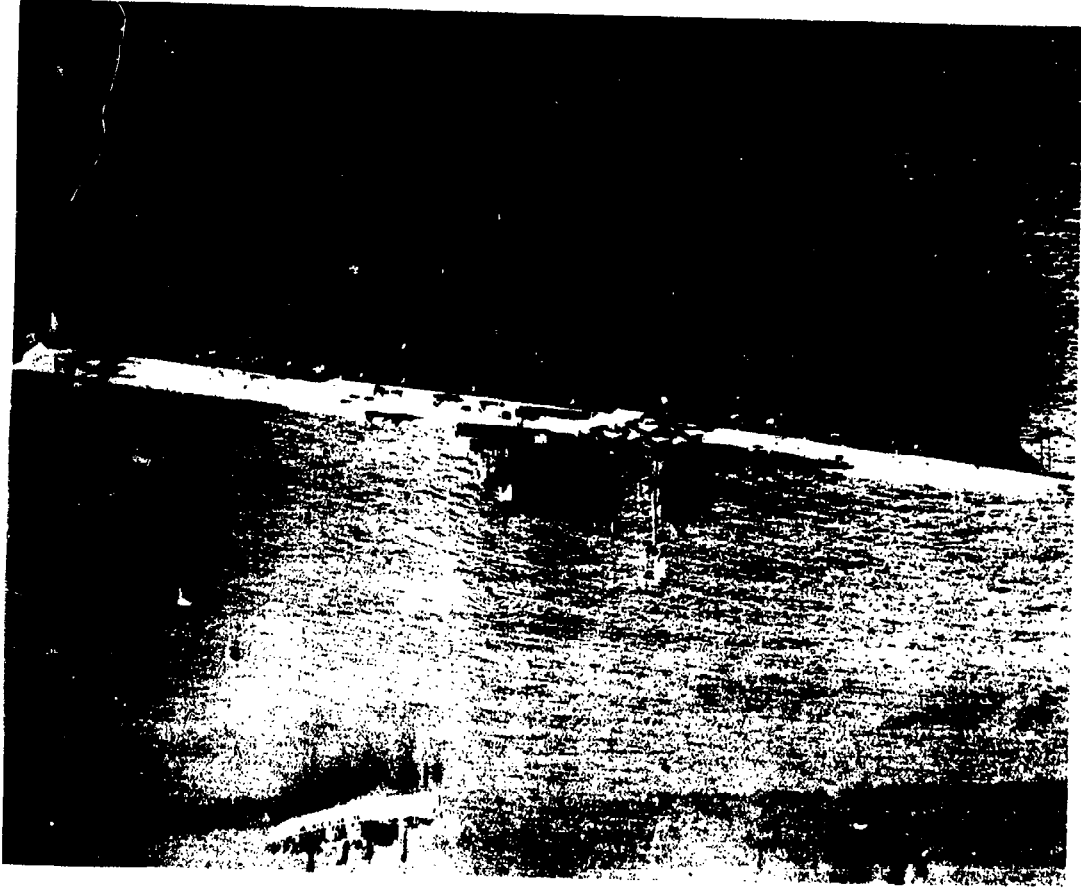
DB-CR-113-286. 0715 to 0850 (-11) 25 July 46/30"/obl/var. Eikini.
Print #8. Pre-burst view of SARATOGA.
