FINAL REPORT

**BAR ARMOR KIT  
(M113) (U)**

JRATA Project No. 1B-172.0

31 August 1966

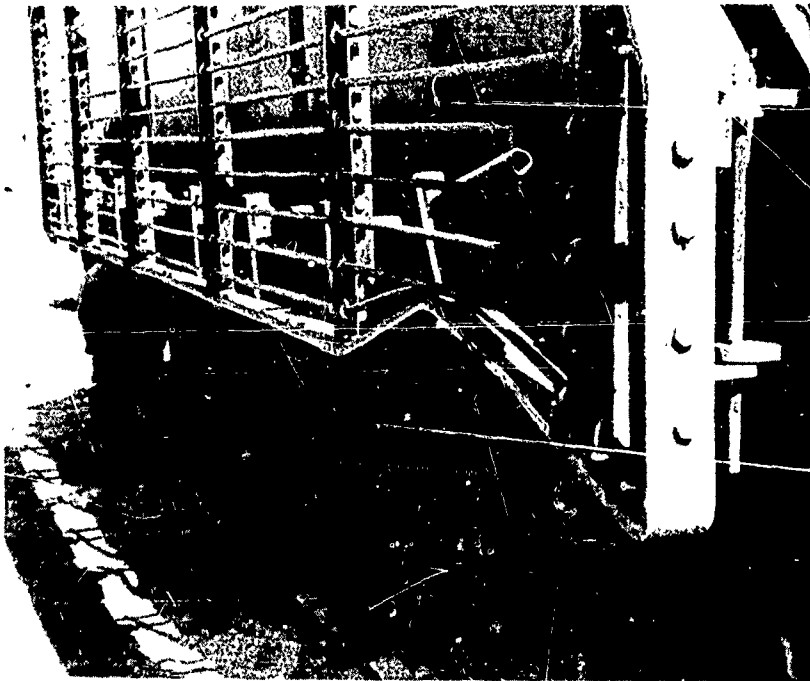
- (a) Front bumper plate support bracket - cracked.
- (b) Side grille frame locking pin - missing.
- (c) Lower support arms, right side - broken (figure 7).
- (d) Right side grille frame - bent (figure 8).

(U) FIGURE 8. Bent right side grille frame.
