ASD Interim Report 7-915 (IV)

CONTAINER FAILURE DETECTION SYSTEM

General American Transportation Corporation  
7501 N. Natchez Ave.  
Niles, Ill.

Interim Technical Engineering Report  
1 September, 1962 - 28 February, 1963

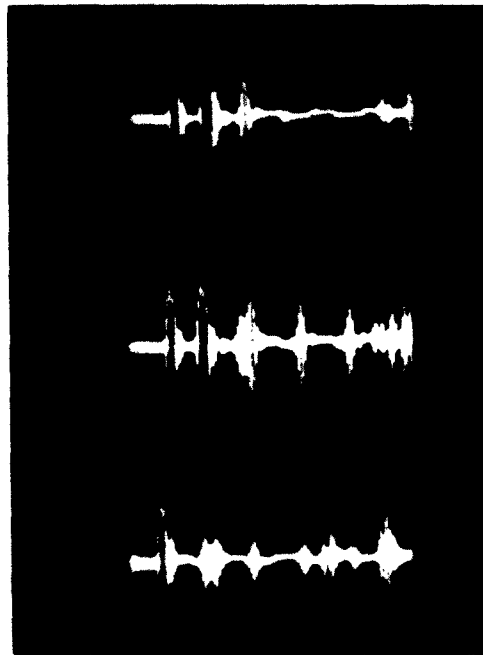
a. uncoupled

b. coupled to steel flat

Several silicone rubber fabricators were consulted, and rubber samples tested to determine their coupling capability at elevated temperatures. A 2.25 Megacycle transducer was press fit into a tube which was subsequently filled with water. The samples were held to the tube end by evacuating grooves milled in the wall at the sample end. The first trace in the oscillograms of Figure 13 shows the signal pattern received before the assembly was coupled to a one inch test block. The first echo is that from the water-rubber

interface while the second is the echo from the working side of the rubber, the third echo simply being a multiple of the second. When the unit was pressed onto a 1" steel plate coated with Dow #41 silicone grease, the multiple echo pattern in the steel was observed as in the second trace. The echo pattern in the third trace shows that coupling could be achieved in the same manner when the flat temperature was 600°F though it degenerated in comparison to room temperature coupling.

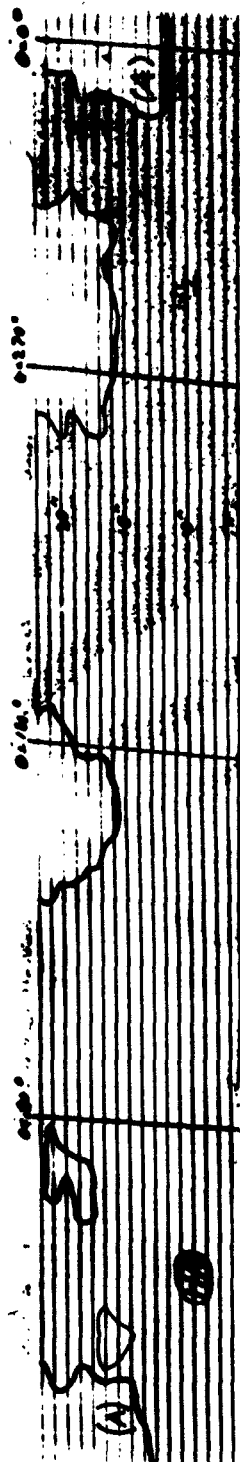
GATE START AT LP 6"  
GATE WIDTH = 4"

GATE START AT LP 10"  
GATE WIDTH = 8"

This phenomena remains yet as conjecture and subject to further investigation, however, it appears as the most plausible explanation. This is particularly evident by observation of the recordings of Figure 24 which shows the effect of changing the gate position. Note that most crack infor-
