INTERIM DEVELOPMENT REPORT

MF RESISTOR FACTORIAL LOAD LIFE TEST

CORNING GLASS WORKS

NAVY DEPARTMENT BUREAU OF SHIPS ELECTRONICS DIVISION

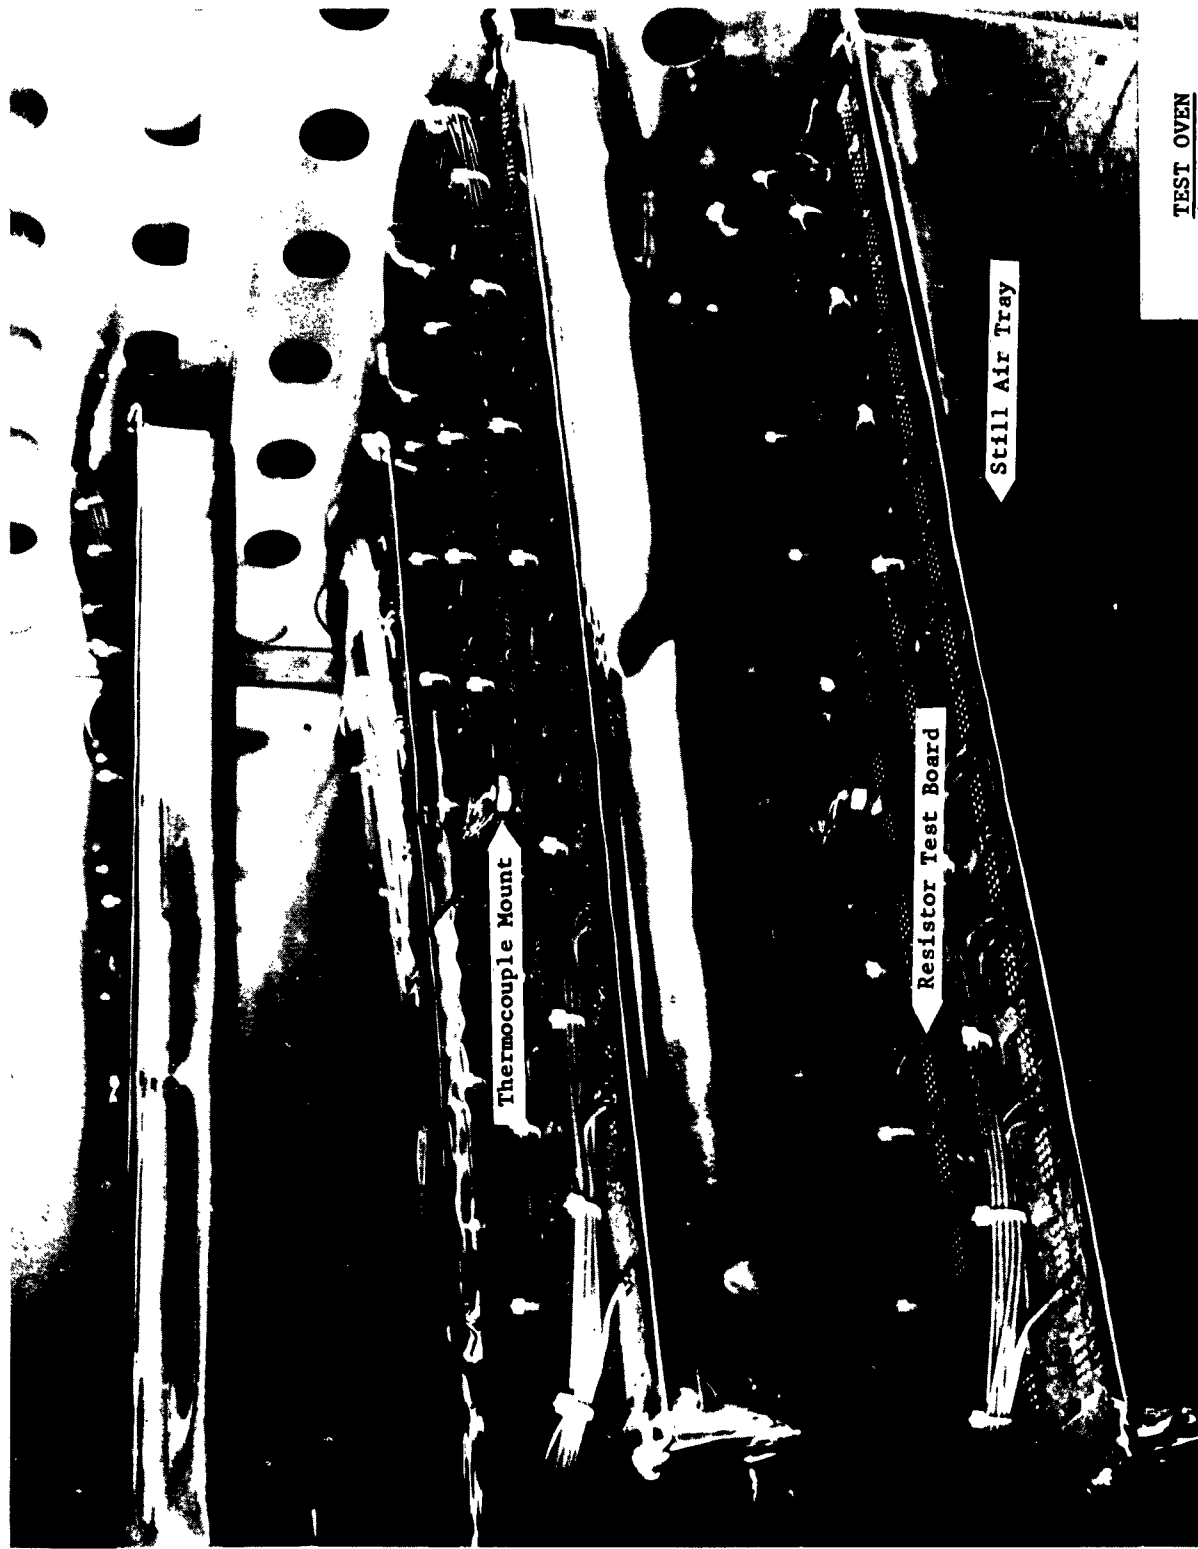
TEST OVEN

Thermocouple Mount

Resistor Test Board

Still Air Tray

The completed test boards with still air trays attached were placed in the oven and supported by 1/4" OD glass rods under the aluminum still air trays. The wires were then fed through the 1 3/4" diameter ports located on the rear panel of the oven. Each bundle of wires attached to a board had been marked to identify them at a later time. When all assigned boards had been placed in the oven, the wires were then segregated into groups according to sequence of assembly. Normally, plugs and relays located at the bottom portion of the chassis were wired first.
