**Second Quarterly Technical Progress Report  
Continuation of 3-KW Stirling Cycle Solar  
Power System Program**

**(1 August through 31 October 1961)**

**Contract No. AF33(616)-8332  
Project No. 3145, Task No. 30500**

**Engineering Dept., Aircraft Engine Operations  
ALLISON DIVISION OF GENERAL MOTORS CORPORATION  
Indianapolis, Indiana**

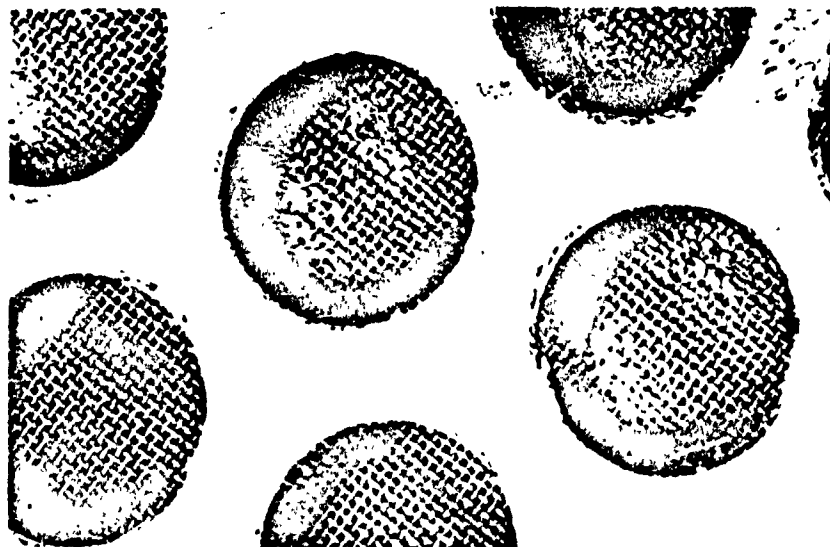
Visual inspection revealed a deposit on the screen mesh on the cold side of each regenerator (see Figure 4). This deposit is believed to be a combination of oil and wear residue from the Teflon K-30 piston rings. A flow test at teardown indicated that the pressure drop through the side arm circuit increased approximately 7 percent when compared with the check made at Build-up 7. This deposit was removed by ultrasonic cleaning, followed by conventional cleaning processes. Damage to the screen was observed on the hot side of the regenerator where heater tubes coincided with regenerator end plate holes (see Figure 5). This is felt to have been caused by bombardment of small foreign particles in the working fluid against the screen which had been weakened by the 1100°F temperature. This problem indicates the need for extreme cleanliness during assembly.

Figure 4. Deposits on Screen Mesh on Cold Side of Regenerator
