RESULTS OF THE PHASE I LONG-TERM  
ENVIRONMENTAL STORAGE TEST PROGRAM  
FOR THE RJ43-MA-11 RAMJET ENGINE  
OCTOBER 1960 THROUGH MARCH 1963

Contract AF 33(657)-7770  
Project 273  
Model RJ43-MA-11

Marquardt  
CORPORATION

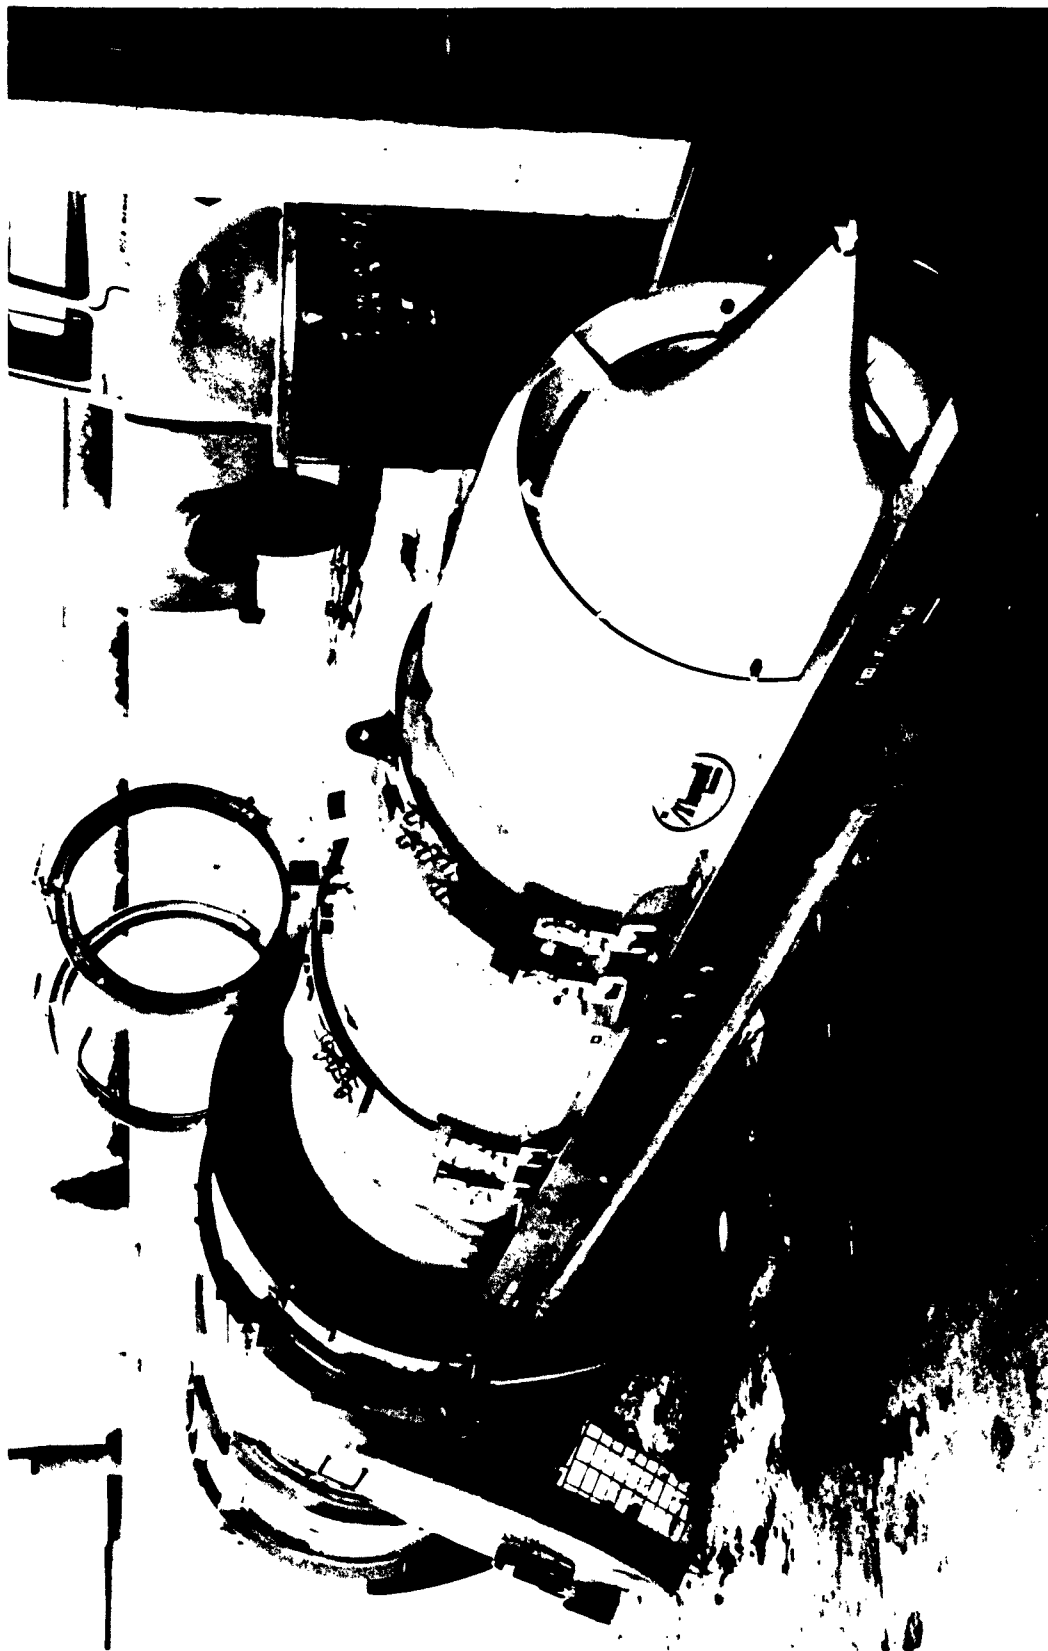
1.14.3-24

FIGURE 5 - RJ43-MA-11 Ramjet Engine Serial MA-E10002-2 Being Removed From its Storage Container at the Conclusion of the RJ43-MA-11 Phase I Long Term Storage Test.

On 15 January 1963 the containers were opened in the presence of the local Air Force Quality Control representative. The fuel control unit storage container, which automatically adjusts the pressure level within the container, was found to be slightly pressurized when opened. A superficial inspection of the test specimens was conducted and all specimens appeared to be in excellent condition. Figures 5 through 7 show the test items at the time the containers were opened.

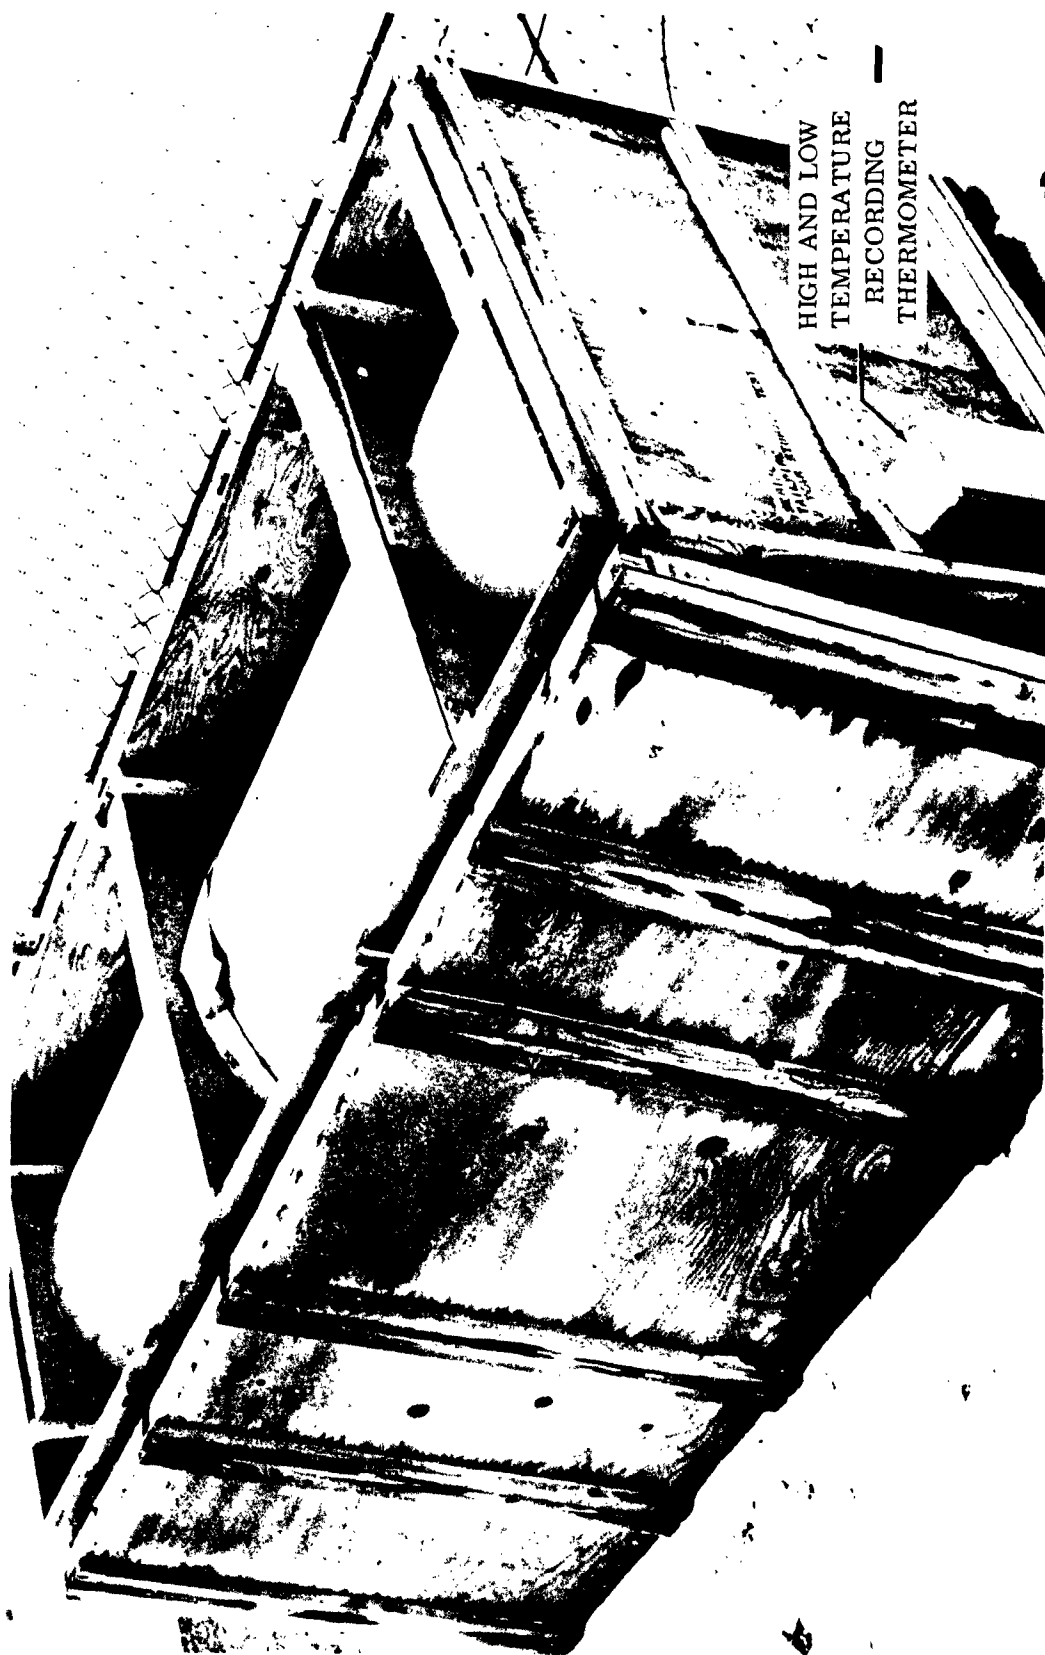
1.14.3-23

FIGURE 6 - RJ43-MA-11 Combustion Chamber Assembly Serial 0054 Being Removed From its Storage Container at the Conclusion of the RJ43-MA-11 Phase I Long Term Storage Test.

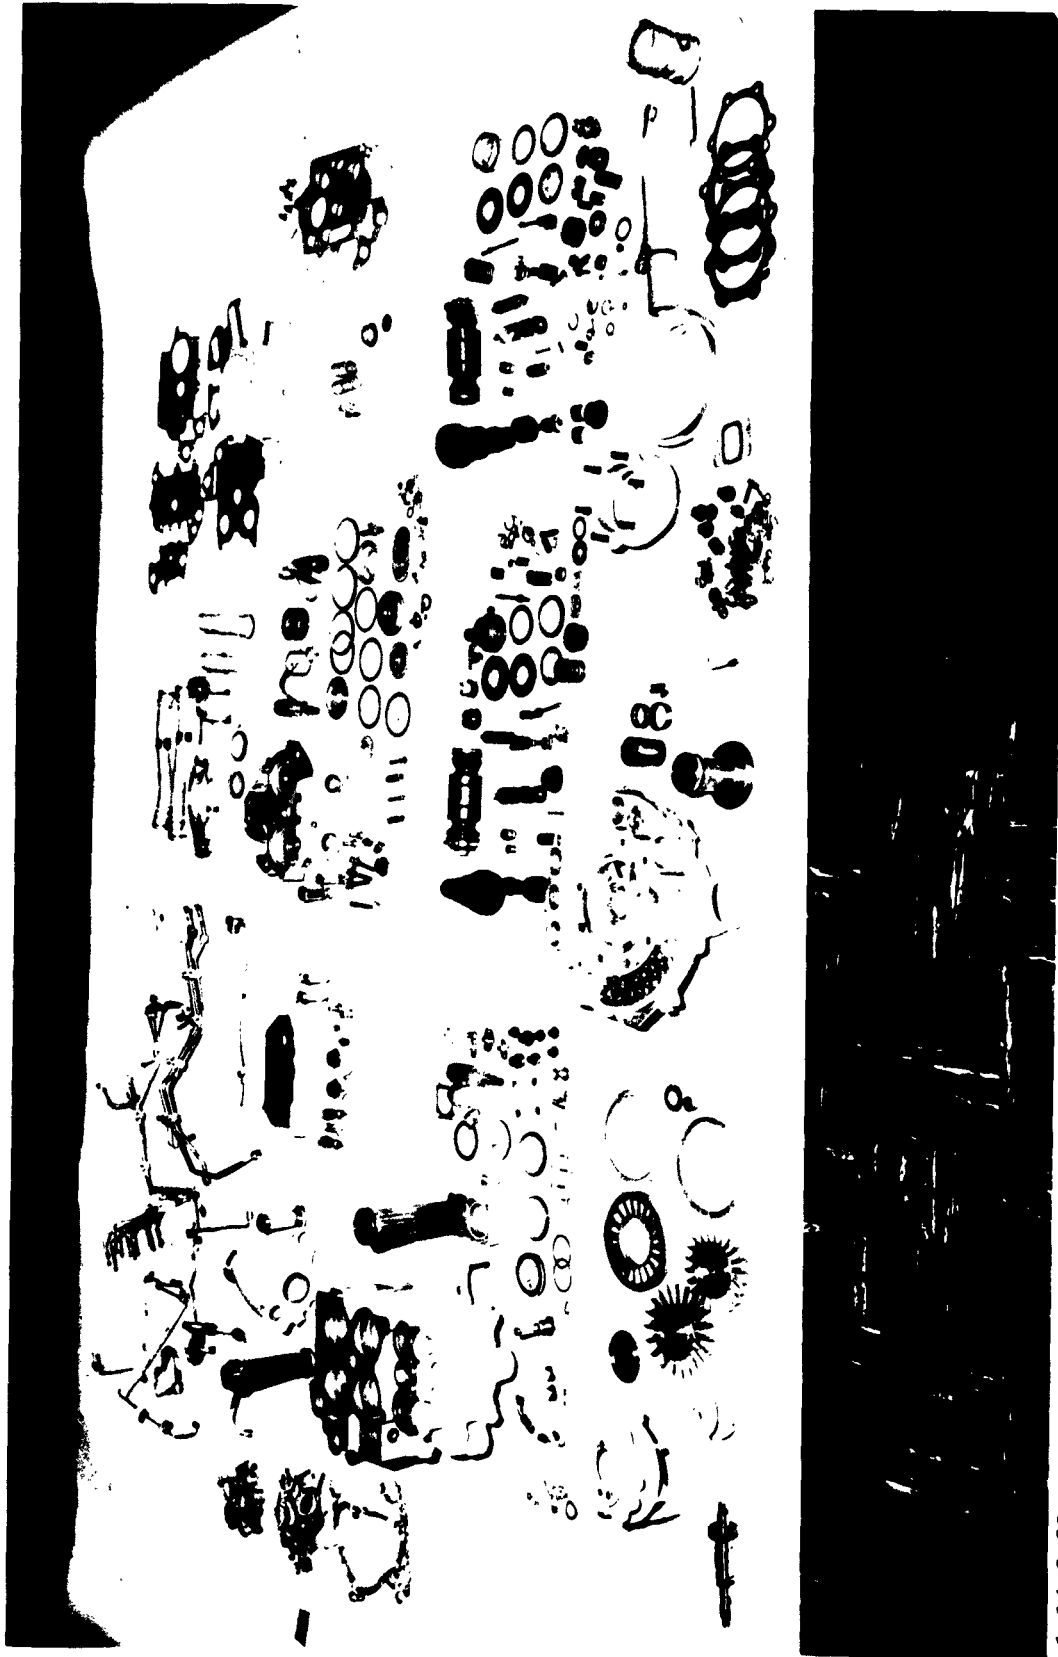
1.14.3-32  
FIGURE 18 - Disassembled Components of Spare RJ43-MA-11 Fuel Control Unit Serial 007 Following the RJ43-MA-11 Phase I Long Term Storage Test.

Each test specimen was disassembled to the degree that any deterioration of the part could be determined. The degree to which the test specimens were disassembled is shown in Figures 15 through 18. The disassembly was conducted under cognizance of the resident Air Force Quality Control representative. An inspection of each part was made by representatives of the resident Air Force Quality Control office, TMC Quality Control Department, and TMC Engineering Department.

Spare fuel control unit Serial 007 was also found to be in excellent condition. One minor discrepancy was noted on the Mach sensor-shock position control housing. This consisted of a small area on the housing, shown in Figure 20, where slight corrosion was evident. This area is open to the atmosphere and, from residue found in the area, had been covered with leak detection soap at the time of initial calibration. It is felt that a flaw in the protective coating in this area combined with the soap, produced the resultant corrosion. This area of the housing has no function other than to provide the area to which the cam adjustment retainer is bolted.
