# AZUSA PLANT

STRESS-CORROSION CRACKING  
OF HIGH-STRENGTH ALLOYS

Contract DA-04-495-ORD-3069

Report No. 0414-01-9 (Quarterly)

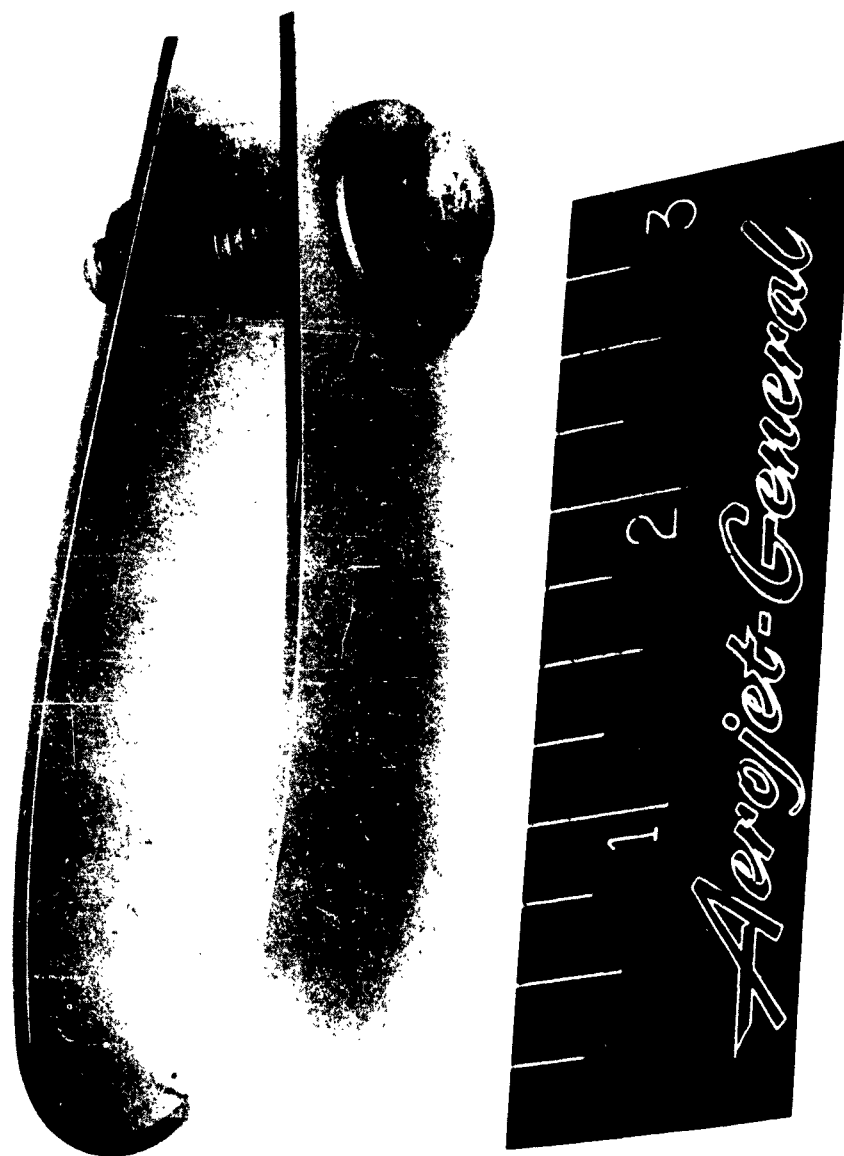
U-Bend Test Specimen

Figure 2 shows a U-bend test sample. This test was used extensively in the initial 2-year program to accelerate failure times by producing stresses beyond the yield strength of the material. The U-bend test method is now being used only for the 6Al-4V titanium alloy because initial testing indicated that some of the maraging steels would not withstand the drastic distortion of a U-bend while in the fully aged condition. Although it is possible to give the samples a partial bend in the annealed condition and to complete the U-bend after subsequent aging, it is believed that this procedure would not represent a realistic condition for study. The center-notch test described below is being used for acceleration of failure times.
