**U. S. Naval Weapons Laboratory  
Dahlgren, Virginia**

**TERRIER Structural Firing Test**

**Aboard the USS LEAHY (DLG-16)**

**NWL Report No. 1857**

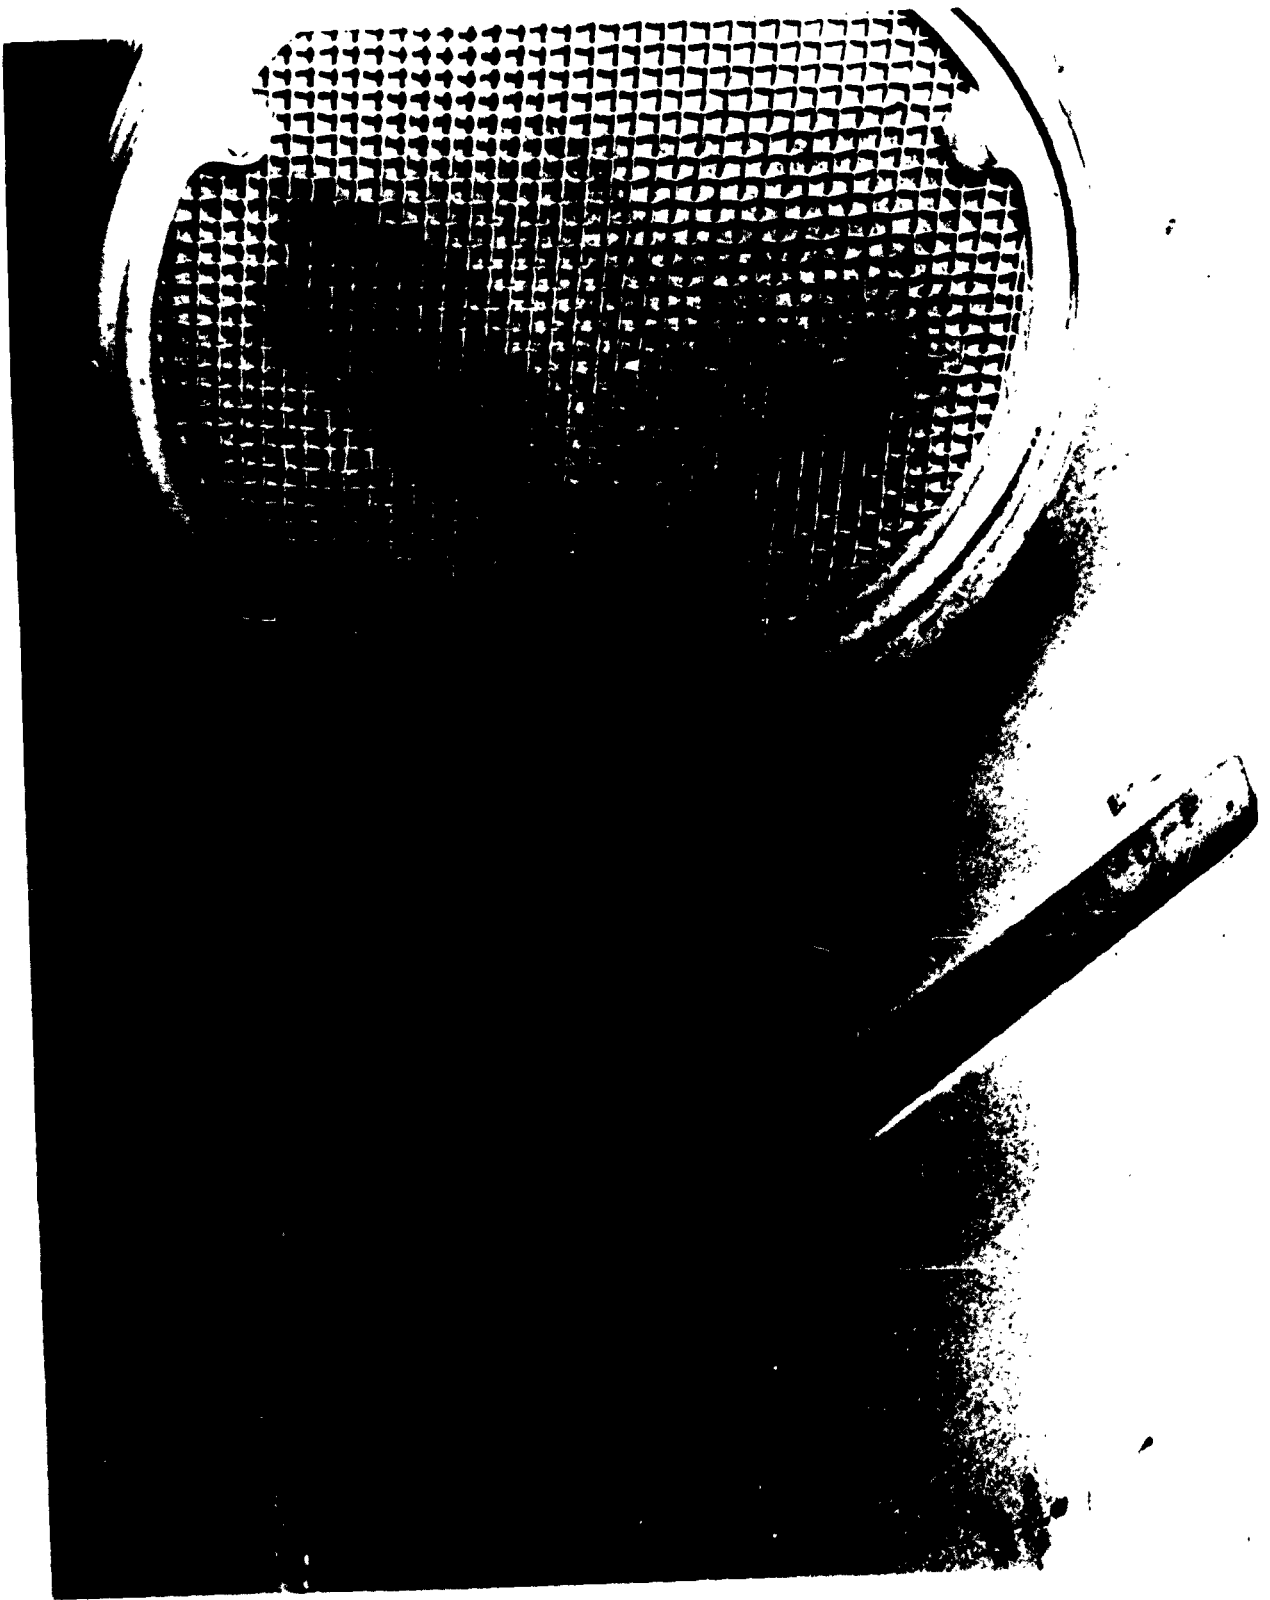
Figure 9

The maximum pressures obtained at the opening of the fuel oil air escape vents, Figure 9, were approximately 6 psig. Pressure-versus-time curves for each of the fuel oil air escape vent locations are shown in Figures 10 through 12. The maximum pressure recorded on the supporting structure for Door 1-176-2 was 17 psig. The location of all the gauges and the maximum pressures recorded are indicated in Table 36.

Fuel Oil Air Escape Vent After Round 7

- A. Pressure probe.
- B. Temperature probe.

5. The fuel oil air escape vents be relocated clear of the blast area.

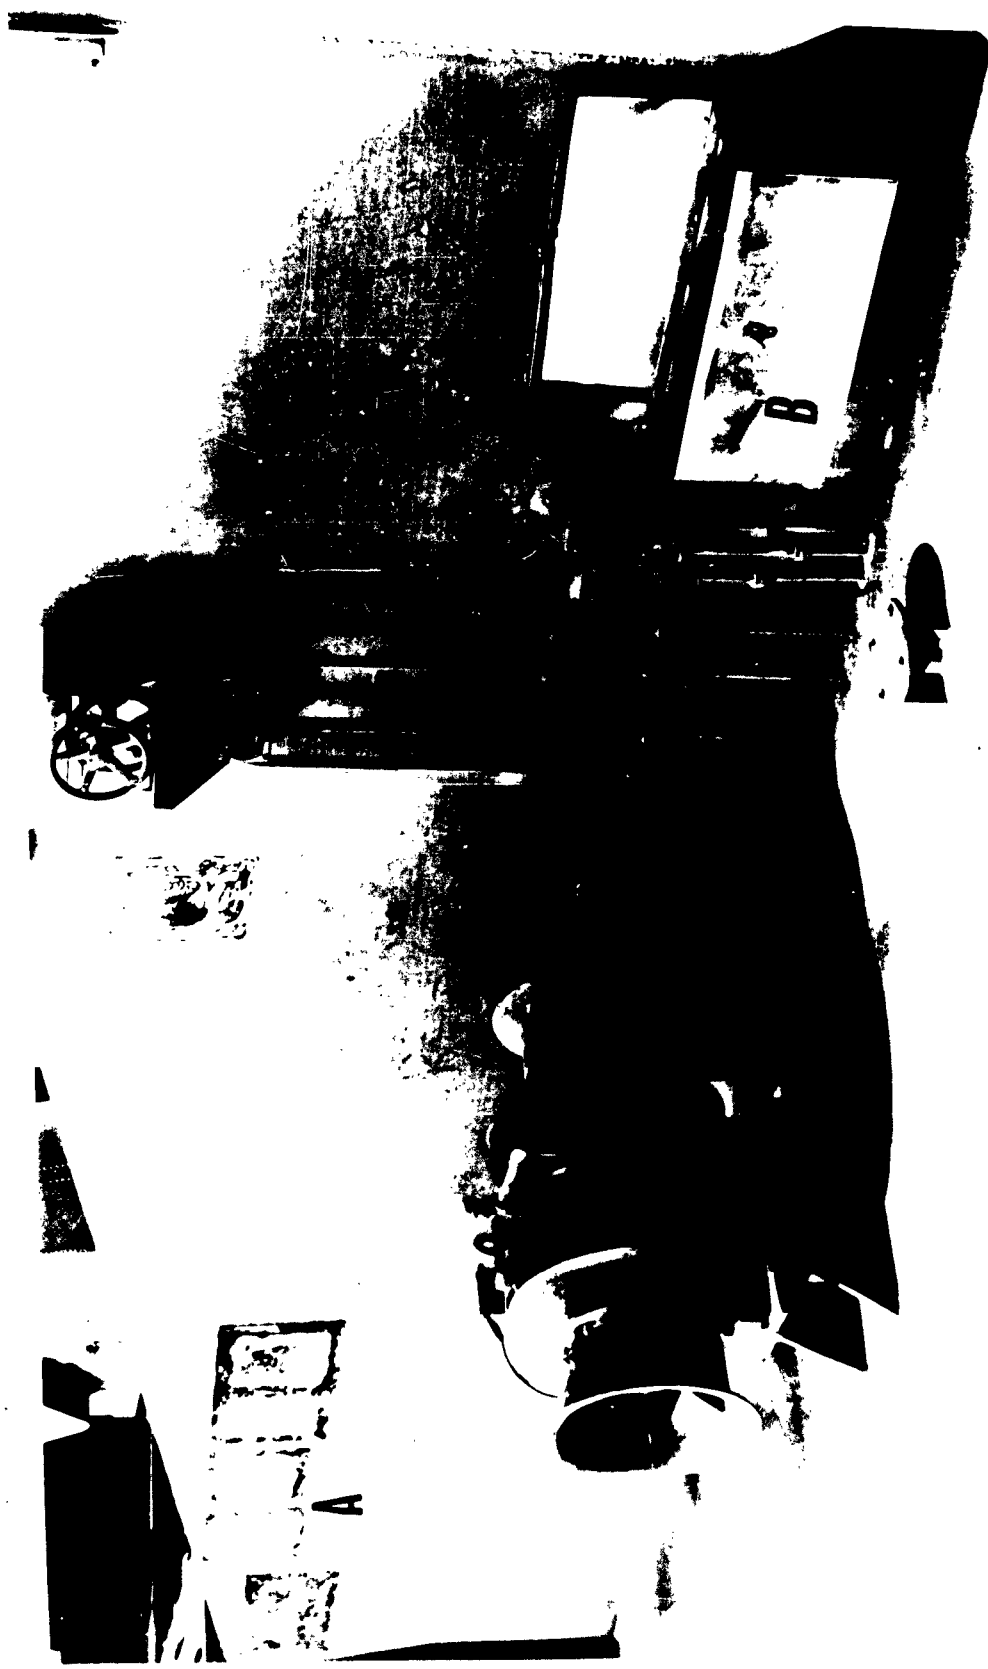
(3) Instruction plates located on the starboard side of the missile house were burned or completely destroyed, Figure 14.

Figure 14  
Starboard Side of Forward Missile House  
A. Location of missing instruction plates.  
B. Damaged sound powered phone storage box.

6. Sound powered telephone storage boxes be located in an area protected from the booster blast.

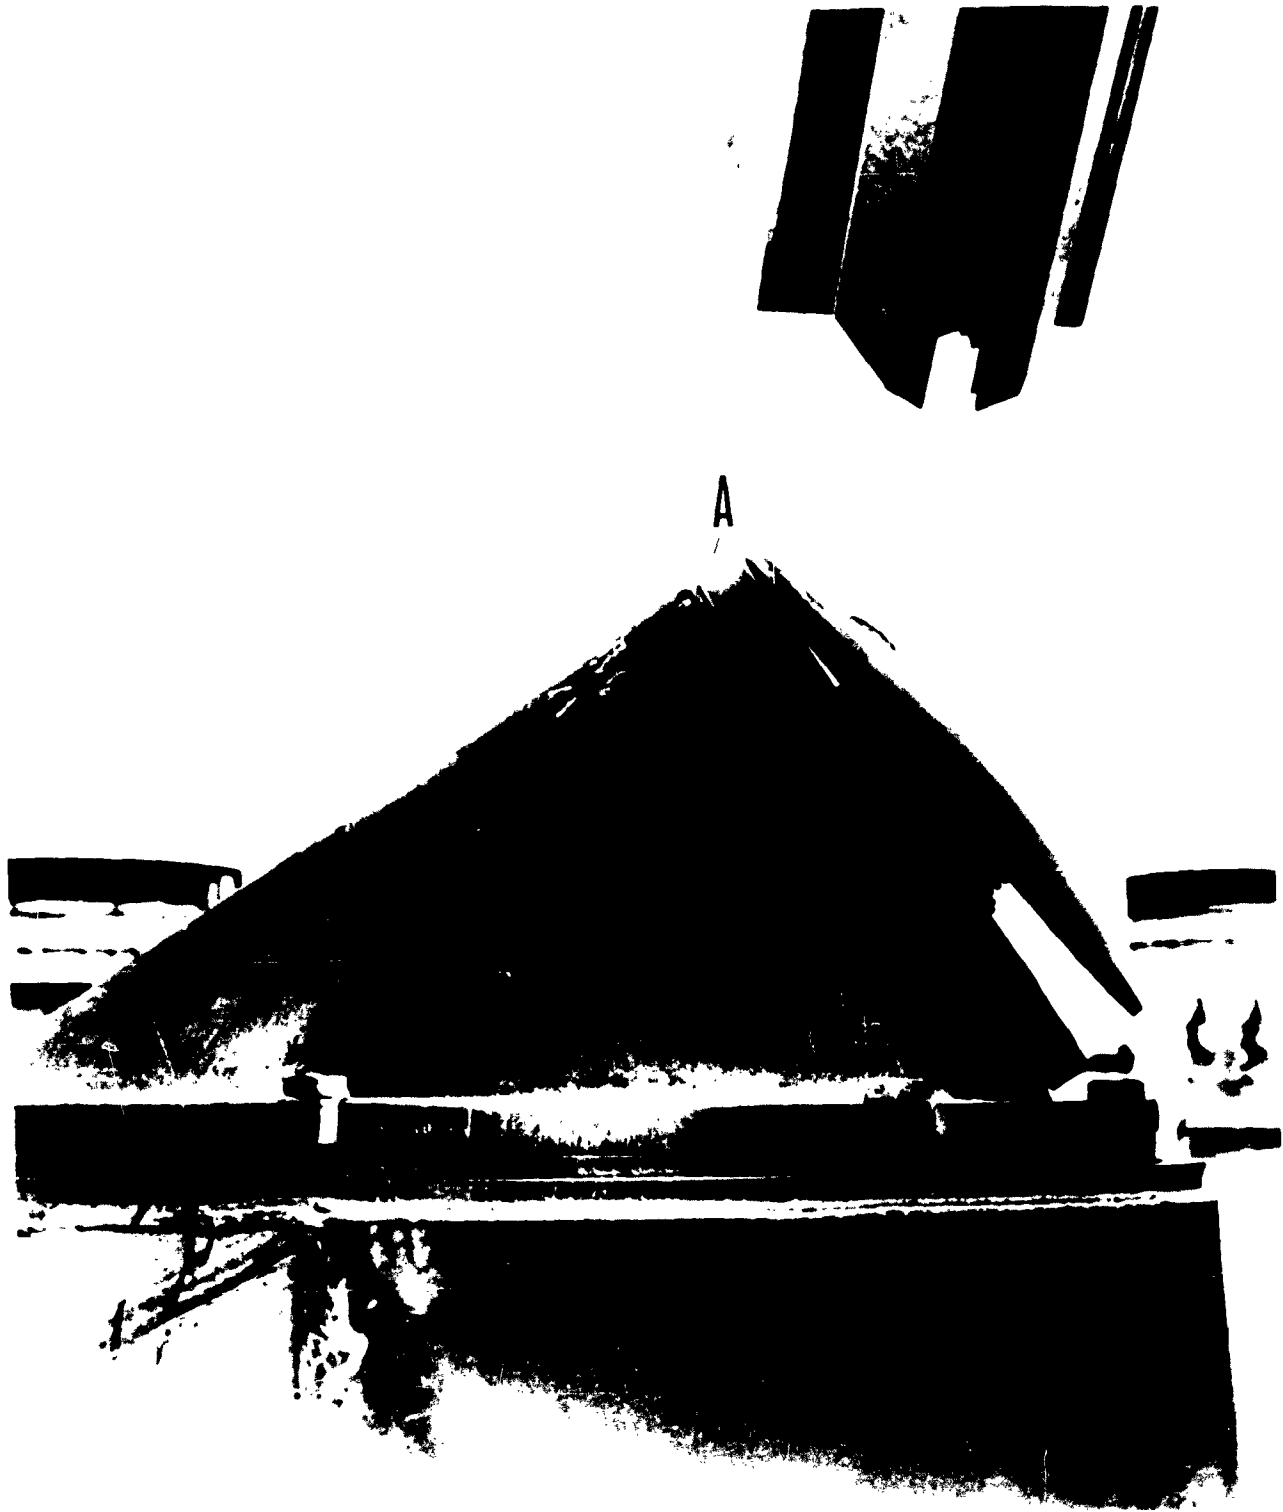
Figure 16

(5) The A dud-jettisoning piston for Launcher No. 1 was extended by the blast during Round 5, Figure 16. The unit contained ORDALT 4679 and Northern Ordnance representatives also modified the unit prior to the test by installing a metal band around the periphery of the cap, Figure 16. The purpose of the band was

to prevent leakage of gases into the unit. It was noted by the EP-2 panel operator that the launcher motors did not shut down until after the BTV had cleared the rail. The piston was restowed after the test.

A Dud Jettisoning Unit, Launcher No. 1  
A. Modification to unit.

4. The dud-jettisoning units be instrumented during blast tests in the DLG-17 to determine the magnitude of forces acting on the unit as a result of booster blast. The data obtained be used to design a positive latch to prevent extension of the piston during missile firings.

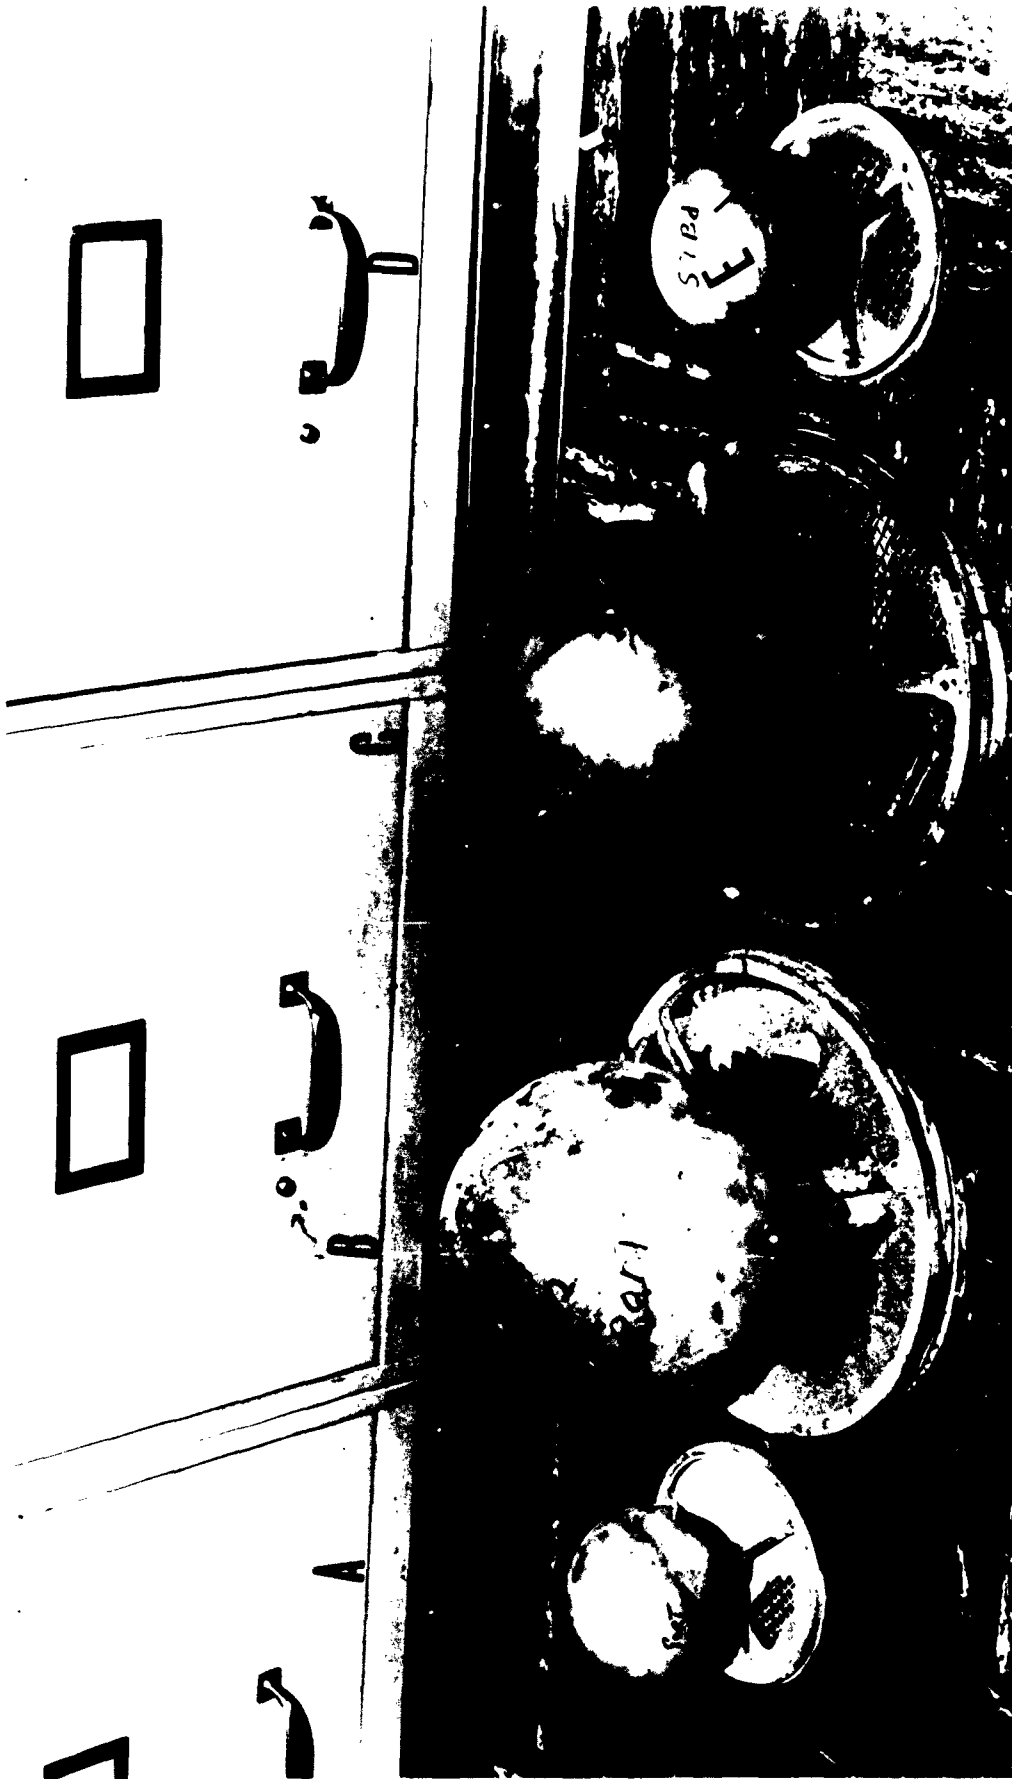
Figure 17

(1) The wire mesh screens for the four fuel oil air escape vents, located at Frame 176 port and starboard, were burned by the booster exhaust and the ball enclosures distended. At the completion of the firings, all of the air escape vents were disassembled and the check valves inspected for damage. The inspection showed that three of the check valves were distorted where they seat at the top of the vents and that one of the check valves had been ruptured, Figure 17. The damage to the ball check valves was attributed to the high overpressure and the resultant impact load upon seating. There also were indications of smoke leakage past the seals of the vents into the fuel oil vents (AE MN 6-174-0-F & 6-185-0-F) and (AE 6-161-1-F) each time the ship rolled to the starboard after Round 10.

Ball Check Valves for Fuel Oil Vents at completion of tests.

- A. Vent (AE 6-161-2-F).
  - B. Vent (AE MN 6-174-C-F & 6-185-O-F) Portside.
  - C. Vent (AE MN 6-174-O-F & 6-185-C-F) Starboard side.
  - D. Vent (AE 6-161-1-F).
  - E. Rupture in vent D.
- The circle at the top of check valves B, C and D is where the balls were distorted.  
 Note the severe damage to the flame screens.

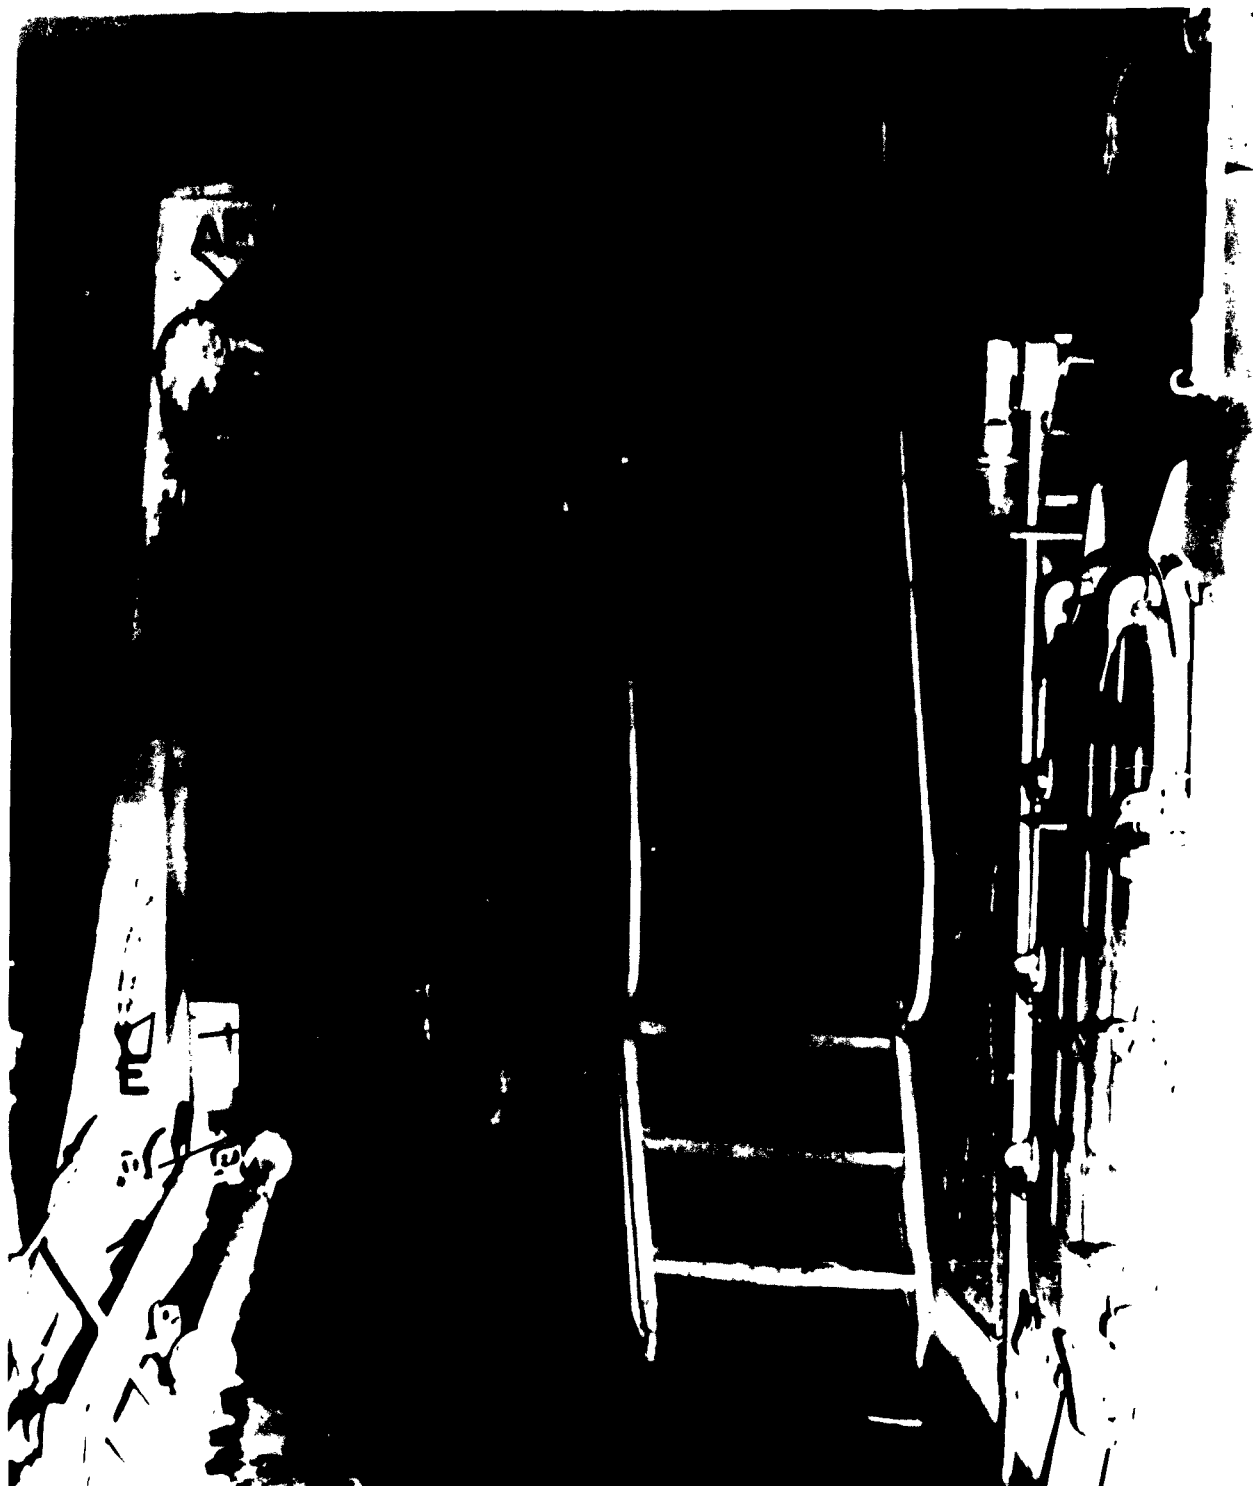
Figure 20

(6) A toggle pin at the bottom of the ladder on the main deck, portside, Frame 177, was blown out and the ladder twisted, Figure 20.

(7) Brackets for securing the boat boom vang king post were distorted, Figure 20.

- A. Fan Room 1-178-2-1.
- B. Pin blown loose during Round 7 permitting ladder to be twisted.
- C. Damage sound powered phone storage box.
- D. Securing clamp for boat boom king post bent upward permitting post to come loose.
- E. Broken life line.

8. The ladder on the main deck, portside, be more rigidly secured.
9. The boat boom vang king post be relocated out of the blast area.
10. An investigation be conducted to determine the feasibility of installing a gas tight door on Fan Room 1-178-2-Q to prevent smoke and toxic gases from entering the ship during missile firings.
11. An investigation be conducted to determine the source of lead concentrations detected in the Crew Living Space 2-20-0-L prior to the booster firings.
12. A positive latching device be designed and installed on all compartment doors in the immediate blast area.
