SNAP 2/10A GROUND TEST PROGRAM, PHASE I

TECHNICAL DOCUMENTARY REPORT NUMBER AFSWC-TDR-62-144

March 1963

Development Directorate  
AIR FORCE SPECIAL WEAPONS CENTER  
Air Force Systems Command  
Kirtland Air Force Base  
New Mexico

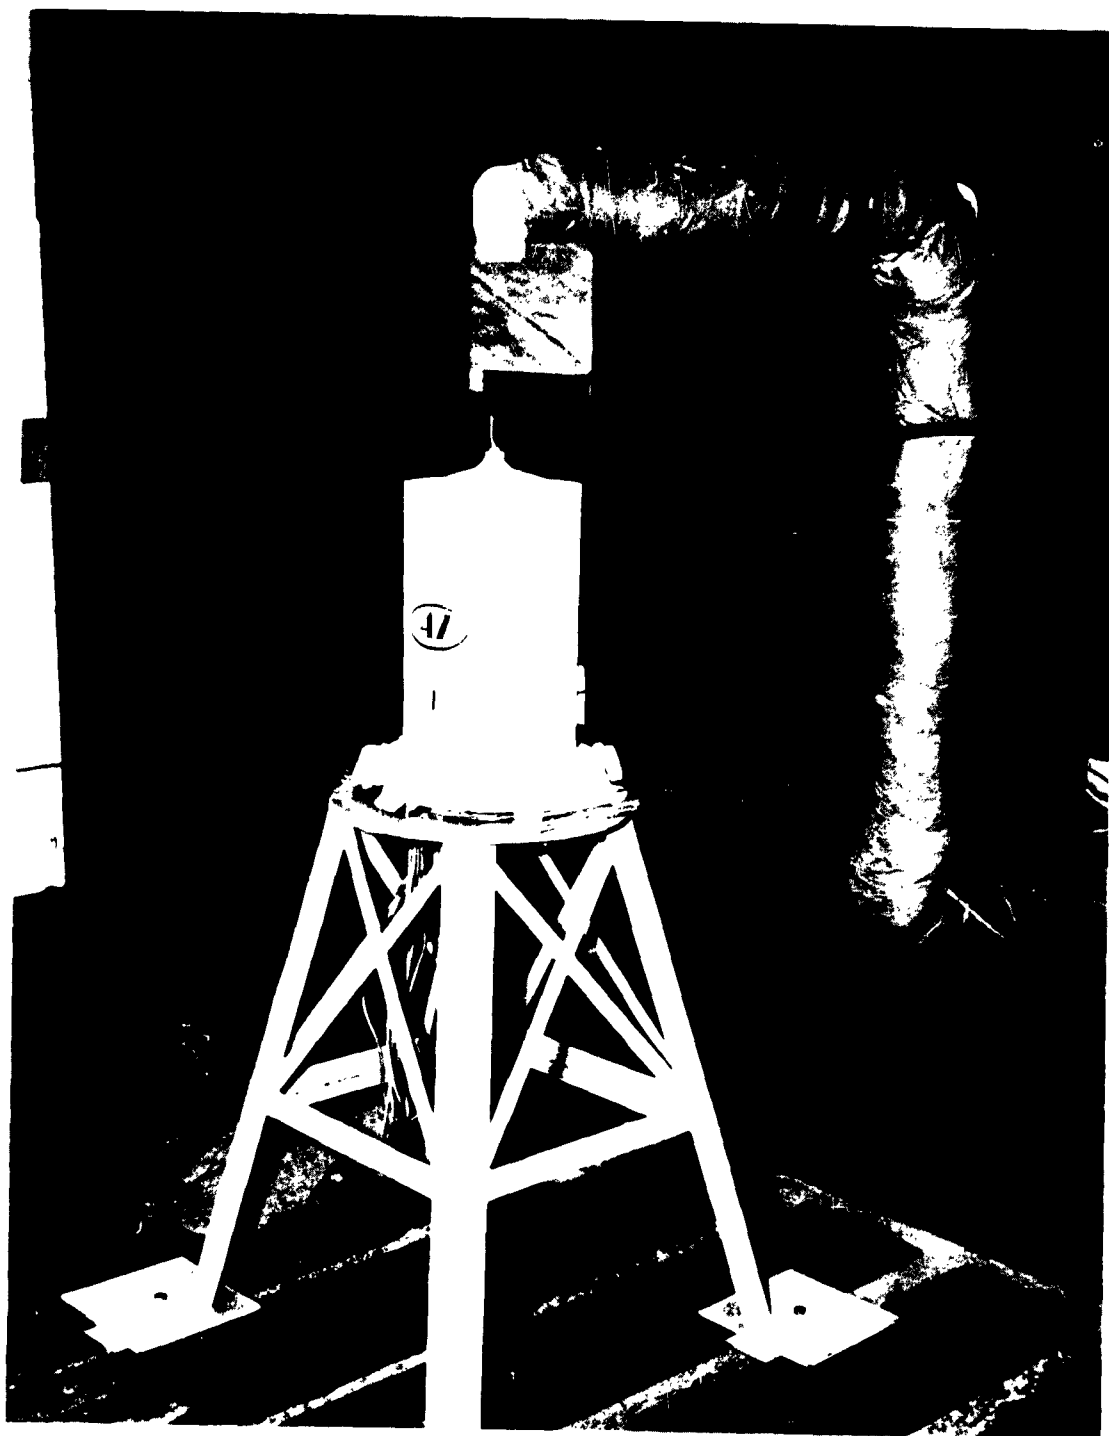
Figure 2. LOX Spray test setup

The reactor assembly, consisting of the reactor vessel, was mounted upright on a metal test stand (figure 2) which was located at the Holloman Horizontal Test Stand Complex. At 1300 hours, 9 May 1962, the reactor vessel was exposed to a spray of LOX for approximately 40 seconds.

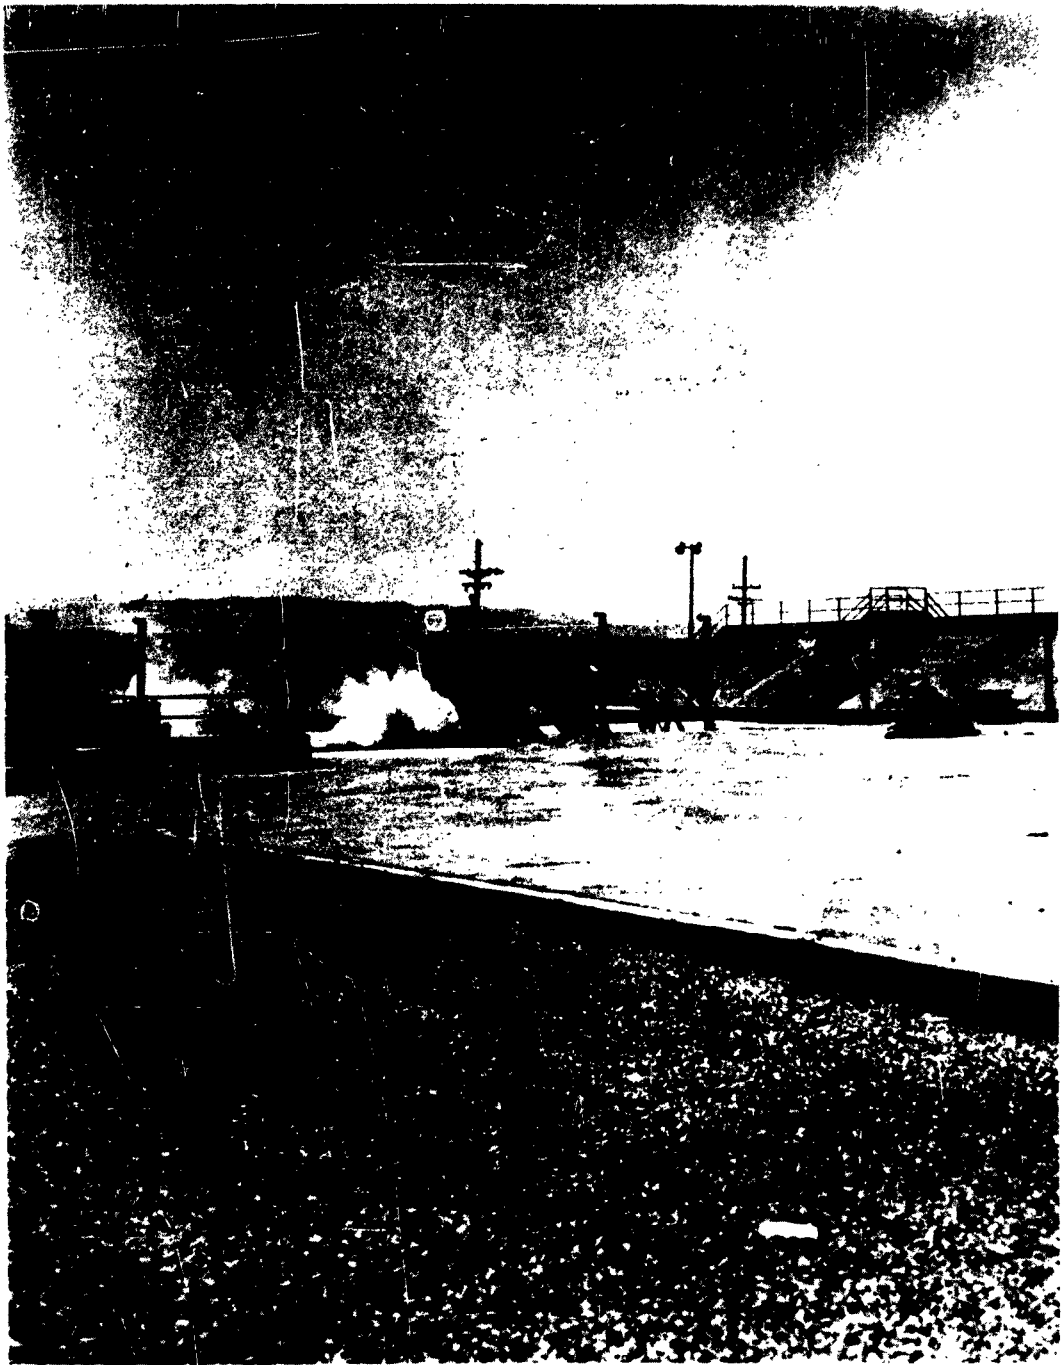
Figure 4. LOX-NaK test

Two seconds after the Squibs were fired to open the NaK lines, the LOX spray was initiated and was continued for approximately 40 seconds. Soon after the LOX spray was initiated, the NaK solidified, minimizing the initial reaction. Approximately 8 minutes after the LOX spray was terminated, the NaK began to liquify and flow from the core vessel. The NaK then reacted violently with water standing under the test stand (see figure 4).

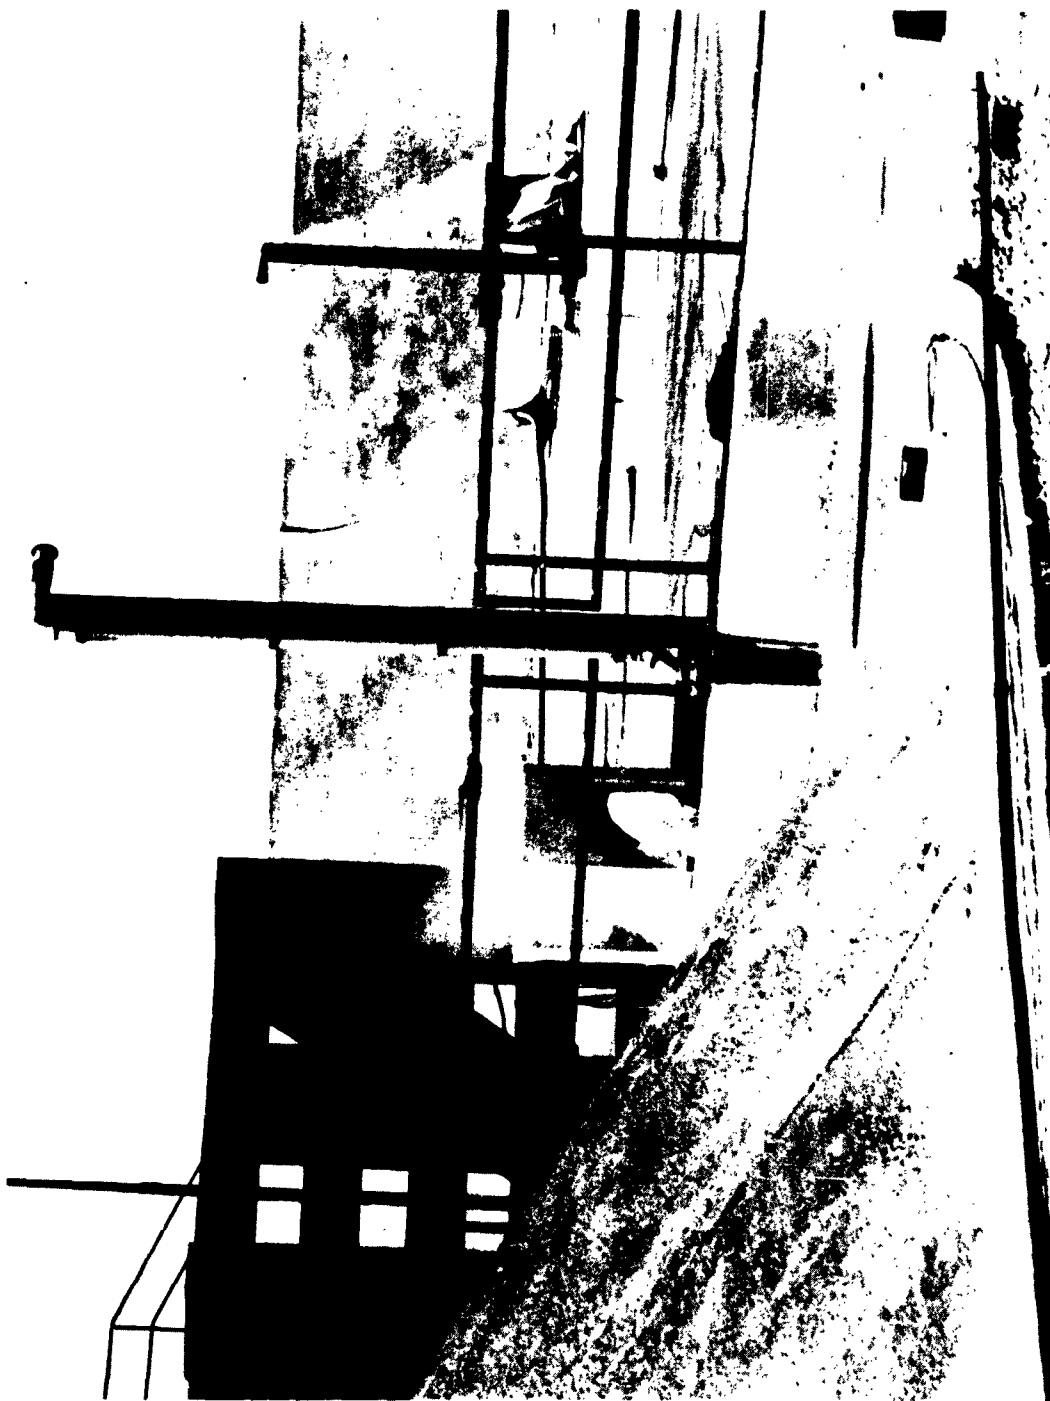
Figure 8. Water tank -- post test

The test was conducted at 0900 hours on 6 June 1962. Soon after the Squibs on the NaK lines were fired, the reaction became so violent that one side of the water tank ruptured, allowing the water to drain from the tank (figure 8). As a result, the  $H_2O$ -NaK interaction was minimized and the test must be considered inconclusive. Visual examination of the reactor vessel showed no external damage aside from some peeling of paint (figure 9).

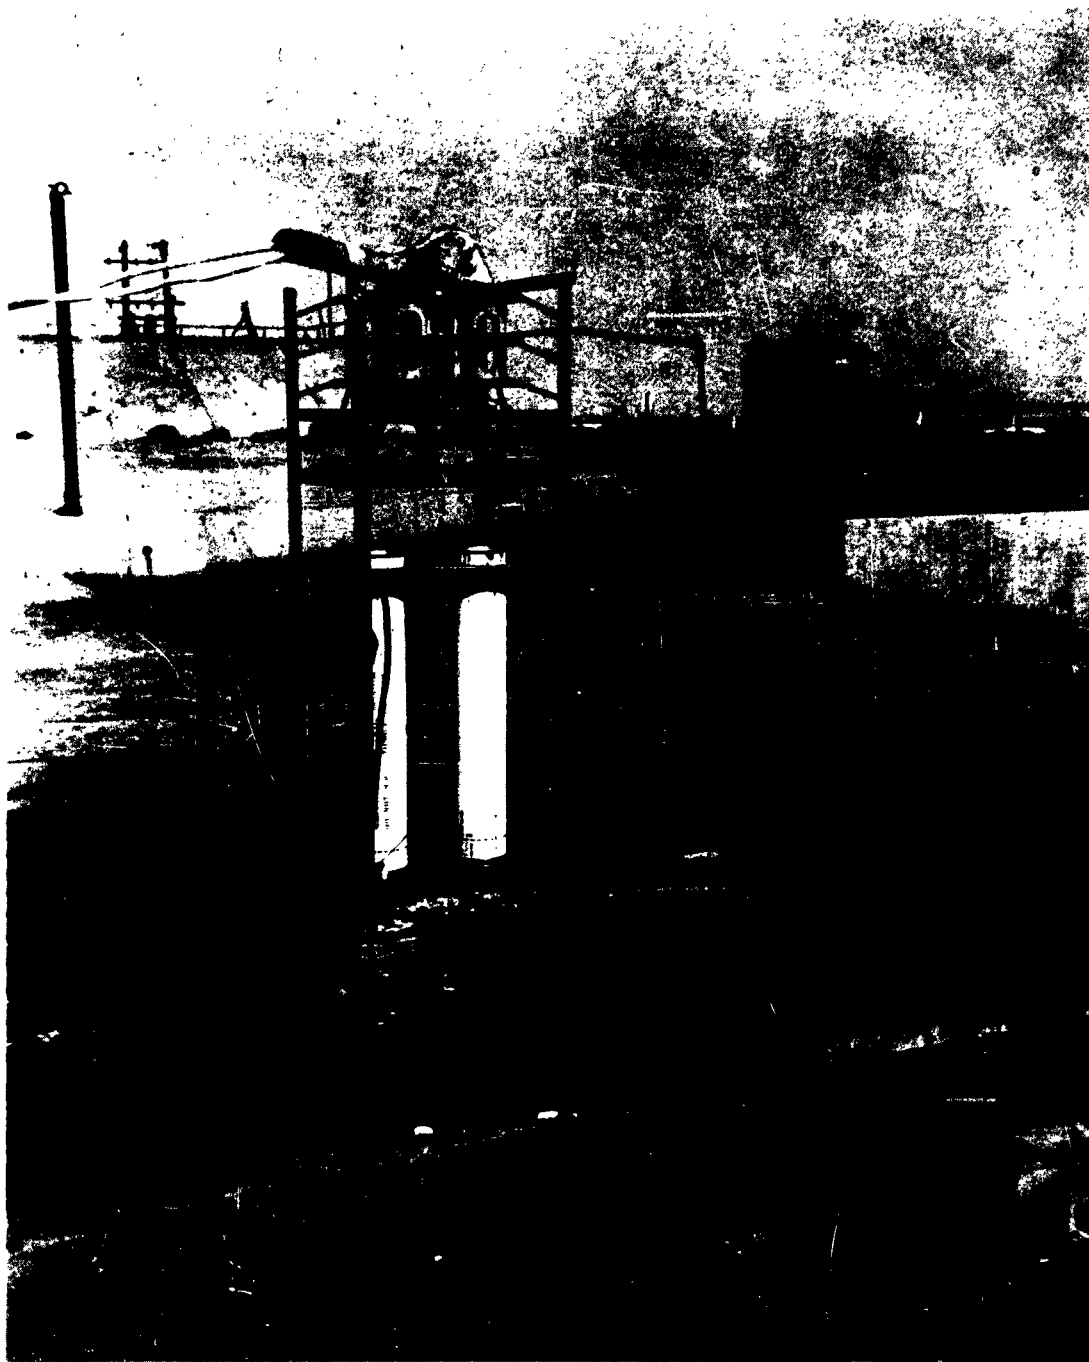
Figure 10. Fire test setup

A reactor assembly consisting of a reactor vessel and reflectors was mounted upright on a high test stand over two Sparrow boosters; three oxygen-butane burners encircled the test item (figure 10). The boosters were ignited and the resulting 4500° F flame enveloped the test item for 2.1 seconds. The "tail-off" of the boosters then ignited the oxygen-butane burners which enveloped the test item in a 1500° F flame for 15 minutes. This fire test was conducted to test reactor deformation when subjected to temperatures representative of a missile-abort fire.

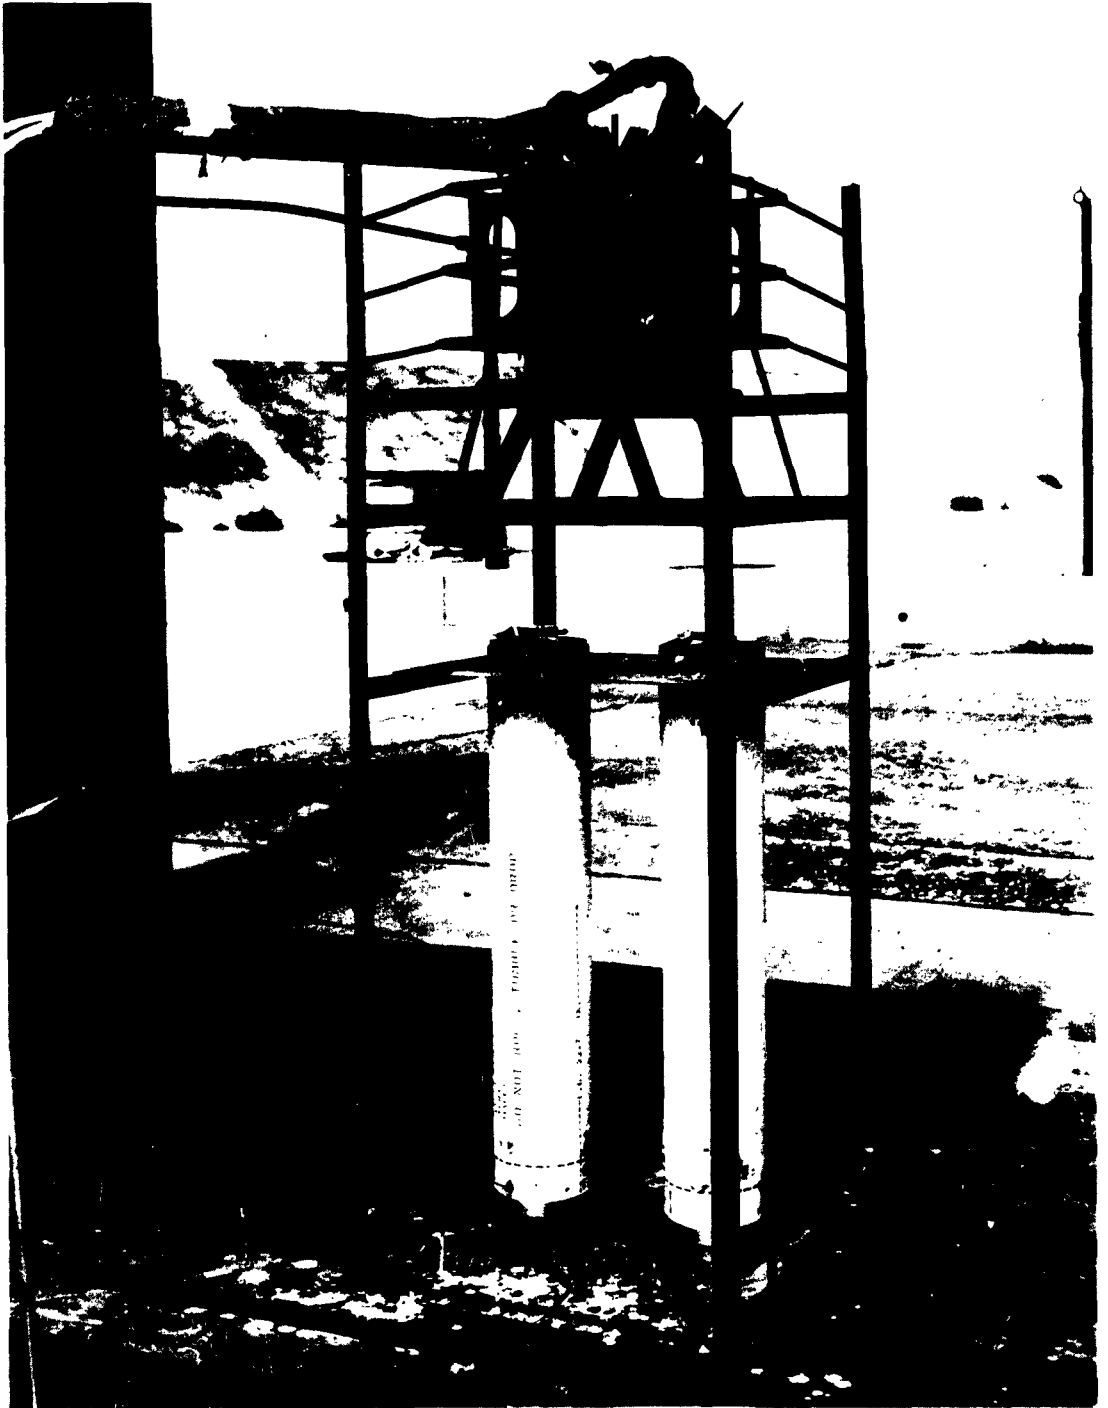
Figure 11. Reactor assembly -- post test

Upon completion of the 15-minute "cooking" period, the gas was shut off and the test item inspected. The reflector retaining band had parted during the booster flame blast, but the reflector assembly was still in its original position; the reflector separation mechanism had been "locked" in place by the thermal expansion of two eye-bolts used for handling purposes. After the test item had cooled for approximately 20 minutes, the eye-bolts had contracted enough so that the reflector halves were released. Complete separation from the test item did not occur, since the reflector assembly was then retained by the three burner rings. Apparently, if the eye-bolts had been removed before the test, the reflector separation mechanism would have

functioned properly. The reactor vessel did not sustain any visual damage as a result of high temperatures (figure 11). Consequently, it appears from the preliminary analysis that the SNAP 2/10A core configuration would not be distorted sufficiently to prevent subsequent criticality.

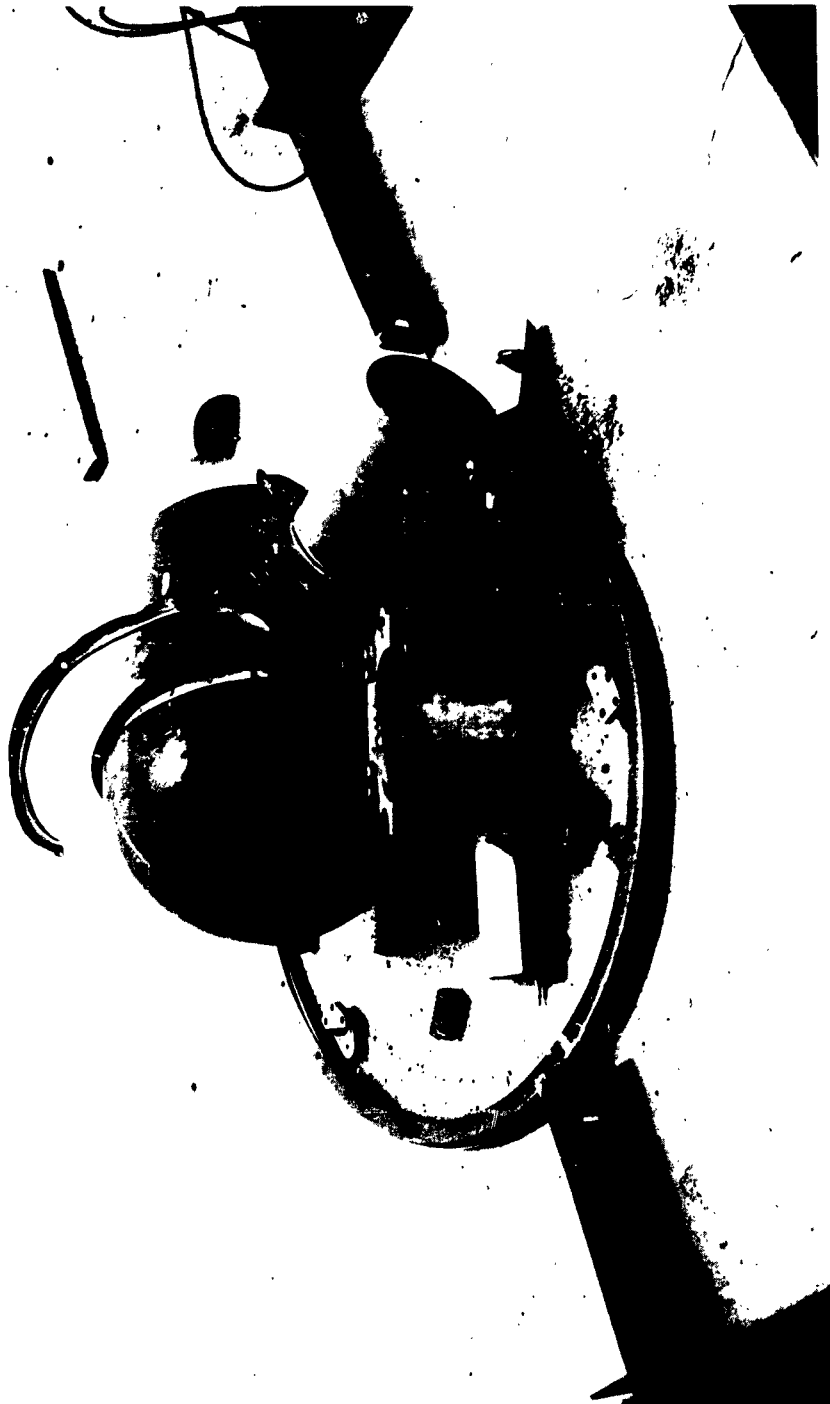
Figure 18. Reactor vessel -- post test

Figure 18 shows the reactor vessel, shield, and reflector assembly after the converter-radiator structure had been lifted from the concrete pad. Examination of the reactor vessel revealed no external damage. All cameras and recorders functioned. Further analysis will be made by Atomics International.

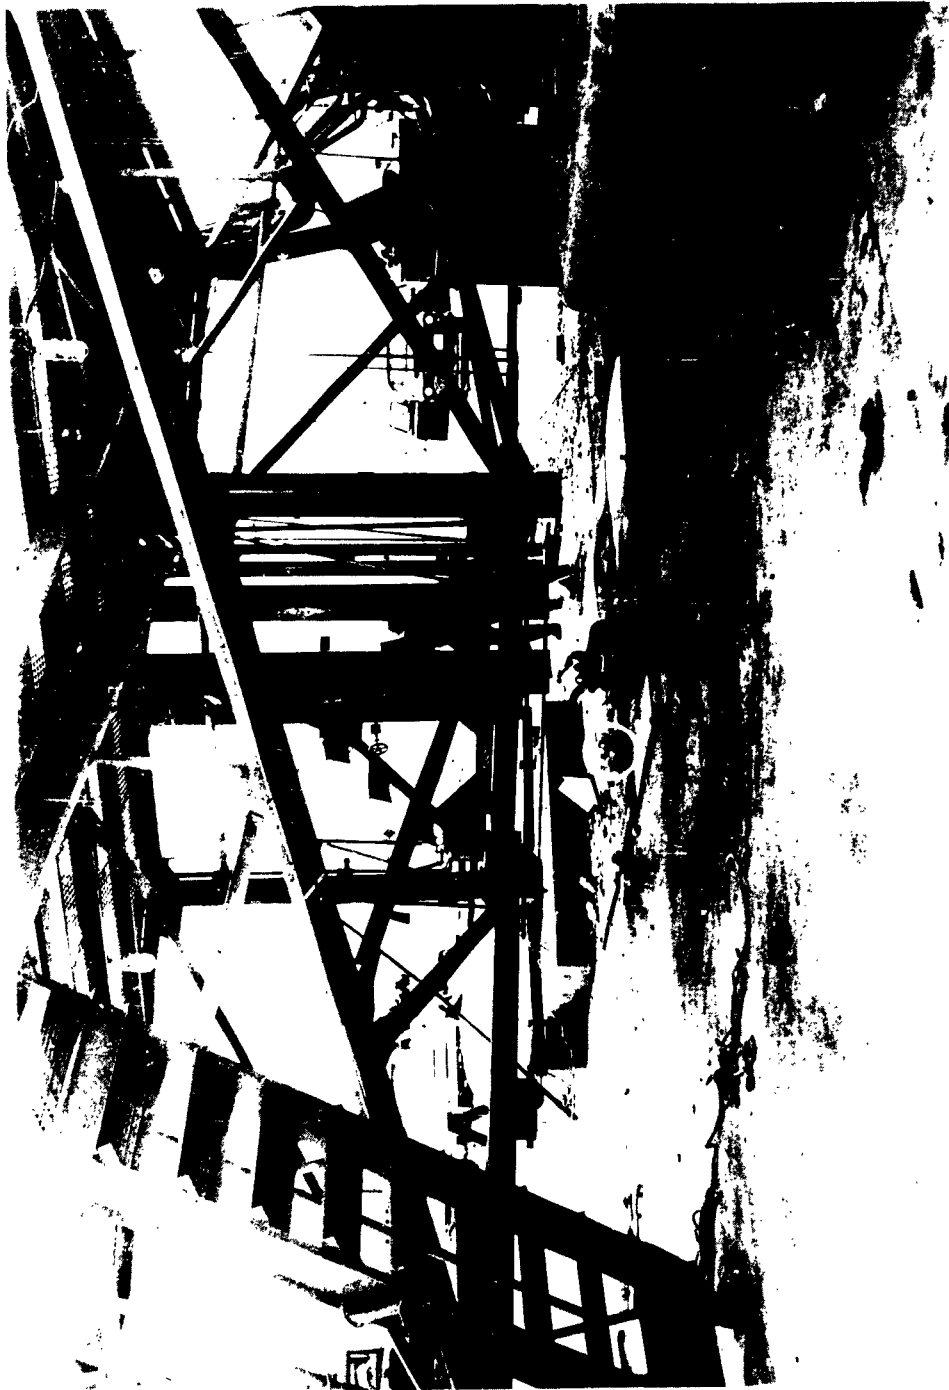
At impact, the reactor vessel broke loose from its converter structure mountings (figure 20). Post-test examination of the reactor vessel showed no external damage. Located to the left of the reactor vessel is a portion of one of the reflector halves with rotatable control drum which had rotated to the "in" position. (See circled portion of photograph.)

Figure 20. Reactor vessel -- post test. Circle shows reflector half with control drum.
