Report No. 8926-157

Material - Magnesium - Aluminum - Zinc -  
Sacrificial Anode

Evaluations in Presence of Sea Water and Clad  
7075-T6 Aluminum Alloy

2 May 1957

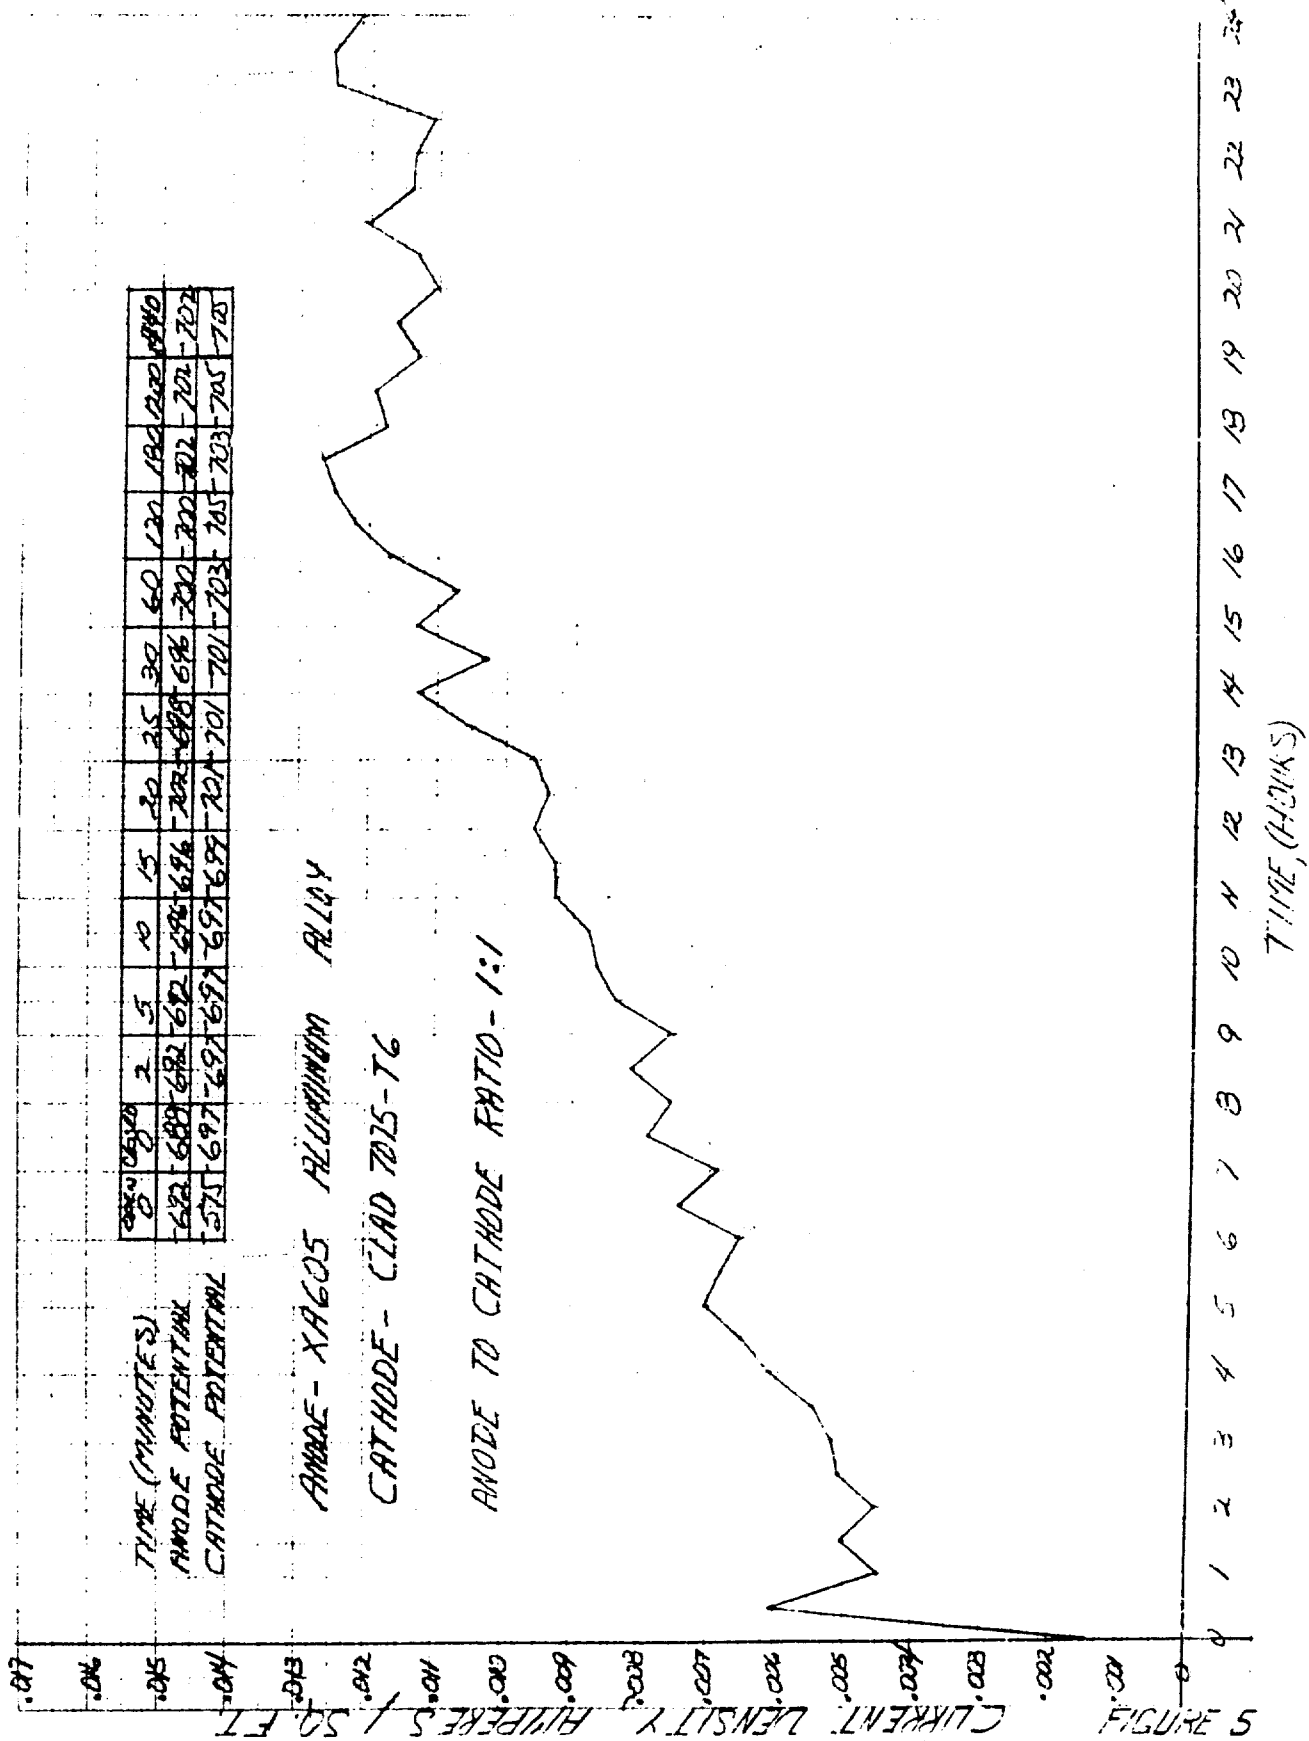
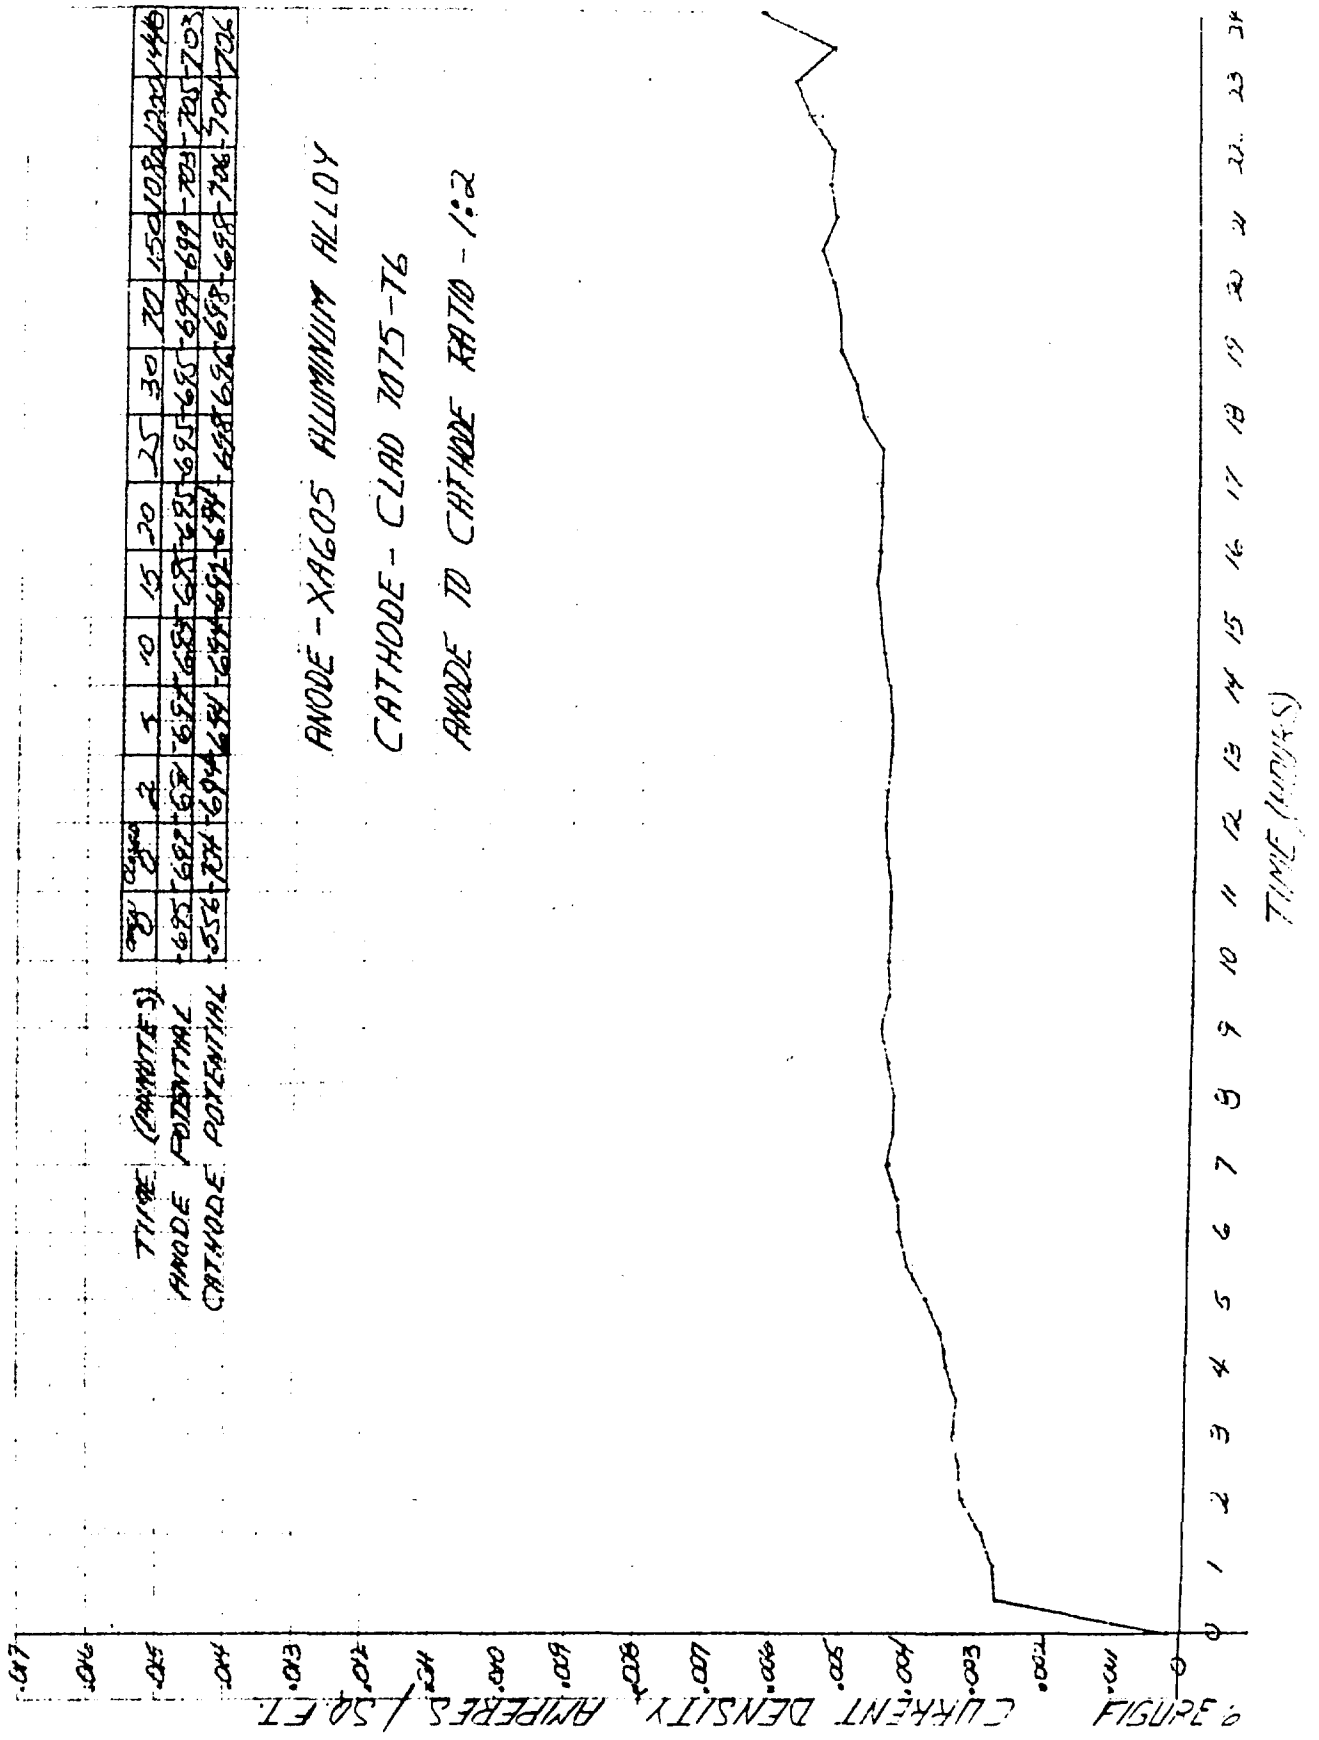
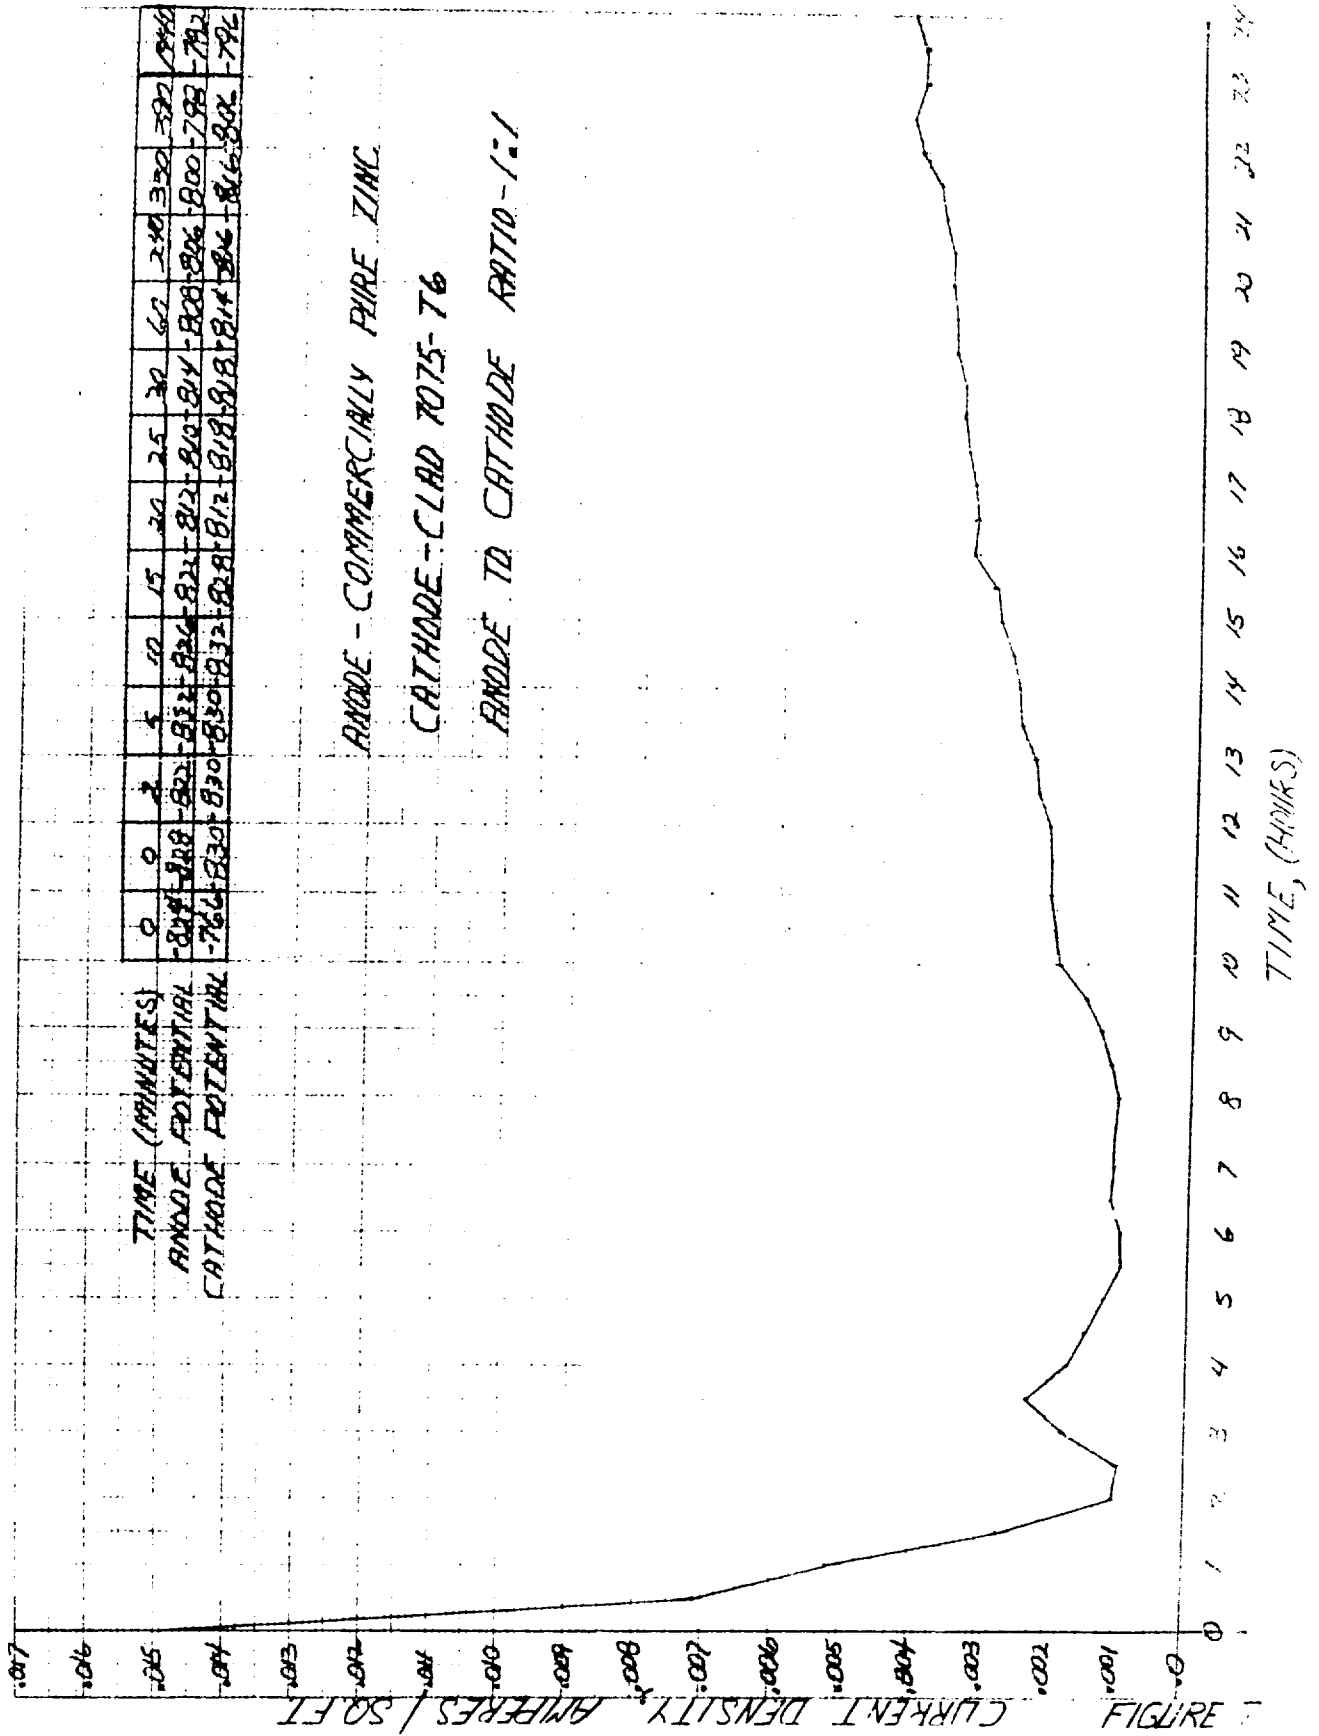
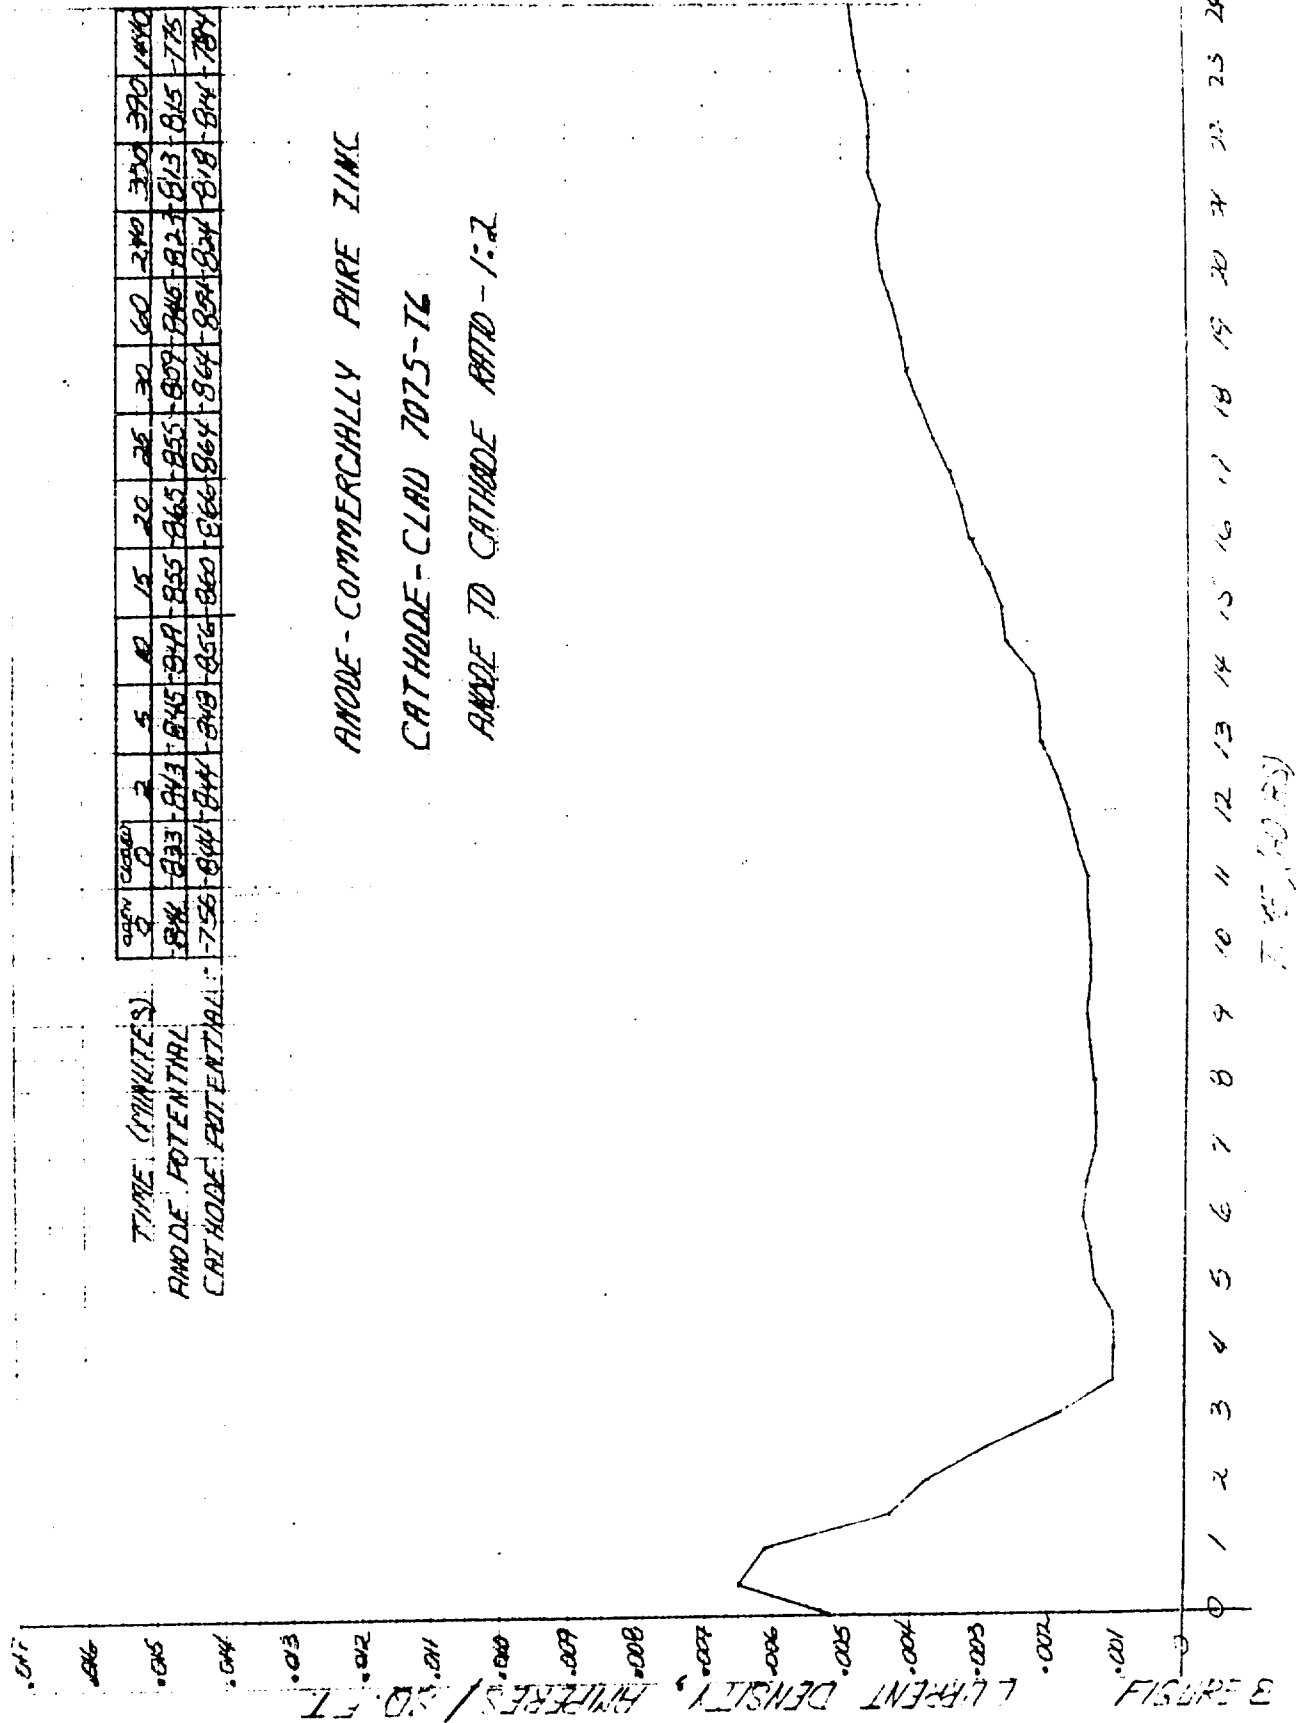
The condition of each metal electrode and the pH readings for each cell tested are shown in Table I. The anode potentials, cathode potentials and current density vs. time curves of the bi-metallic cells tested are shown in Figures 3 - 8.

The current density of the galvanic couple of FS-1H - clad 7075-T6 was higher than the galvanic couples of XA605 - clad 7075-T6 and commercially pure zinc - clad 7075-T6. (See Figures 3 - 8). The high current density of the FS-1H - clad 7075-T6 couple is the resultant of a greater difference in solution potential between the component electrodes. The current density of this couple with anode-cathode ratio of 1:1 was higher than the same couple with a ratio 1:2. The current density was calculated using a constant cathode area, therefore giving lower values for a smaller cell with the lesser current flow.

The galvanic couple of FS-1H - clad 7075-T6 shows the effect of an active polarization reaction causing a decrease in current flow. This polarization reaction has been caused by a build-up of insoluble corrosion products on the anode and the formation of hydrogen gas at the cathode. Polarization of this type could stifle the flow of current necessary for cathodic protection.

The galvanic couples of XA605 - clad 7075-T6 and commercially pure zinc - clad 7075-T6 have a less active polarization reaction with an increasing current flow. The corrosion products of these two sacrificial anodes are more soluble and migrate away from the anode surface during the electrochemical reaction. In order for a sacrificial cathodic protection system to function successfully the sacrificial material must not become polarized by the formation of a dense film on its surface.

The current density of the galvanic couple of XA605 - clad 7075-T6 decreased when the anode-cathode ratio was varied from 1:1 to 1:2, showing limitation for XA605 as a sacrificial material in this couple. The ratio of the commercially pure zinc - clad 7075-T6 couple was varied in the same manner, but showed no appreciable change in current density. Therefore, commercially pure zinc is believed to be a better sacrificial material for cathodically protecting an aluminum alloy.
