Technical Note N-515

EVALUATION OF A HYDRO-PNEUMATIC FLOATING FENDER OR CAMEL

June 1963

U. S. NAVAL CIVIL ENGINEERING LABORATORY  
Port Hueneme, California

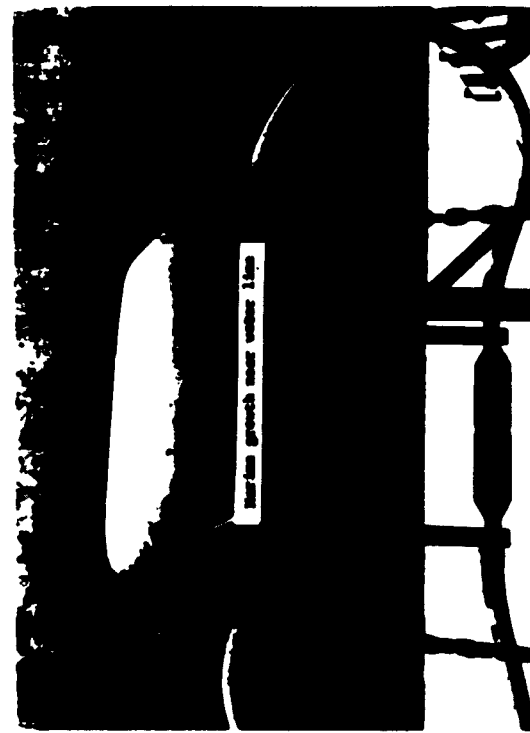
Figure 12 Corrosion and Marine-Growth Characteristics of Hydro-pneumatic Camel  
(three months' immersion) (See also Fig. 13)

(a) Front View

(b) Rear View

(c) Close View of Hydro Ship-fender

(d) Corrosion of the Ballast Pipe

2. The rubber fenders showed no evidence of deterioration. The sides of rubber fenders near the top surface were covered with a heavy growth of algae, Figure 12c. Only a small amount of fouling and slime remained on the sides of the fenders because of the rubbing action from ships and the floating bulkhead. No mechanical damage from this rubbing action was observed. The lower area and the bottom of the fenders were covered with small barnacles and brown algae, Figure 13a. The adhesion of attachments of fouling on the rubber fenders was light and the fouling was easily scraped off.

ballast pipe were severely rusted. The coating on the sea water screen filter had failed and the water screen filter was severely rusted, Figure 13c. The coating on the ballast pipe was abraded in several areas and light rusting was occurring here, Figure 12d. Also rusting was occurring along many of the welds.
