QUARTERLY PROGRESS REPORT  
SPUR POWER SYSTEM  
CONTRACT AF33(657)-8954  
FOR PERIOD ENDING MARCH 31, 1963  
PROJECT NUMBER 3145  
TASK NUMBER 314511

SY-5396-R4

April 15, 1963

**AIRESEARCH MANUFACTURING COMPANY**

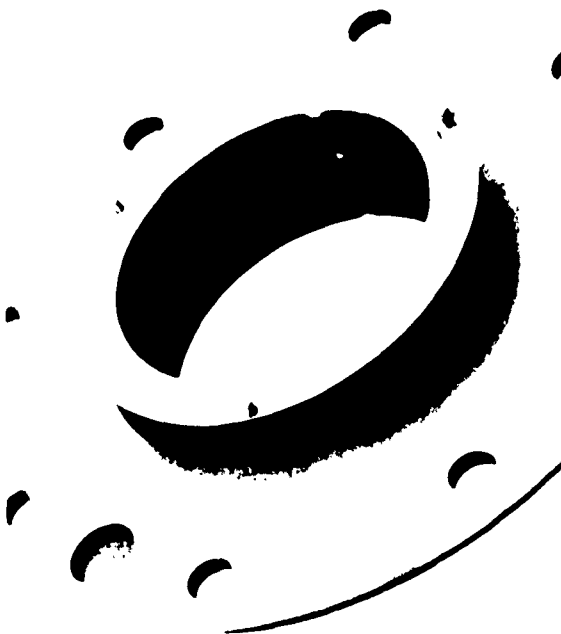
**FIGURE 10**

**POTASSIUM-TO-ARGON-TO-OIL  
BACKUP SEAL FOR BEARING TEST RIG**

- (a) A new seal, of the backup design initiated several months earlier, will be installed. This seal is shown in Figure 10, and in the drawing, Figure 11.
- (b) An oil level warning device is being installed in the middle chamber, and an oil sump sight glass is being installed.

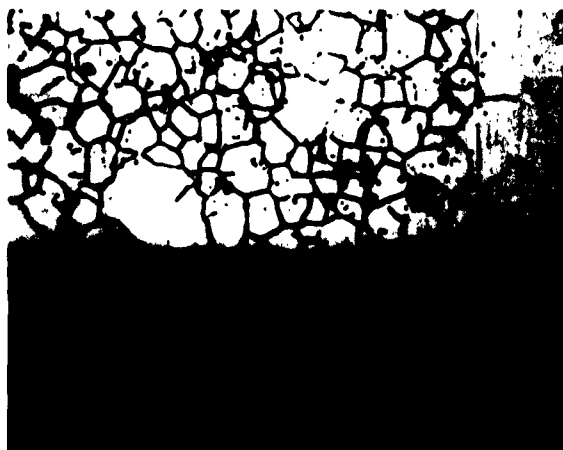
RENE 41

HS-6B

**TURBINE MATERIAL EROSION TESTS**

The results of the second erosion test again indicate that the erosion problem in potassium at elevated temperature is less severe than in water under similar conditions of impact velocity, stream diameter, and nozzle-to-specimen clearance. Furthermore, this second potassium test indicates that the erosion resistance of the molybdenum alloys used in the test is essentially the same as that of stellite 6B.

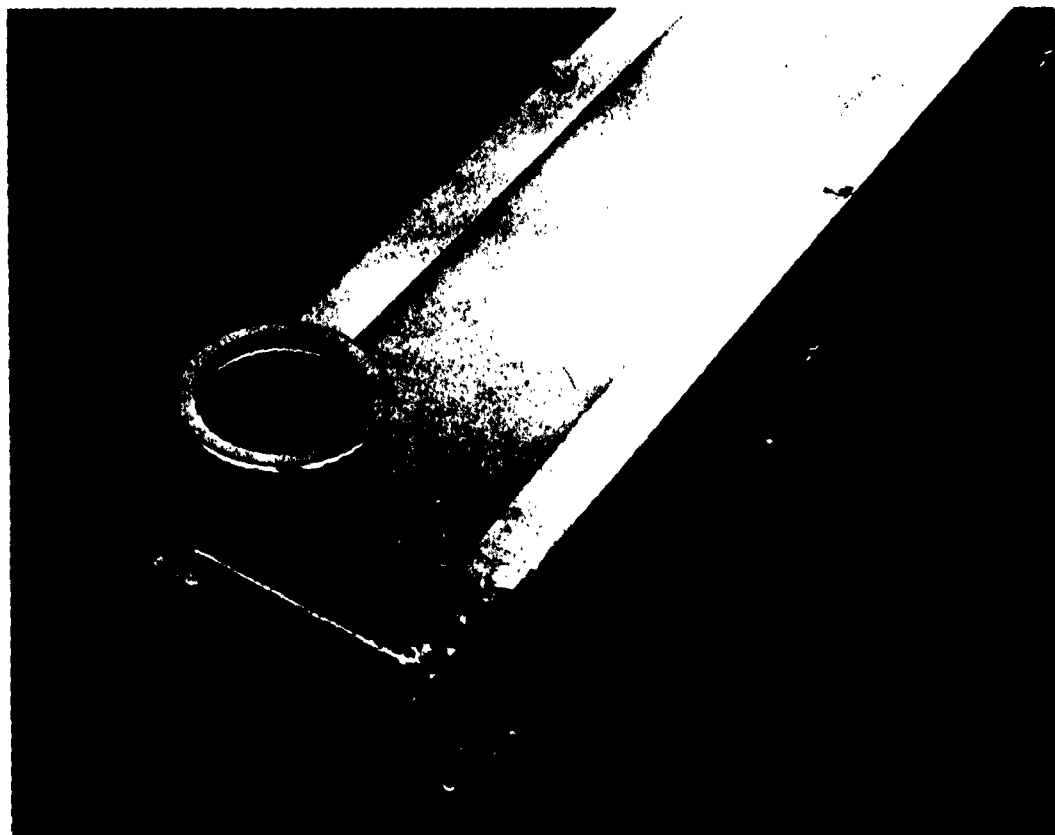
FIGURE 18

FREON BOILER

Fabrication of the Freon condenser and boiler was completed, and these units are shown in Figures 17 and 18. The loop design was also completed, and the loop has been fabricated. Testing of this loop will be continued during Phase III.
