R-5304

INVESTIGATION OF ATLAS F-SERIES  
FLAME DEFLECTOR  
PRESSURE PULSE

Contract AF04(694)-328  
Part I, Item 4 of  
Exhibit B and  
Paragraph 4.2.1 of  
AFBM Exhibit 58-1

Presented are the results of a test program to determine the effects of the pressure pulse that is generated in the flame deflector during initial thrust buildup of the Atlas MA-3 booster engine.

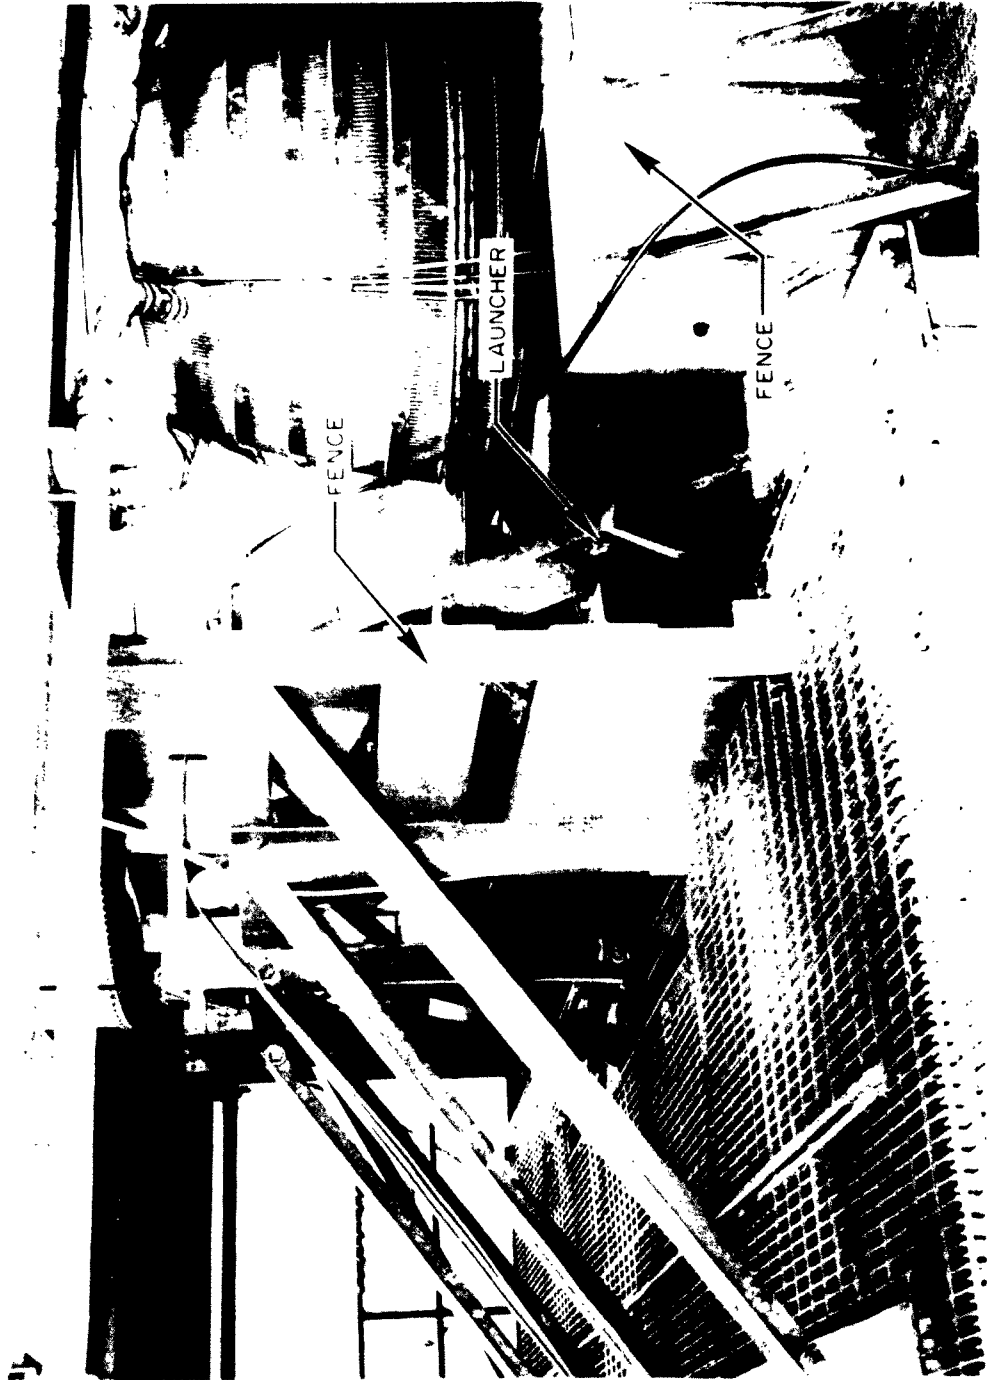
Figure 6. Fences and Launcher in Simulated Quadrant IV

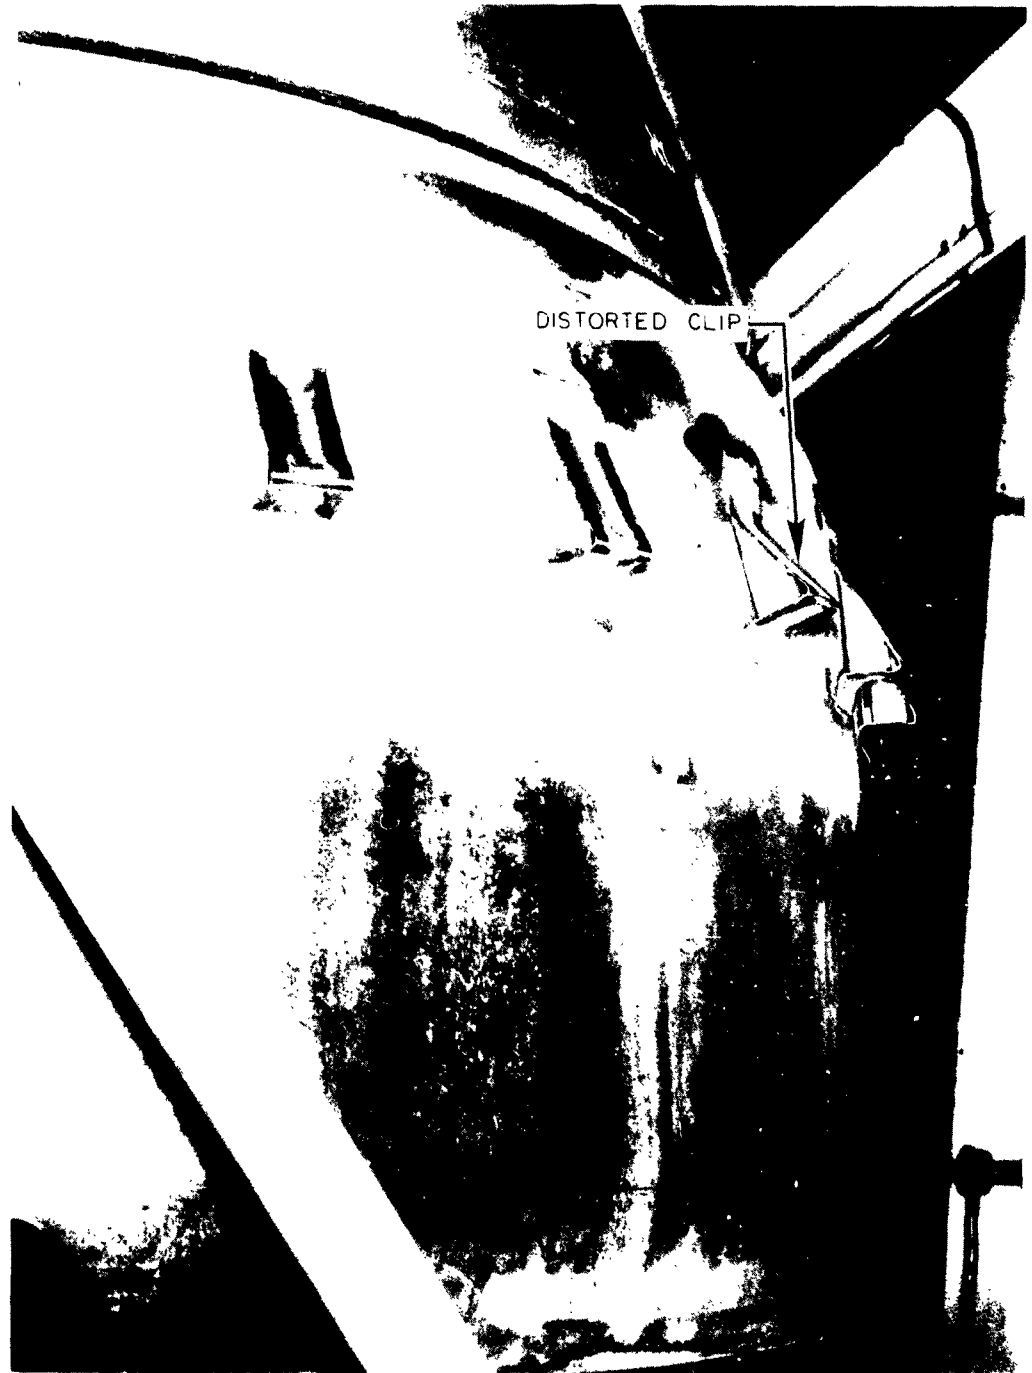
Figure 10. Sustainer Aspirator Clip Distortion

the load capability of the sustainer boot. Hardware inspection upon completion of the 17-test program revealed slight distortion of the exhausterator and certain clips (Fig. 10), but the gussets had not distorted and the clips had held the boot in position throughout the program. The sustainer boot had been cut by the exhausterator clips (Fig. 11) at each supporting edge as a result of repetitive testing which would not occur with an operational missile; the damage is not considered to be a serious condition.

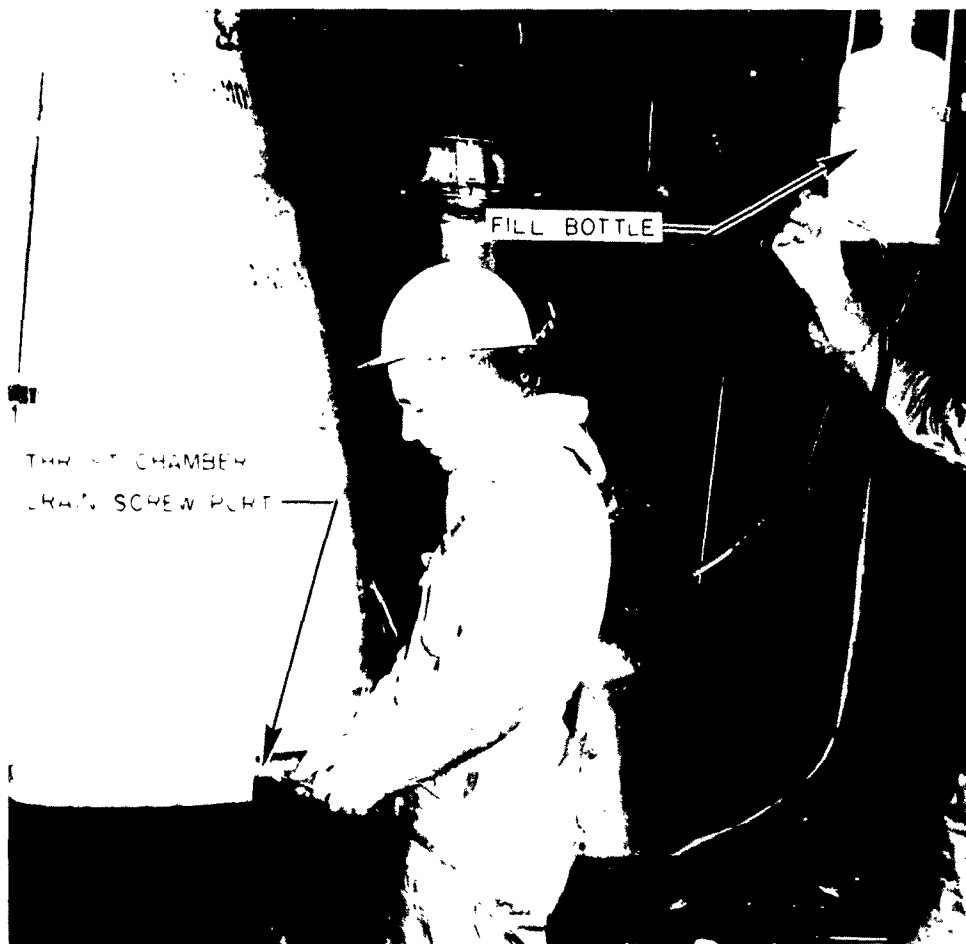
Figure 12. Inert Fluid Emergency Fill Equipment

During tests utilizing an inert fluid prefill, the fluid was introduced into the thrust chambers by implementing the procedures recommended by Rocketdyne for field application. An associated ground equipment (AGE) kit of the type sent to field sites were used to accomplish the prefill (Fig. 12).
