ULTRASONIC WELDING PROCESS AND EQUIPMENT FOR CONSTRUCTION OF ELECTRON-TUBE MOUNTS

Third Quarterly Progress Report
For the Period
January 1 through March 31, 1963

Contract No. DA-36-039-sc86741

AEROPROJECTS INCORPORATED
West Chester, Pennsylvania

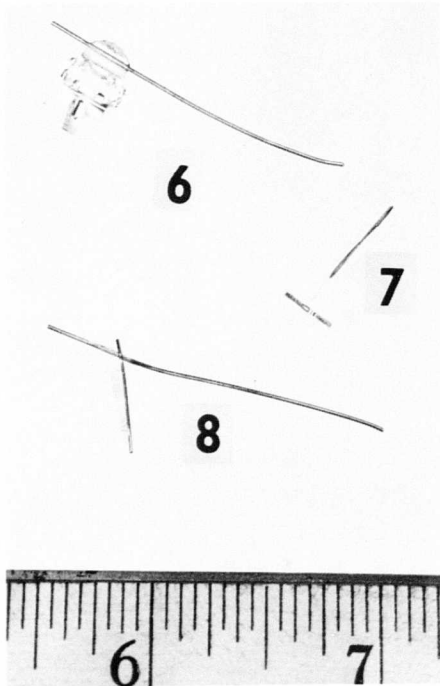
Figure 12

WELDMENTS - TYPE 6205 ELECTRON TUBE

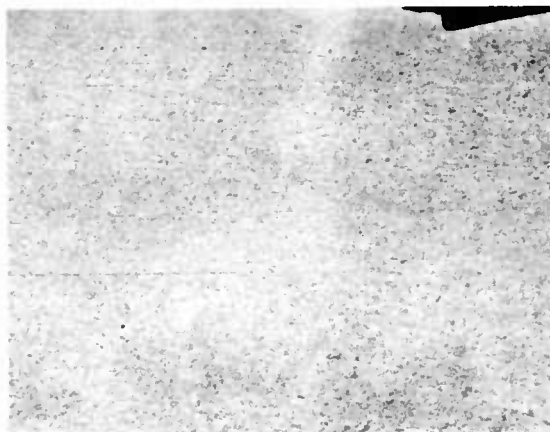
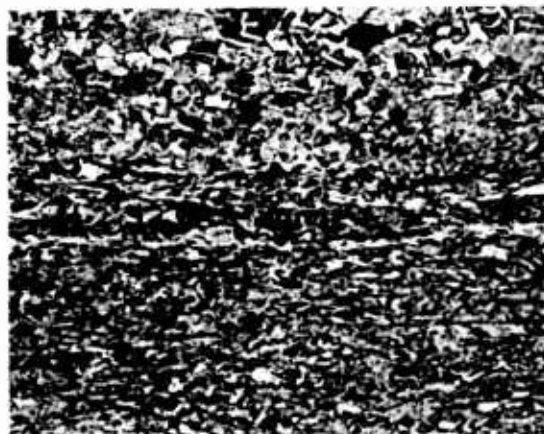
Magnification: 36X

Magnification: 250X

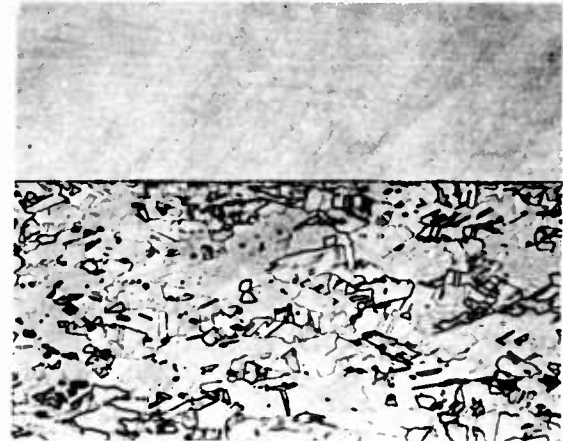
Combination: Gold to Copper
Number 2 (wire) (coupon)
0.060 gage 0.055

Magnification: 40X

Magnification: 250X

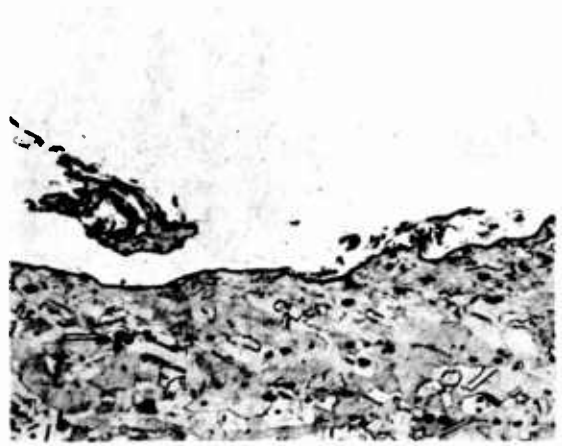
Comments: The joint shows a high degree of interpenetration and interfacial flow. Bond quality is uneven, but satisfactory bonding was achieved along the center of the wire-sheet contact surface. The longitudinal section illustrates only a small portion of the weld zone.

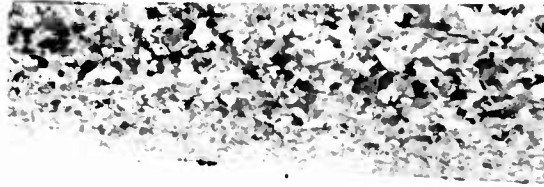
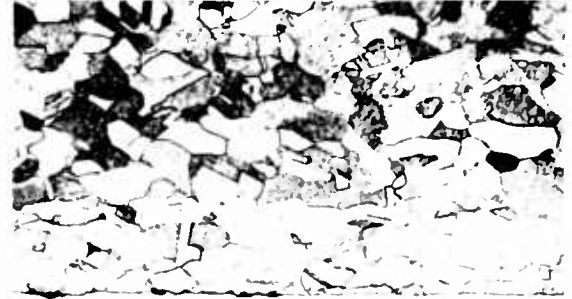
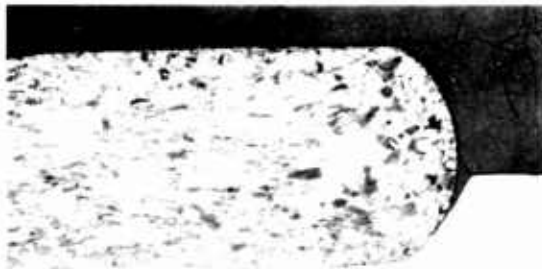
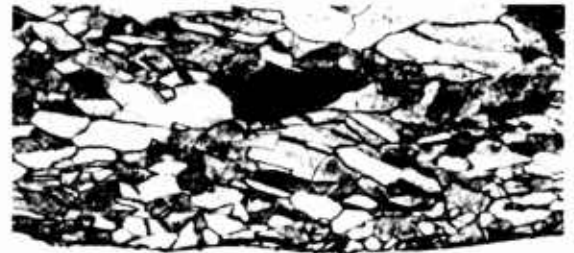
Combination: Nickel to Gold
 Number 14 (Wire) (Coupon)
 0.060 gage 0.060

Magnification: 36X

Magnification: 250X

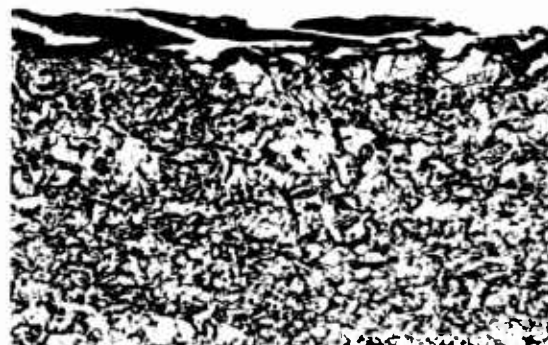
Combination: Silver to Gold
Number 15 (wire) (coupon)
0.060 gage 0.060

Magnification: 36X

Magnification: 250X

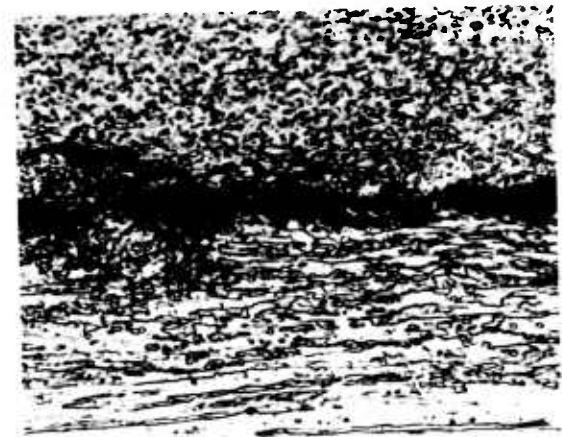
Comments: Almost complete weld separation was observed.

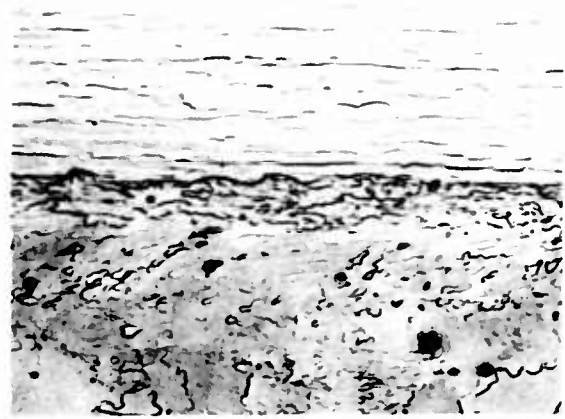
Combination: Molybdenum to "A" Nickel
Number 28 (wire) (coupon)
0.061 gage 0.060Longitudinal

Magnification: 36X

Magnification: 250X

Comments: Bonding is accompanied by recrystallization of the nickel along the interface. No voids or separations were observed.

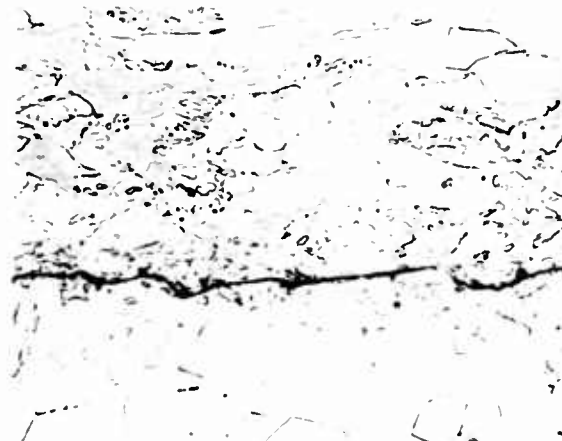
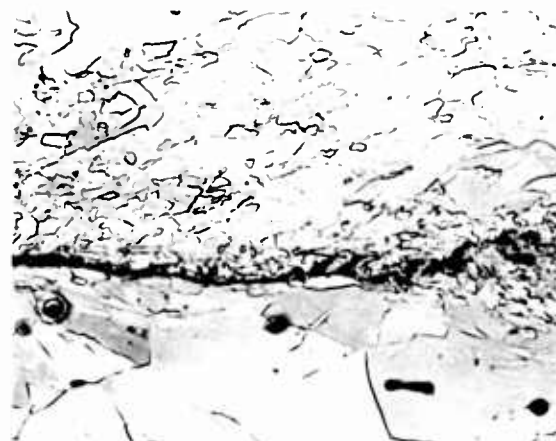
METALLOGRAPHYEtchant: KCN + NH₄S₂O₈ + H₂OCombination: "A" Nickel to "A" Nickel
Number 29 (wire) (coupon)
0.060 gage 0.060Longitudinal

Magnification: 36X

Magnification: 250X

Comments: Despite severe deformation of the wire, uniform bonding was not achieved. The central area of the joint is unbonded. Bond quality and uniformity may be improved by modified tooling or surface preparation.

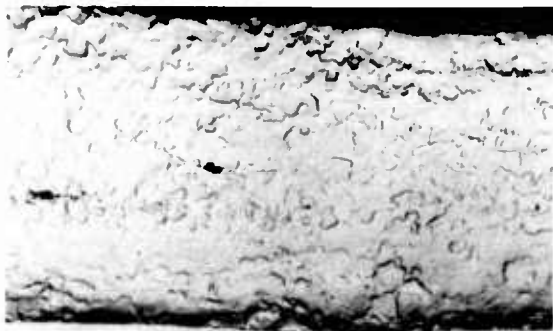
Combination: Rhenium to "A" Nickel
Number 30 (wire) (coupon)
0.060 gage 0.060Longitudinal

Magnification: 38X

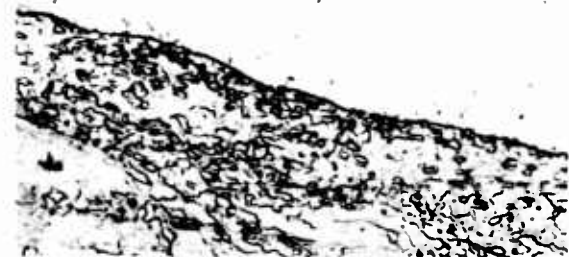
Magnification: 250X

Comments: Satisfactory weld characteristics are evident. Mutual interpenetration of the faying surfaces and absence of voids or non-bond areas indicate the integrity of the joint. Note the flow and expulsion of the nickel sheet and recrystallization structure adjacent to the weld interface.

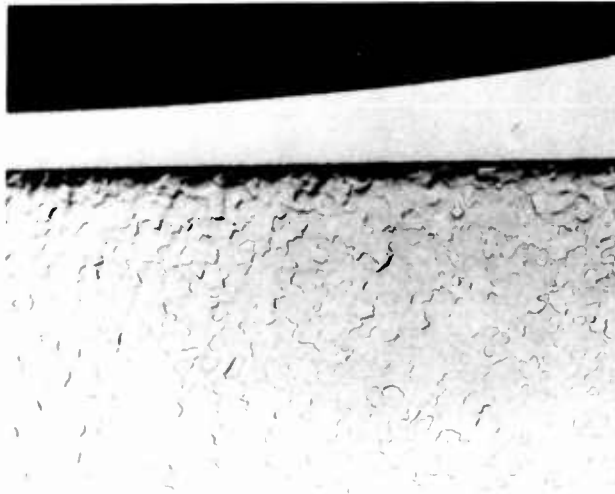
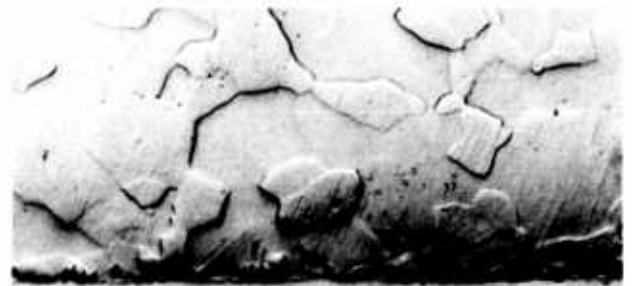
Combination: "A" Nickel to Rhenium
Number 39 (wire) (coupon)
0.060 gage 0.060Longitudinal

Magnification: 38X

Magnification: 250X

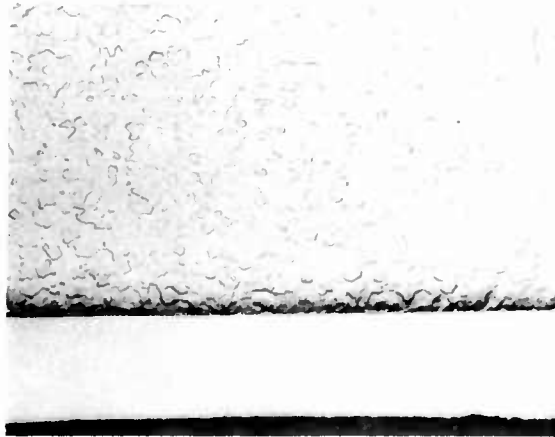
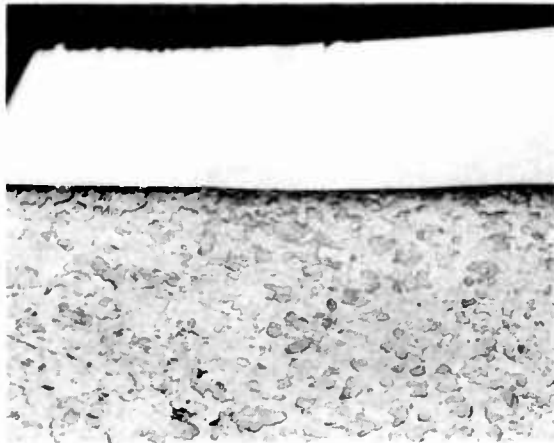
Combination: AISI 304
 St. Steel to Rhenium
 Number 41 (wire) (coupon)
 0.060 gage 0.0625

Magnification: 32X

Comments: Deformation of the stainless steel wire produced intimate surface contact. There is evidence of an alloy layer or barrier film along the interface. Good bonding.

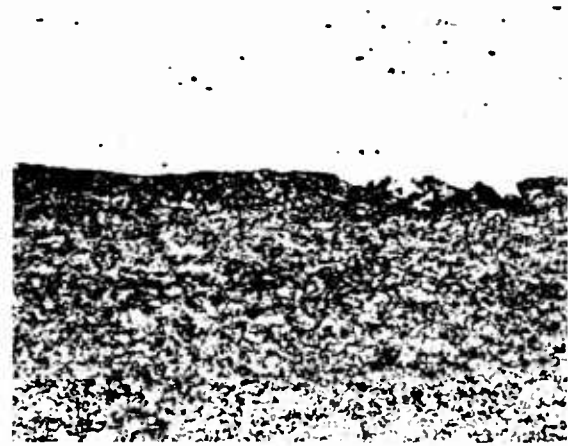
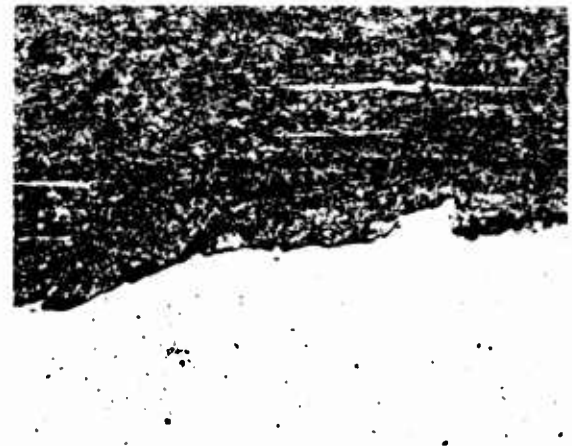
Combination: Copper to Silver
 Number 45 (Wire) (Coupon)
 0.064 gage 0.060

Comments: The edge-to-edge integrity of the joint and the degree of interpenetration of the mating surfaces exemplify a high degree of bond quality. No voids or unbonded areas were observed in these sections. Eccentric contact of the welding tip and wire resulted in deep indentation into the silver sheet along one edge (see lower left photomicrograph).

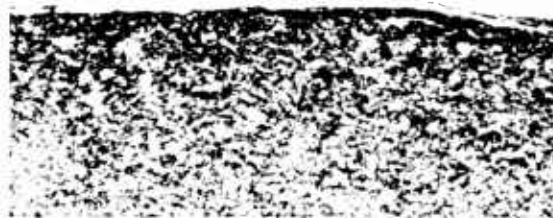
METALLOGRAPHYEtchant: KCN + NH₄S₂O₈ + H₂OCombination: Gold to Silver
Number 46 (wire) (coupon)
0.060 gage 0.060Longitudinal

Magnification: 36X

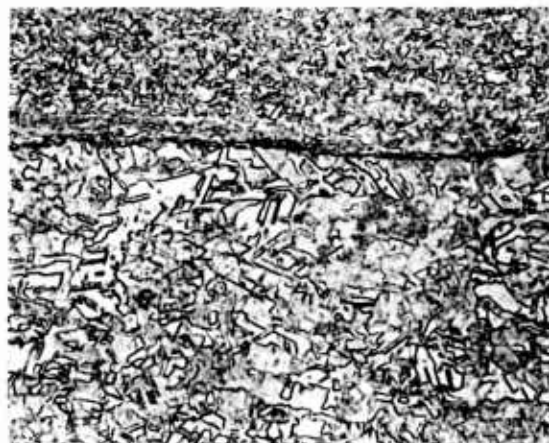
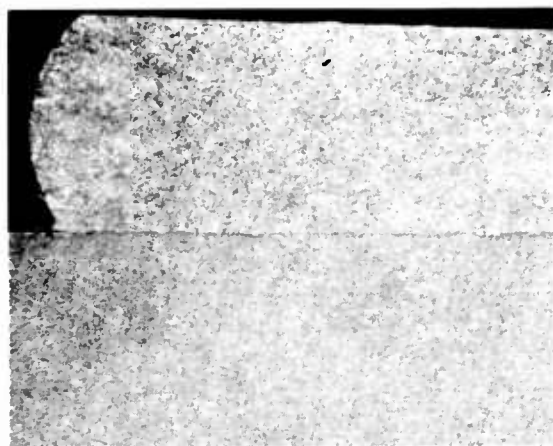
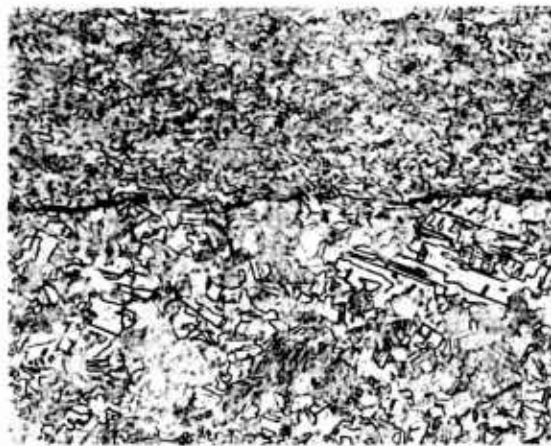
Comments: Bonding appears satisfactory although some non-bond regions occur at the center (see upper right micro). The interface is outlined by residual oxide accumulations. The high thermal conductivity of silver apparently prevented local heating at the interface.

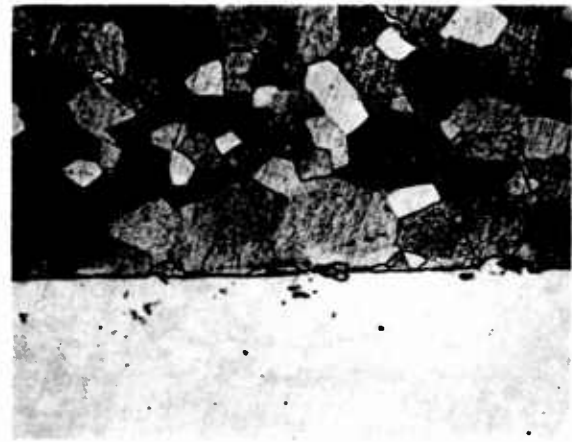
Comments: Bond is characterized by local areas of interpenetration and surface contiguity. Surface films are locally dispersed. Bond appears satisfactory except at edges (upper right photo).

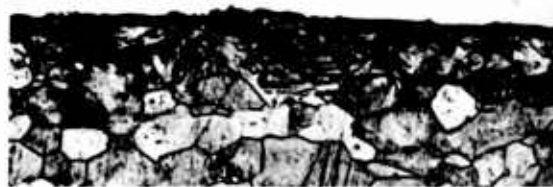
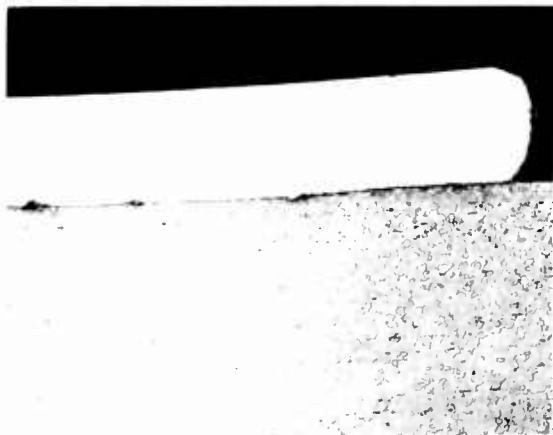
Comments: This bond displays very little interpenetration and non-uniform bond quality. Only superficial deformation of the mating surfaces has been produced at these welding conditions. Joint strength is satisfactory but improved bond quality would probably be achieved by modification of welding conditions.

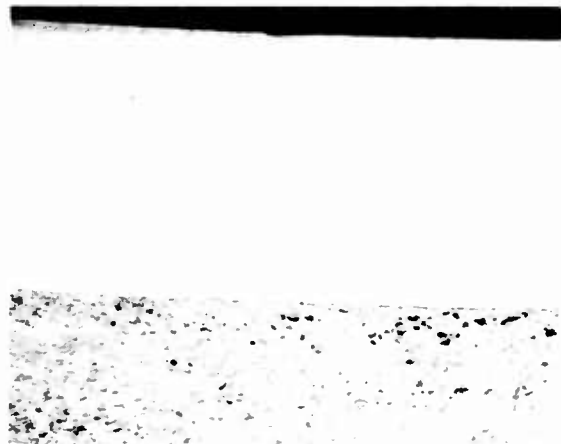
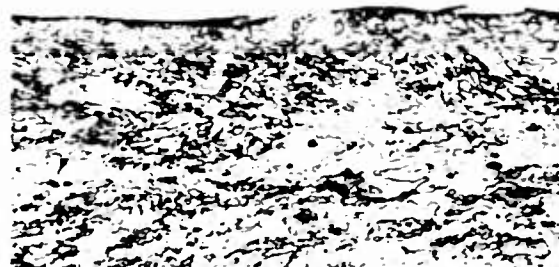
Combination: AISI 304 AISI 1010
Stainless Low Carbon
Steel to Steel
Number 56 (Wire) (Coupon)
0.062 gage 0.060

Comments: This joint exhibits very good bond characteristics. The sub-grain formation and/or recrystallization hold evidence to the thermal effects in the carbon steel.

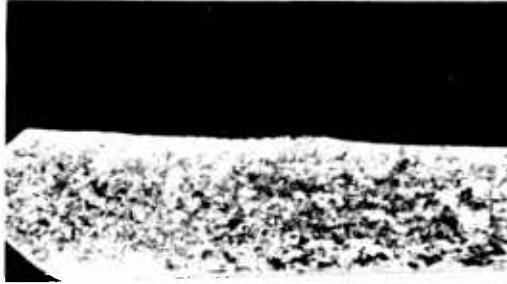
Combination: Copper to St. Steel
Number 57 (wire) (coupon)
0.064 gage 0.060
AISI 304

Not photographed at
higher magnification

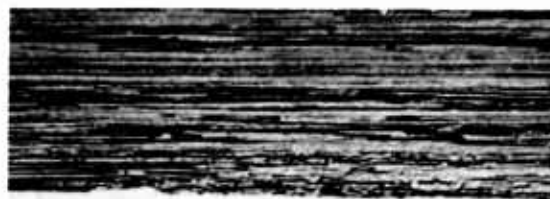
Combination: Molybdenum to St. Steel
 Number 59 (wire) (coupon)
 0.060 gage 0.060

Comments: Satisfactory bond. No voids or separations were observed. Intimate contact of the faying surfaces exists along the bond line.

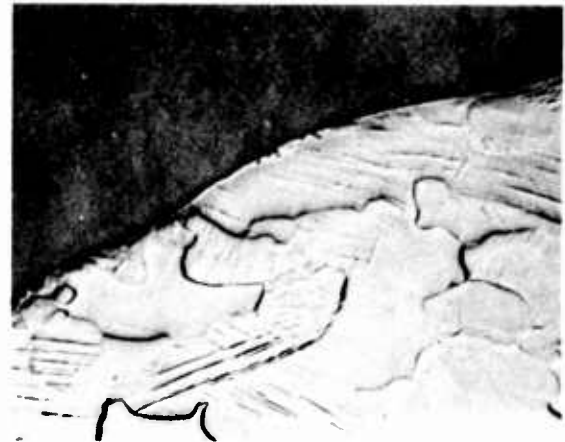
Comments: Bond quality appears satisfactory except at edges of weld. Rhenium wire is porous.

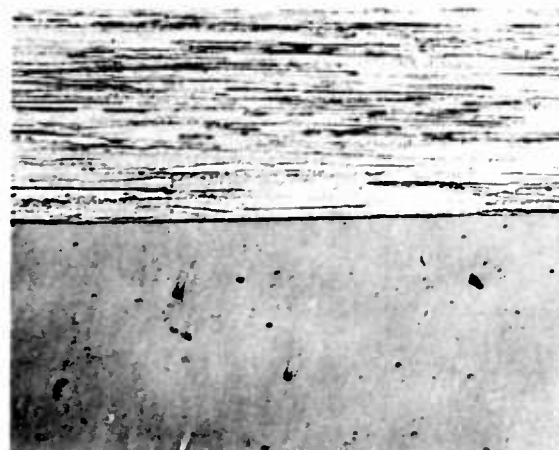
Comments: Metallographically, bond quality proved difficult to determine because of the interface relief. No large voids were observed; the surfaces appeared to be in intimate contact. Note the crack in the tungsten wire.

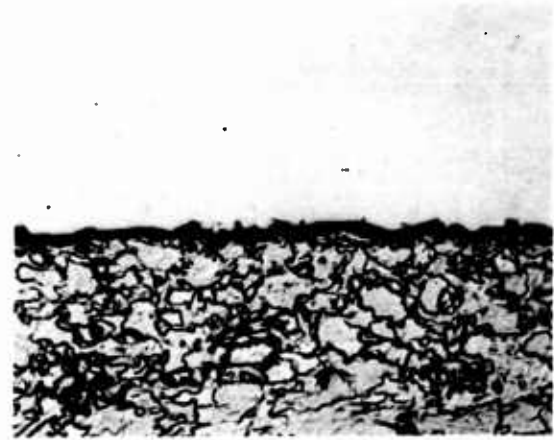
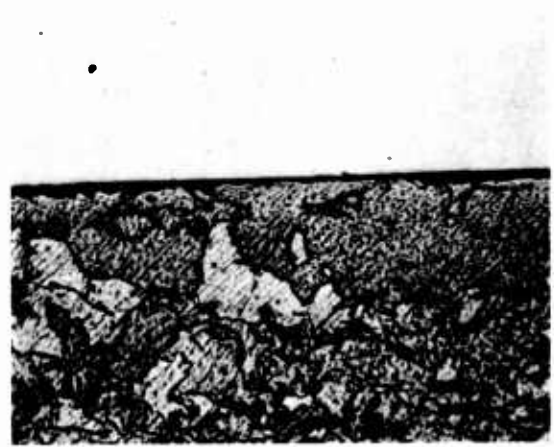
Comments: A recrystallized zone in the titanium surrounds the bond interface. Local etching attack at the interface exaggerates the width of the bond line. Bonding quality is unsatisfactory in transverse section.

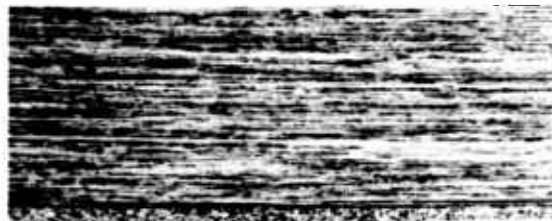
Combination: Molybdenum to Titanium
Number 79 (wire) (coupon)
0.060 gage 0.062Longitudinal

Comments: Bonding resulted in a thin bond of recrystallization in the titanium sheet. Width of the bond line is exaggerated by etching. Lack of interpenetration of faying surfaces was observed. Good bonding.

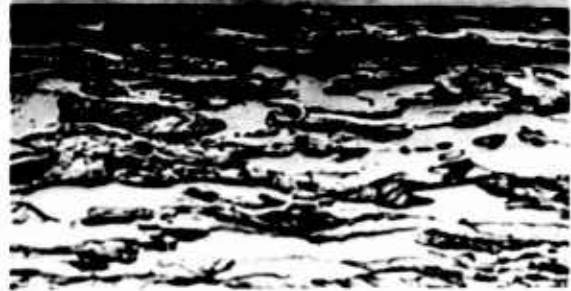
Comments: Cracks in the tungsten sheet parallel to the weld plane are evident in the micros. Bonding is satisfactory.

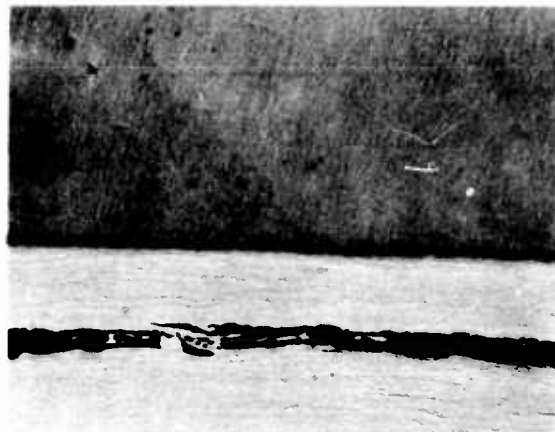
Comments: Unsatisfactory bonding with catastrophic cracking in the tungsten sheet beneath the contact surface.

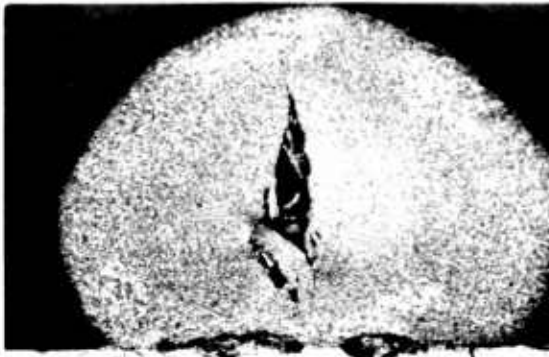
Comments: The tungsten wire is split through the center and the sheet is cracked in the weld region. Unsatisfactory welding.
