REPORT NO. RD-64-27

FINAL REPORT  
Project No. 432-1-5V

EVALUATION OF LIGHTED  
CROSSBARS AND LIGHTED  
RUNWAY DISTANCE MARKERS

FEDERAL AVIATION AGENCY  
Systems Research & Development Service  
EVALUATION DIVISION  
Atlantic City, New Jersey

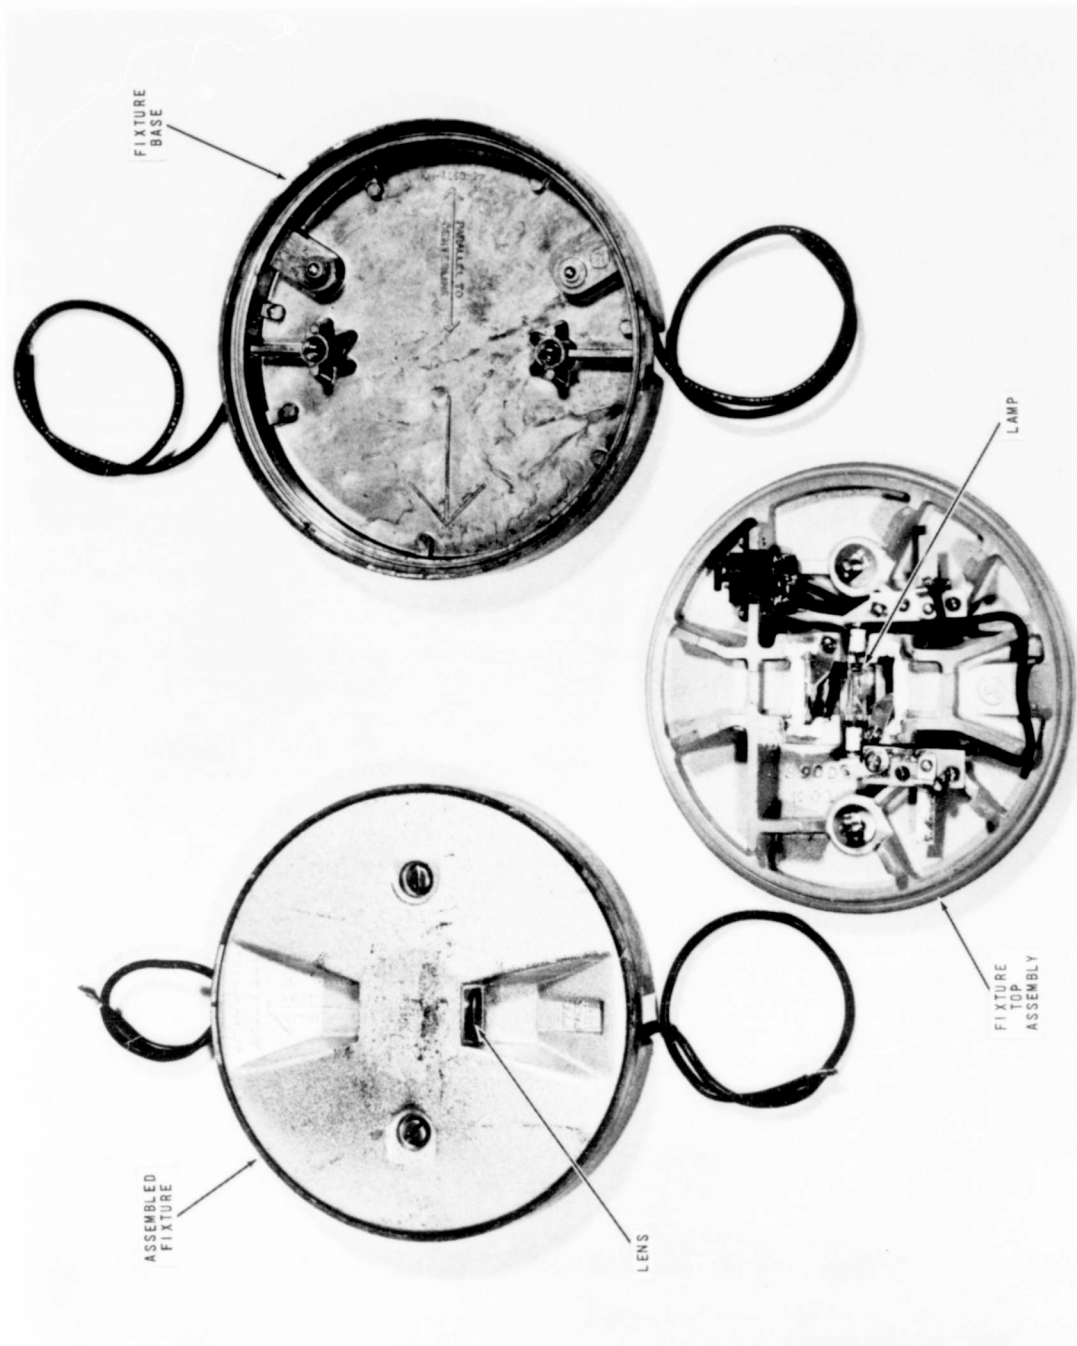
FIG. 1 WESTINGHOUSE ELECTRIC CORPORATION FIXTURE

The Westinghouse fixture (FIG. 1) projected  $\frac{3}{8}$  of an inch above the runway surface. The Sylvania (FIG. 2) and the Structural (FIG. 3) fixtures projected  $\frac{1}{4}$  inch above the surface. The Stillman fixture (FIG. 4) projected  $\frac{7}{16}$  of an inch above the surface and was so constructed that pressure from above compressed the fixture flush with the runway surface.

Lighted Crossbars: The crossbars utilized two basic types of bidirectional inset lights; an enclosed type manufactured by Westinghouse Electric Corporation and open types manufactured by Sylvania Electric Products Incorporated, Structural Electric Products Corporation and the Stillman Rubber Company. Each fixture was approximately eight inches in diameter and contained a 45W quartz lamp.
