CIVIL ENGINEERING STUDIES

STRUCTURAL RESEARCH SERIES NO. 285

**STUDIES OF THE FATIGUE BEHAVIOR
OF BUTT-WELDED JOINTS
IN HY-80 AND HY-100 STEELS**

THE CIVIL ENGINEERING DEPARTMENT
UNIVERSITY OF ILLINOIS

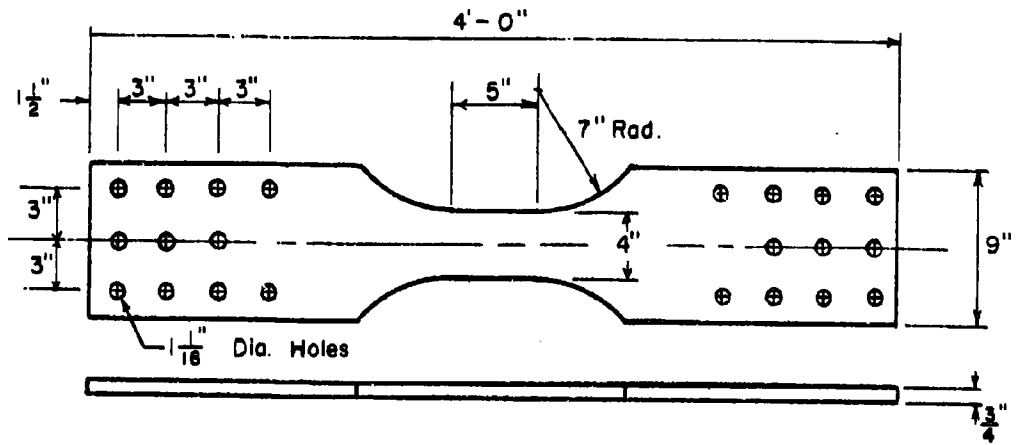
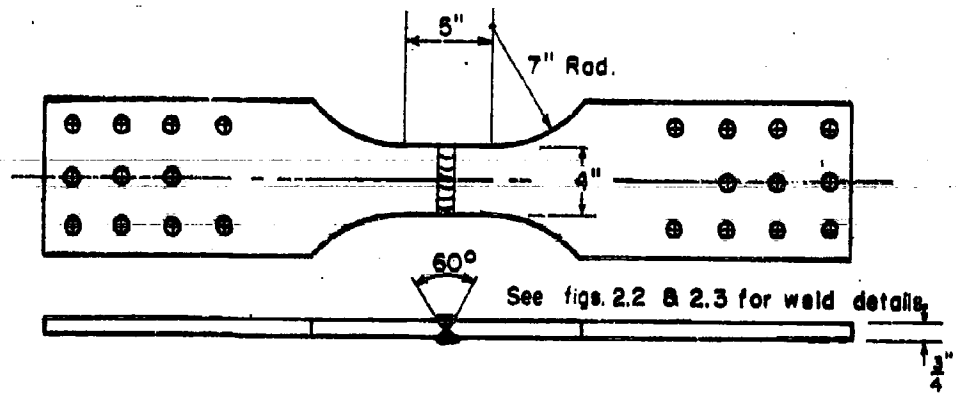
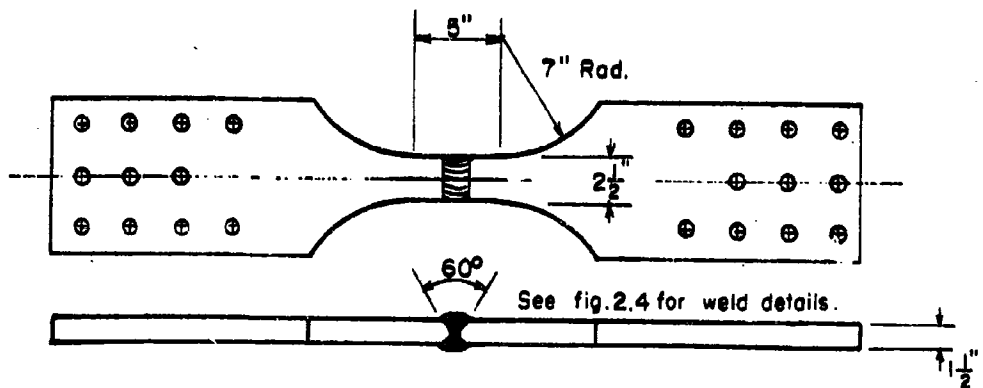
FIG. 2.1 DETAILS OF TEST SPECIMENS.

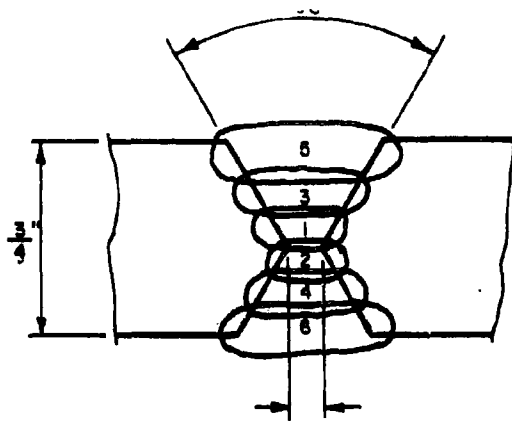
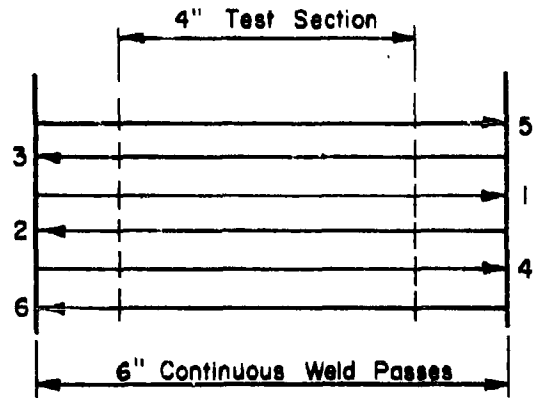
Root opening $\frac{1}{8}$ in.

Arrows indicate direction of welding.

Surface of plate adjacent to weld cleaned by grinding before welding.

Underside of pass 1 ground before placing pass 2

FIG. 2.2 WELDING PROCEDURE P80-11018-A
(Transverse Butt Welds in HY-80)

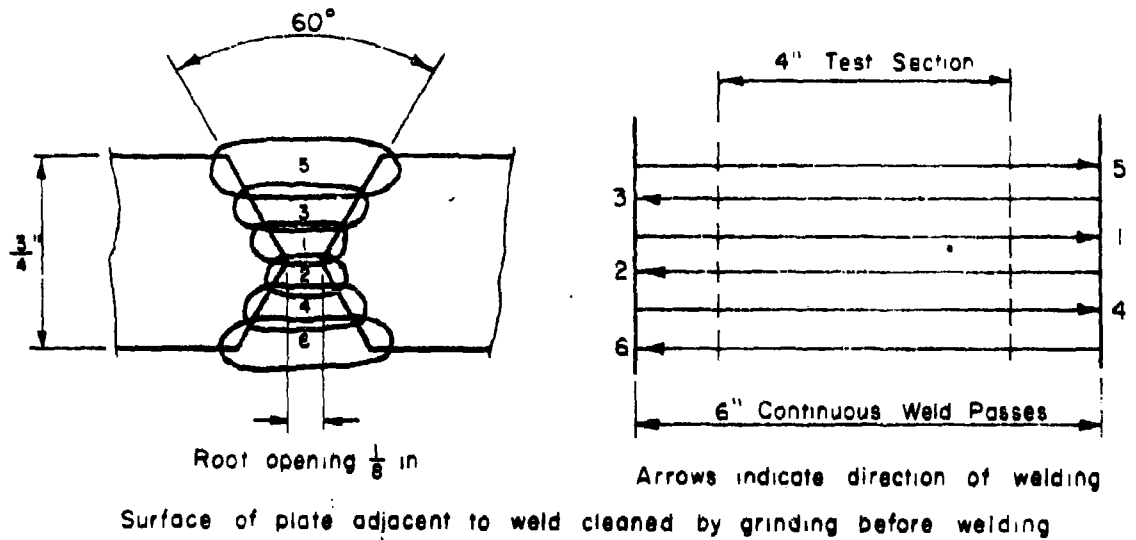
Pass	Electrode size, in	Current, amps	Rate of travel, in./min
1	$\frac{5}{32}$	130	5
2	$\frac{5}{32}$	140	5
3	$\frac{3}{16}$	230	8
4	$\frac{3}{16}$	220	7
5	$\frac{3}{16}$	210	7
6	$\frac{3}{16}$	210	7

Voltage . 21 Volts

Underside of pass 1 ground before placing pass 2

FIG.2.3 WELDING PROCEDURE P100-11018-J
(Transverse Butt Welds in HY-100)

The transverse butt welds were fabricated using welding procedure P100-11018-J, which is identical to procedure P80-11018-A used for the HY-80 material; no difficulty was encountered in the welding of the HY-100 material. The weldor and the welding procedure were qualified in accordance with requirements given in Ref. (5) for HY-80 material. The joint was able to undergo a 180° guided side bend test without cracking. Figures 3.1 and 3.2 show typical micrographs for the HY-80 and HY-100 materials, respectively; the microstructures of these materials are very similar.

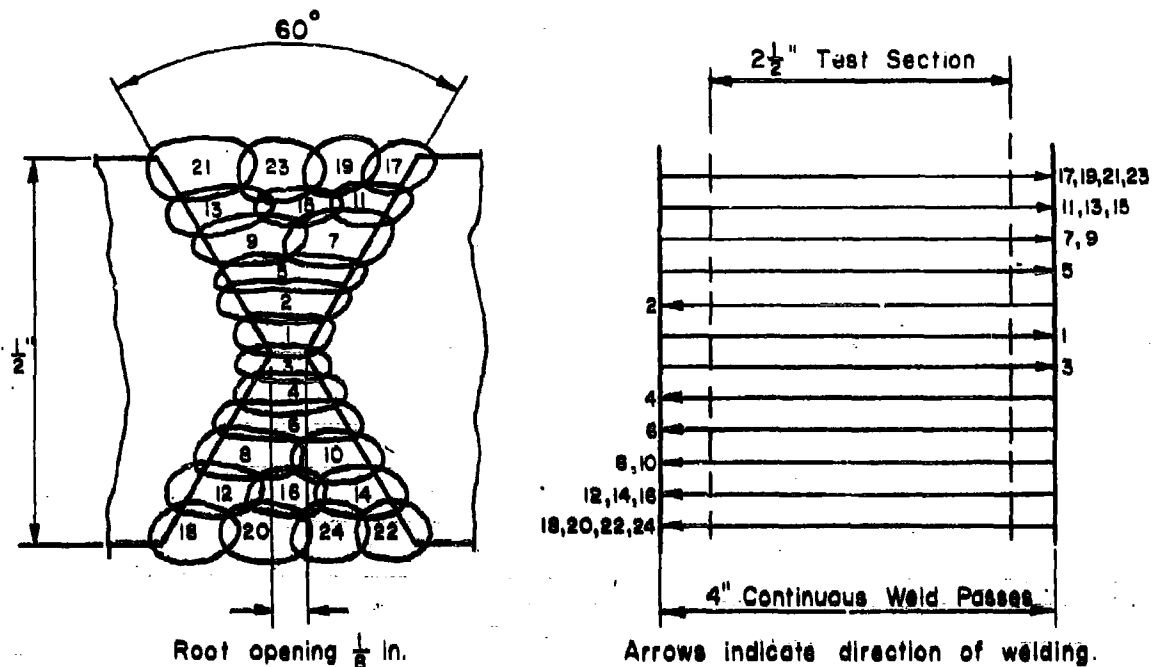
Surface of plate adjacent to weld cleaned by grinding before welding.

Pass	Electrode size, in.	Current, amps.	Rate of travel, in./min.
1	$\frac{5}{32}$	140	4
2	$\frac{3}{16}$	230	6
3	$\frac{5}{32}$	160	4
4-16	$\frac{3}{16}$	230	6
17-24	$\frac{3}{16}$	200	5

Underside of pass 1 back-gouged with air arc before pass 3.

**FIG.2.4 WELDING PROCEDURE P80-11018-D
(Transverse Butt Welds in HY-80)**

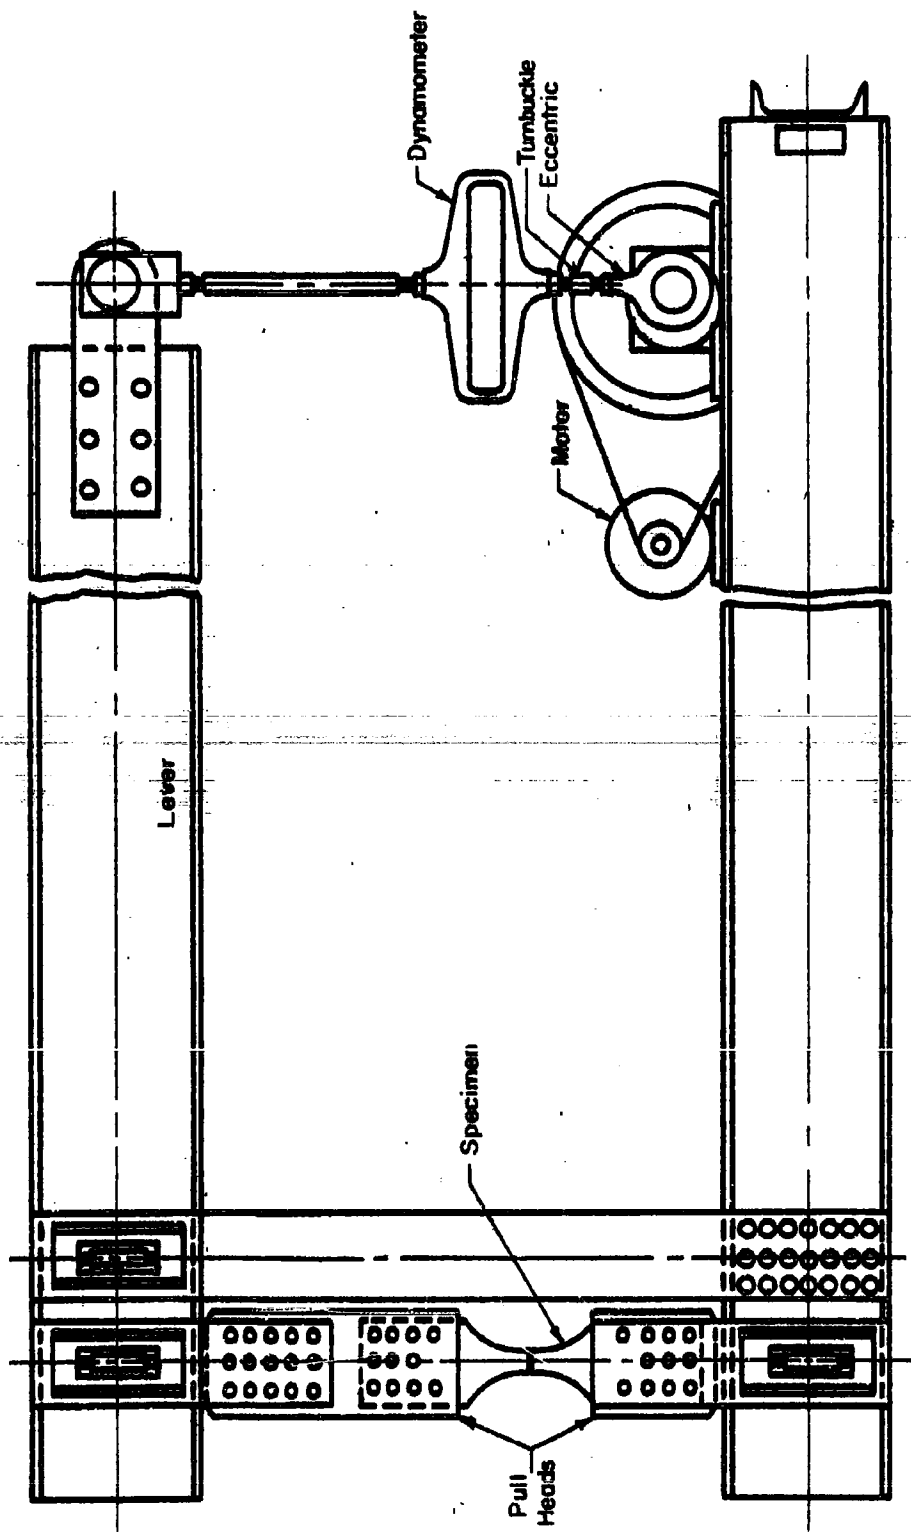
FIG.2.5 ILLINOIS' FATIGUE TESTING MACHINE AS USED FOR AXIAL LOADING OF WELDED JOINTS

After the load had been set and the machine started, a microswitch was set so that the machine would shut off when a crack had propagated partially through the specimen. Failure was assumed to have occurred when the microswitch shut the machine off. The microswitch was then disconnected and the machine restarted; this was done to completely fracture the specimen so that the fracture surface could be examined and photographed.

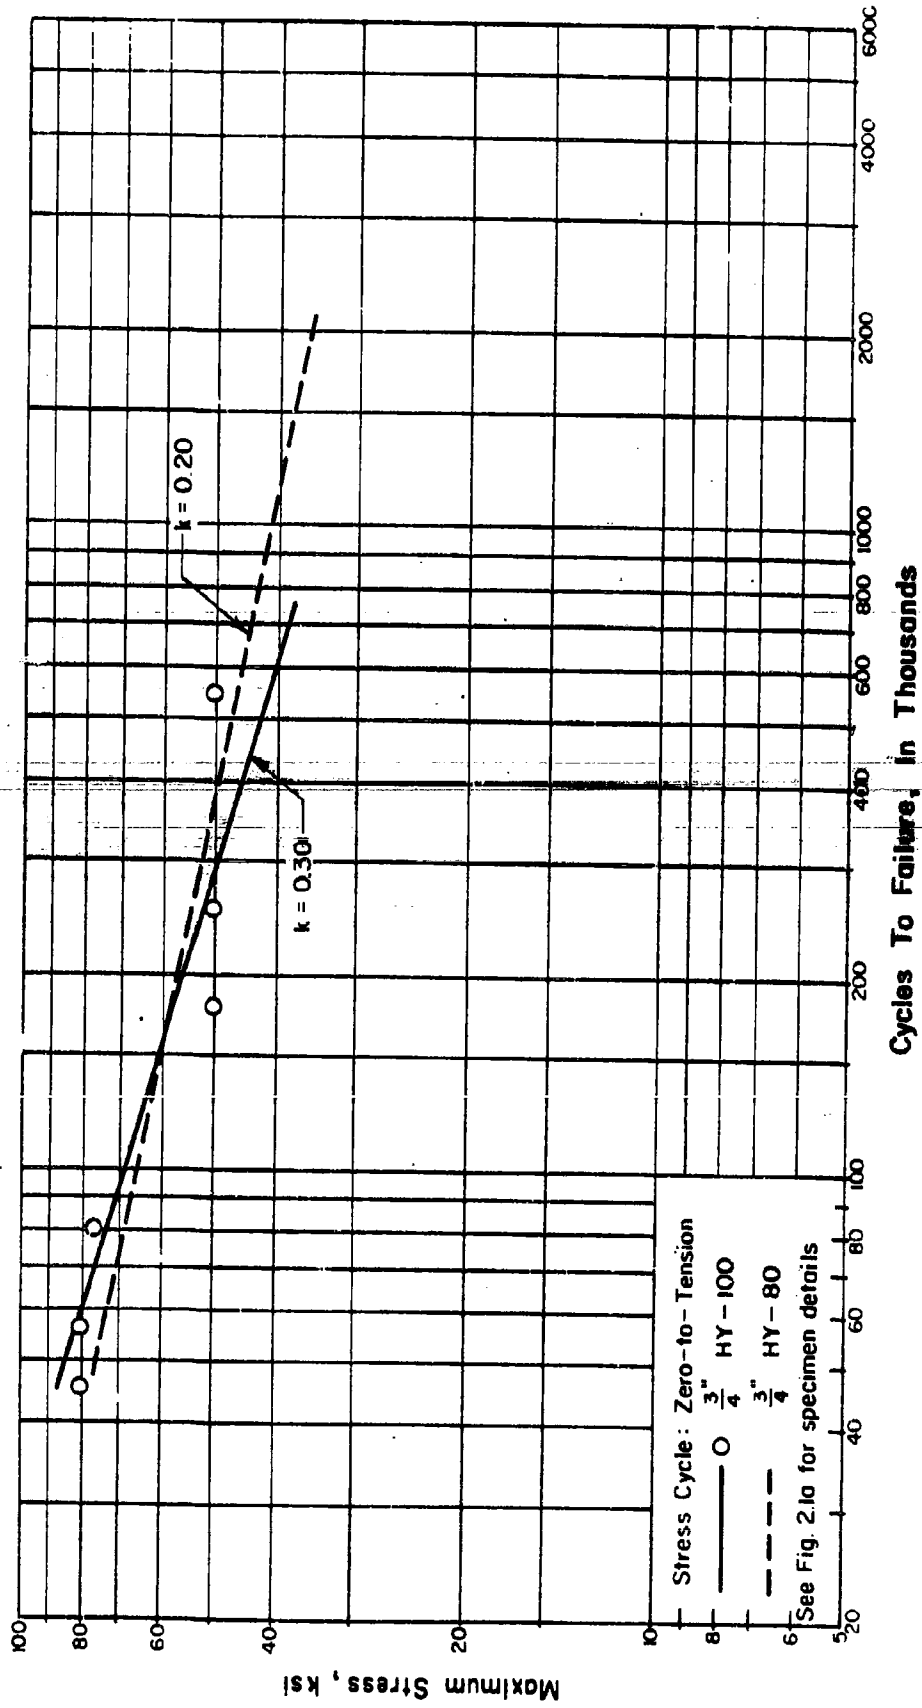
FIG. 3.3 RESULTS OF FATIGUE TESTS OF AS-ROLLED HY-100 PLAIN PLATE SPECIMENS.

The results of the fatigue tests of plain plate specimens on a zero-to-tension stress cycle are tabulated in Table 3.1 and plotted in Fig. 3.3. The S-N curve shown in this figure for HY-100 material was obtained using the procedure outlined in Ref. (2). In addition, Fig. 3.3 contains the S-N curve for 3/4 in. HY-80 plain plates⁽⁴⁾. Comparing the curves it is noted that the slope for the HY-100 material is greater than that for the HY-80 material. However, only a limited number of tests were included in the study.

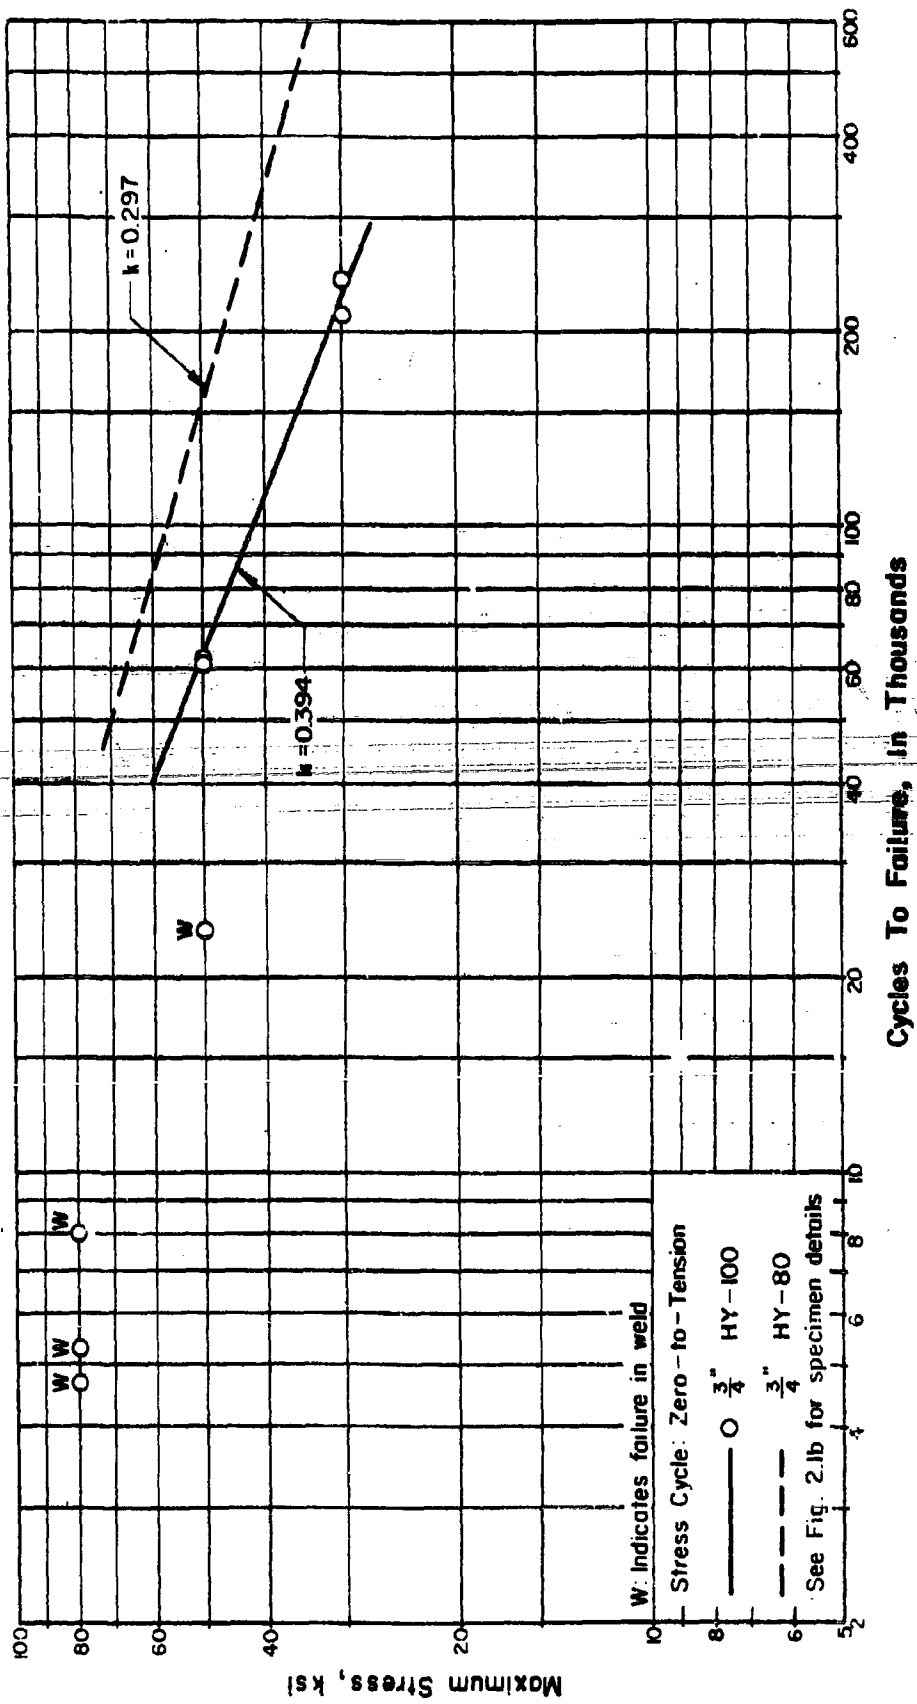
FIG. 3.5 RESULTS OF FATIGUE TESTS OF HY-100 TRANSVERSE BUTT WELDS IN THE AS-WELDED CONDITION.

The results of the fatigue tests of as-welded butt joints on a zero-to-tension stress cycle are tabulated in Table 3.2 and plotted in Fig. 3.5. Figure 3.5 also contains the S-N curve for 3/4 in. HY-80 as-welded butt joints⁽⁴⁾. Although the 3/4 in. HY-80 specimens all failed due to the stress concentration of the external weld geometry, this was not true for the HY-100 material. In a number of cases, failure occurred in the weld rather than at the edge of the weld reinforcement because of very small defects which were present in the root area of the weld. These defects (Fig. 3.6) were not visible on the radiographs taken of the as-welded specimens prior to testing. Even on the fracture surface, it was difficult to locate the defects because of their smallness.

It can be seen on Fig. 3.5 that there was a large amount of scatter in the test results when failure occurred in the weld. In addition the failures propagated rapidly when they originated in the weld. When failure occurred in

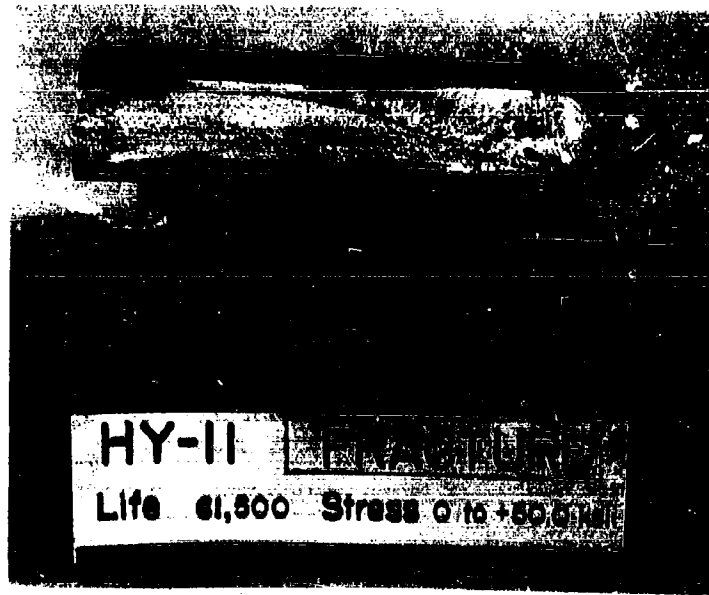
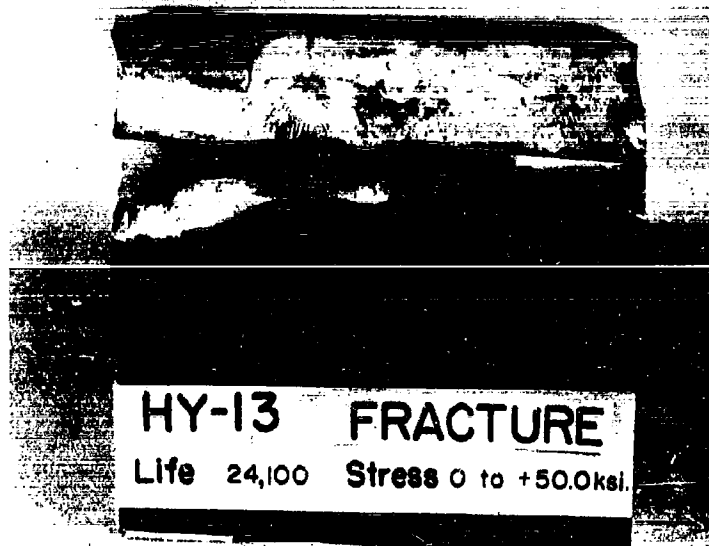
a) FAILURE INITIATED AT EDGE OF WELD REINFORCEMENT.

b) FAILURE INITIATED IN WELD.

FIG.3.6 TYPICAL FRACTURES OF TRANSVERSE BUTT WELDS IN 3/4 IN. HY-100 MATERIAL.

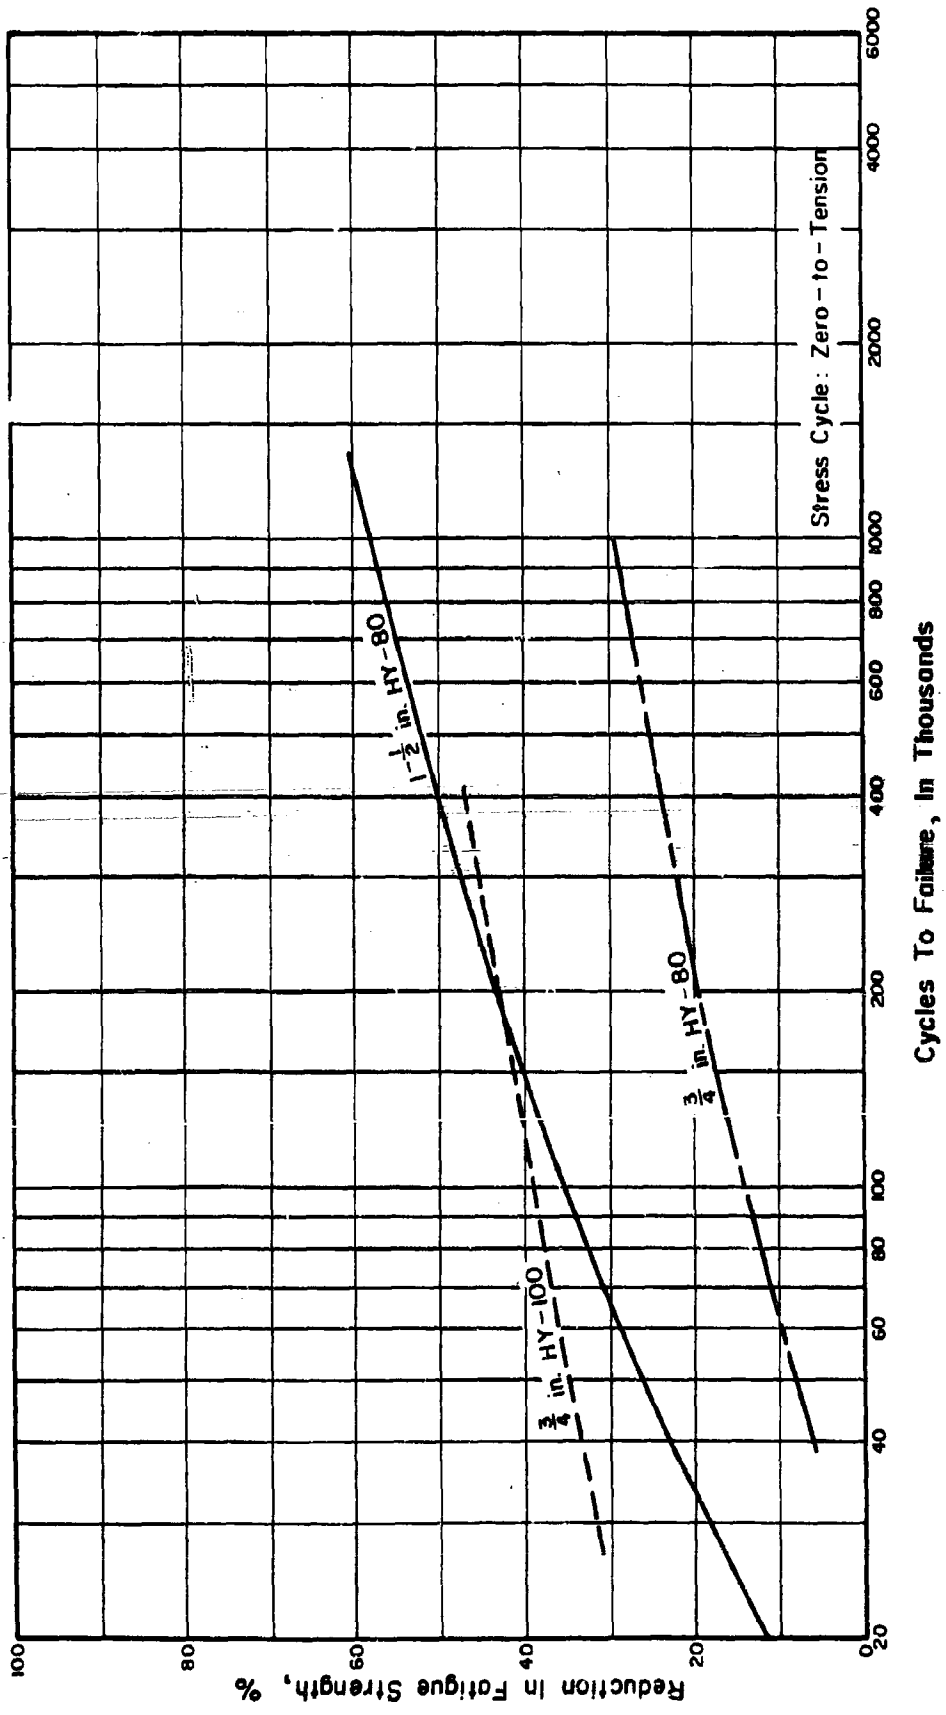
FIG. 3.7 REDUCTION IN FATIGUE STRENGTH FROM AS-ROLLED PLAIN PLATES DUE TO A TRANSVERSE BUTT WELD IN THE AS-WELDED CONDITION.

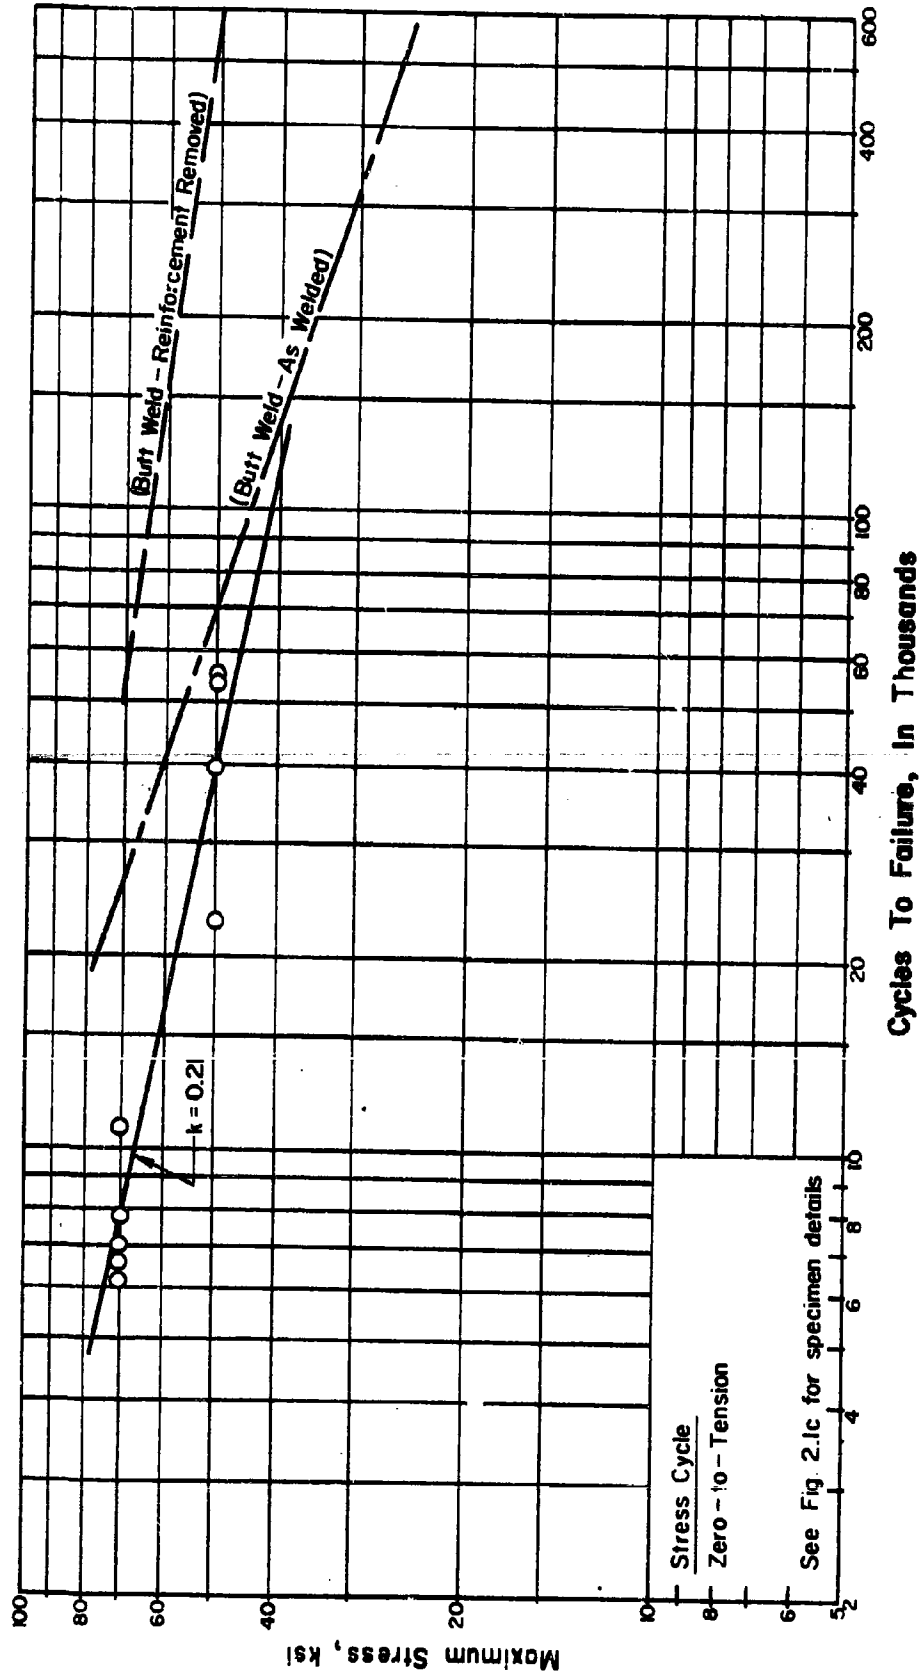
FIG. 4.1 RESULTS OF FATIGUE TESTS OF 1-1/2 IN. TRANSVERSE BUTT WELDS CONTAINING VARIOUS AMOUNTS OF INTENTIONAL POROSITY (REINFORCEMENT REMOVED).

The results of fatigue tests of 1-1/2 in. defective butt welds are tabulated in Table 4.1 and plotted in Fig. 4.1. Since the tests were carried out using two stress cycles, 0 to +70.0 ksi and 0 to +50.0 ksi, it was possible to draw the S-N curve which is shown in Fig. 4.1. The slope, $k = C^{-1}$, is larger than that for sound butt welds with weld reinforcement removed but is less than that for butt welds tested in the as-welded condition. The S-N curves for sound butt welds with and without weld reinforcement are also given

in Fig. 4.1 Comparing the three curves one may see that although the curve for defective welds lies entirely below that for welds with reinforcement removed, it is below the curve for as-welded joints for lives less than 150,000 cycles but above the curve for higher lives. This indicates that at long lives the external geometry is more critical, with respect to fatigue, than internal defects when the defects are of a size permitted by the code; at the shorter lives the internal defects produce greater effects than the external geometry.

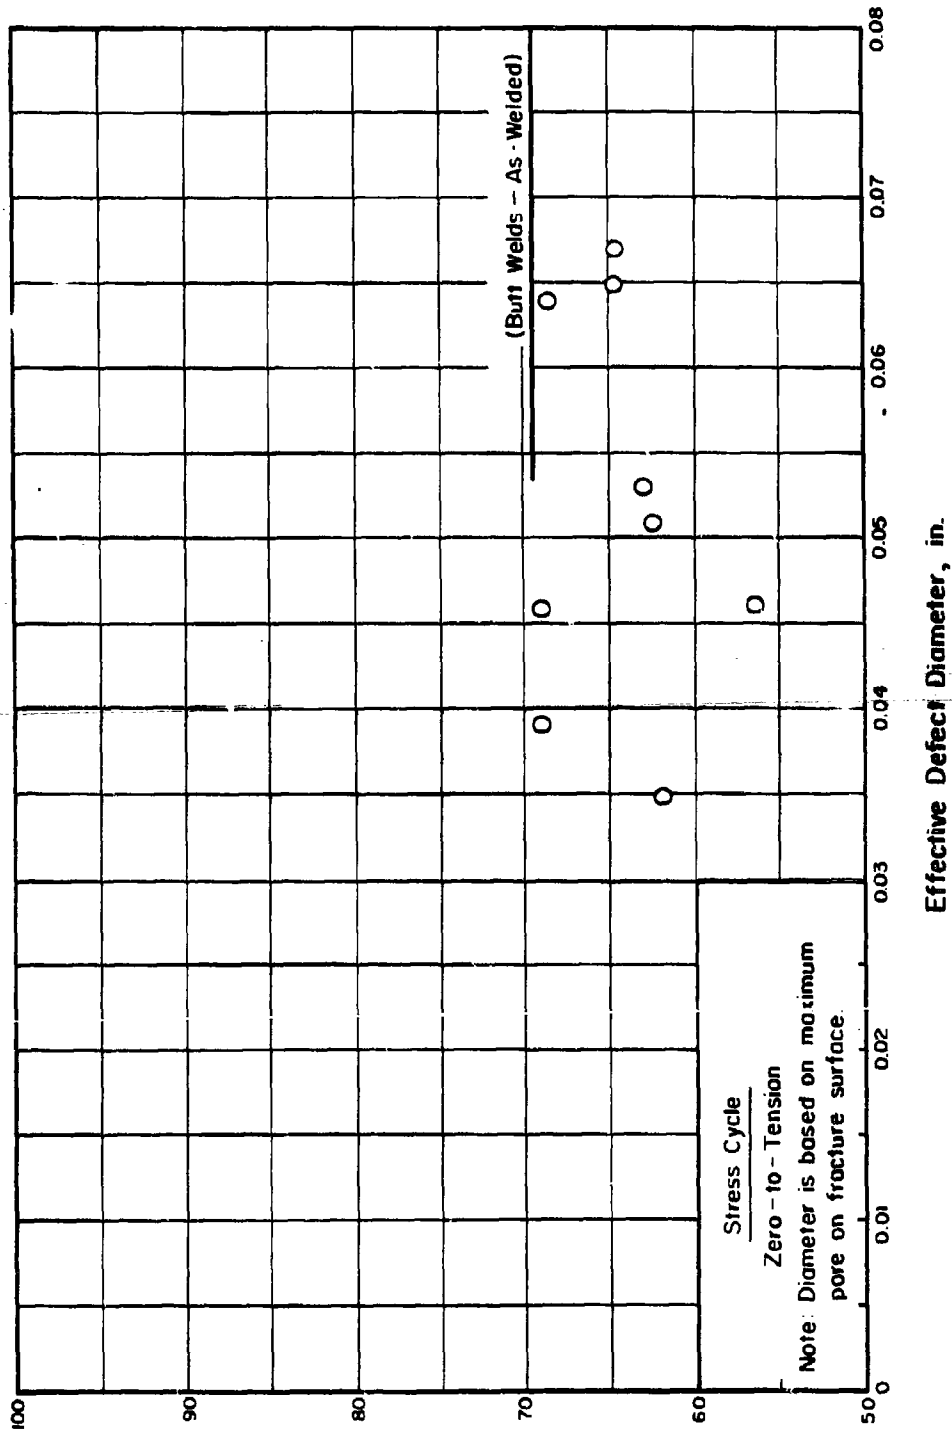
FIG. 4.3 PERCENT FATIGUE STRENGTH AT 100,000 CYCLES vs. EFFECTIVE DEFECT DIAMETER OF POROSITY IN 1-1/2 IN. MATERIAL.

The pore diameters in most of the test welds ranged from 1/64 in. to 3/64 in. The effective defect diameter^{*}, d_e , was determined for the largest flaw in any cluster that propagated to failure and is tabulated in Table 4.2. Figure 4.3 shows a plot of the percent of $F_{100,000}$ for a sound weld with the reinforcement removed vs. the effective defect diameter; over the small range

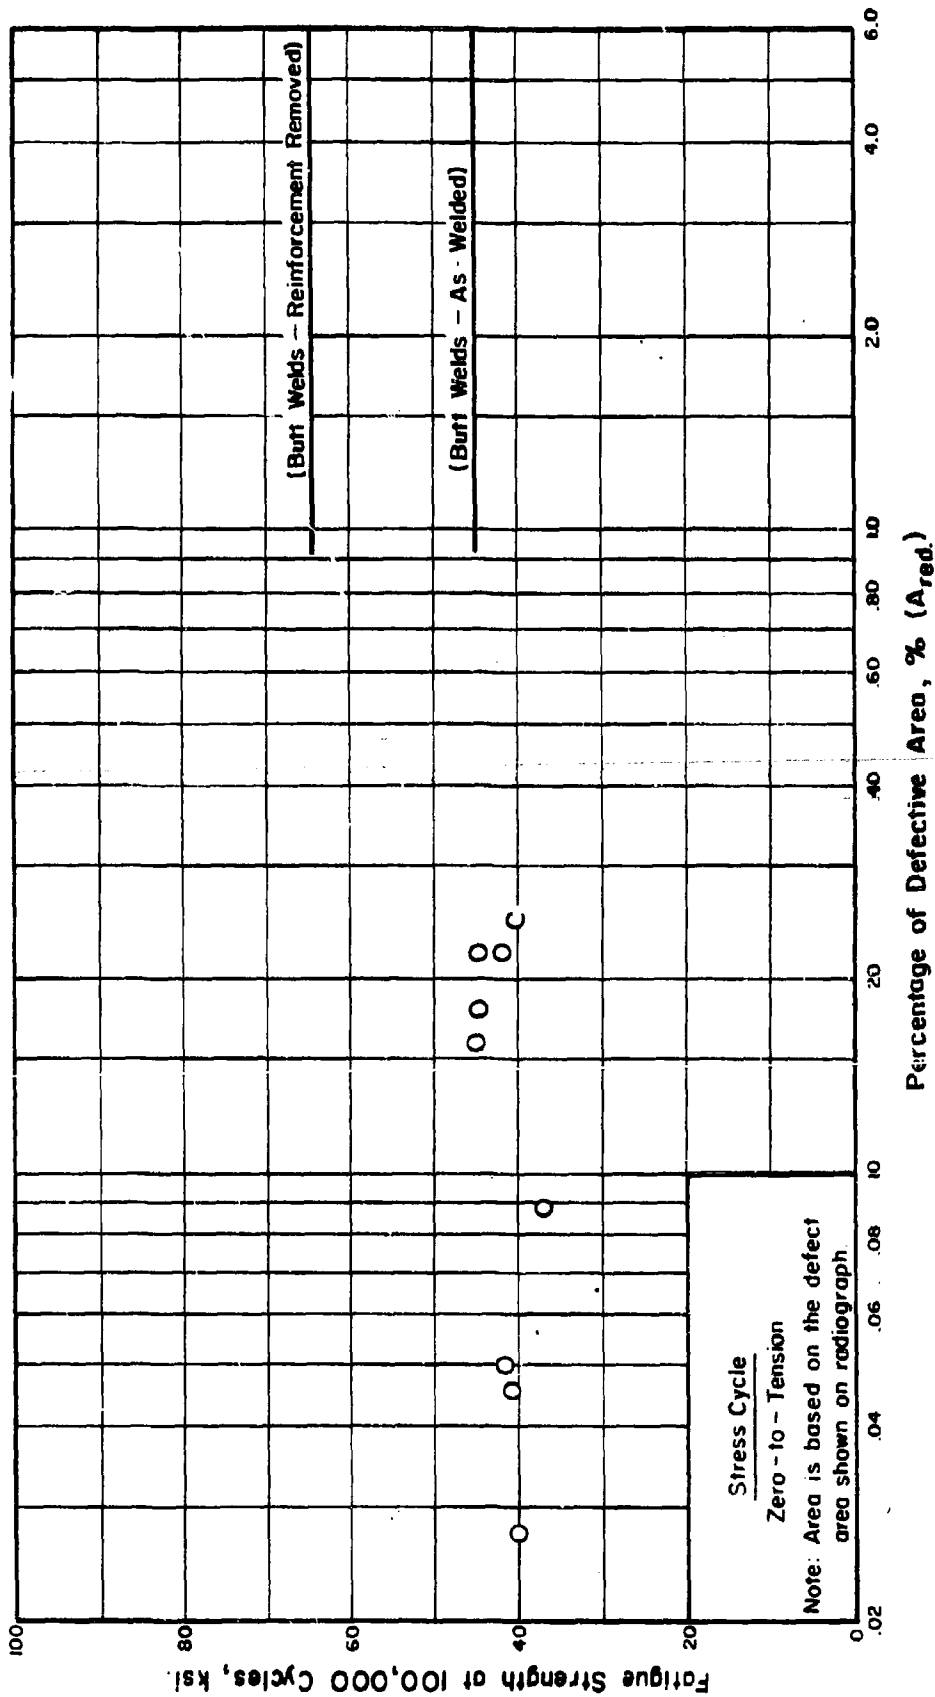
FIG. 4.4 COMPUTED FATIGUE STRENGTH AT 100,000 CYCLES vs. DEFECTIVE AREA DUE TO INTENTIONAL POROSITY IN 1-1/2 IN. MATERIAL.

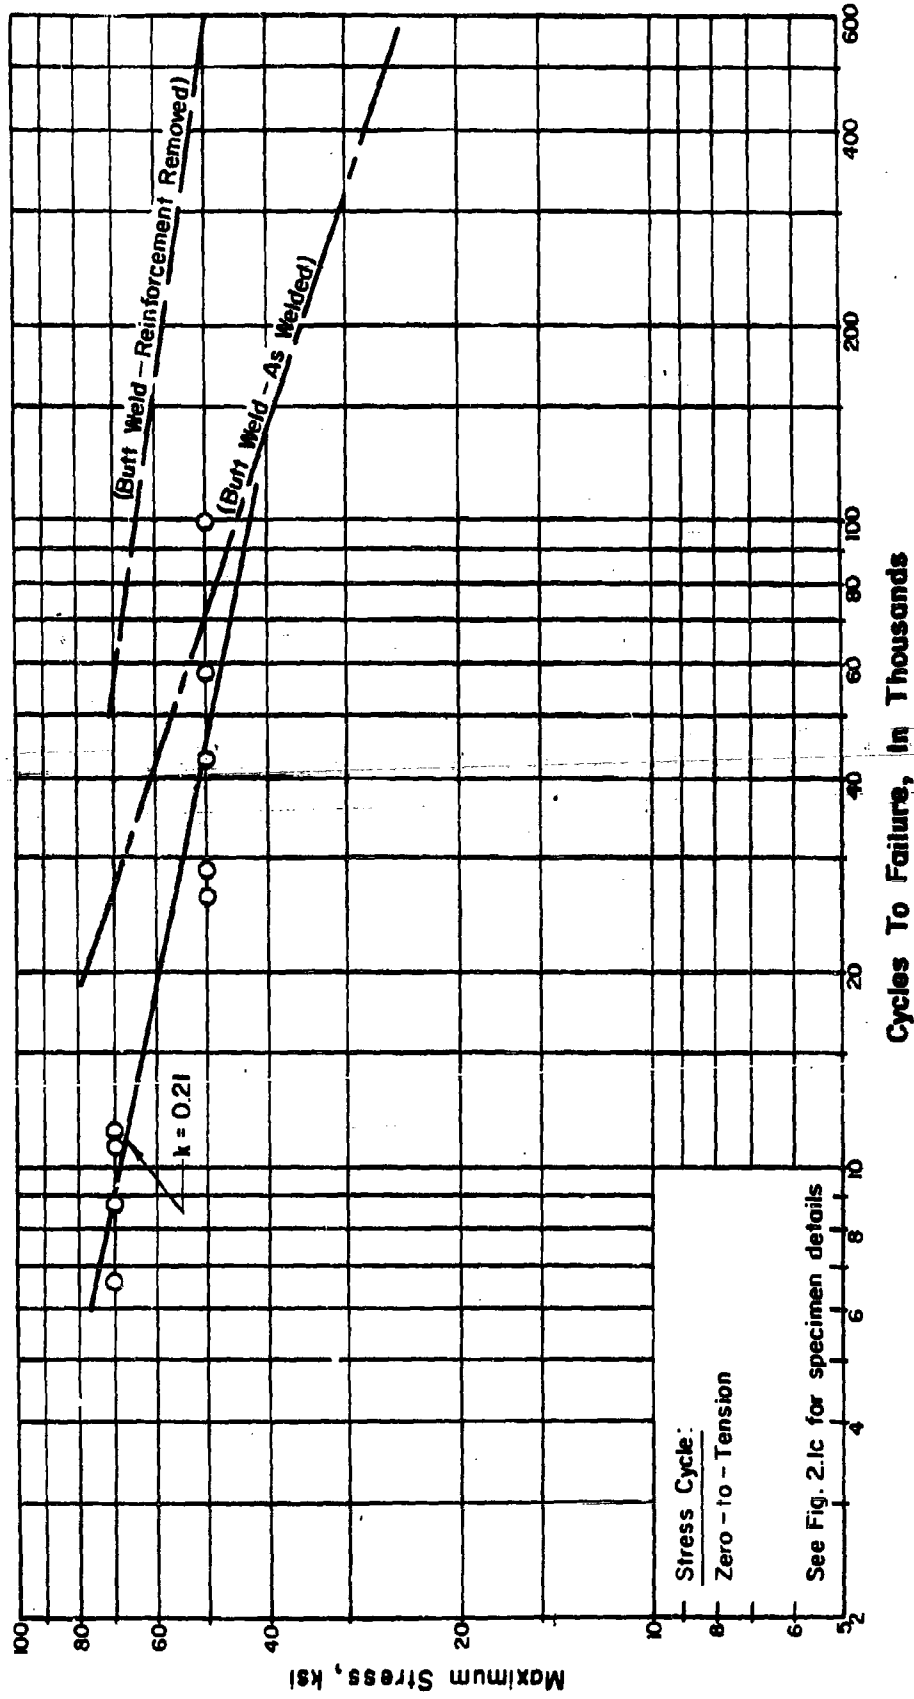
FIG. 4.5 RESULTS OF FATIGUE TESTS OF 1-1/2 IN. TRANSVERSE BUTT WELDS CONTAINING VARIOUS AMOUNTS OF INTENTIONAL SLAG (REINFORCEMENT REMOVED).

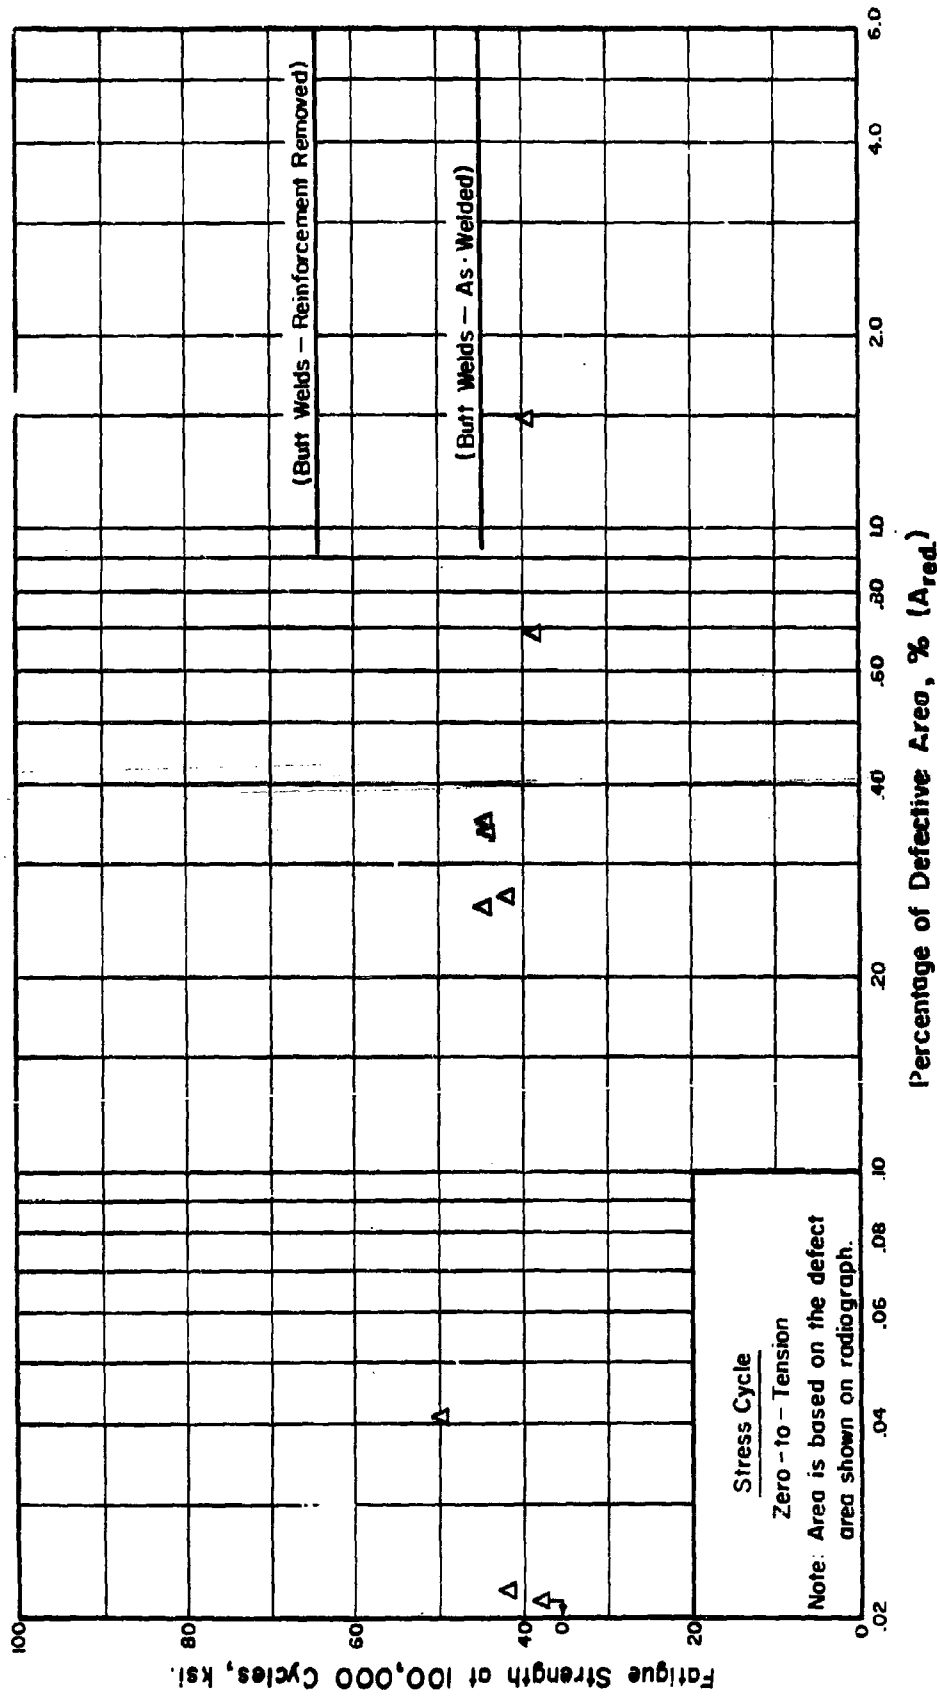
FIG. 4.6 COMPUTED FATIGUE STRENGTH AT 100,000 CYCLES VS. DEFECTIVE AREA DUE TO INTENTIONAL SLAG INCLUSIONS IN 1-1/2 IN. MATERIAL.

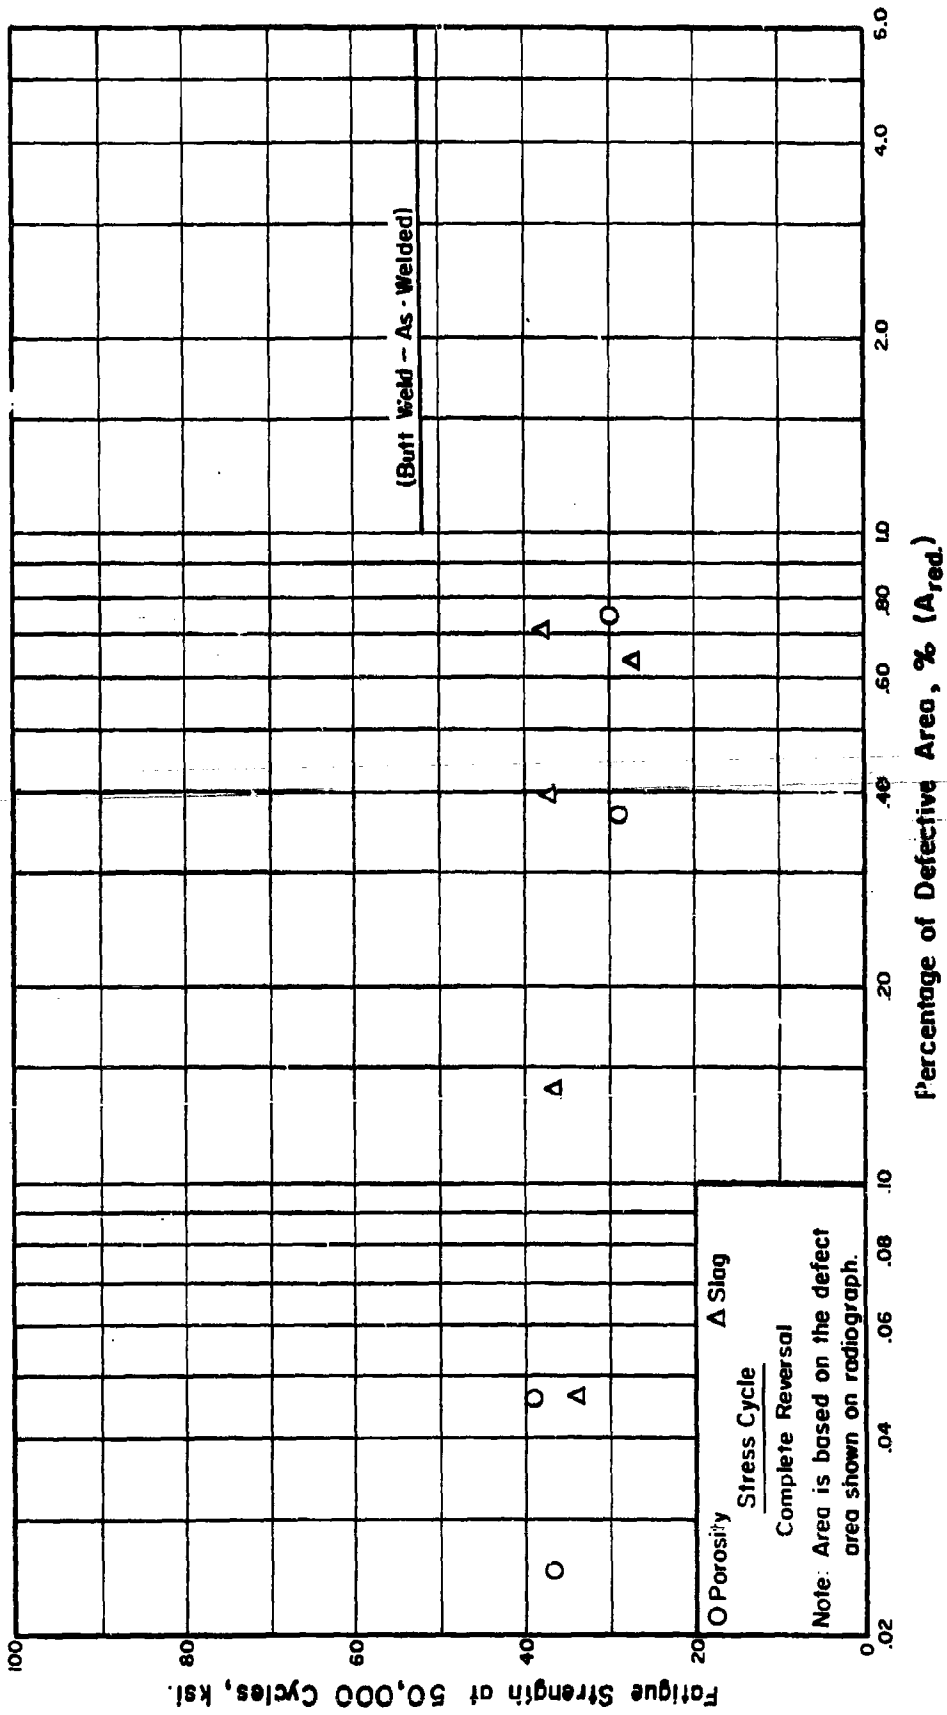
FIG. 4.9 COMPUTED FATIGUE STRENGTH AT 50,000 CYCLES vs. DEFECTIVE AREA DUE TO INTENTIONAL WELD DEFECTS IN 3/4 IN. MATERIAL.

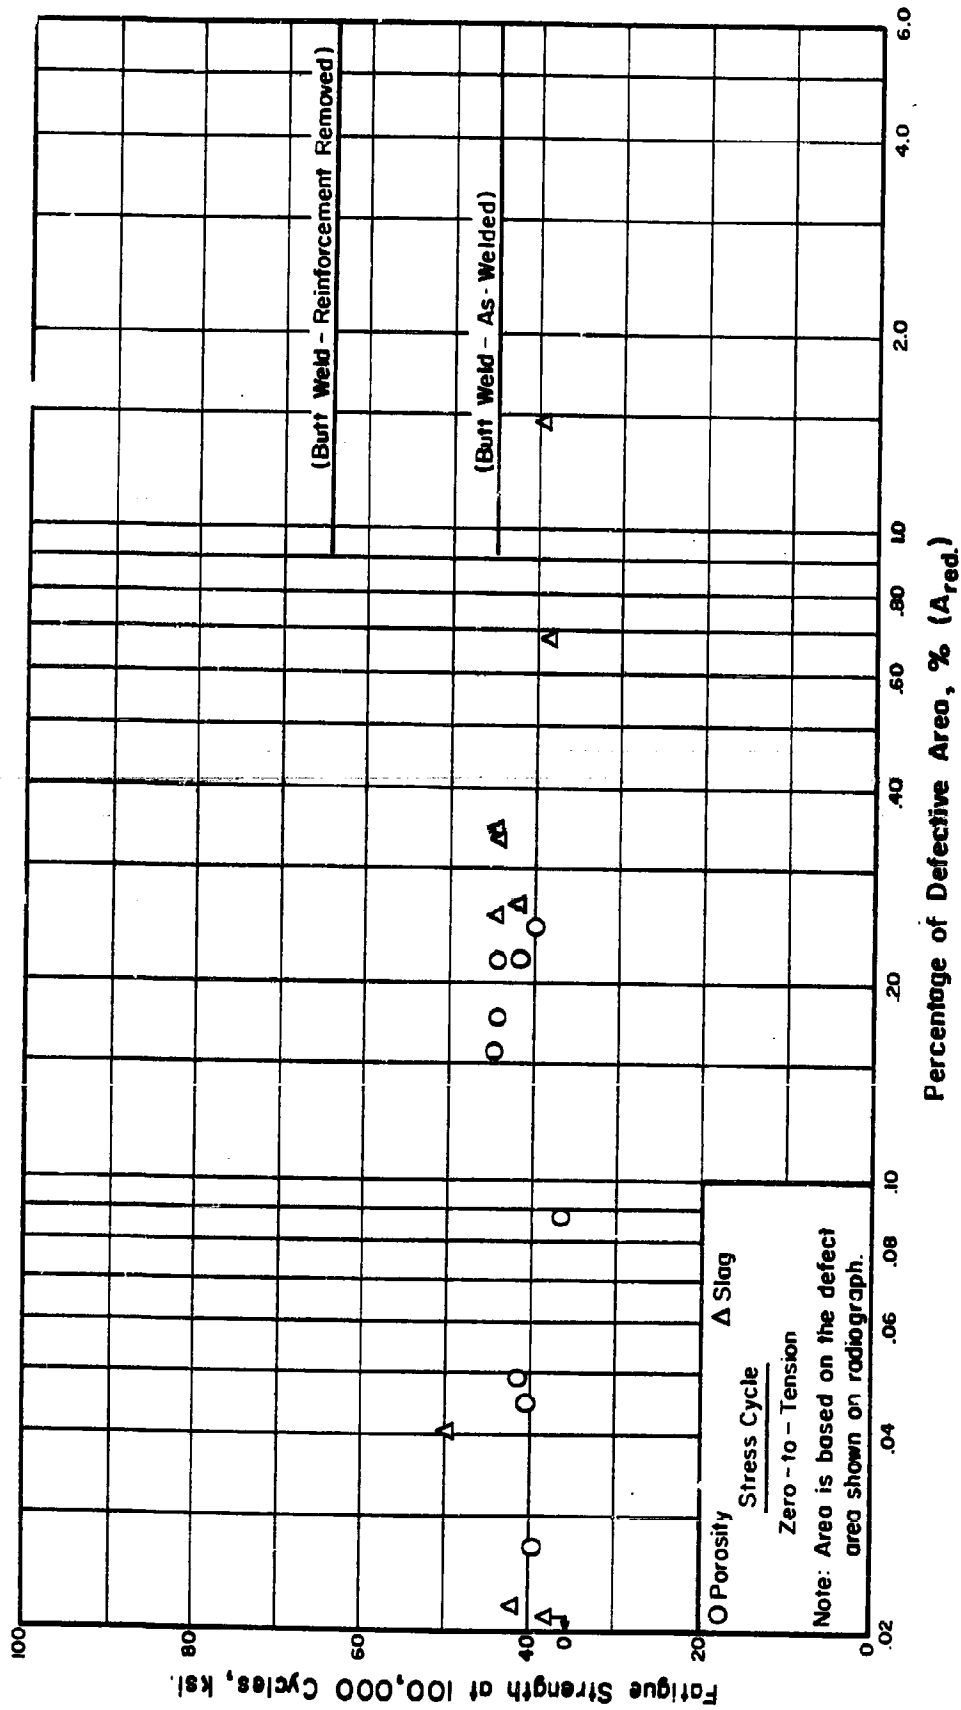
FIG. 4.10 COMPUTED FATIGUE STRENGTH AT 100,000 CYCLES VS. DEFECTIVE AREA DUE TO INTENTIONAL WELD DEFECTS IN 1-1/2 IN. MATERIAL.
