CIVIL ENGINEERING STUDIES

STRUCTURAL RESEARCH SERIES NO. 285

**STUDIES OF THE FATIGUE BEHAVIOR
OF BUTT-WELDED JOINTS
IN HY-80 AND HY-100 STEELS**

THE CIVIL ENGINEERING DEPARTMENT
UNIVERSITY OF ILLINOIS

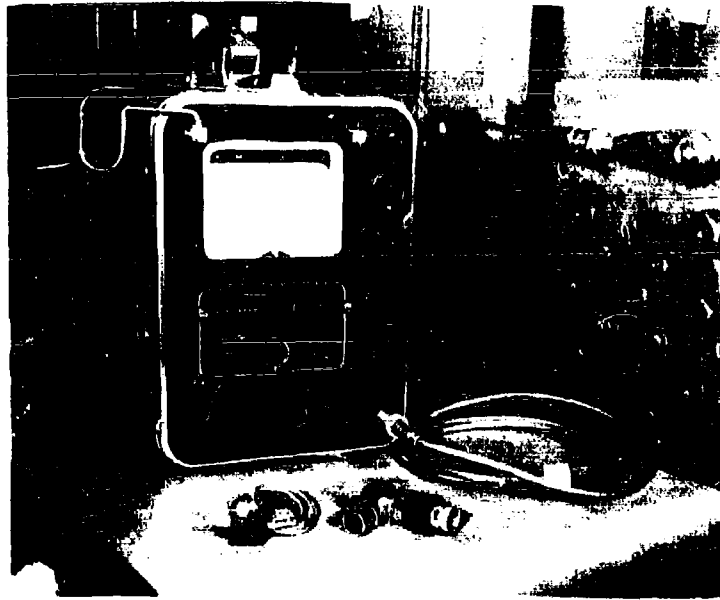
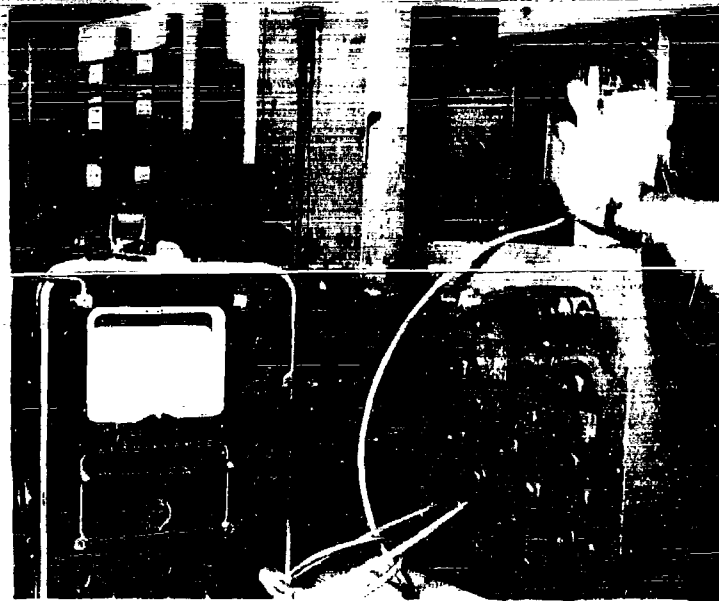
a) EQUIPMENT SHOWING NORMAL AND 45° ANGLE PROBES.

b) EQUIPMENT IN POSITION FOR RECORDING.

FIG. 5.2 SETUP FOR ULTRASONIC STUDY OF
CRACK PROPAGATION.

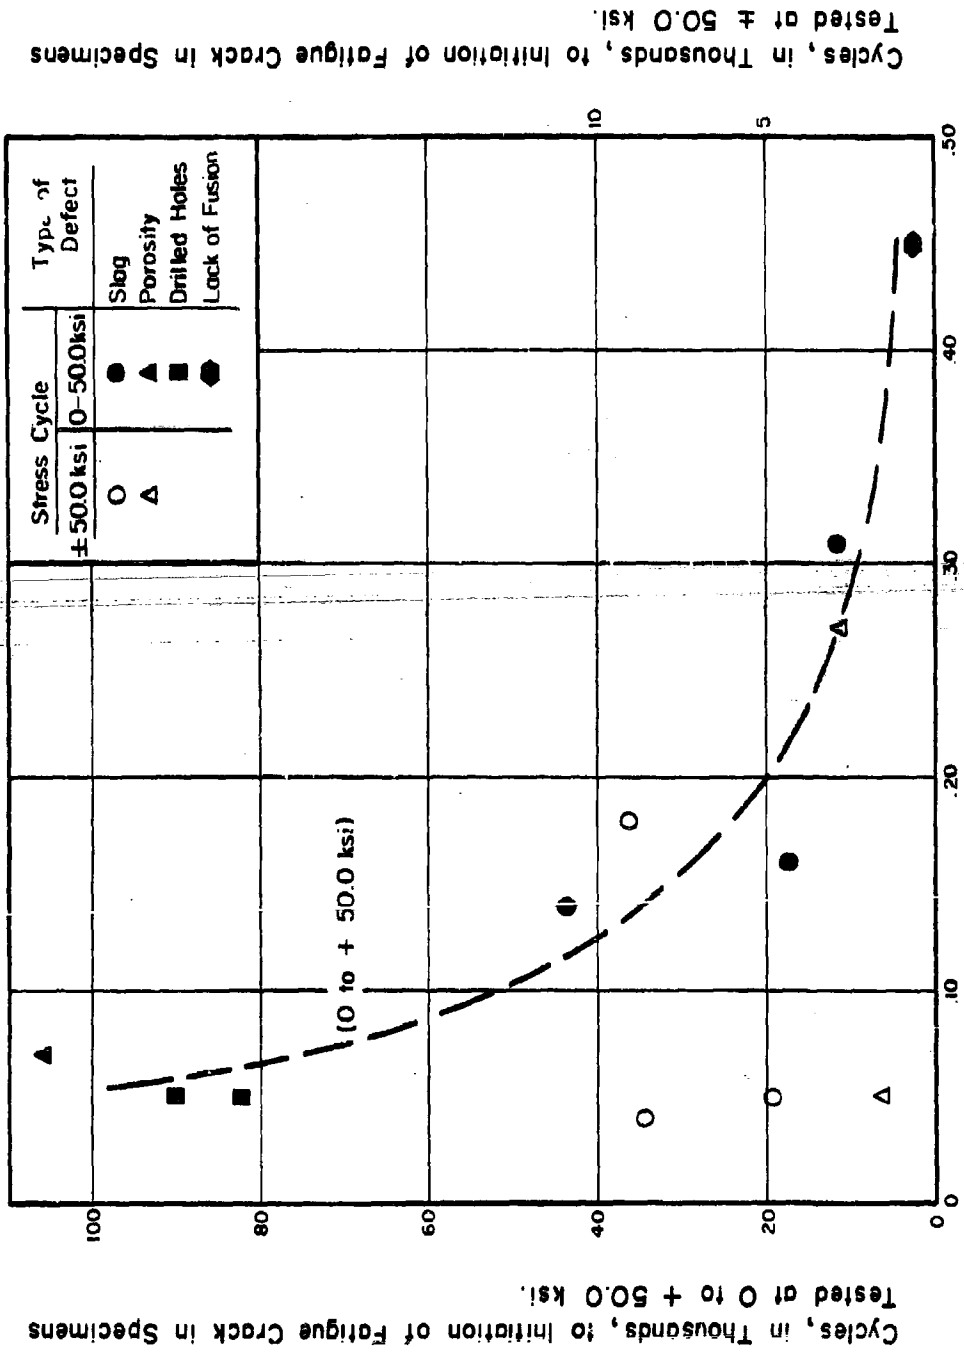
FIG. 5.3 CORRELATION BETWEEN INITIAL LENGTH OF INTENTIONAL WELL DEFECT AND INITIATION OF FATIGUE CRACKS.

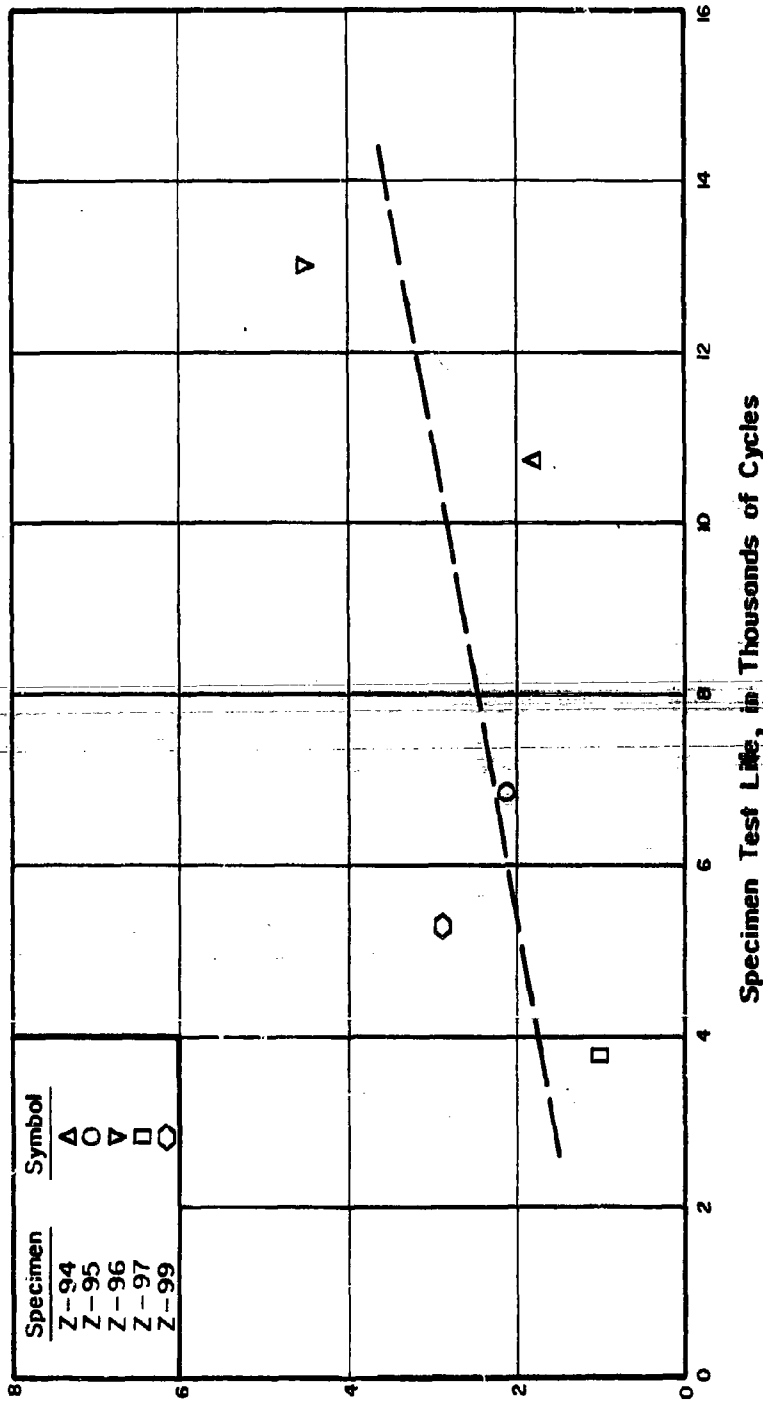
Duration of Fatigue Crack Propagation From
Initiation to Test Life, in Thousands of Cycles

FIG. 5.4 COMPARISON OF CYCLES OF FATIGUE CRACK PROPAGATION TO TEST LIFE IN 3/4 IN. HY-80 TRANSVERSE BUTT WELDED SPECIMENS TESTED AT ± 50.0 KSI.

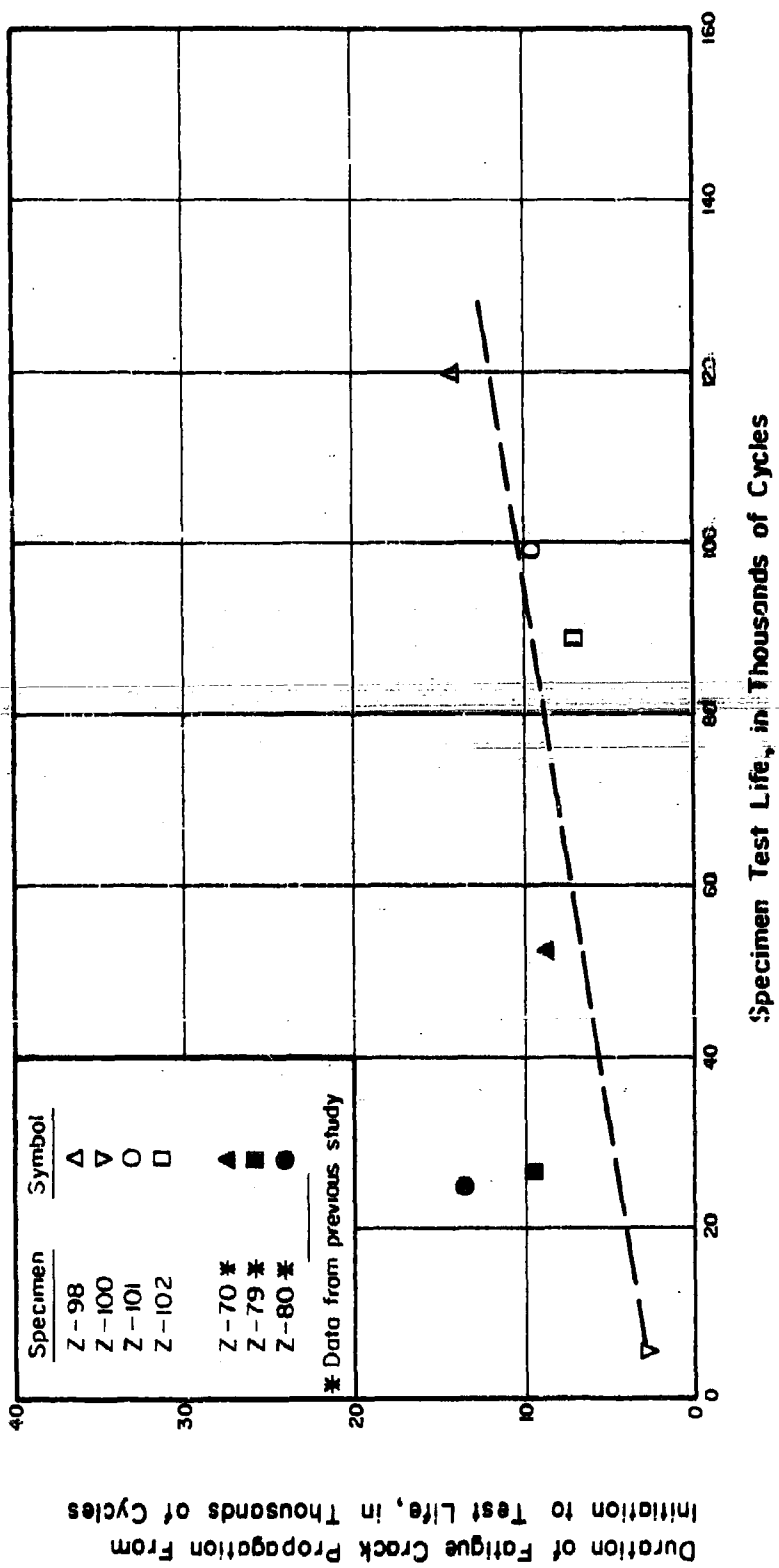
FIG. 5.5 COMPARISON OF CYCLES OF FATIGUE CRACK PROPAGATION TO TEST LIFE IN 3/4 IN. HY-80 TRANSVERSE BUTT WELDED SPECIMENS TESTED AT 0 TO + 50.0 KSI.

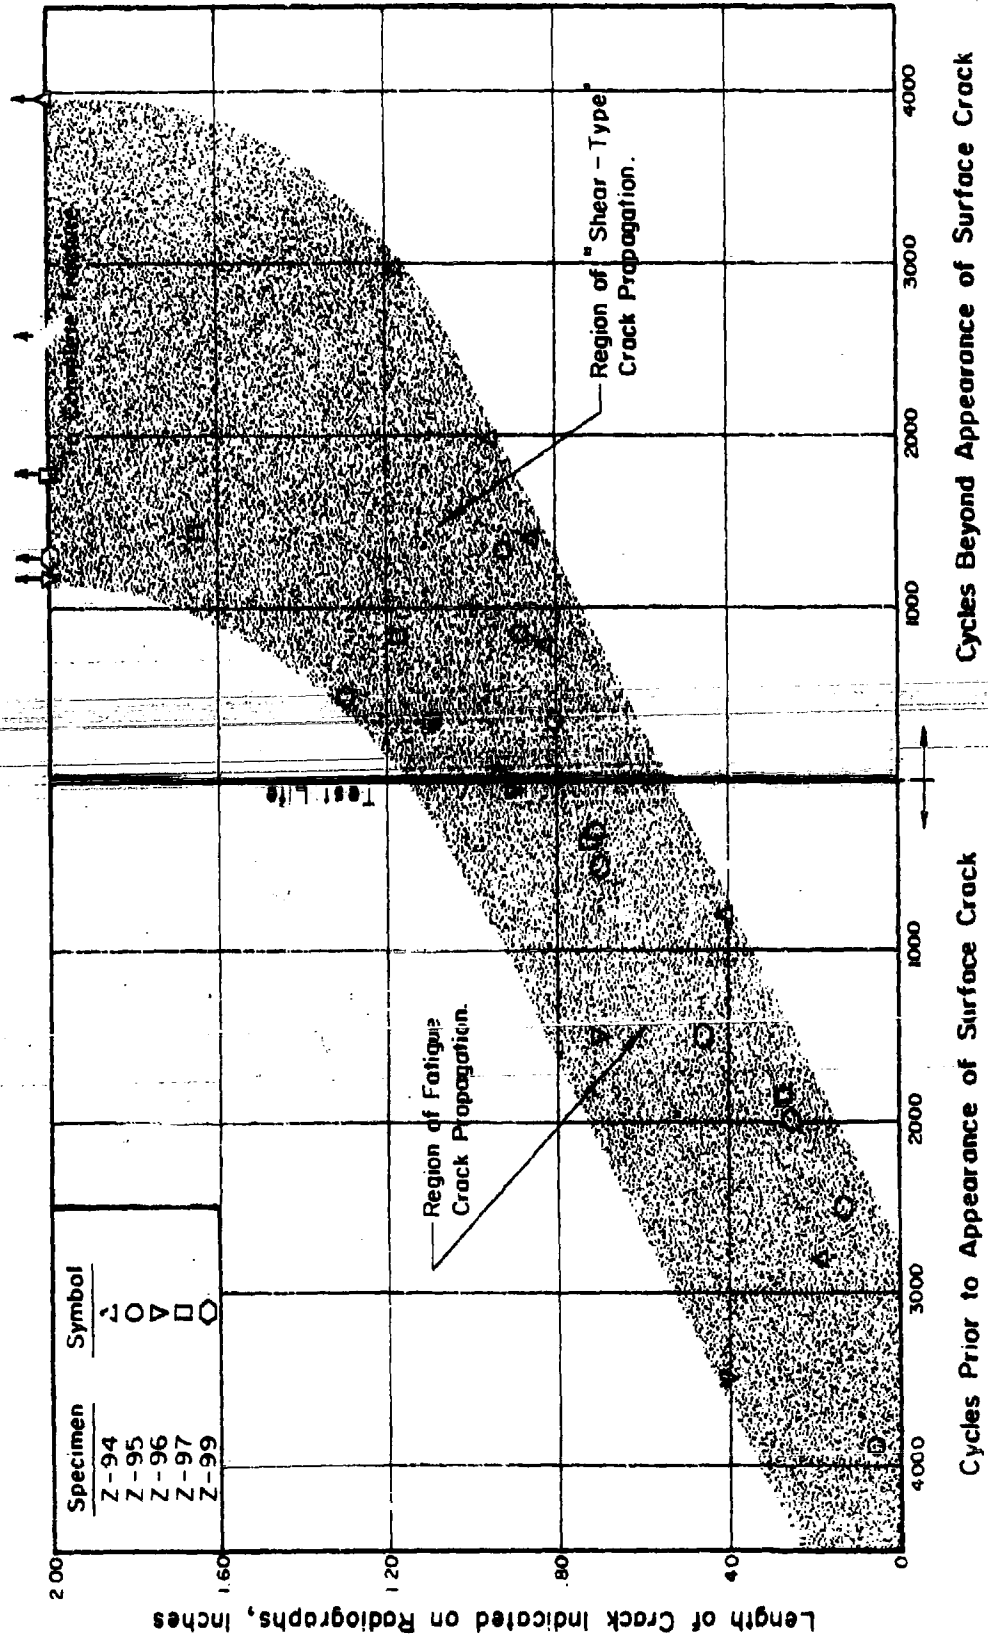
FIG. 5.6 RATE OF CRACK PROPAGATION IN 3/4 IN. HY-80 TRANSVERSE BUTT WELDED SPECIMENS TESTED AT ± 50.0 KSI.

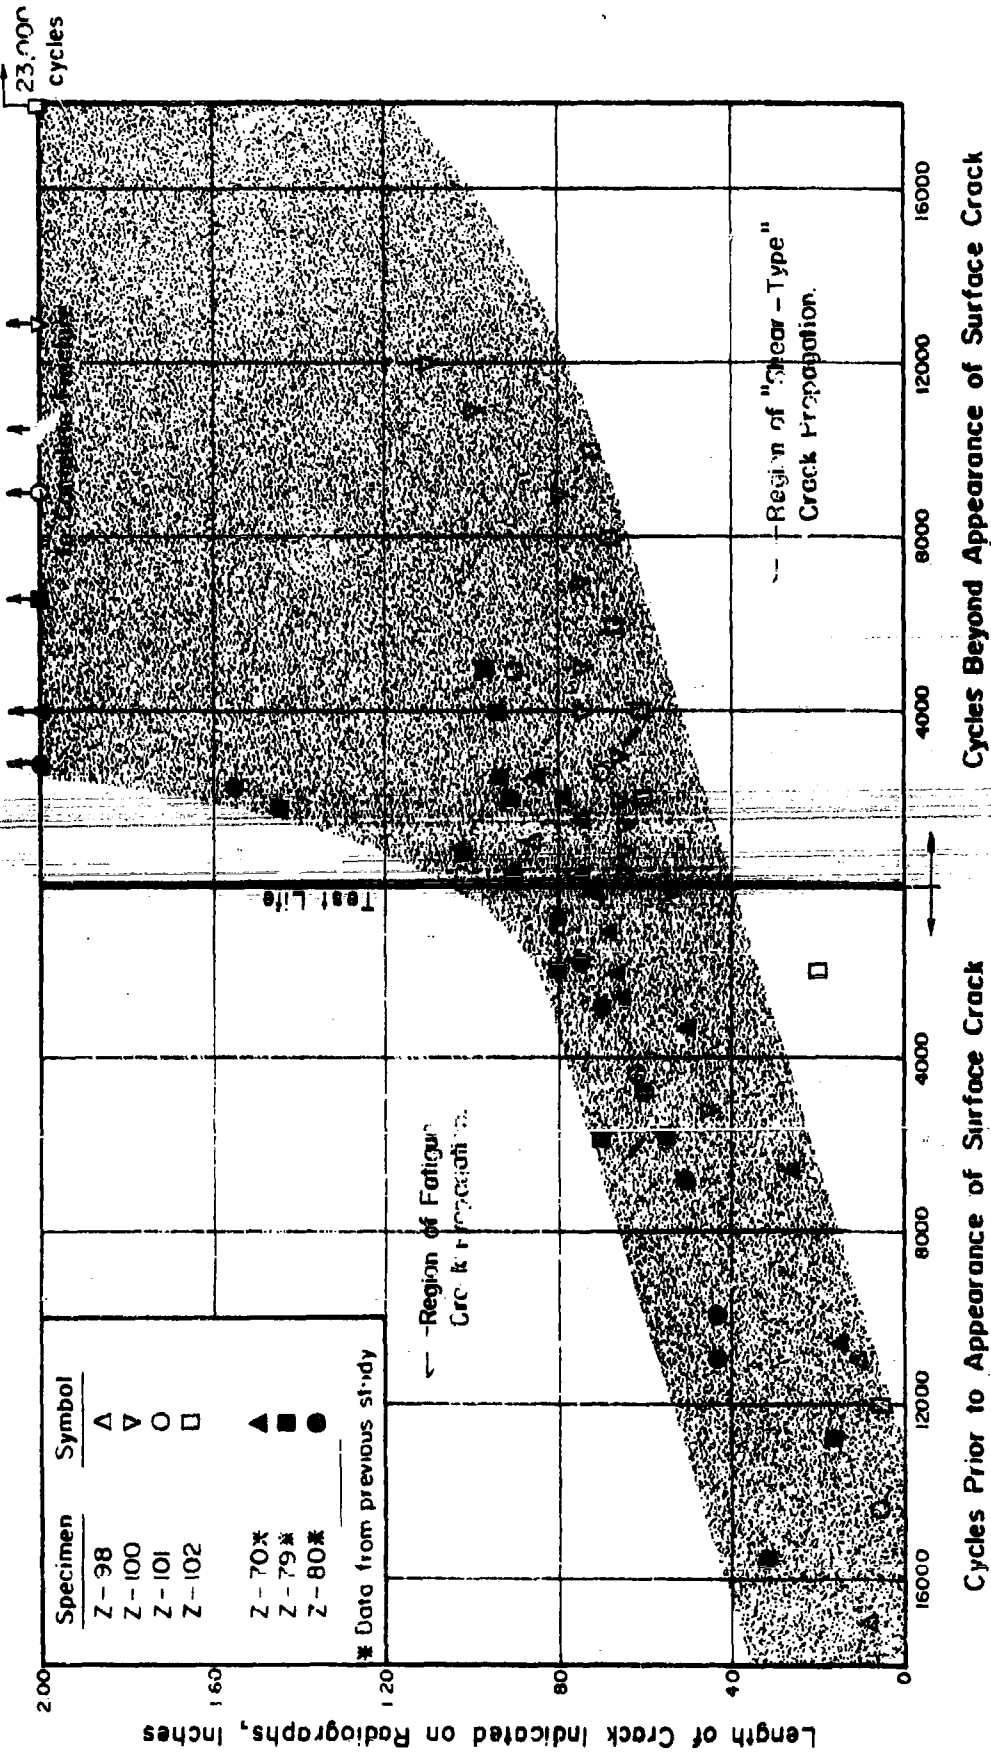
FIG. 5.7 RATE OF CRACK PROPAGATION IN 3/4 IN. HY-80 TRANSVERSE BUTT WELDED SPECIMENS TESTED AT 0 TO + 50.0 KSI.

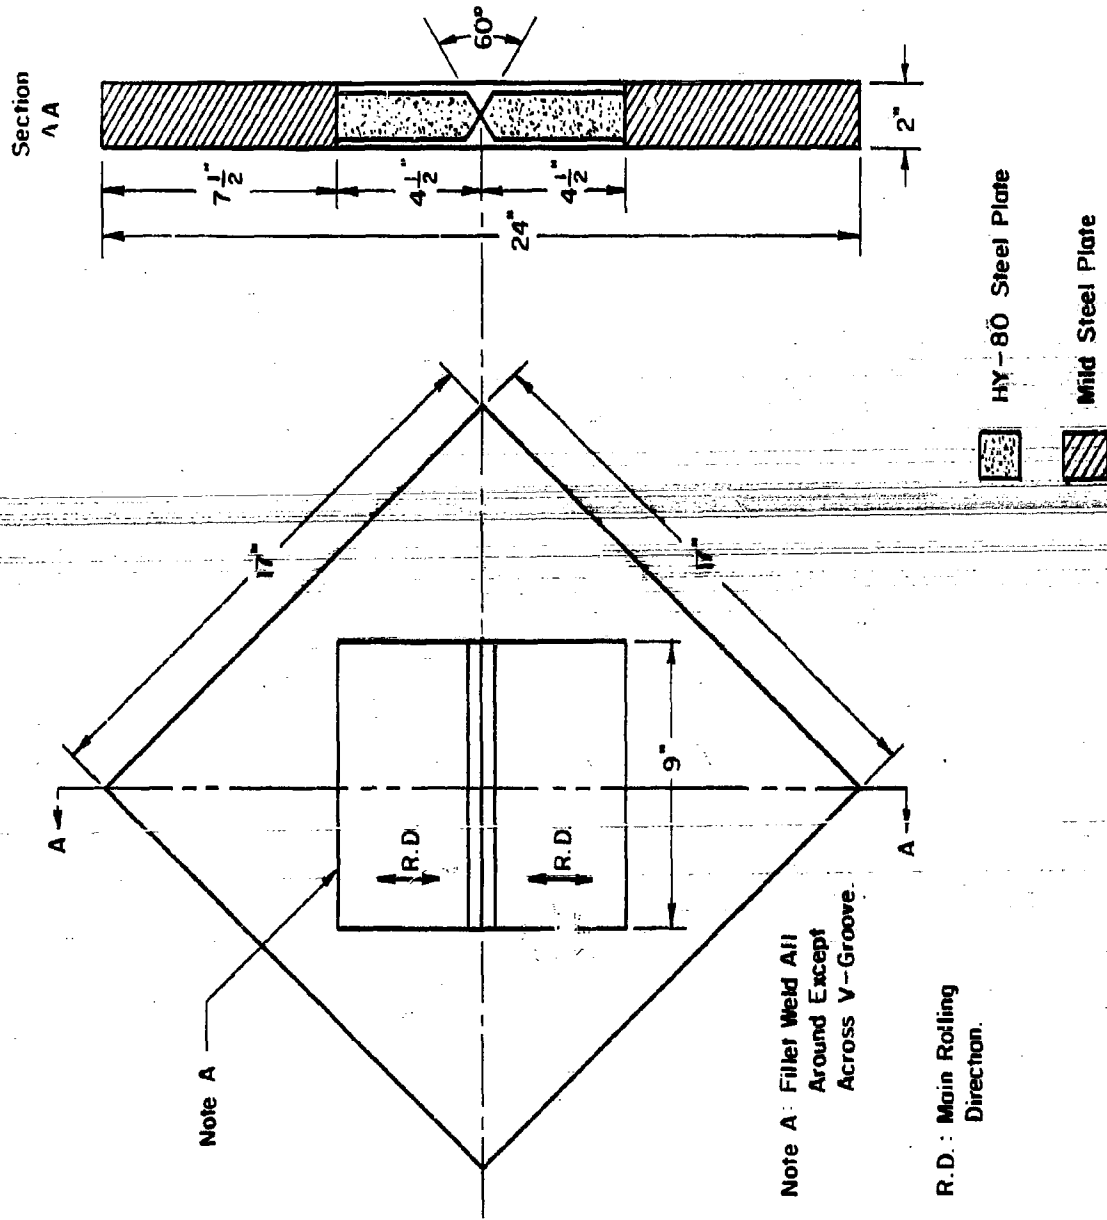
FIG. 6.1 WELDING JIG USED TO RESTRAIN HY-80 STEEL DURING BUTT WELDING.

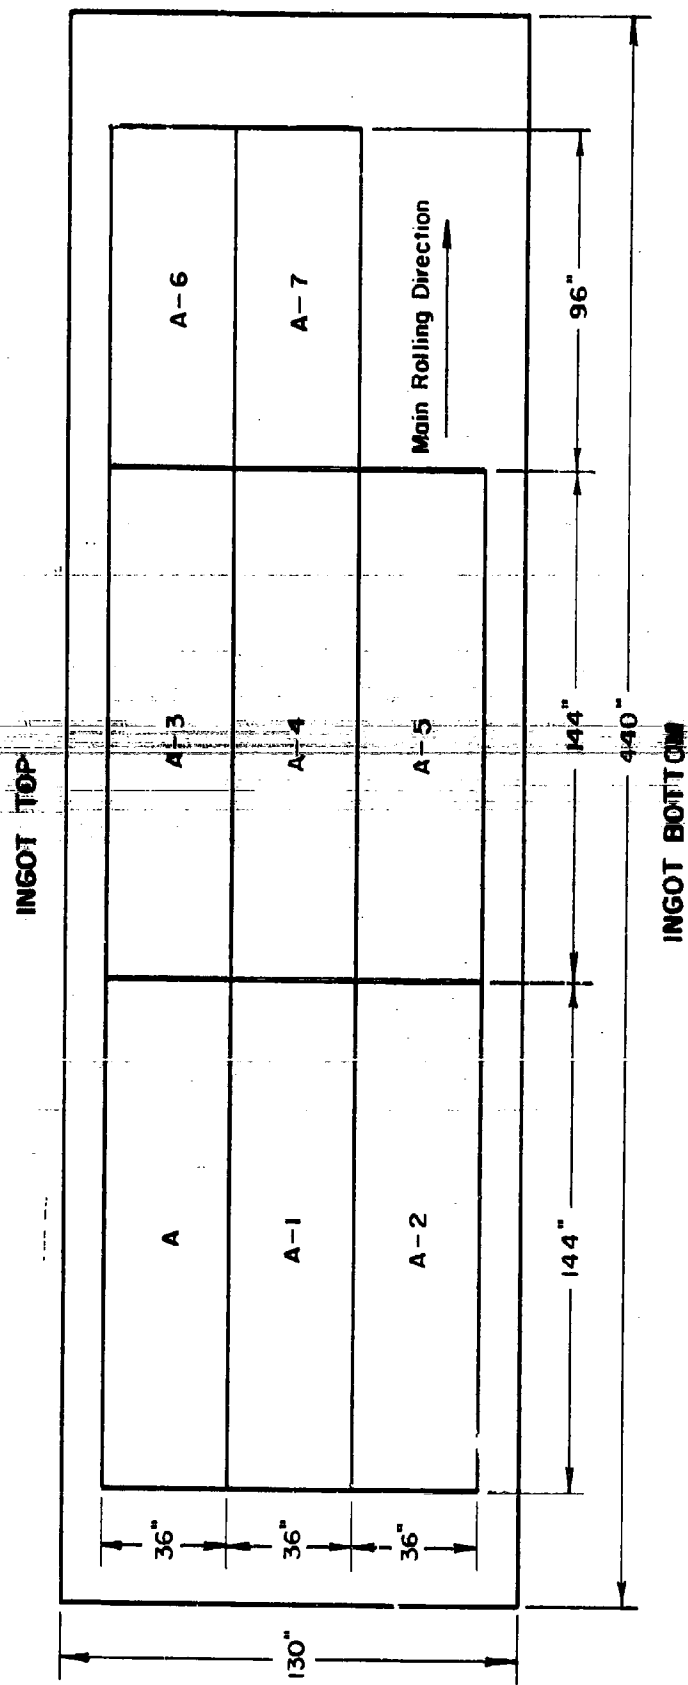
FIG. 6.2 MAIN PLATE OF HY-80 STEEL FROM WHICH TEST PLATES G-67, G-68, AND G-69 WERE OBTAINED.

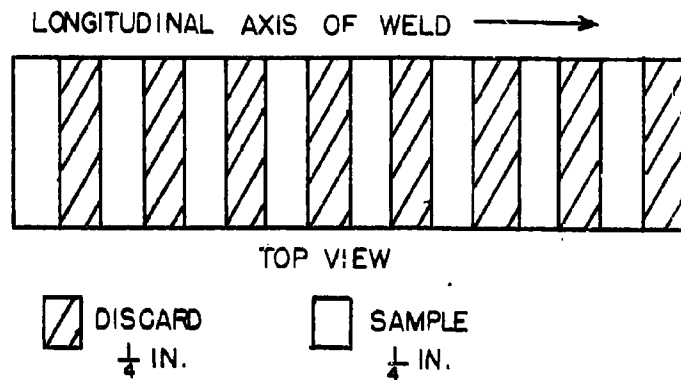
**FIG 6.3 SECTIONING PLAN FOR METALLOGRAPHIC
SAMPLES OF BUTT WELDED HY-80 STEEL.**

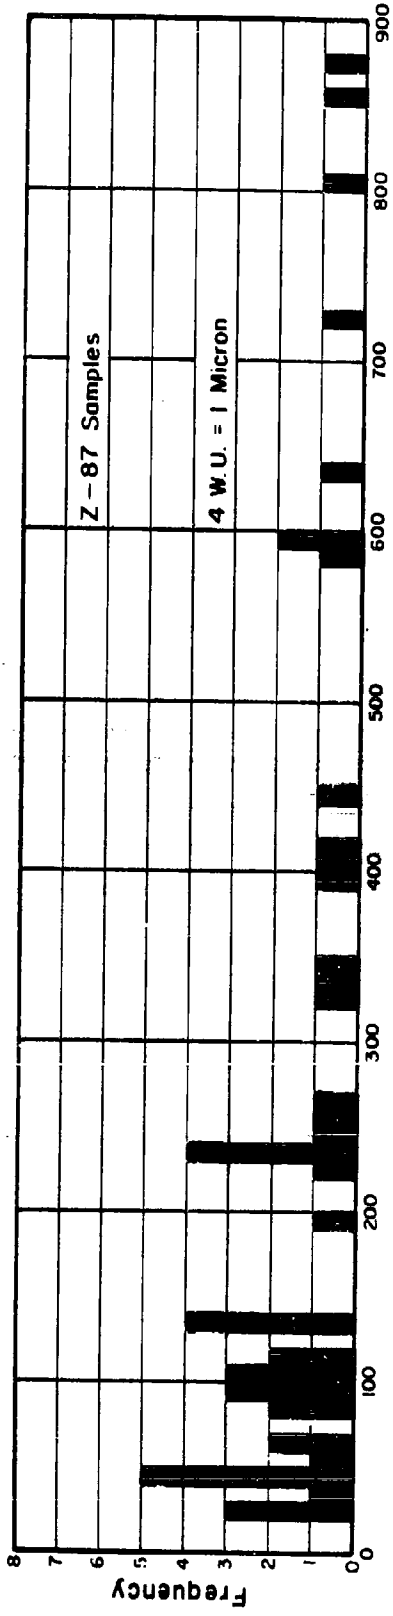
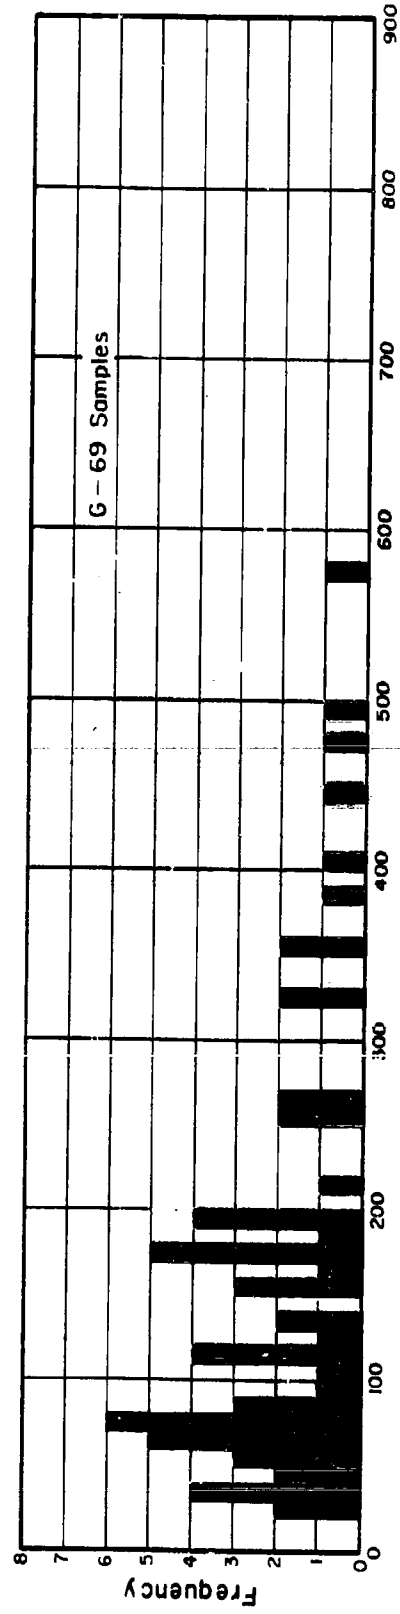
FIG. 6.5 HISTOGRAM OF THE WIDTH OF INCLUSIONS IN THE Z-87 AND G-69 SAMPLES OF HY-80 STEEL.

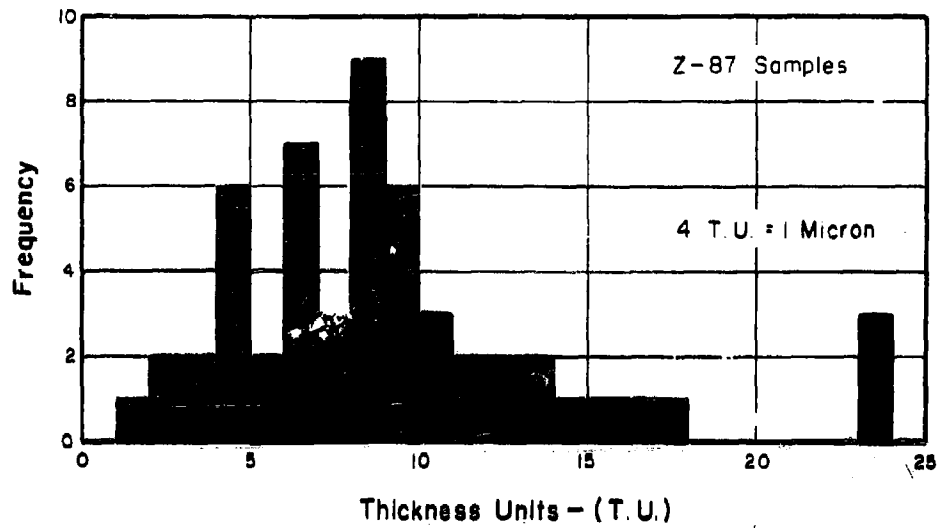
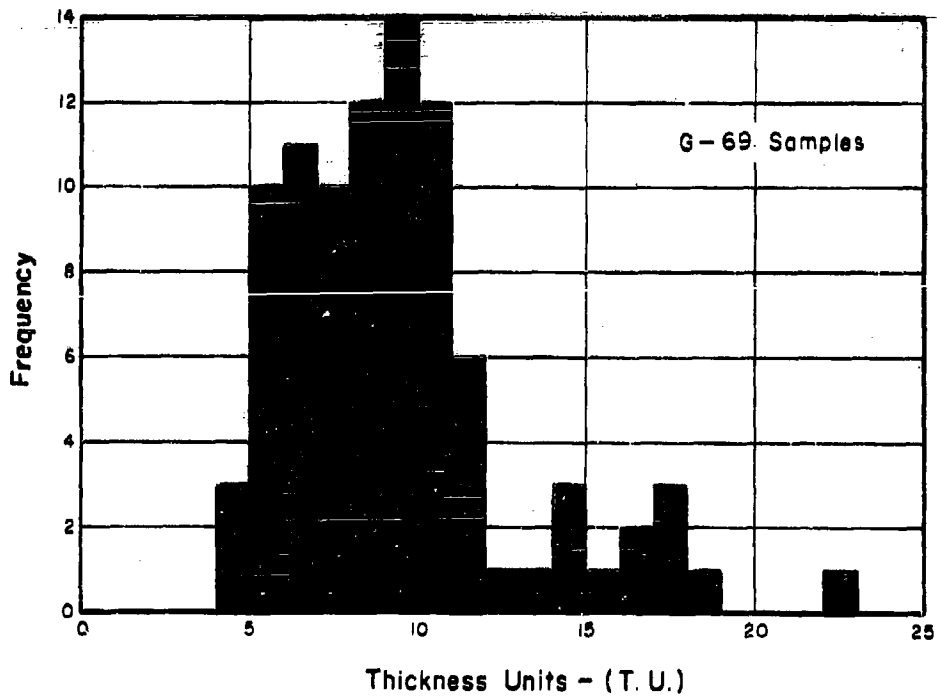
FIG. 6.6 HISTOGRAM OF THE THICKNESS OF INCLUSIONS IN THE Z-87 AND G-69 SAMPLES OF HY-80 STEEL.

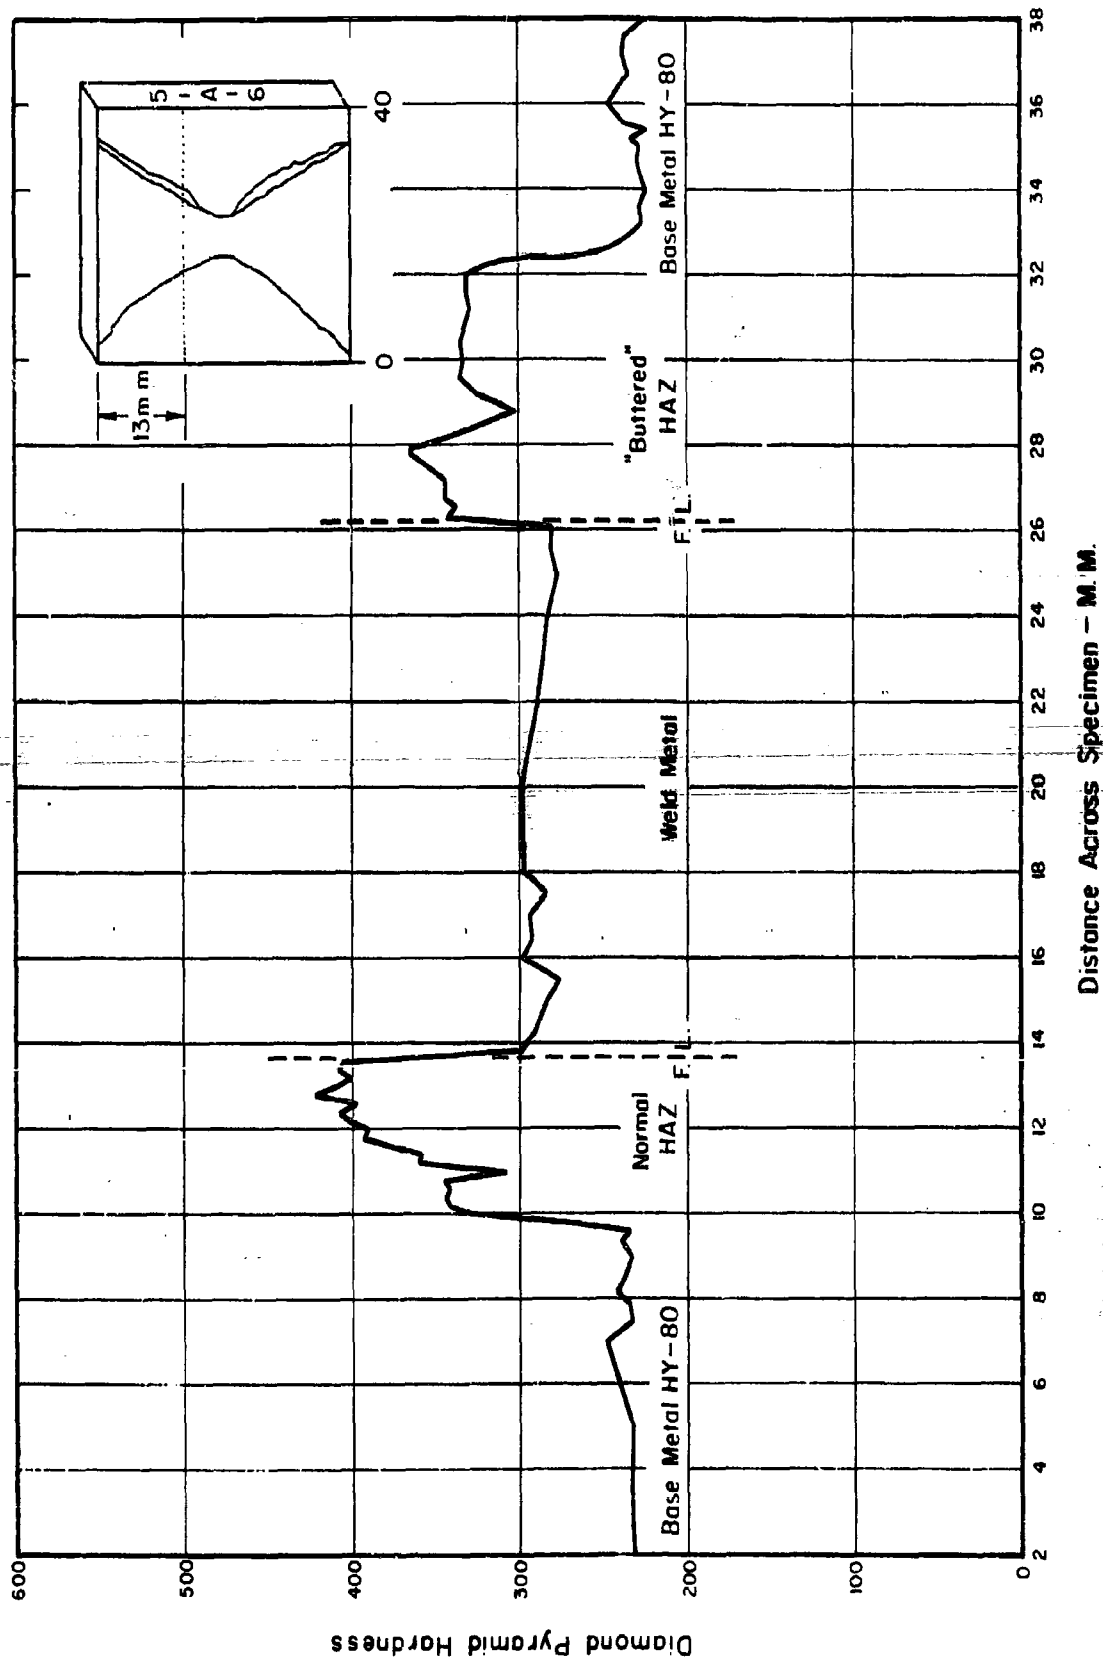
FIG. 6.12 MICRO HARDNESS SURVEY OF 1-1/2 IN. THICK HY-80 STEEL BUTT WELD.

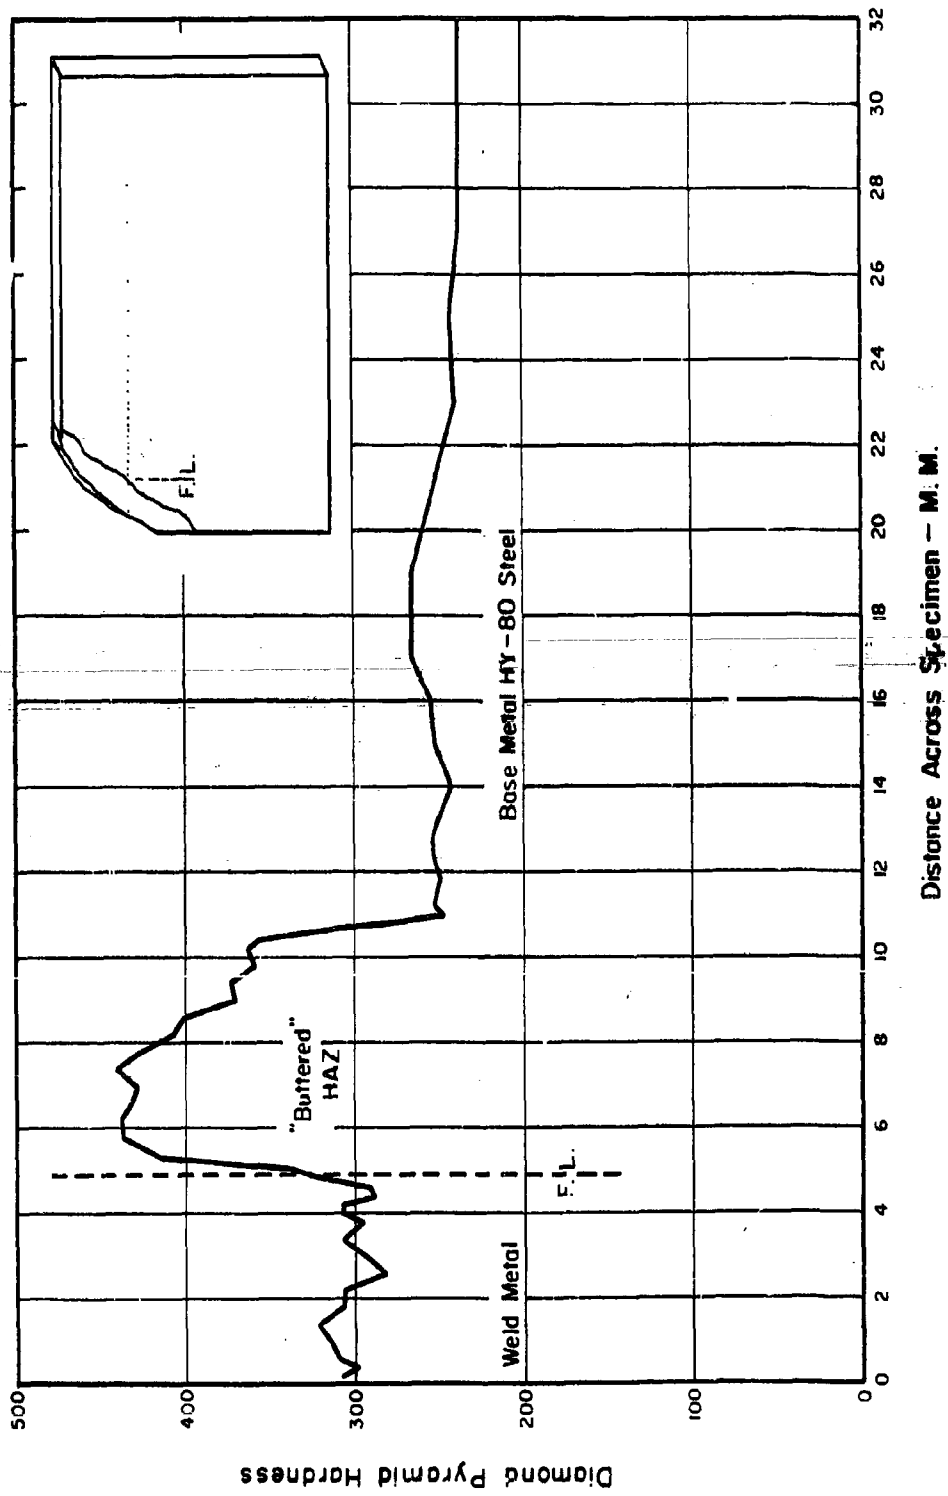
FIG. 6.13 MICRO HARDNESS SURVEY OF THE WELD METAL AND HAZ OF "BUTTERED" HY-80 STEEL SCARF.

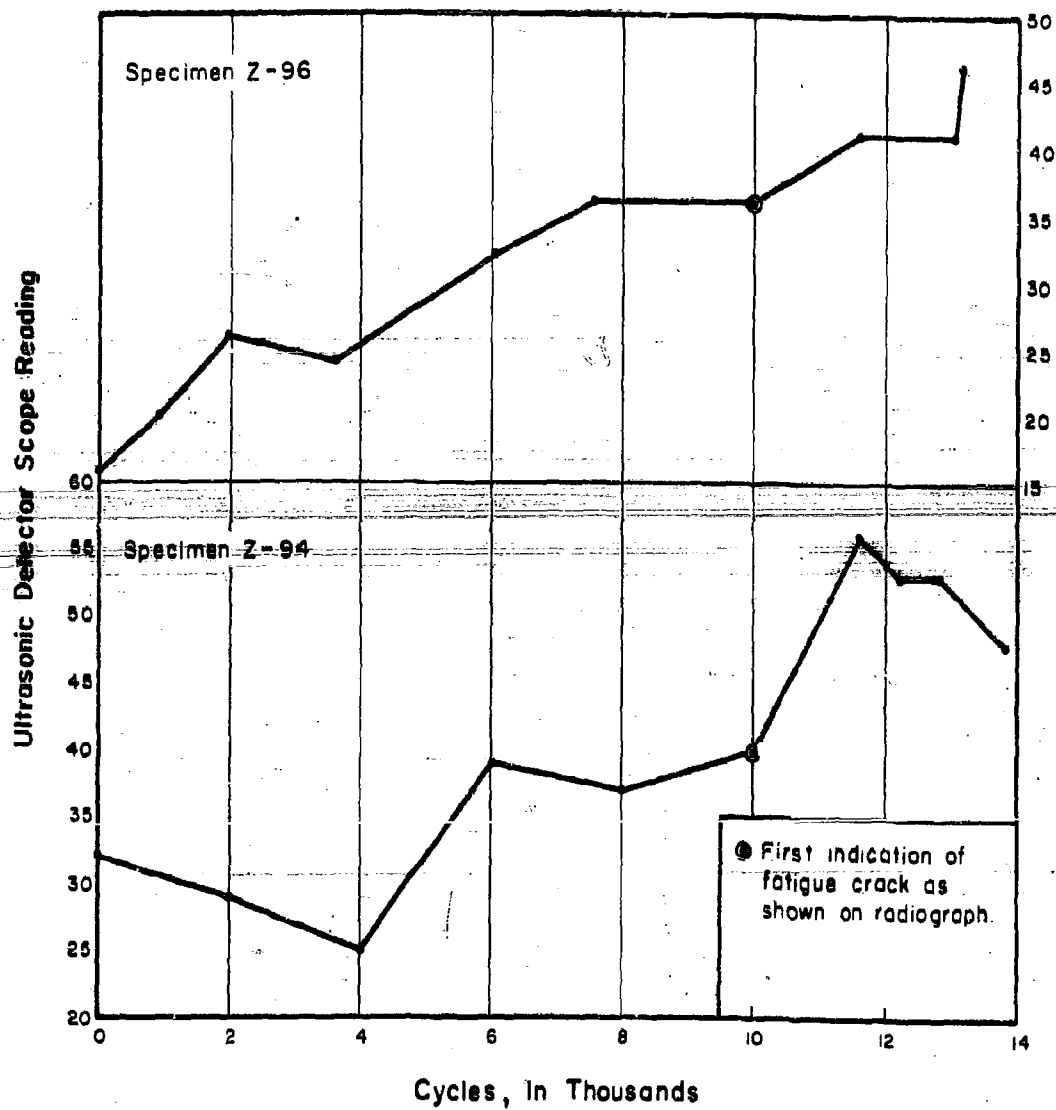
FIG. A.1 RESULTS OF ULTRASONIC CRACK DETECTION STUDY FOR SPECIMENS TESTED AT ± 50.0 KSI.

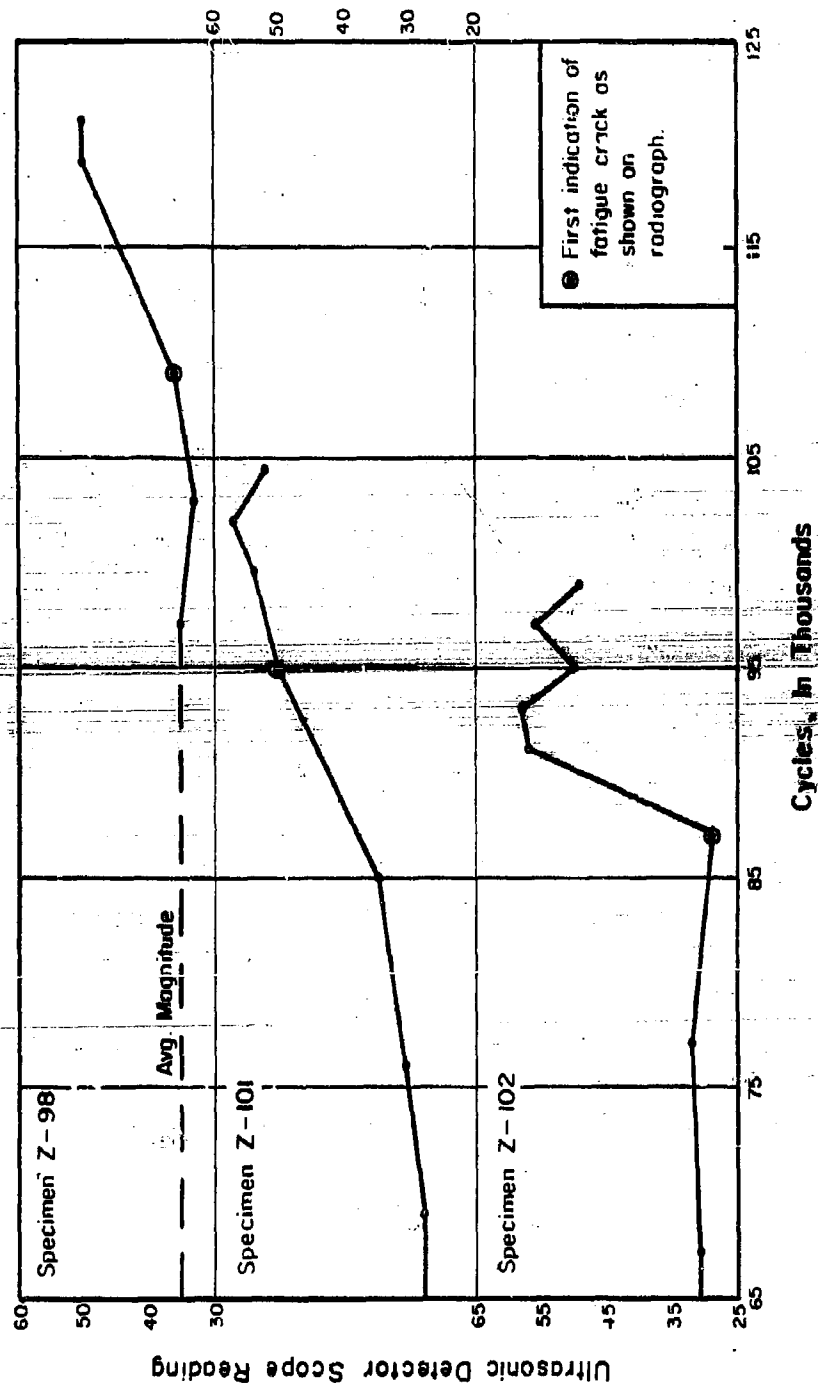
FIG. A.2 RESULTS OF ULTRASONIC CRACK DETECTION STUDY FOR SPECIMENS TESTED AT 0 TO + 50.0 KSI.
