ELASTOMERS FOR FUEL SYSTEMS CONTAINING  
MICROORGANISM-CONTROLLING ADDITIVES

TECHNICAL DOCUMENTARY REPORT NO. RTD-TDR-63-4195, Part II  
January 1965

Air Force Materials Laboratory  
Air Research and Technology Division  
Air Force Systems Command  
Wright-Patterson Air Force Base, Ohio

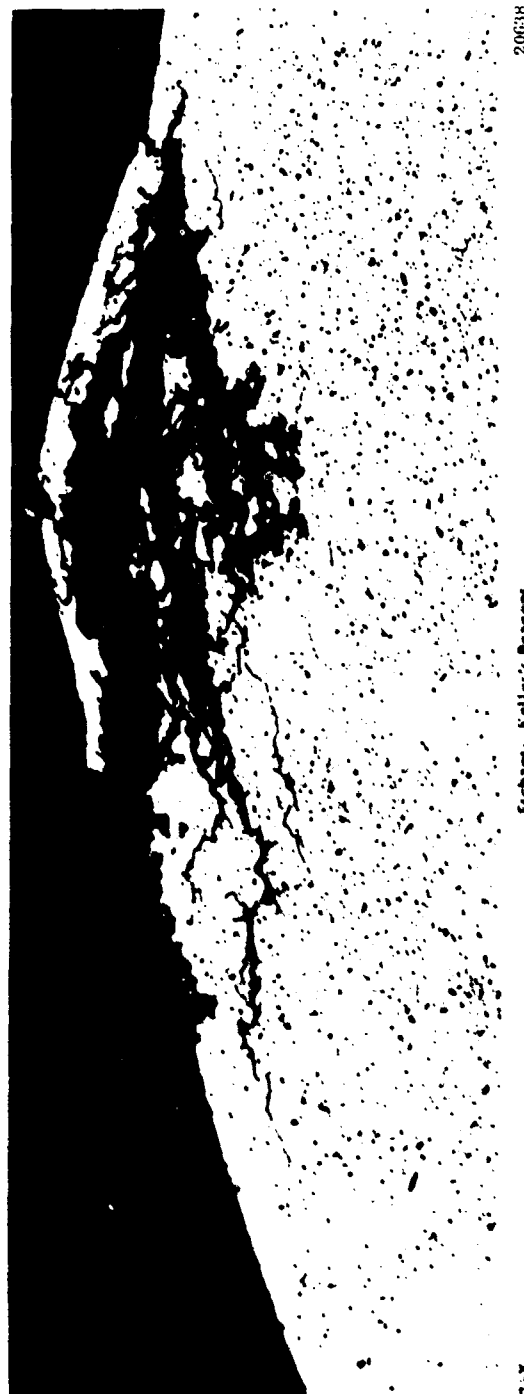
FIGURE 36. CROSS SECTION THROUGH BLISTERS FOUND ON ANODIZED 7075-T6 ALUMINUM ROD SPECIMEN EXPOSED 42 DAYS IN SUMP WATER FROM BERGSTROM AFB, TEXAS

Note intergranular attack.

Etchant: Keller's Reagent
