LIGHTNING PROTECTION OF BURIED CABLE BY SEMI-CONDUCTING JACKETS

H. D. CAMPBELL

FOURTEENTH ANNUAL SYMPOSIUM
ON
TECHNICAL PROGRESS IN COMMUNICATIONS WIRES AND CABLES

Northern Electric Co. Ltd., Montreal

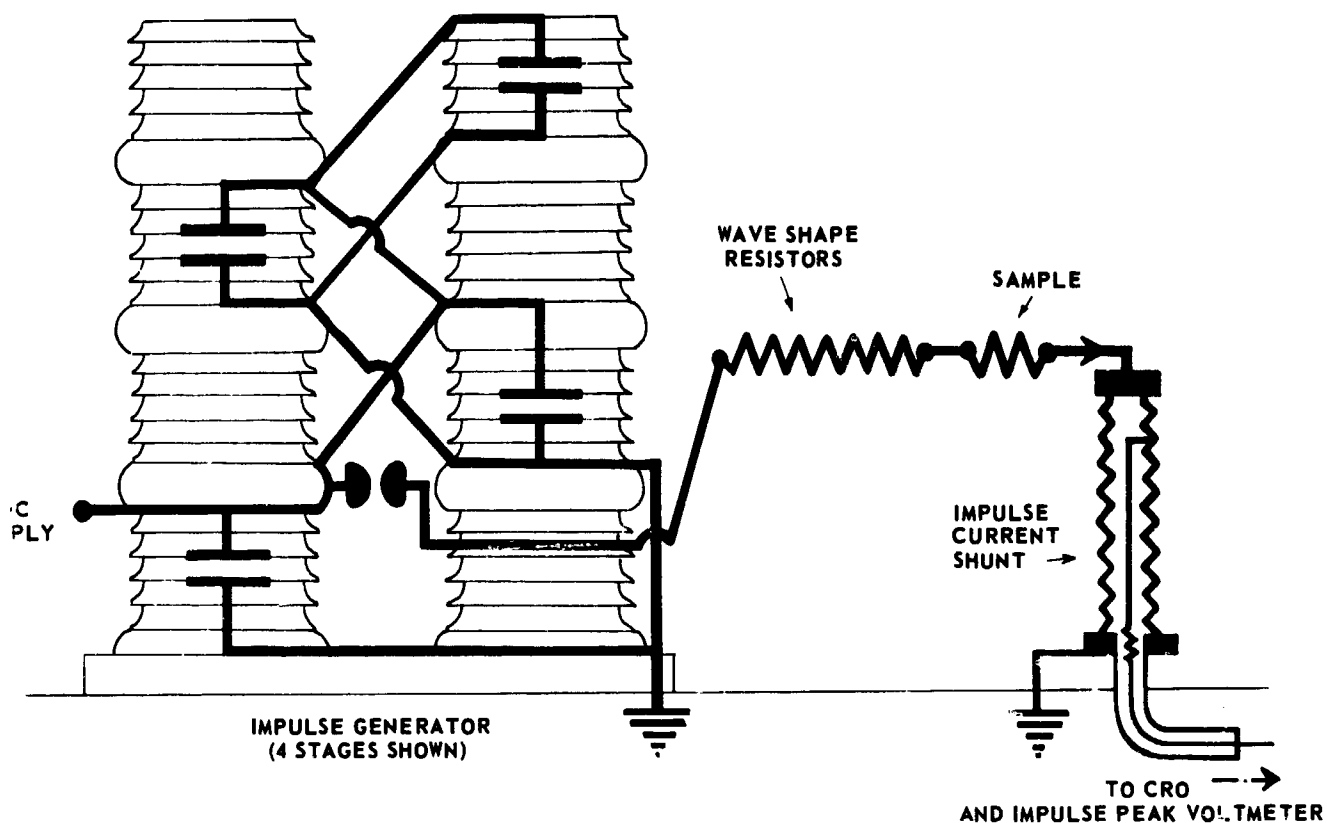
FIG. I. SCHEMATIC OF TEST CIRCUIT

Since our laboratory does not include an impulse current generator, the existing high voltage impulse generator circuit was modified and used as an impulse current generator. In this configuration all capacitors are arranged to fire in parallel. This method causes some distortion of the wave tail when a plurality of stages are used because of the different impedance of each parallel stage. A maximum of four stages were used to keep the distortion to reasonable limits. In this configuration the maximum stored energy was 40 kilowatt-seconds, the peak current about 15 kilo-amperes, and the waveshape 2.0/22 microseconds, i.e. the time to crest value was 2.0 microseconds and the time to half value 22 microseconds.

The impulse current was measured by a conventional tubular surge current shunt. The voltage developed across the shunt was fed by voltage terminals and leads inside the tube through a coaxial cable to a cathode ray oscillograph and an impulse peak voltmeter. Since the resistance of the test samples formed only a very small fraction of the total resistance of the impulse current circuit, the waveshape remained virtually constant for all samples. The waveshape was changed, when required, by varying the number of stages. The peak current of each impulse was monitored by the impulse peak voltmeter but only periodic use of the cathode ray oscillograph was required. A schematic view of the test circuit is shown in Fig. 1.

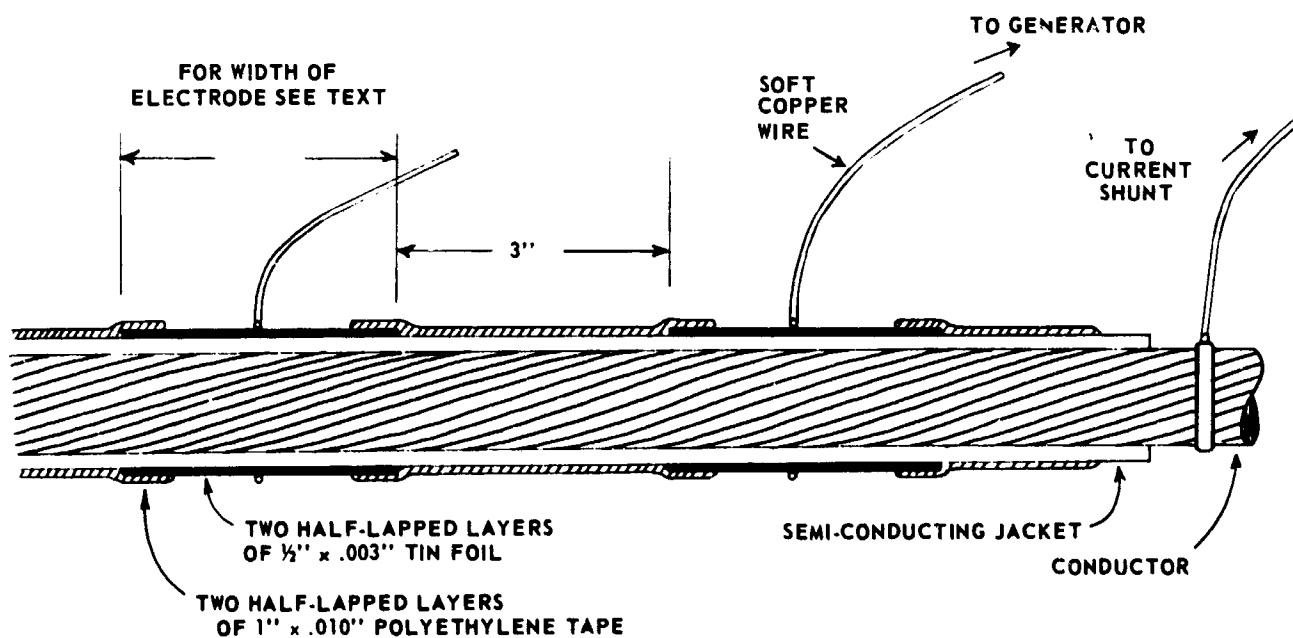
FIG. II. ARRANGEMENT OF ELECTRODES

Samples about five feet long were cut from the cable and electrodes placed as shown in Fig. II. The lengths of the electrodes were kept as long as possible to keep edge errors small, and in most cases three-inch electrodes were used. Some two- and four-inch electrodes were also used.

Initial work on cable jacket samples gave unmistakable evidence that edge effects were also causing large errors. Spark discharges were observed from the ends of the electrodes and large changes in electrode area did not cause proportional changes in the rupture strength. In fact, in one case it was impossible to rupture the material even when the electrode length was successively reduced from two inches to less than 0.1 inch. When insulating tape was applied to suppress the spark discharge as shown in Fig. II, rupture was readily obtained on a four-inch electrode. Further tests with guarded electrodes and with different sizes of electrodes showed that the electrode arrangement in Fig. II produced quite small edge errors, and increased the effective length of the electrode by not more than 0.2 inches.

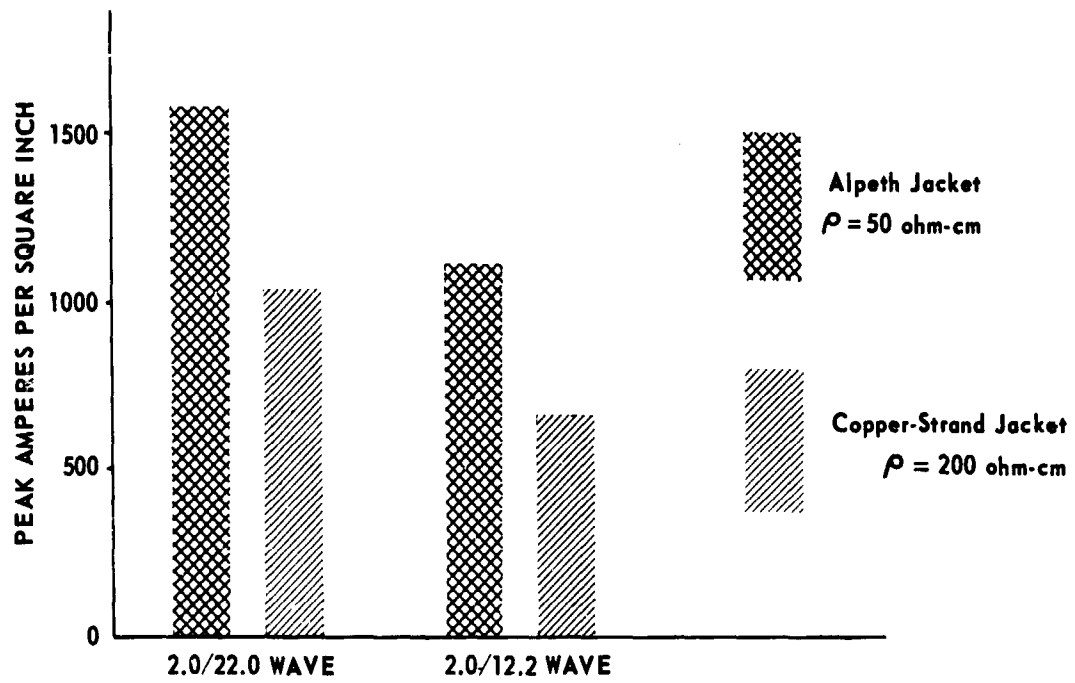
FIG. III. RUPTURE STRENGTHS OF SEMI-CONDUCTING JACKETS

Page 15, FIG. III

2.0/22.0 WAVE *should read* 2.0/12.2 WAVE

2.0/12.2 WAVE *should read* 2.0/22.0 WAVE

Rupture strength measurements were made both on the Alpeth jacket and the copper-strand jacket. It was found that the rupture strength of the Alpeth jacket was substantially higher than that of the copper-strand jacket. This increase in strength is to be expected from the lower resistivity values of the Alpeth jacket. Comparison of the Alpeth jacket and the copper-strand jacket is shown in Fig. III.

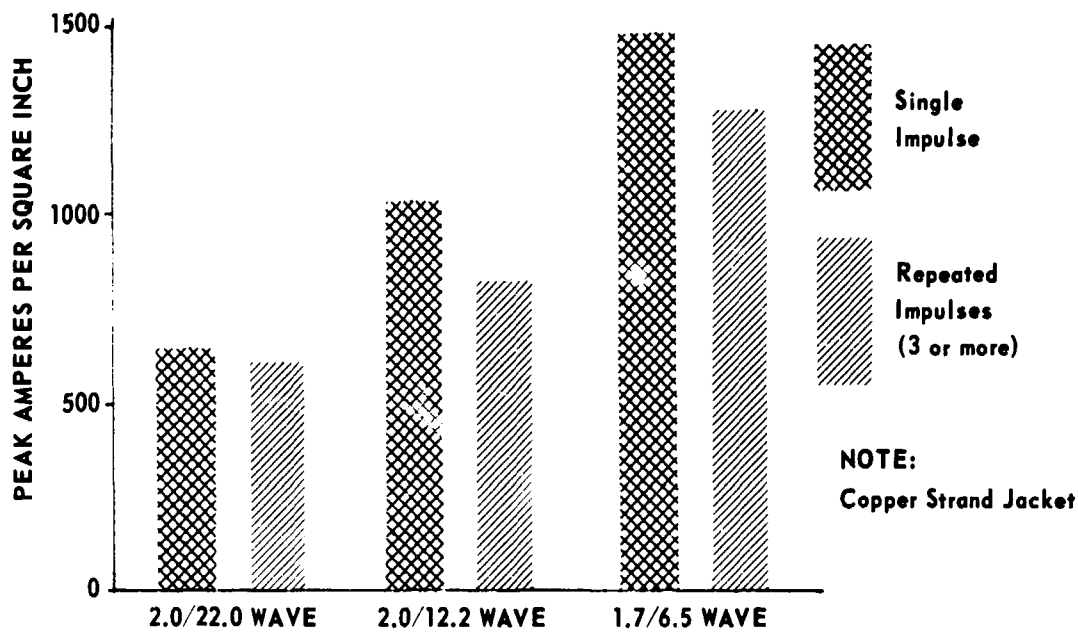
FIG. V. EFFECT OF REPEATED IMPULSES ON RUPTURE STRENGTH

The general effect of waveshape is shown in Fig. V but a more accurate comparison was made between the 2.0/12.2 microsecond wave and the 2.0/22.0 wave for which average values were obtained from about 50 specimens. The energy function under each wave was measured and compared. Due to some distortion the decay time to half value could not be accurately measured in the usual manner. The equivalent energy function and waveshape were measured by plotting the i^2t curve and measuring the area under the curve. The energy functions for the two waveshapes, measured in this manner, are shown in Fig. VI. It can be seen that the energy required for rupture is virtually equal for both.

Initial work showed that repeated impulses greatly reduced the required rupture current. Trials were conducted with impulses at 30-second and at 90-second intervals. Although the temperature rise of the samples appeared to be small in both cases, there was a small but definite change in results. Further experiments with a 15-minute interval between impulses resulted in far higher rupture values. Values of the one-shot rupture (i.e., rupture strength) are compared in Fig. V to rupture values obtained with at least three repeated impulses (i.e., impulse current strength). These results show that the repeated impulses cause a fairly small reduction of the required rupture current.

Repeated impulses - The reduction of rupture strength varied from about 5 to 20 percent (Fig. V). It will be assumed that the repeated impulses cause a reduction of 20 percent, that is, the impulse current strength is 20 percent less than the rupture strength.

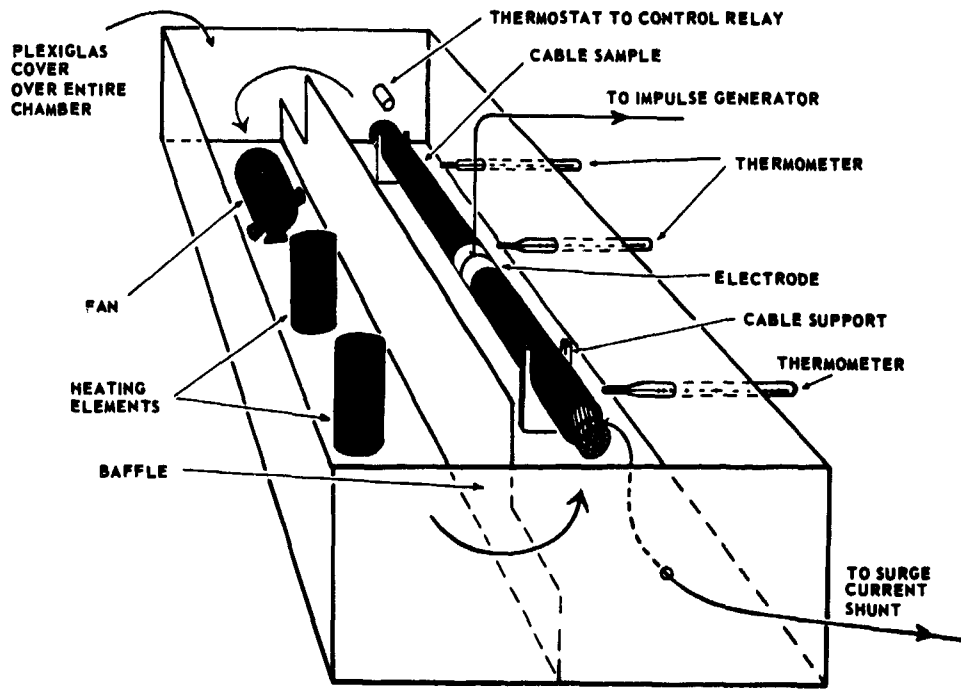
FIG. VII. HEATING CHAMBER

The rapid increase of resistivity with increase in temperature indicated that the impulse current strength would also be dependent upon the temperature. Tests were carried out in a heating chamber as shown in Fig. VII. One test was made below ambient temperature. The samples were subjected to the test temperature for at least one hour before the tests were begun. Rupture strength versus temperature is plotted in Fig. VIII. The curve of rupture current versus temperature is a straight line and indicates that at about 80°C the rupture current would be negligible compared to that at room temperature.

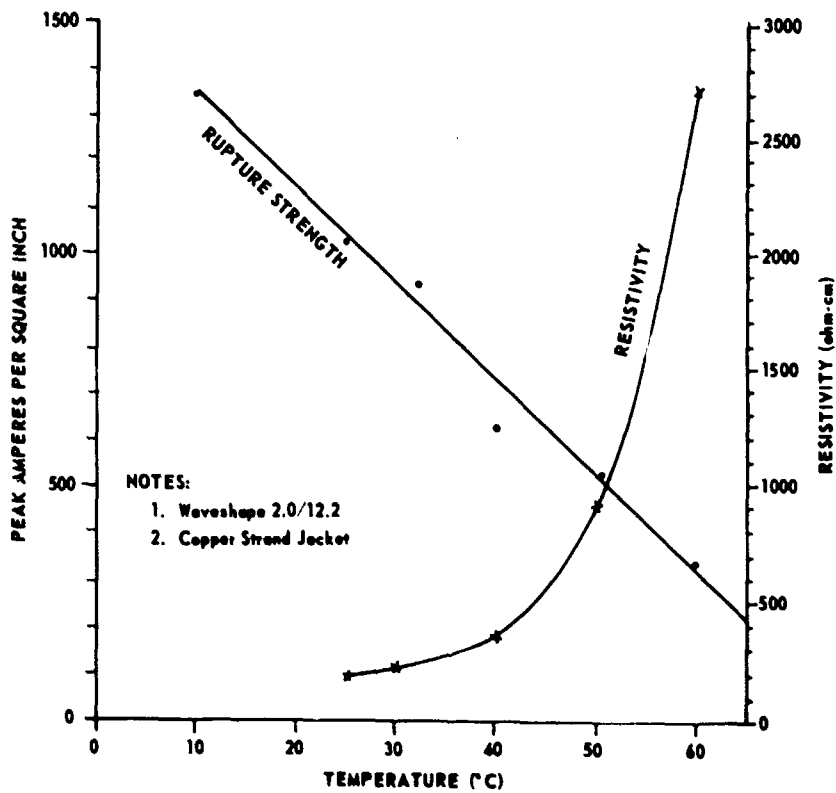
FIG. VIII. EFFECT OF TEMPERATURE ON RUPTURE STRENGTH AND RESISTIVITY

Based on the above assumptions an impulse current strength can be established for field conditions and a given waveshape. From Fig. VIII the rupture strength at 30°C is 950 amp/in² for a 2.0/12.2 wave. This value must be reduced for repetitive surges (i.e., impulse current strength) and is 0.8 x 950 = 760 amp/in². If the correction factors for the other assumed conditions are applied, the practical value for service conditions reduces to 0.67 x 0.9 x 760 = 460 amp/in².

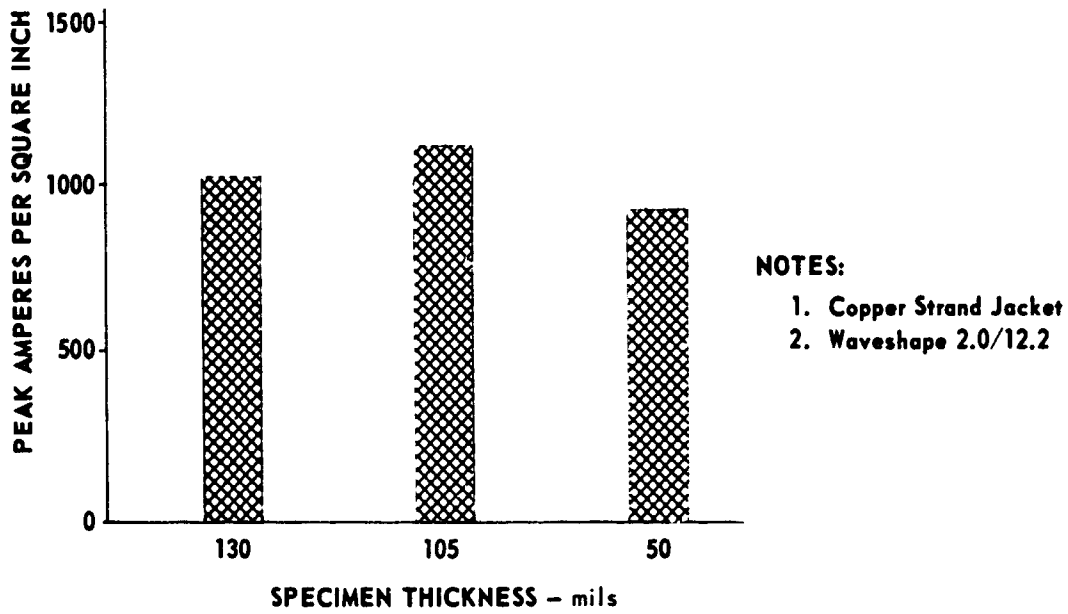
FIG. IX. EFFECT OF THICKNESS ON RUPTURE STRENGTH

Tests were made on three different thicknesses of jacket. The samples were removed from the cable and placed on a mandrel. Two sets of samples were turned down on a lathe to a thickness of 105 mils and 50 mils. The third set was not reduced in thickness but was tested on the mandrel to ensure uniform conditions for the three sets of tests. The results are shown in Fig. IX. The value obtained for the 50-mil thickness is slightly less than values obtained for full thickness in this and other tests. This reduction is believed to be due to the non-uniform current flow in the thin samples in which the strand wire convolutions are an appreciable fraction of the total thickness. It can be said that rupture strength is independent of thickness and this result is to be expected if the rupture strength is a function of energy.

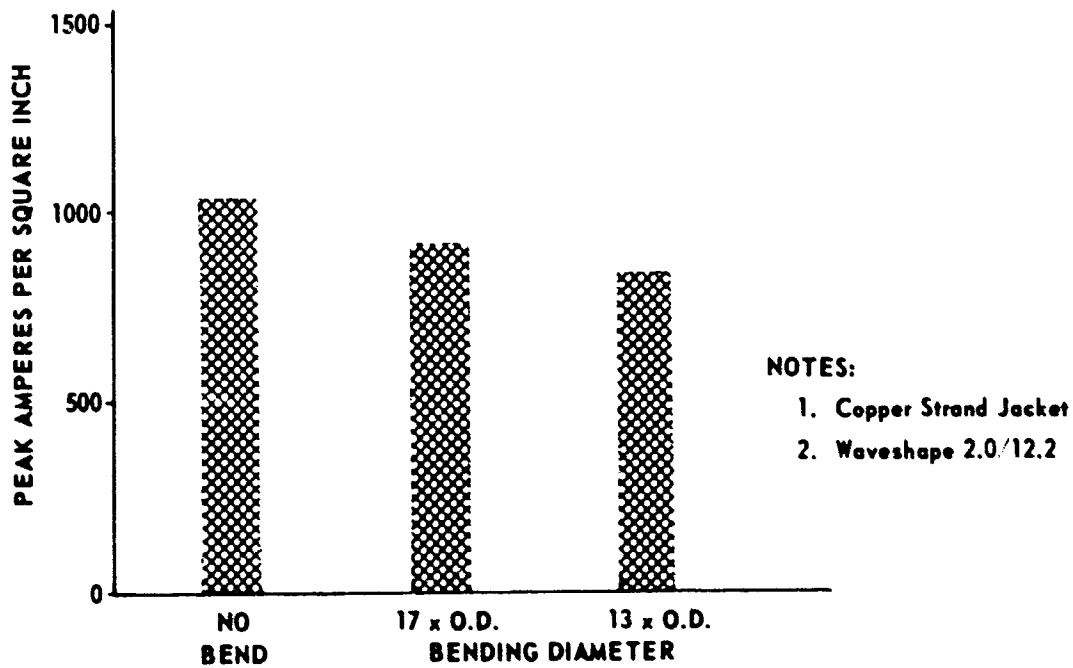
FIG. X. EFFECT OF BENDING ON RUPTURE STRENGTH

Published data³ has shown how resistivity increases when semi-conducting material is subjected to a tensile force and elongated. It follows that the impulse current strength of the jacket is likely to be reduced when the cable is in a bent position. Tests were conducted with two different size mandrels on which the cable was subjected to four 180-degree reverse bends and held in the bent condition during the tests. The results are shown in Fig. X and indicate a small reduction in impulse current strength can be expected at bends encountered in service. The reduction in strength may be less on a telephone cable in which the core is softer than the copper strand of the sample used in the tests.

Bending - Fig. X indicates a reduction of rupture strength of about 20 percent for a rather severe bend. This reduction is likely to be less on telephone cable than on the compact core investigated and bends of this severity in service will be few. A reduction of 10 percent will be assumed.

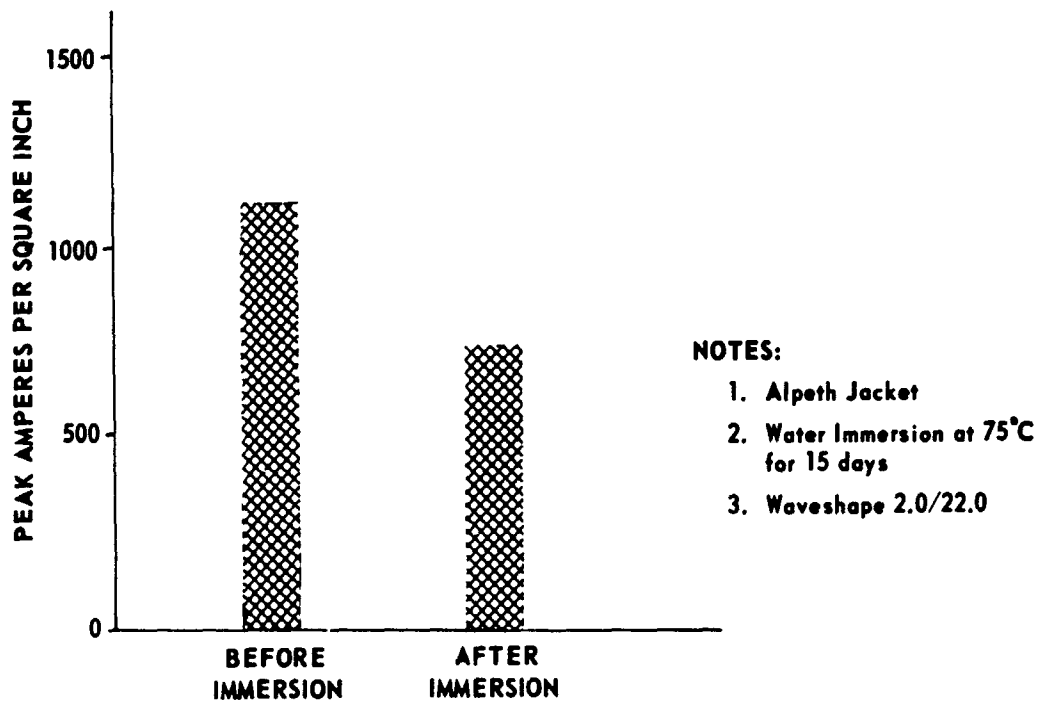
FIG. XI. EFFECT OF WATER IMMERSION ON RUPTURE STRENGTH

Page 19, FIG. XI

2. Water Immersion at 75°C for 15 days

2. Water Immersion at 75°C for 15 weeks

The effect on rupture strength is shown in Fig. XI. The substantial decrease is expected from the resistivity measurement. It is believed that the decrease in rupture strength was the effect of water absorption rather than aging, and that no significant change would occur with continued immersion.

Water Immersion - A decrease of about one-third in the rupture strength was found after water immersion (Fig. XI) and this factor will be assumed to be representative.

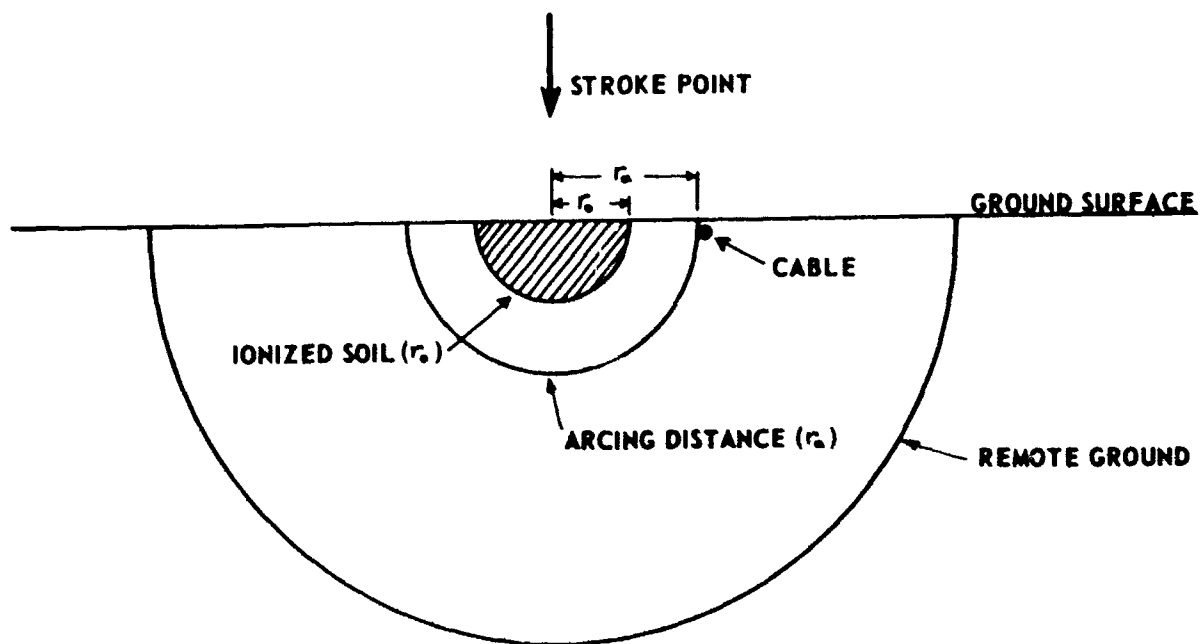
FIG. XII. EFFECT OF LIGHTNING STROKE ENTERING THE GROUND

When a lightning stroke enters the ground, the current spreads and, if there is a cable near the stroke point, the stroke may arc to the cable. Even if no arcing occurs, much of the current may still flow to the cable sheath because of its low impedance to remote ground. If no cable is in the vicinity of the stroke point and the resistivity of the soil is uniform, the current will flow radially in a hemisphere as represented in Fig. XII.

When a cable is present just beyond the arcing radius the symmetry of Fig. XII will be disturbed. A rigorous solution of the division of current between remote earth and the cable is beyond the scope of this paper; a satisfactory approximation, however, can be made by using certain simplifying assumptions. First, the potential of the cable will be considered to be the same as remote ground. Secondly, although a greater portion of current will flow in the direction of the cable with attendant greater soil ionization on the cable side of the stroke point, the conducting sphere cannot be expected to be appreciably distorted because current will flow from a large part of the surface area to an object "connected to it" by a path having relatively high resistance compared to that to remote ground. The resistance between the conducting sphere and the cable will be at a minimum opposite the stroke point. The stress in this area will be at a maximum. If the sphere, which is large compared to the cable, is considered to be "seen" by the cable opposite the stroke point as a plane surface, the stress at the cable can be estimated and the soil around the cable will be ionized for an approximate distance:
