C.W.R. REPORT NO. 300-38

The design, fabrication, and full-scale engine test program to establish the feasibility of increasing the turbine inlet temperature of jet engines, through the use of a transpiration air-cooled rotor stage, was successfully completed. Testing was performed on a modified J65 engine using a variable area exhaust nozzle to match the compressor to the turbine for the elevated temperature operation. The maximum condition tested was at an average turbine inlet temperature of 1845°F with an increase in cooling air flow over the standard uncooled (1640°F) configuration of approximately 2%. While this percentage was more than required by the cooled blade assembly, it was the minimum flow from a controllability standpoint. The test data clearly indicates this percentage of coolant would be sufficient for turbine inlet temperatures up to approximately 2100°F. While the program required investigation only between 1560°F and 1800°F turbine inlet temperature, 2 hours and 20 minutes of testing was conducted between 1800°F and 1845°F to demonstrate the structural durability of the design, to collect additional data relevant to blade metal temperatures, and to determine e

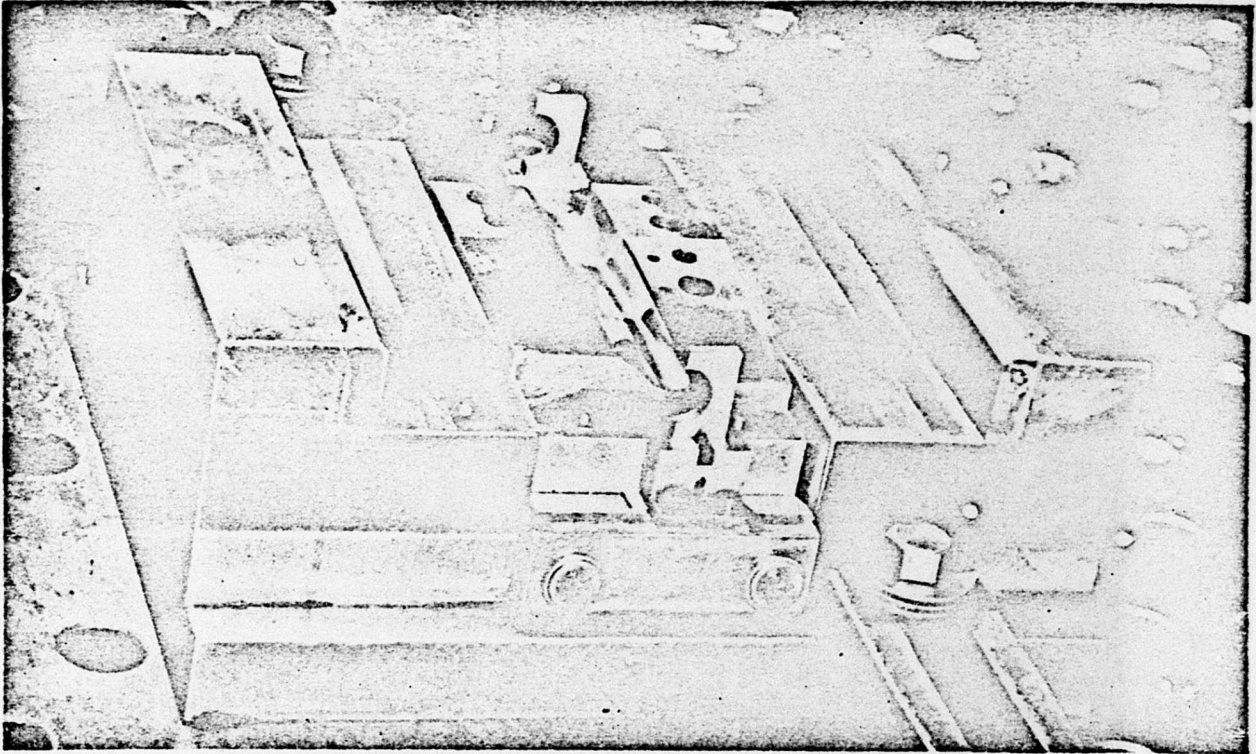
Figure 17

Lower Airfoil Die

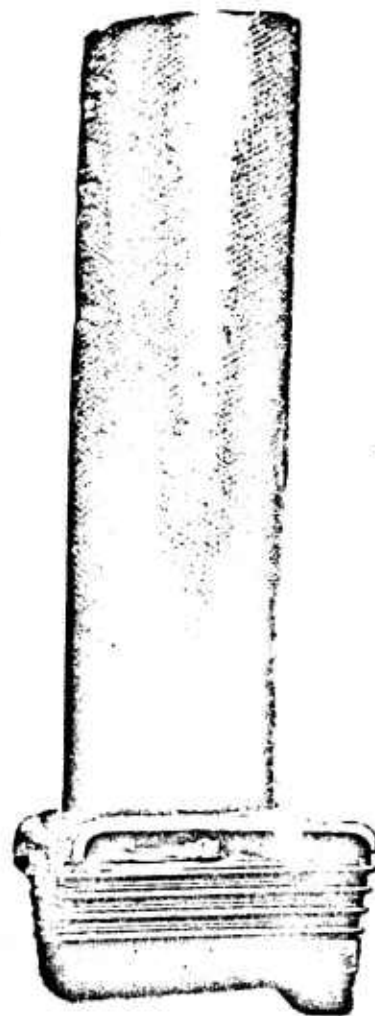
Figure 47b

Blade No. 75

Blade No. 85

Photograph of engine run turbine blades Nos. 75 and 85. The blades are still in good condition in spite of secondary damage on the trailing edge.

Shortly after taking a reading, when two hours of endurance had been completed, turbine flange vibration amplitudes increased 2 to 3 mils. A test stand inspection of the blades again revealed that another blade airfoil had separated from the blade strut. Figures 46 and 47 show the rotor assembly and the strut from which the porous airfoil came off along with the resulting secondary damage. The remaining transpiration cooled turbine blades were in very good condition. Figures 47a and 47b show blades that were tested in the engine through the entire high temperature operation.
