AIRCRAFT GROUND-FLOTATION INVESTIGATION
PART II. DATA REPORT ON TEST SECTION I

U. S. ARMY ENGINEER WATERWAYS EXPERIMENT STATION

TECHNICAL REPORT AFFDL-TR-66-43, PART II

APRIL 1966

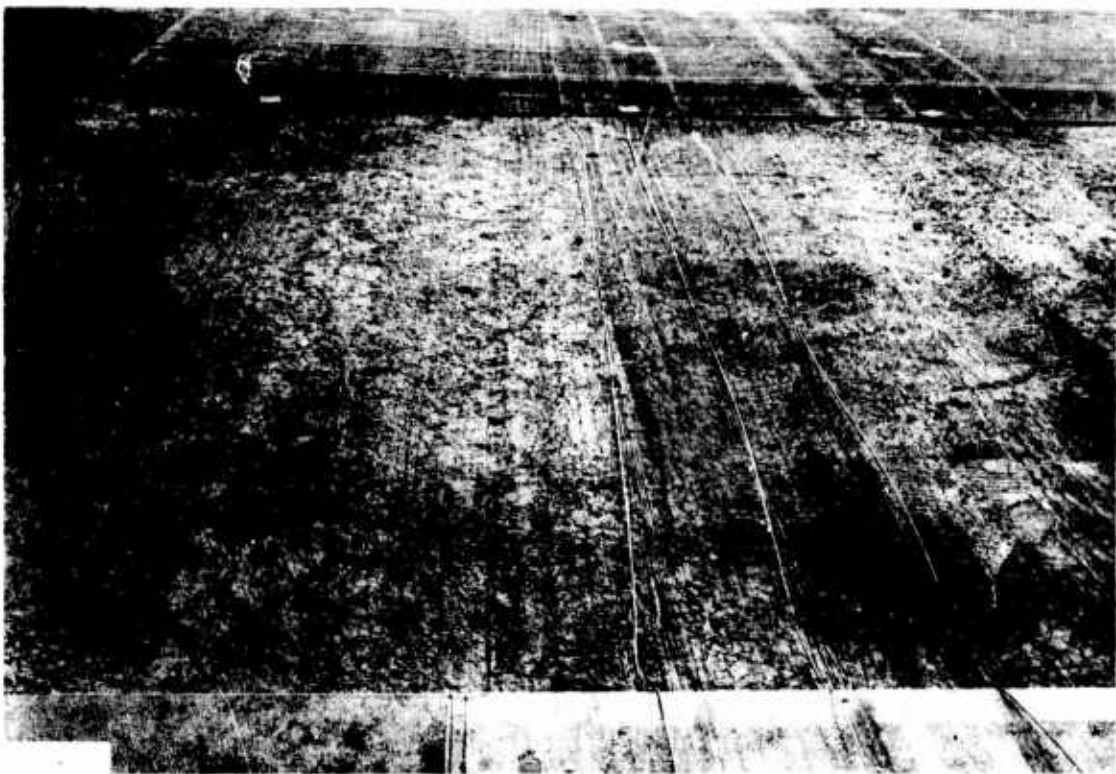
Figure 3. Lane 1, item 2, at 20 coverages

Item 2. The average subgrade CBR was 15 for the top 12 in. of soil in item 2 prior to traffic. Slight rutting of the surface resulted from two passes of the load vehicle during 0-coverage drawbar pull tests. After 20 coverages, the entire item had depressed in the tracked lane approximately 1 in. and the surface was relatively flat and in very good condition (**Figure 3**). A reduced rate of soil depression continued throughout the traffic period. At 40 coverages, the average CBR had increased to 34 for the top 12 in. of soil. Slight rutting of the surface was evident when traffic was suspended at 300 coverages, but the overall condition of the item remained good (**Figure 4**) and it was not considered failed. The traffic was discontinued because the CBR was increasing with traffic, and an excessive amount of time would have been required to develop a failure. The rated CBR of the item was 27 after 300 coverages of the test vehicle.

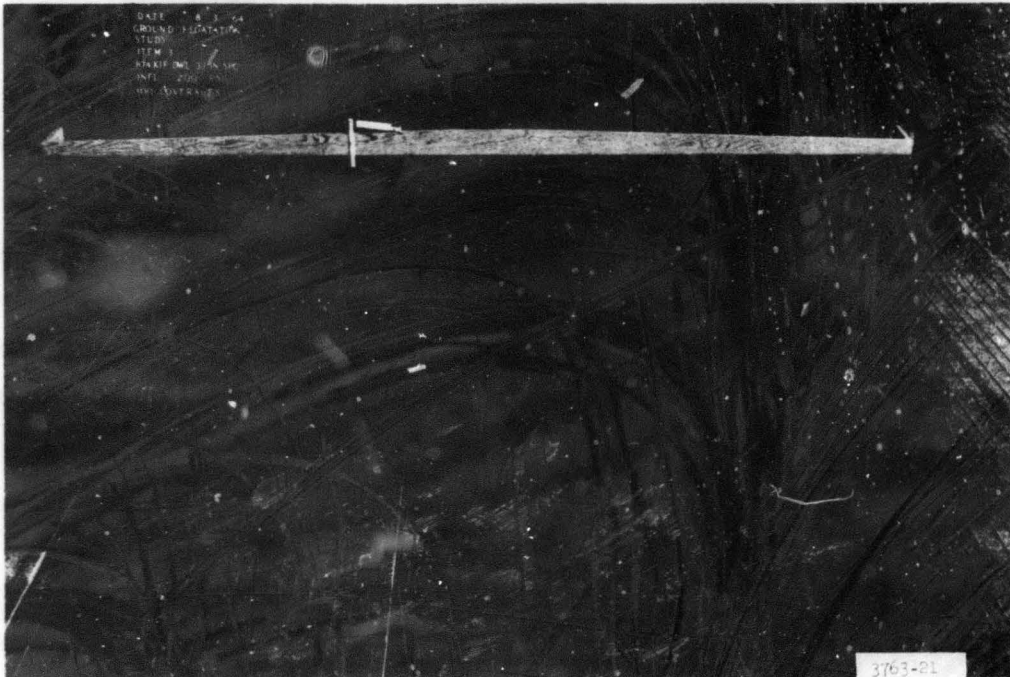
Figure 7. Lane 1, item 3, at 300 coverages (failure).
Longitudinal straightedge shows deformation

Item 3. Item 3 prior to traffic is shown in **Figure 5**. After 20 coverages, there were slight differential mat deformations along with an initial soil depression of about 1 in. No significant mat damage was evident with continued traffic to 100 coverages. At 135 coverages, sheared rivets and increasing differential deformations were noted. At 200 coverages, cracks appeared in the mat surface, but the item remained in serviceable condition. Traffic was continued to 300 coverages, at which time the mat was considered failed due to excessive roughness and mat deterioration (**Figures 6 and 7**). The rated CBR for the item was 7.4.

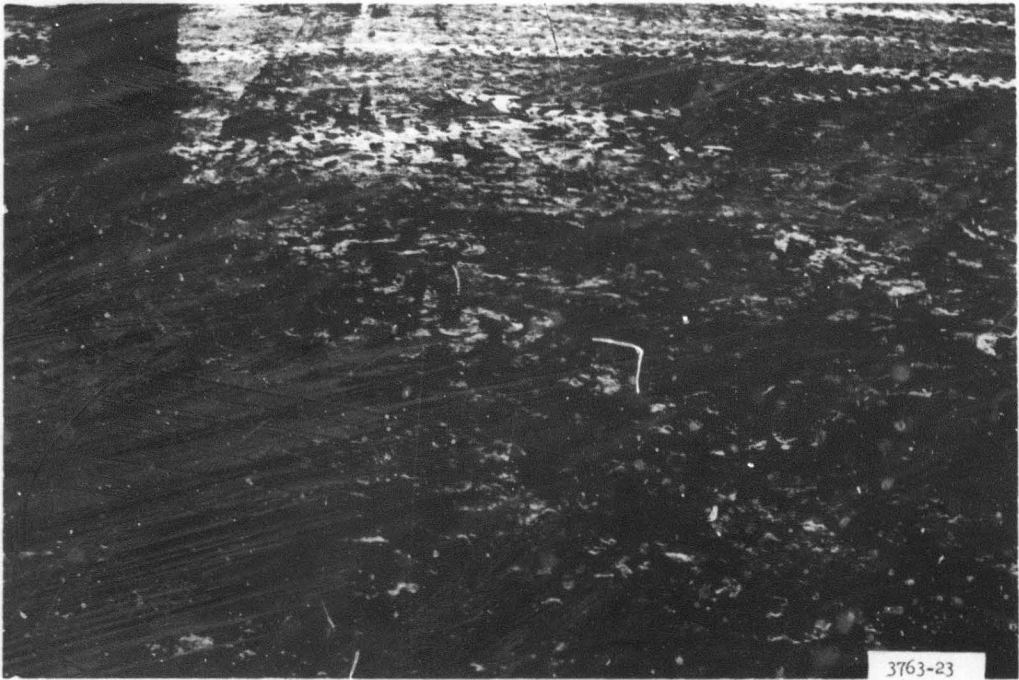
Figure 8. Lane 2, item 1, prior to traffic

Item 1. Item 1 prior to traffic is shown in **Figure 8.** The average subgrade CBR for the top 12 in. of soil in item 1 was 10 prior to traffic. The test vehicle caused severe rutting after two passes were made in an attempt to record 0-coverage drawbar pull values. Rut depths exceeded 4 in., and the item was judged failed at two passes **Figure 9.**

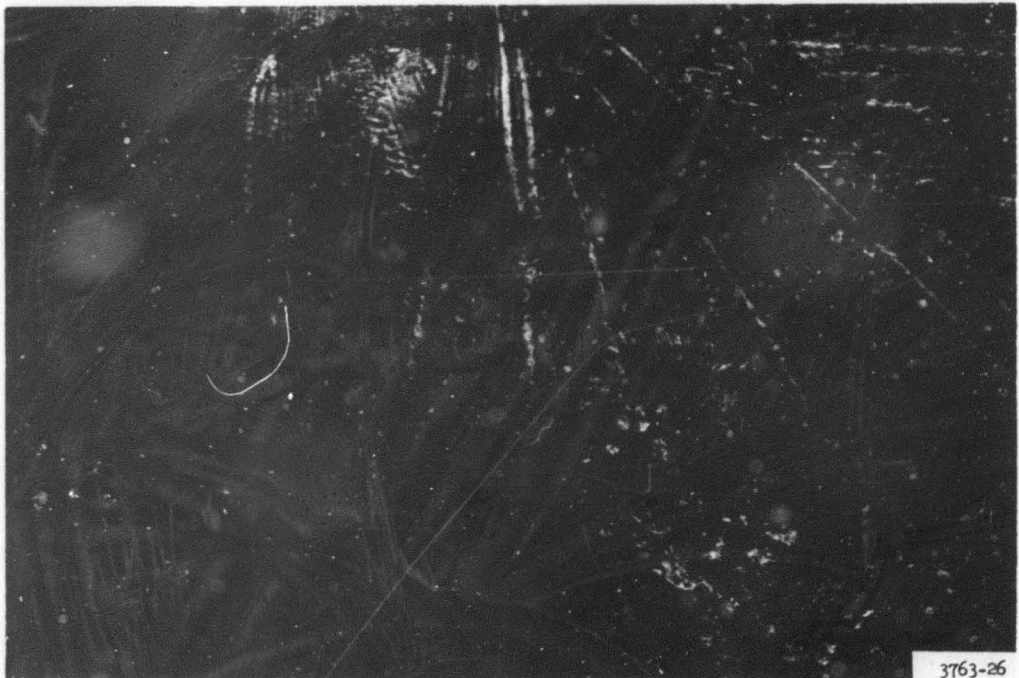
Figure 9. Lane 2, item 1, at two passes (failure)
