# NAVAL RESEARCH LABORATORY REPORT

22 December 1946

REMOVAL OF LAST REFLECTIONS BY HARP  
IN THE SG 1. STILLATION ABOARD DESTROYERS

Report R-3036

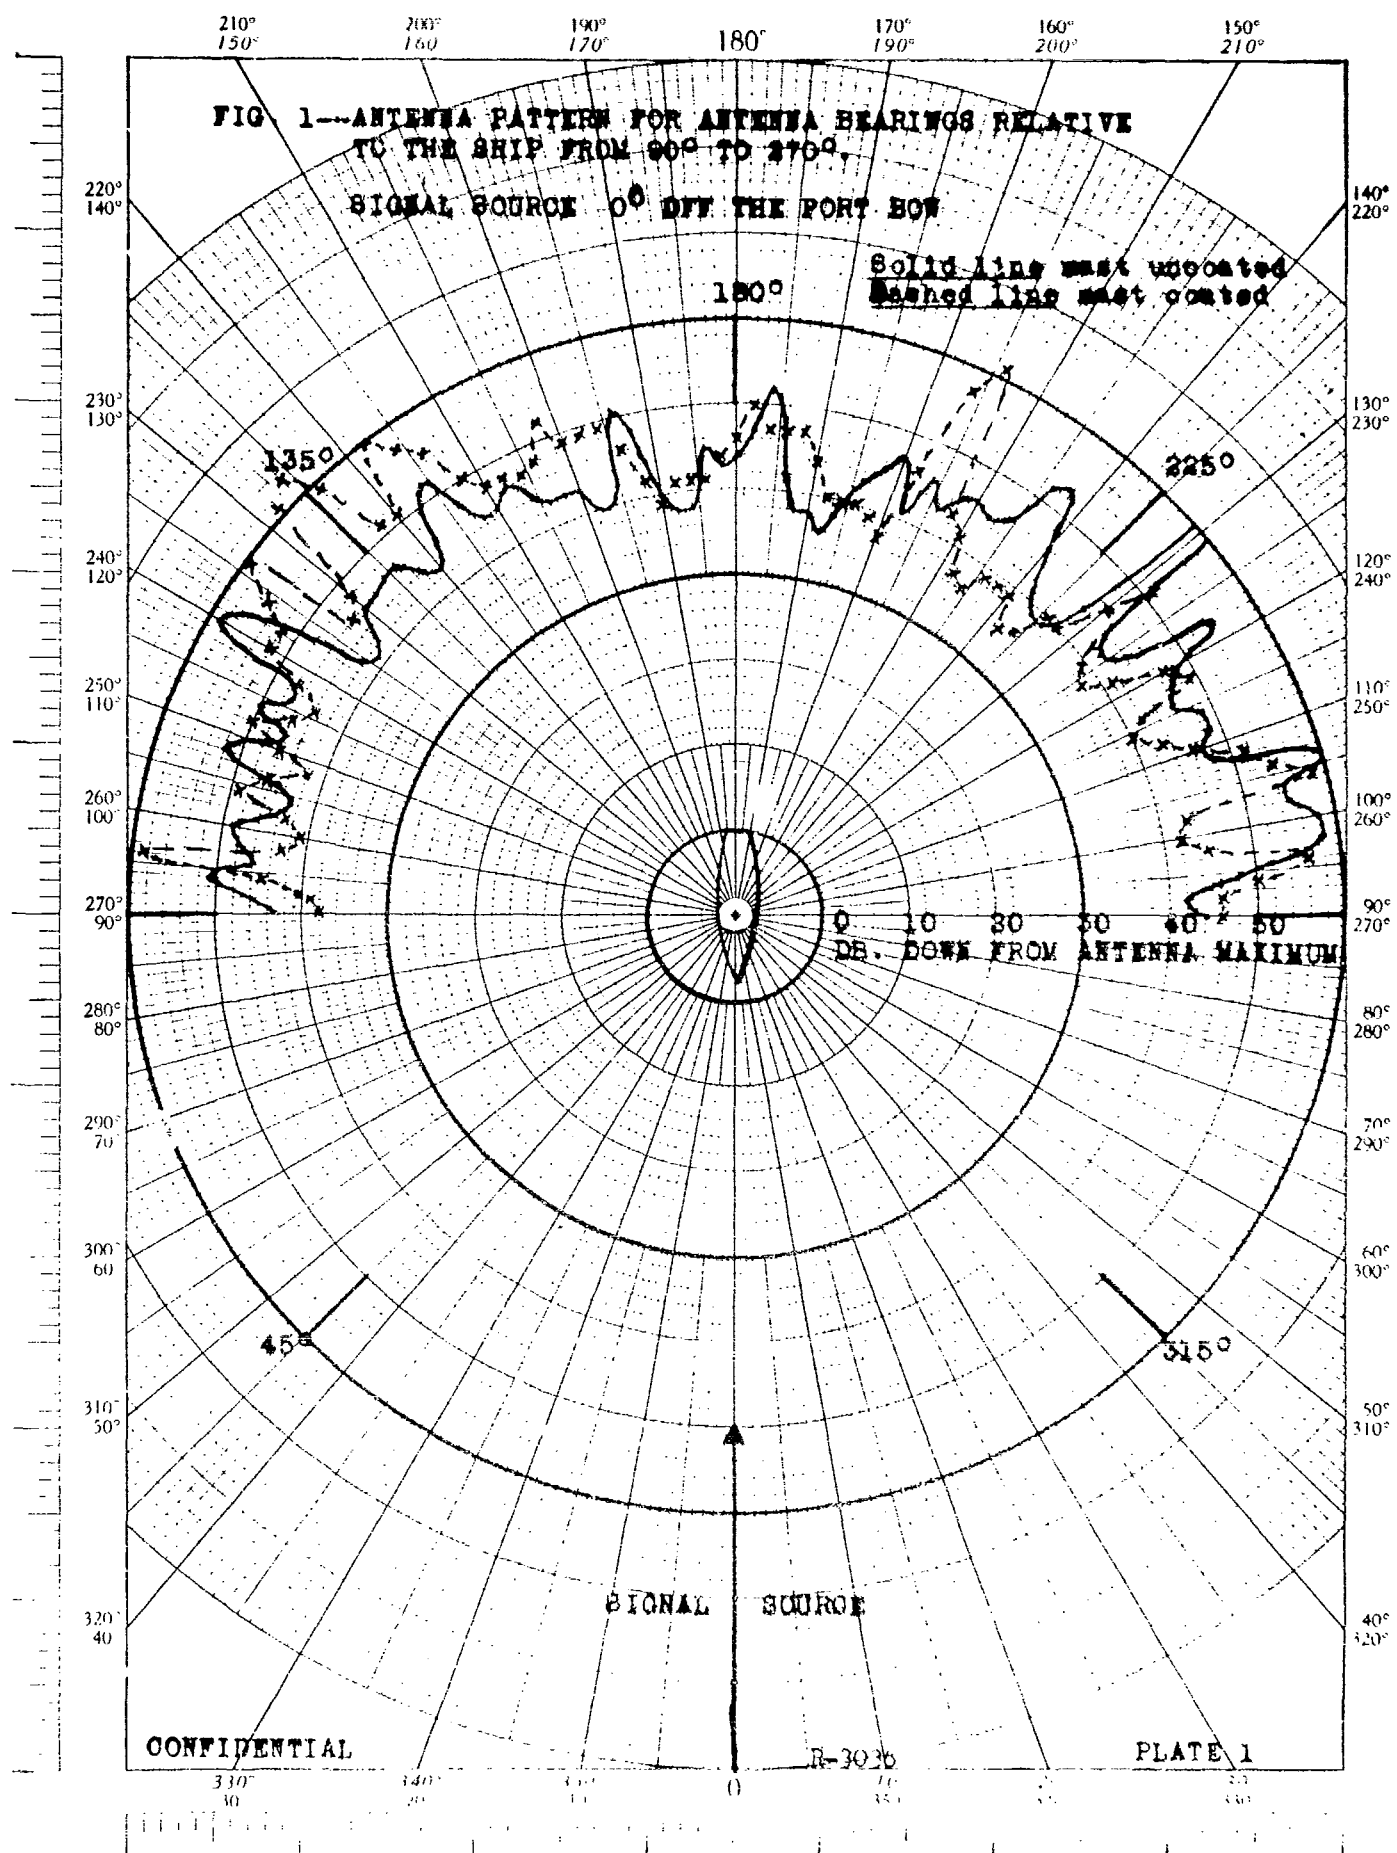
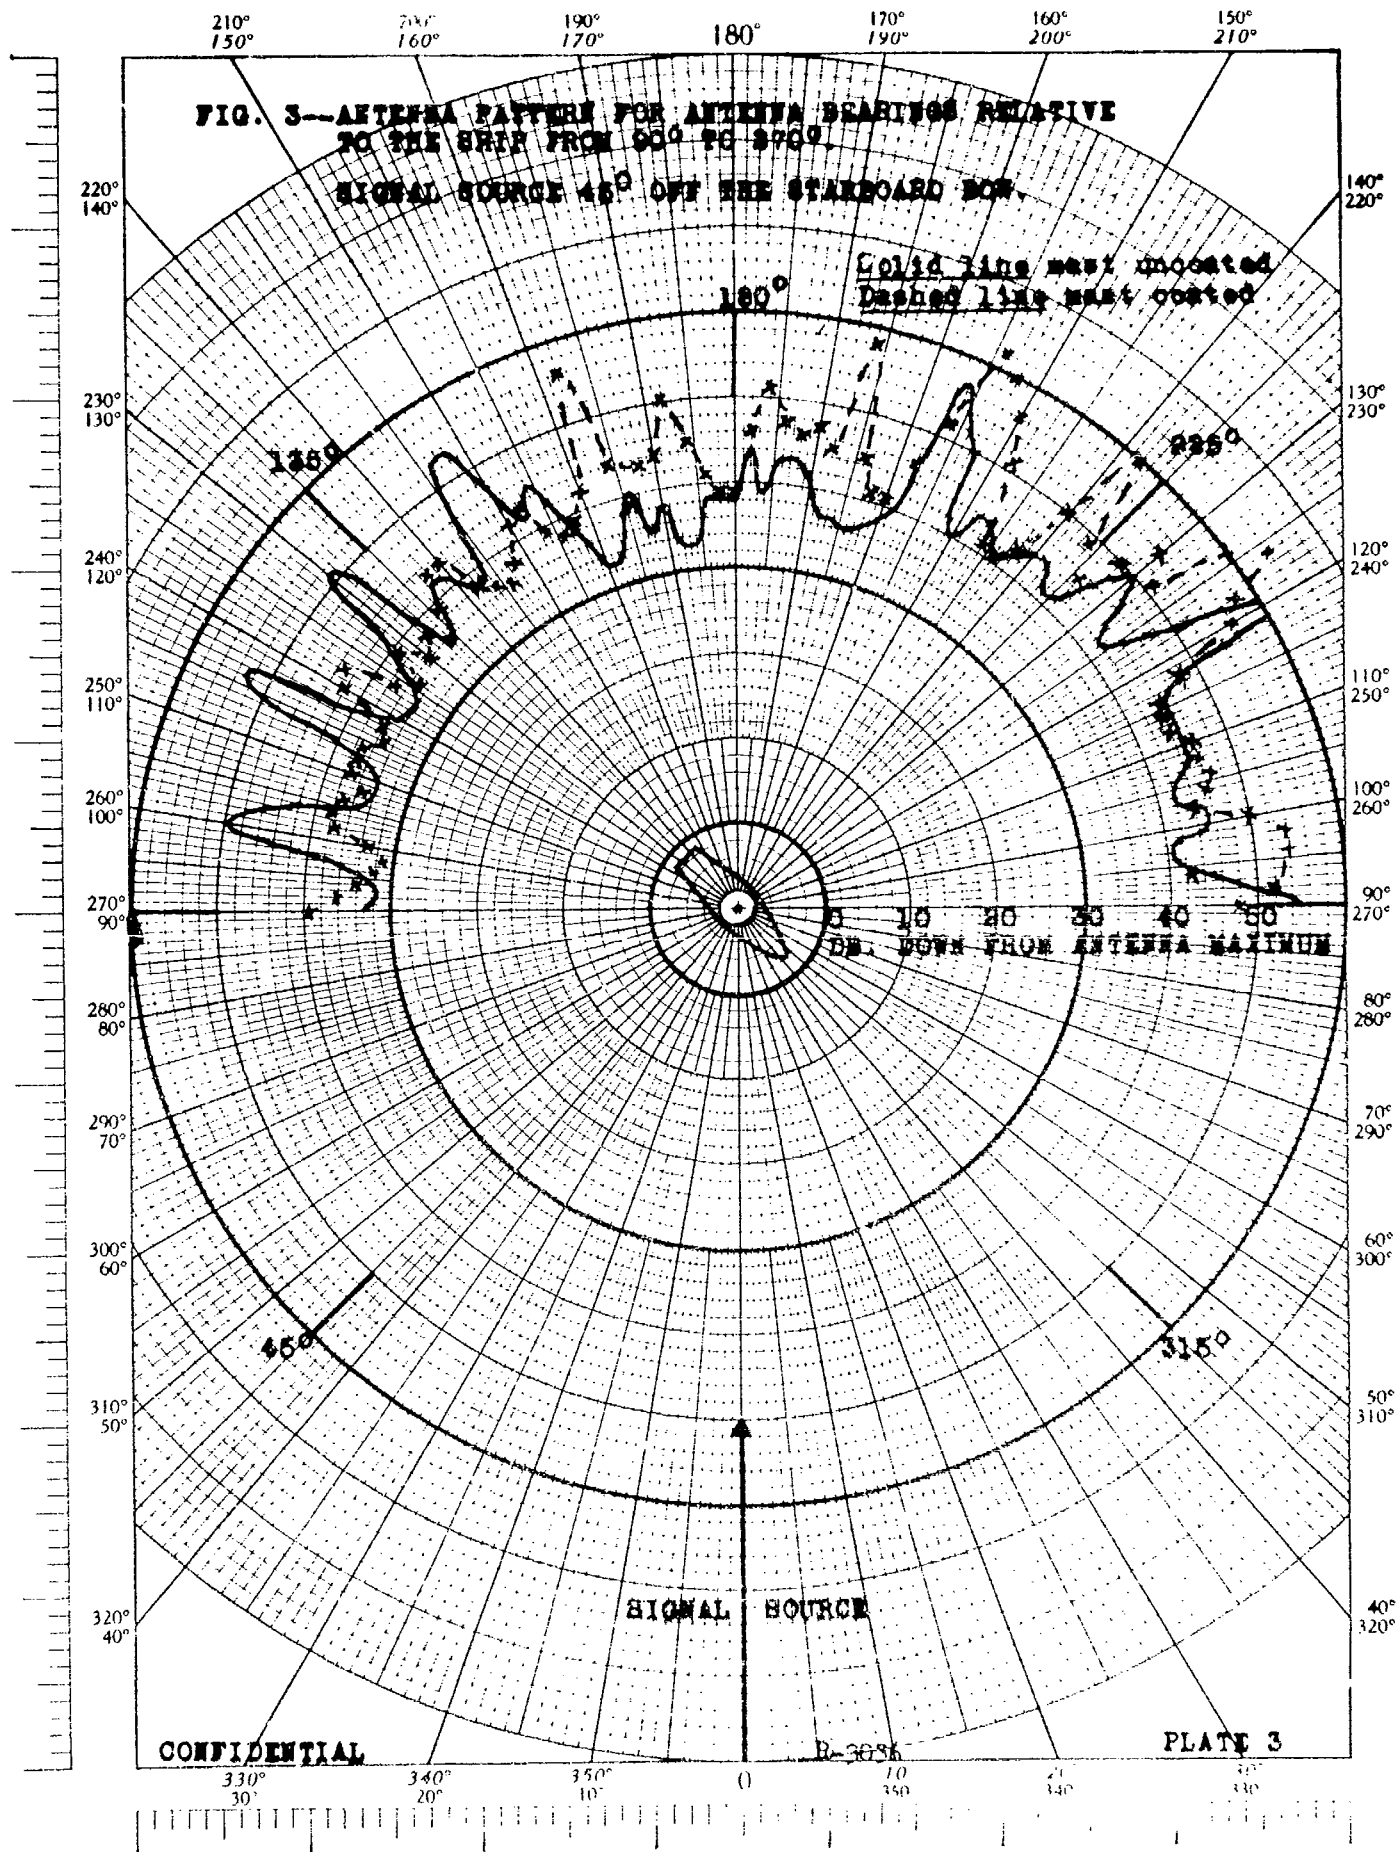
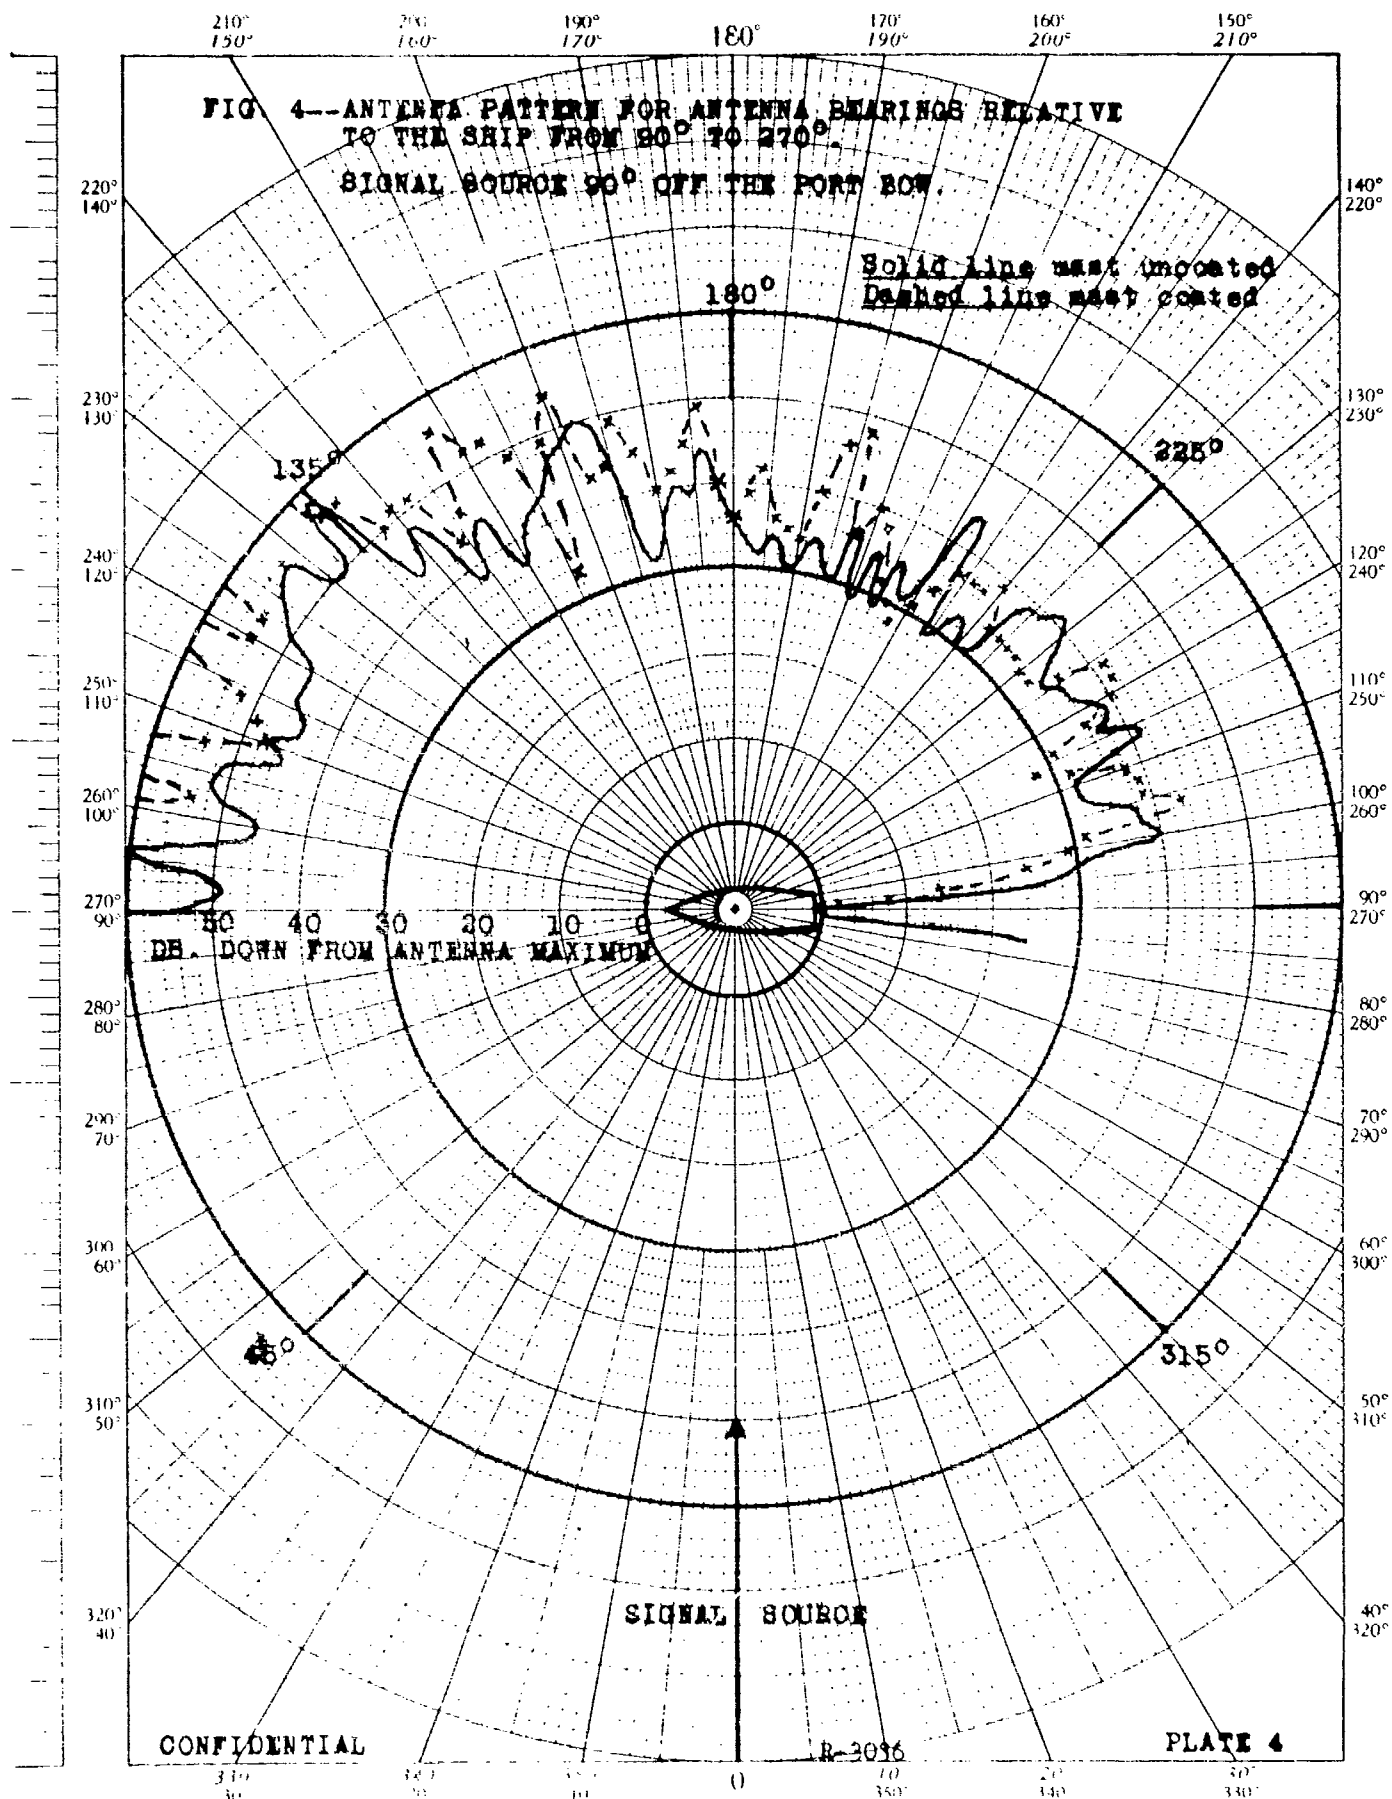
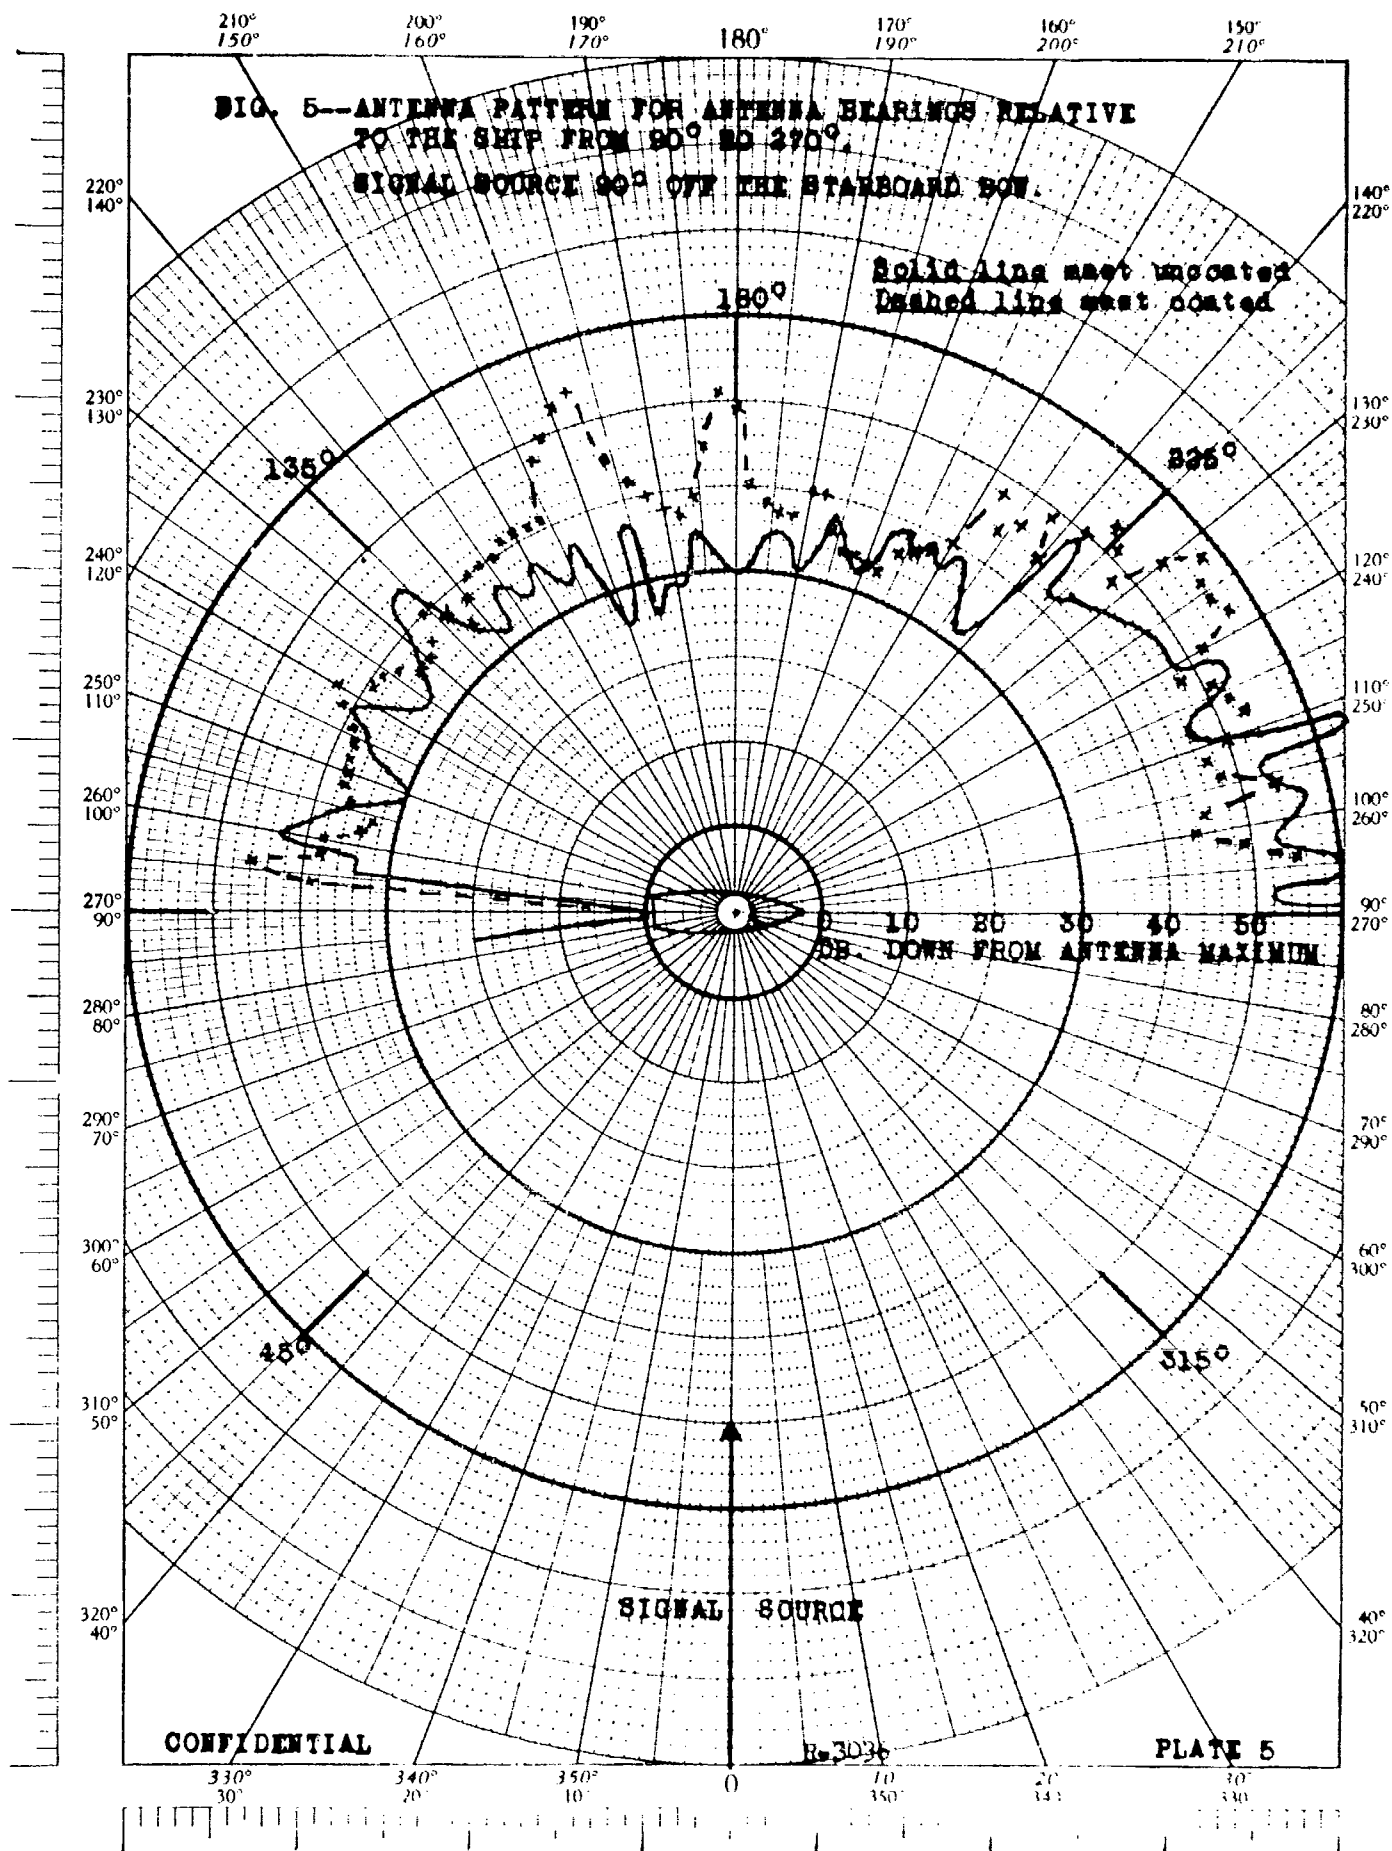
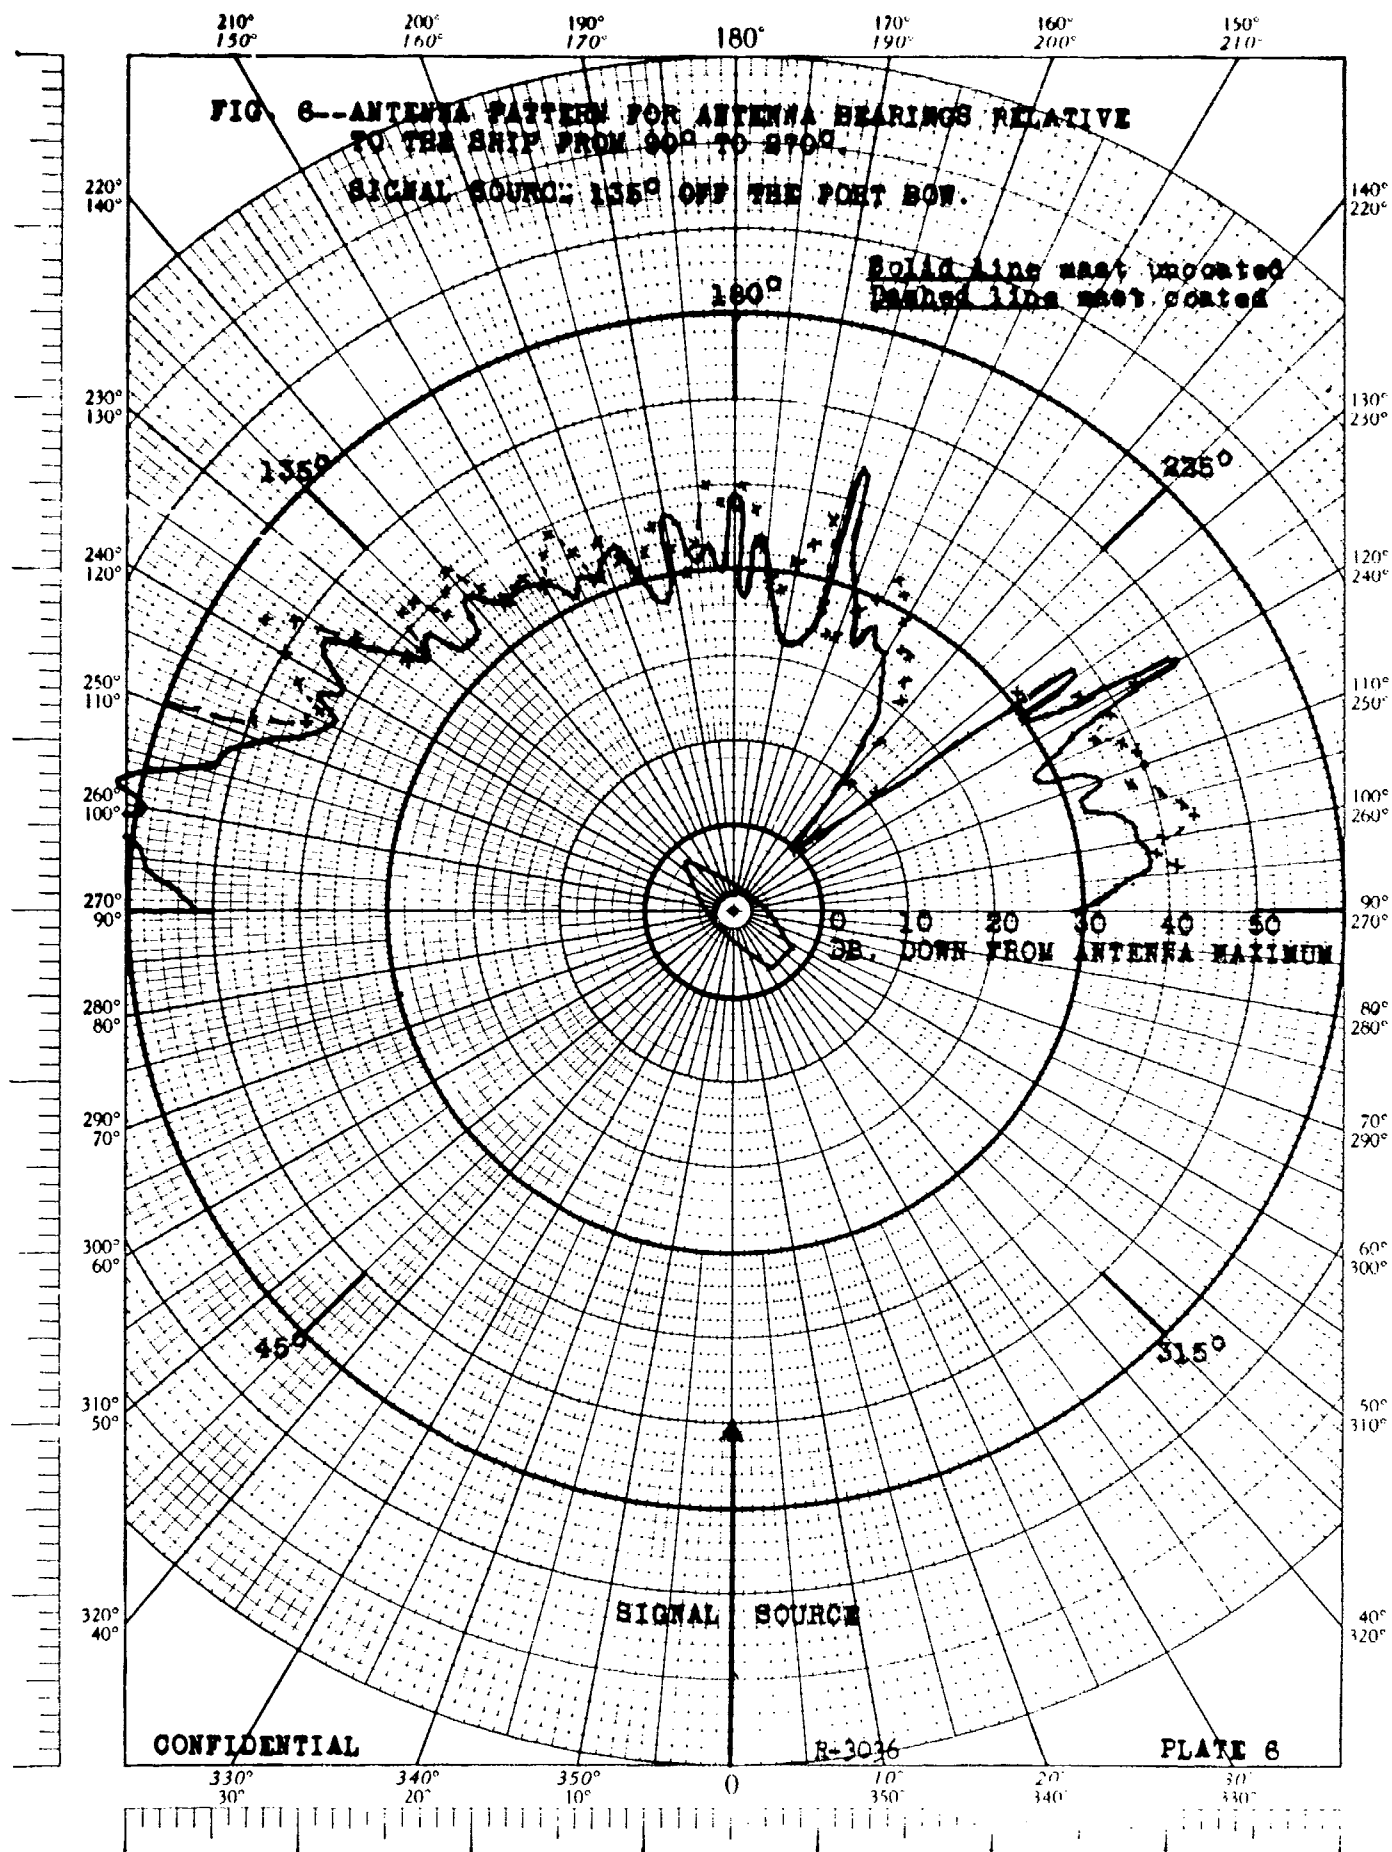
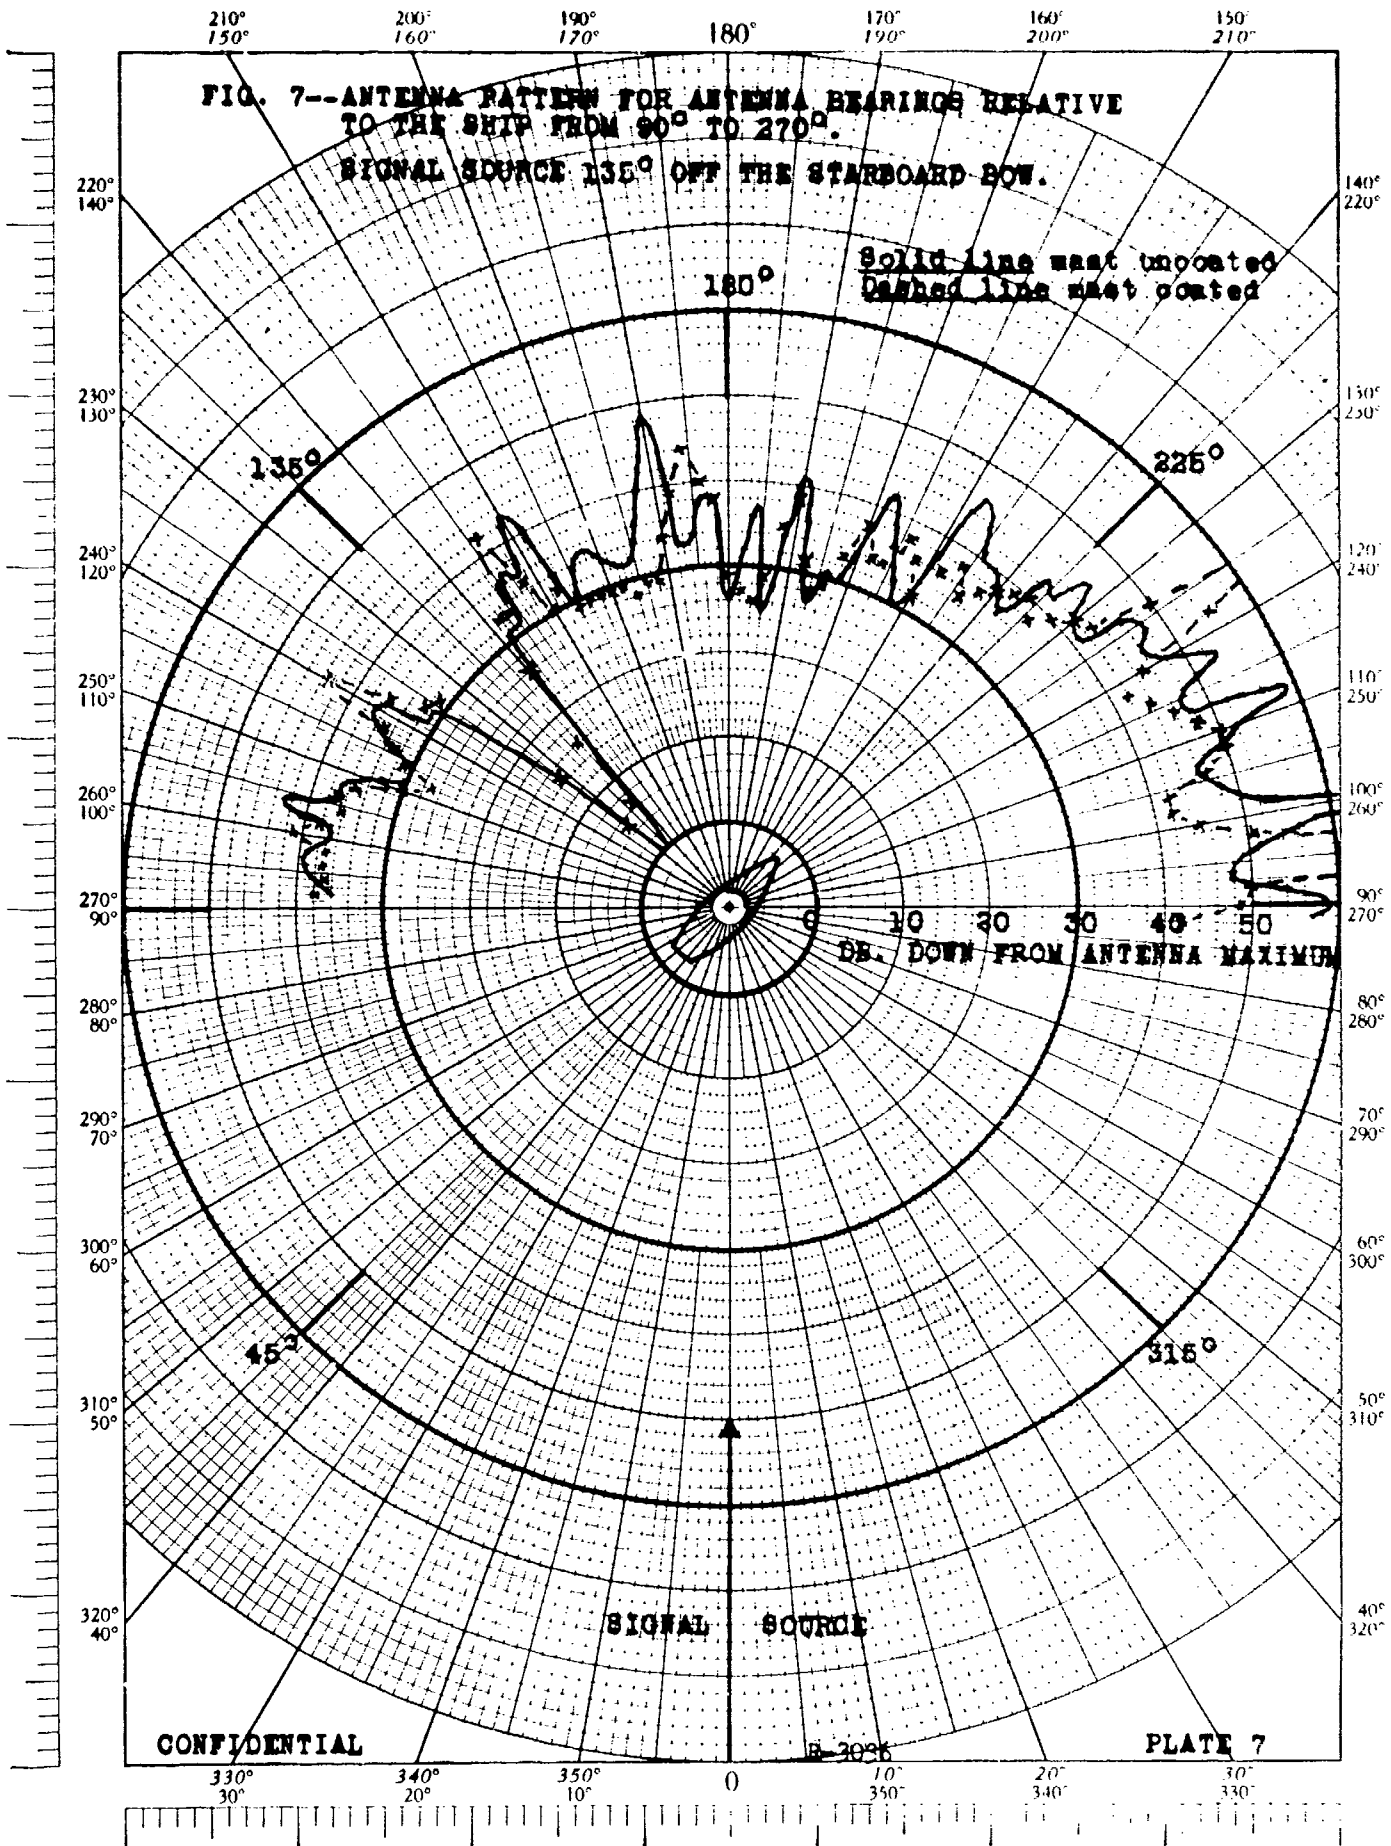
3.1. Receiving antenna patterns were taken with the ship's head at 0°, 45°, 90°, 135°, 180°, 225°, 270°, and 315° bearing with respect to the signal source. These curves are shown as the solid lines in Plates 1 to 8, inclusive. A similar set of patterns were taken with Harp on the illuminated portion of the mast and are shown as the dotted lines in the same plates. Each curve is drawn from a set of points taken at 2° intervals for relative bearings of the antenna with respect to the ship between 90° and 270°. The radial coordinate is db down from the center of the main beam so that the center of the main beam is represented by the radius corresponding to 0 db. A solid circle has been drawn at 30 db down and represents a "danger line". A satisfactory antenna system should have side lobes below this line.

3.2. Sizable mast reflections which are removed by Harp appear in Plates 2 and 5.

| <u>Plate No.</u> | <u>Bearing of Source</u> | <u>Antenna Bearing</u> | <u>Height of Side Lobe</u> | <u>Height After Harp Installation</u> |
| 2 | 45° off port bow | 185 | 22 db | 35 db |
| 5 | 90° off starboard bow | 160 | 26 db | 50 db |

3.4. The pattern with the target directly off the stern (Plate 5) shows clearly the effect of the mast obstruction both in widening the beam and in causing a minor lobe to appear at 6° from the center of the main beam on both sides. The distortion of the main beam causes a serious loss in antenna gain for this position

3.6. Study of these patterns reveals that side lobes from the mast reflections appear in many positions and are sometimes as high as 21 db down. When the illuminated section of the mast is covered with Harp, however, all side lobes of the antenna system are reduced below 27 db.

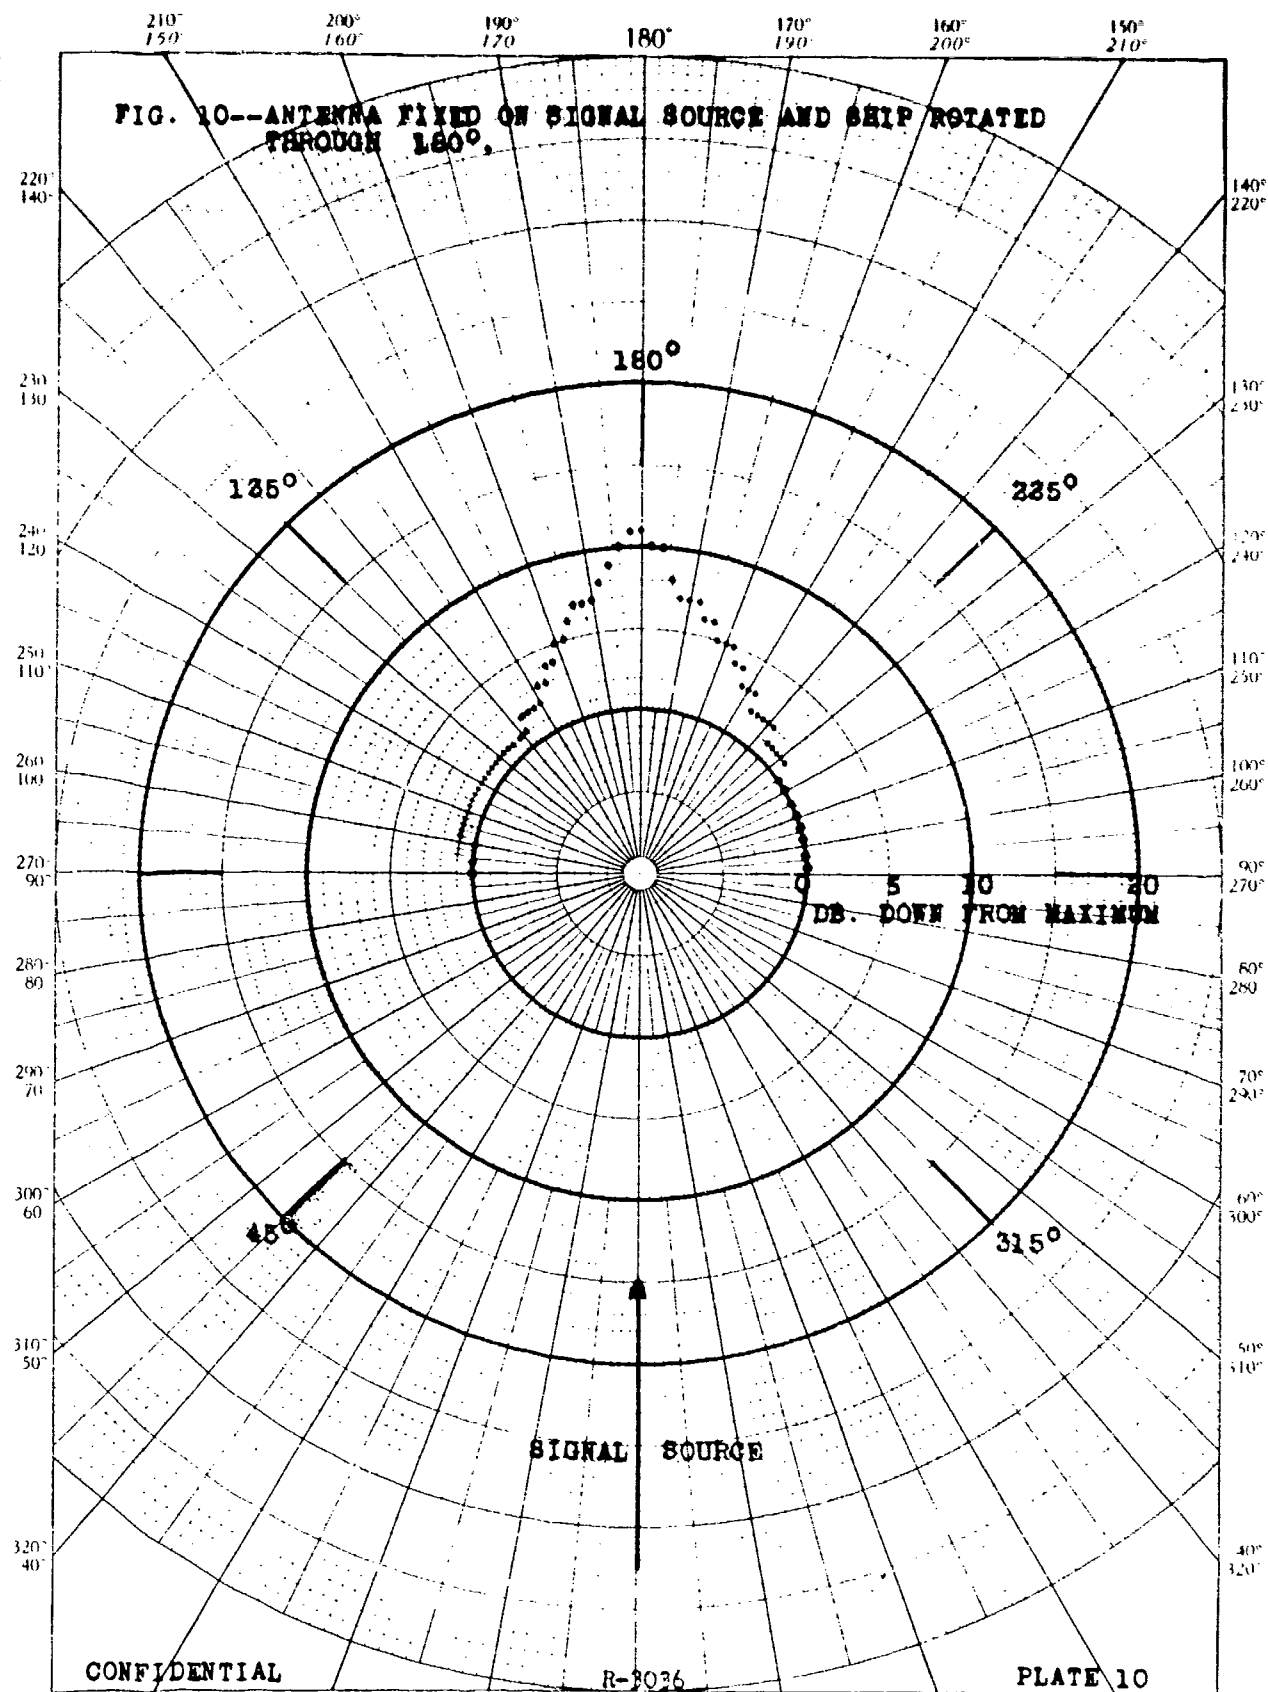
showed less than 1 db variation. In a similar way the ship's pattern was determined by measuring the signal strengths for various bearings of the ship while the antenna was continuously trained on the shore transmitter (Plate 10).

3.7. The ship's pattern was taken with the antenna trained directly on the signal source and the ship's head at various bearings between 90° and 270° relative to the signal source. As there was no significant difference when Harp was in place, only one curve has been plotted in Plate 10. (It should be noted that the radial scale has been changed in this figure). A loss of 11 db appears when the mast is directly between the signal source and the reflector and a loss of 5 db or more is present in a sector of 40° centered in the backward direction. The 11 db loss corresponds to a 22 db loss in radar performance and is approximately twice (in db) as great as that found on DD-836. This undoubtedly arises from the improved design of the MTI antenna for reduction in side lobes from the reflector is obtained by illuminating the center of the reflector more strongly and tapering the illumination to zero at the edges. Hence, close to the antenna, the radiated energy is more concentrated at the center of the beam and therefore is more strongly affected by an obstacle (the mast) of a fixed size.

FIG. 10--ANTENNA FIXED ON SIGNAL SOURCE AND SHIP ROTATED THROUGH 180°.

5.4. With the same antenna there is an 11 db loss in gain with the antenna trained directly backwards which is not affected by Harp.
