AFRPL-TR-70-127

**ADVANCED MANEUVERING PROPULSION  
TECHNOLOGY PROGRAM - INTERIM FINAL REPORT  
(VOLUME II: FLUORINE/HYDROGEN ENGINE CRITICAL  
COMPONENT DEMONSTRATION TESTING)**

**Rocketdyne  
A Division of North American Rockwell Corporation  
6633 Canoga Avenue  
Canoga Park, California**

**October 1970**

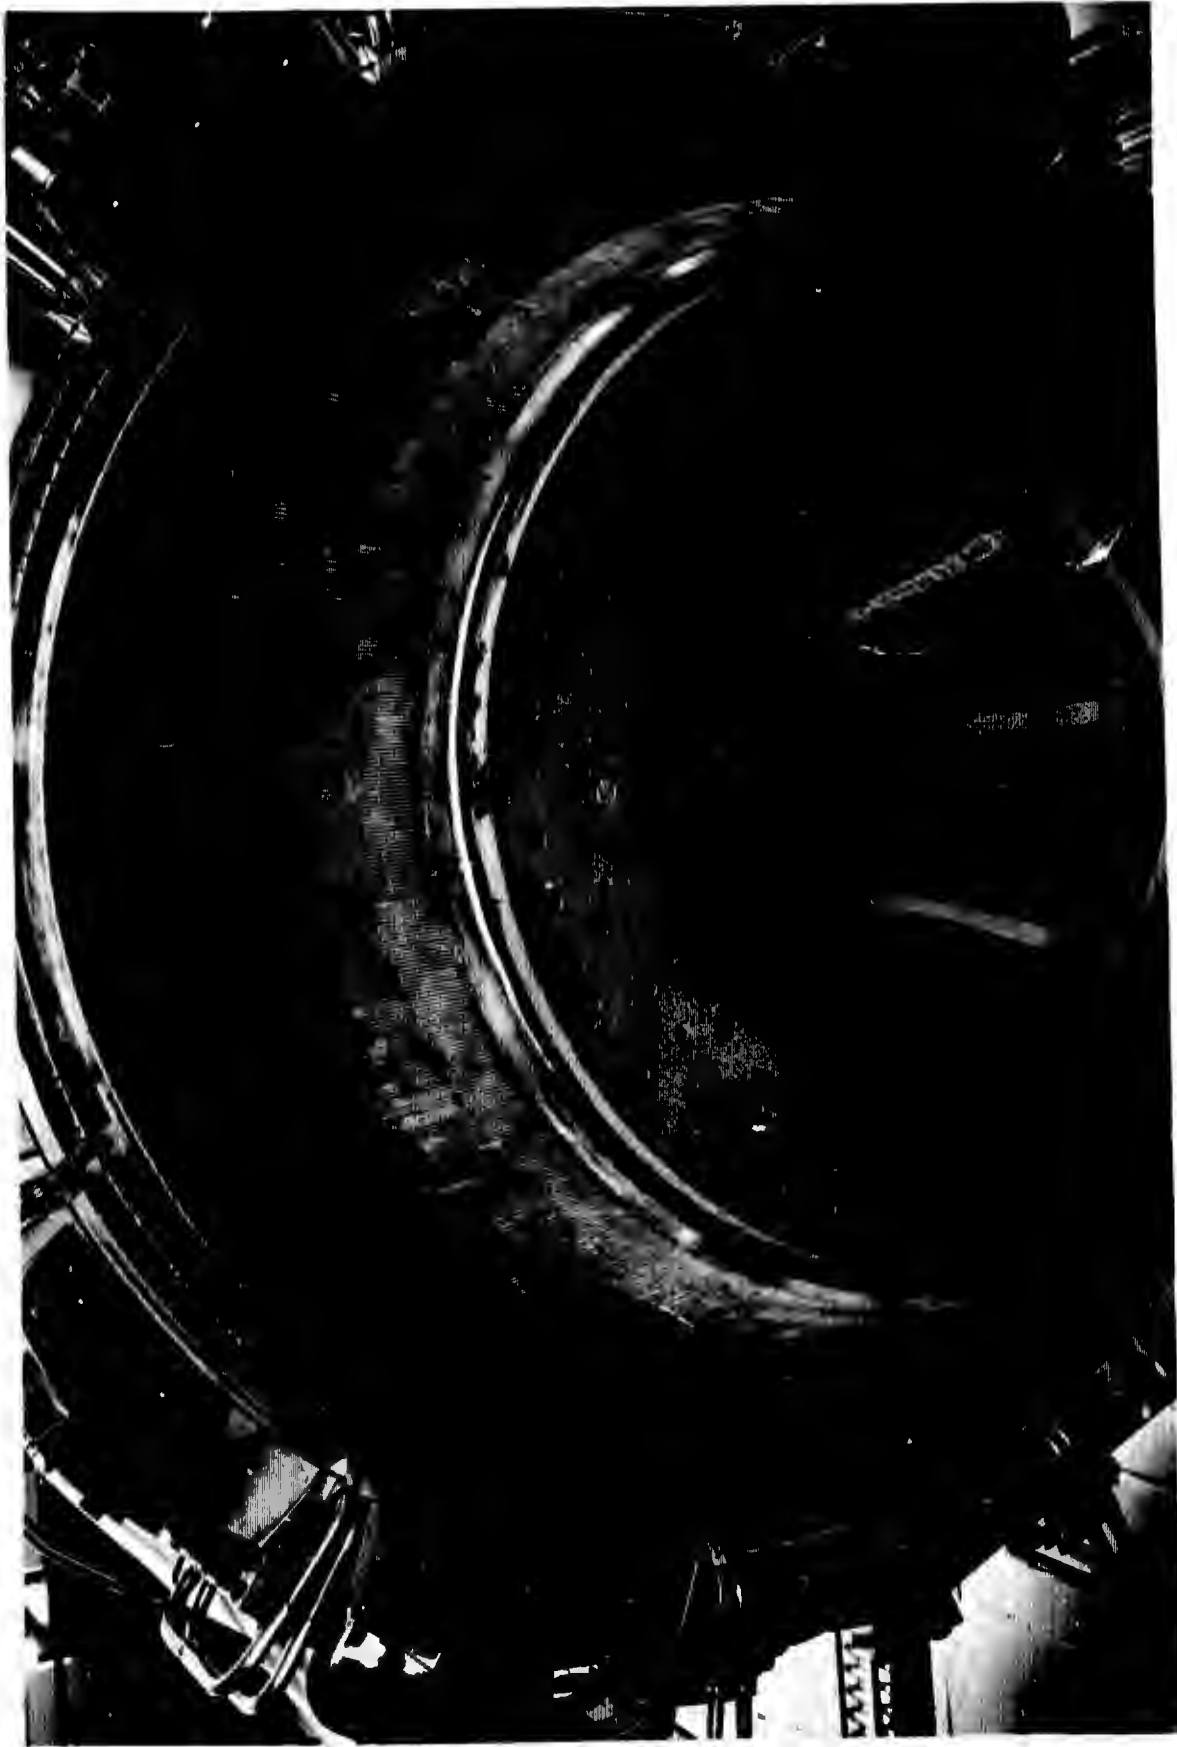
1EH32-2/18/70-CLH

Figure 13. Thrust Chamber Assembly (Aft View) (U)

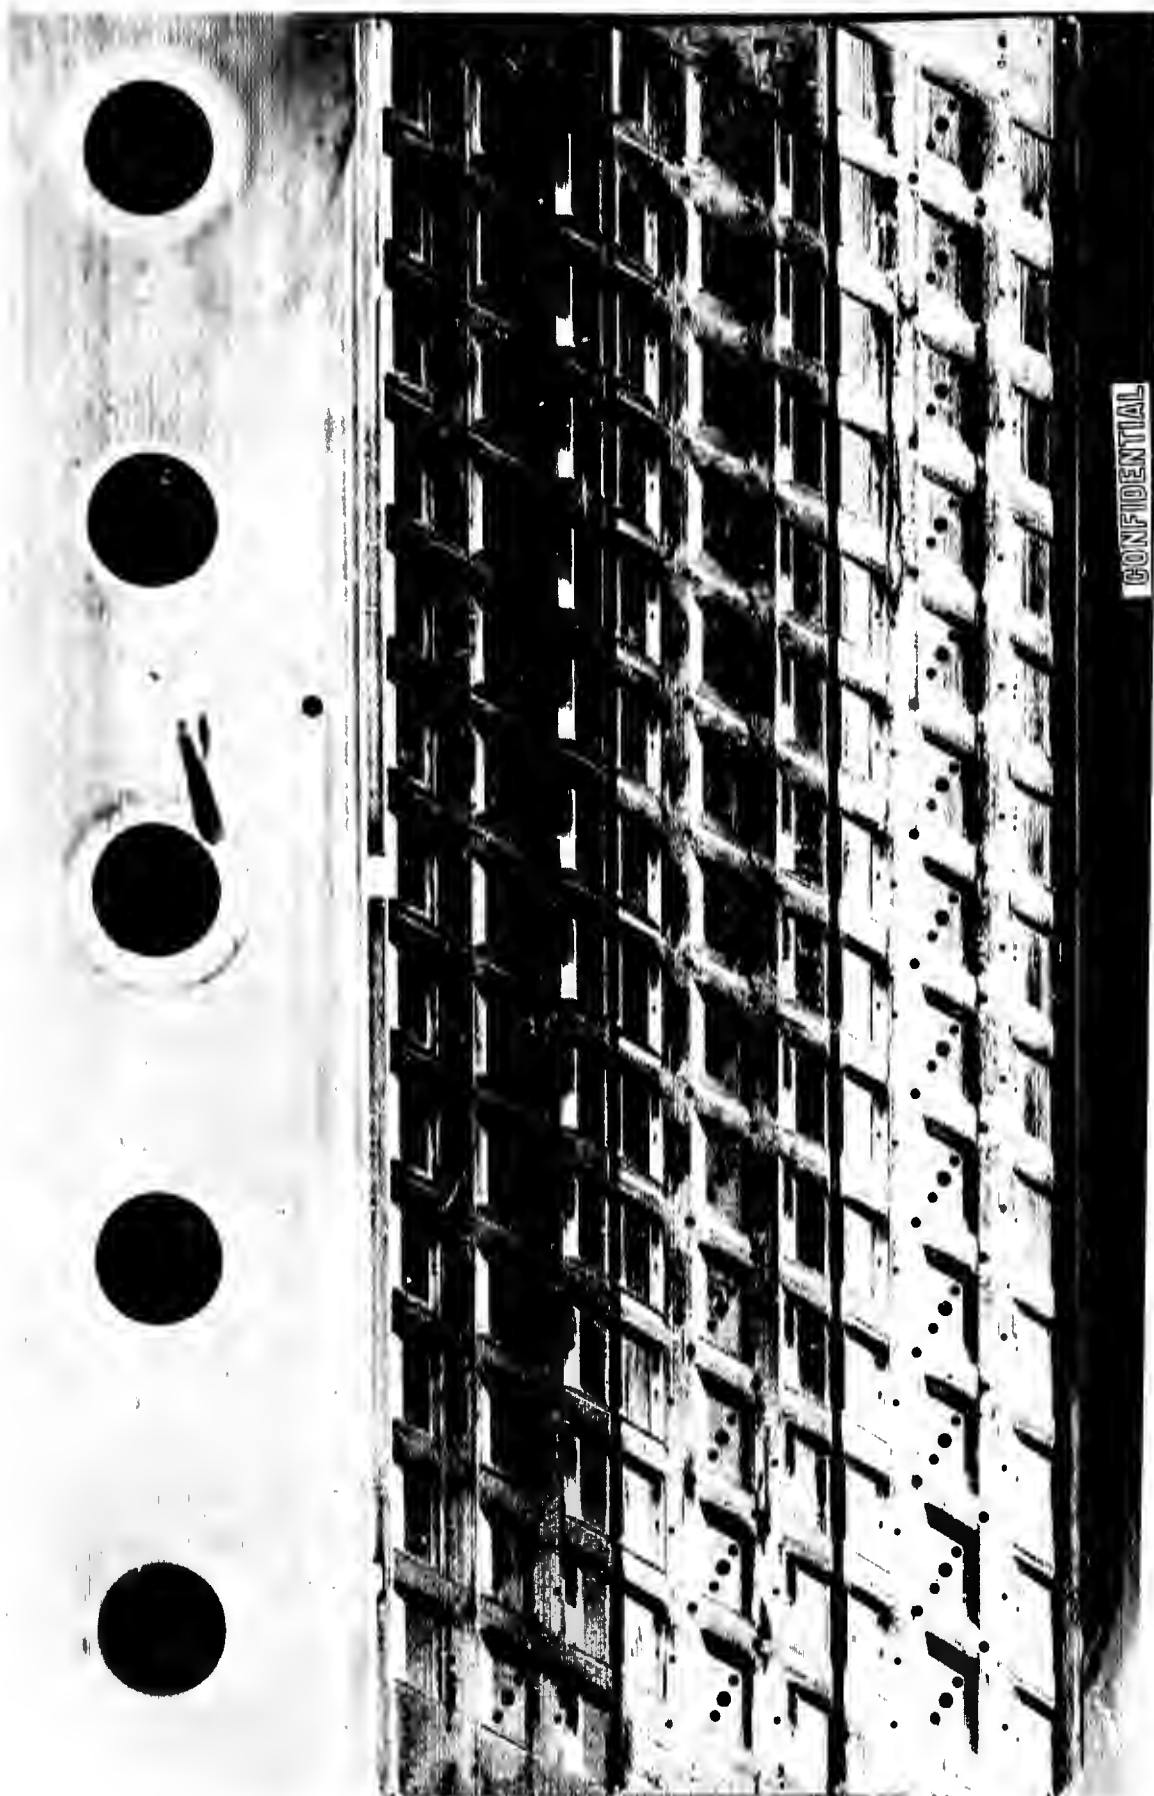
1EH44-2/1/68-CIB

Figure 28. 5-Inch Fan Injector Assembly U/N 1 (U)

(C) The impinging fan injector design was based on the work accomplished in the previous program (Ref. 1). The injector elements each have three fuel orifices and two pairs of oxidizer orifices. A single element and the complete face of the U/N 1 injector are shown in Fig. 24 and 28, respectively. Gaseous hydrogen was injected from the three central shower head orifices. The fluorine was injected from the two pairs of doublet orifices, forming fans whose flat side face the central gaseous hydrogen streams. The fluorine fans and hydrogen streams, in turn, impinged at a central common point.

(U) but the injector body material was changed from CRES 347, used on the triplet injectors, to 304L stainless steel for the fan injectors to provide a low carbon content material with better weld characteristics. The initial impinging fan injector, U/N 1 (Fig. 28), face strips and body were machined by conventional methods, and a combination tension-shear furnace braze joint was used for face attachment. The injector did not incorporate feed control webs in the oxidizer feed passages. Drilled vent holes were utilized for disposal of possible propellant leakage past the face strip-to-body braze joint, similar to the U/N 2 and U/N 3 triplet injectors.

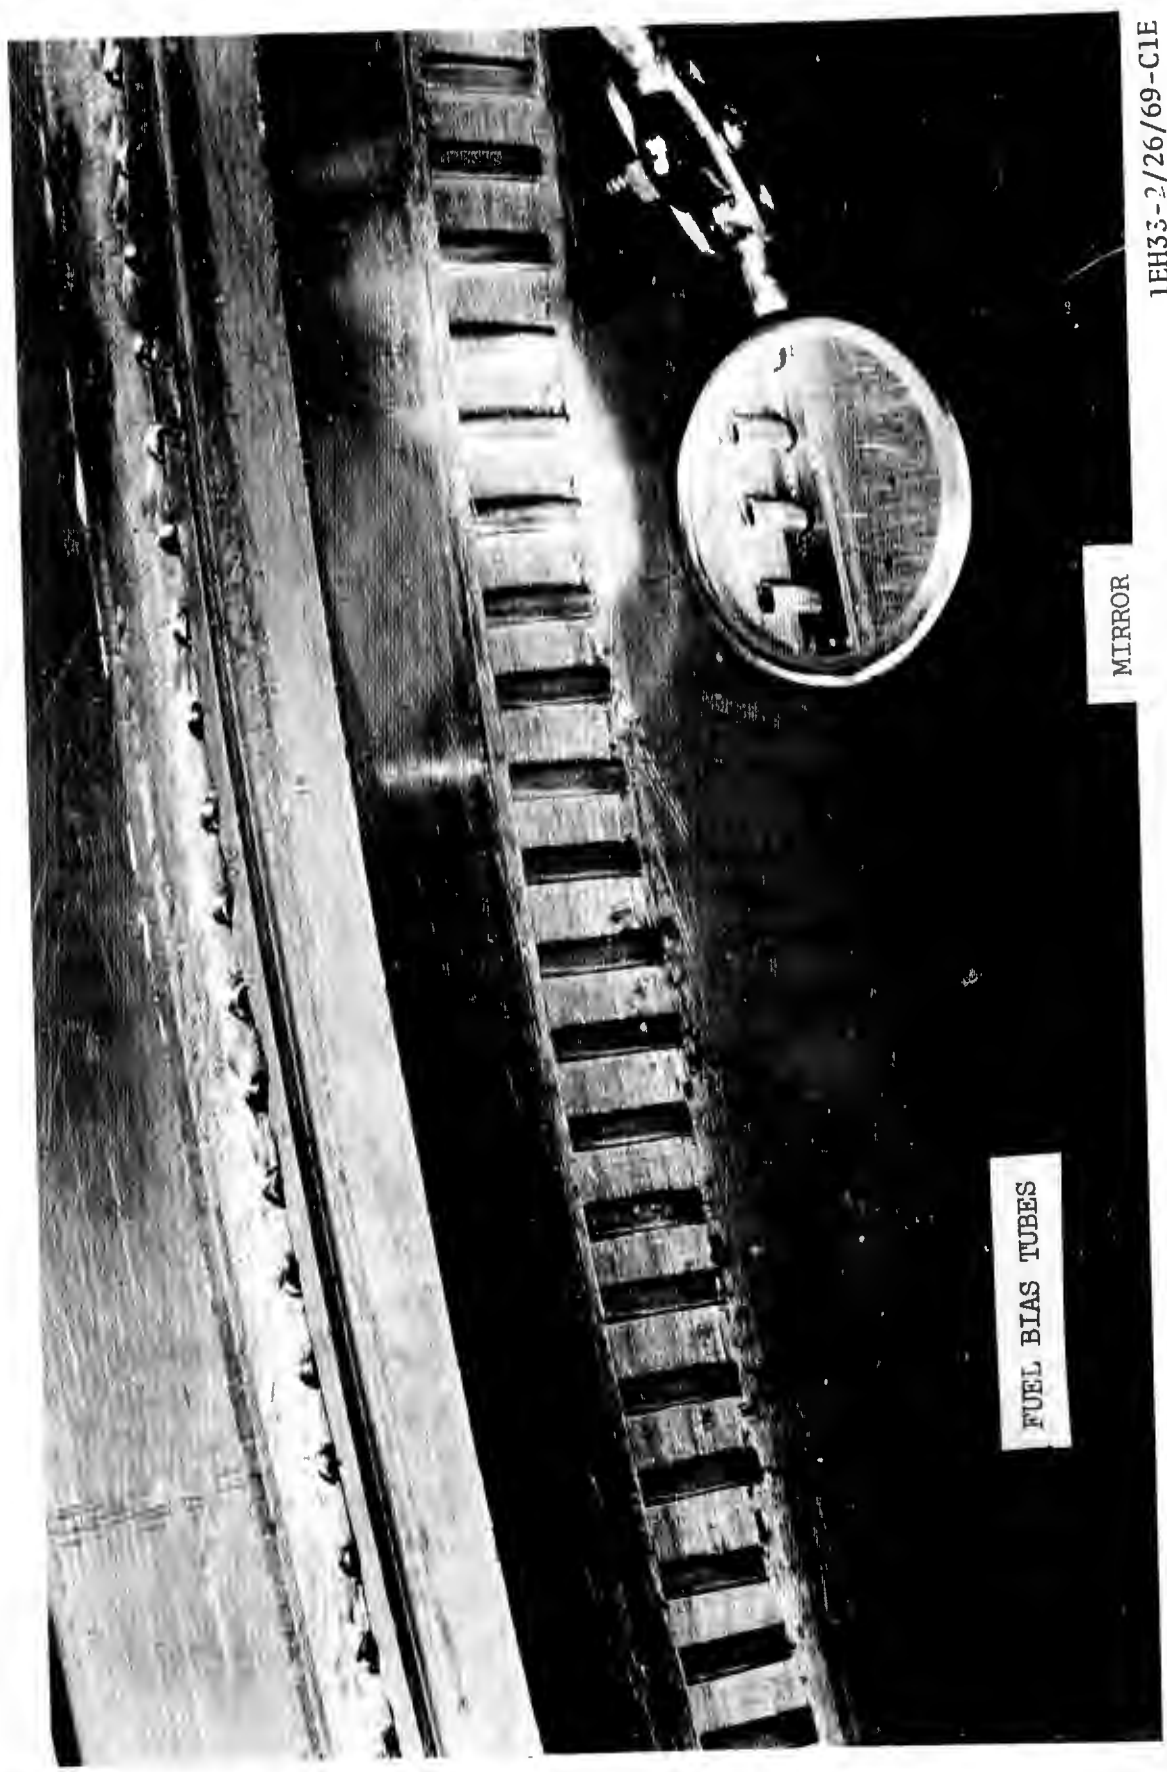
Figure 57. 30-Degree Water-Cooled Segment Modified for Fuel Bias (U)

- (U) Both injectors incorporated flow devices (inserts) that increased the oxidizer velocity at the back side of the injector face and improved cooling of the injector face. The insert designs were similar to those used for the 5-inch integral and brazed face injectors described earlier in Section III, 2, a(2)(b).

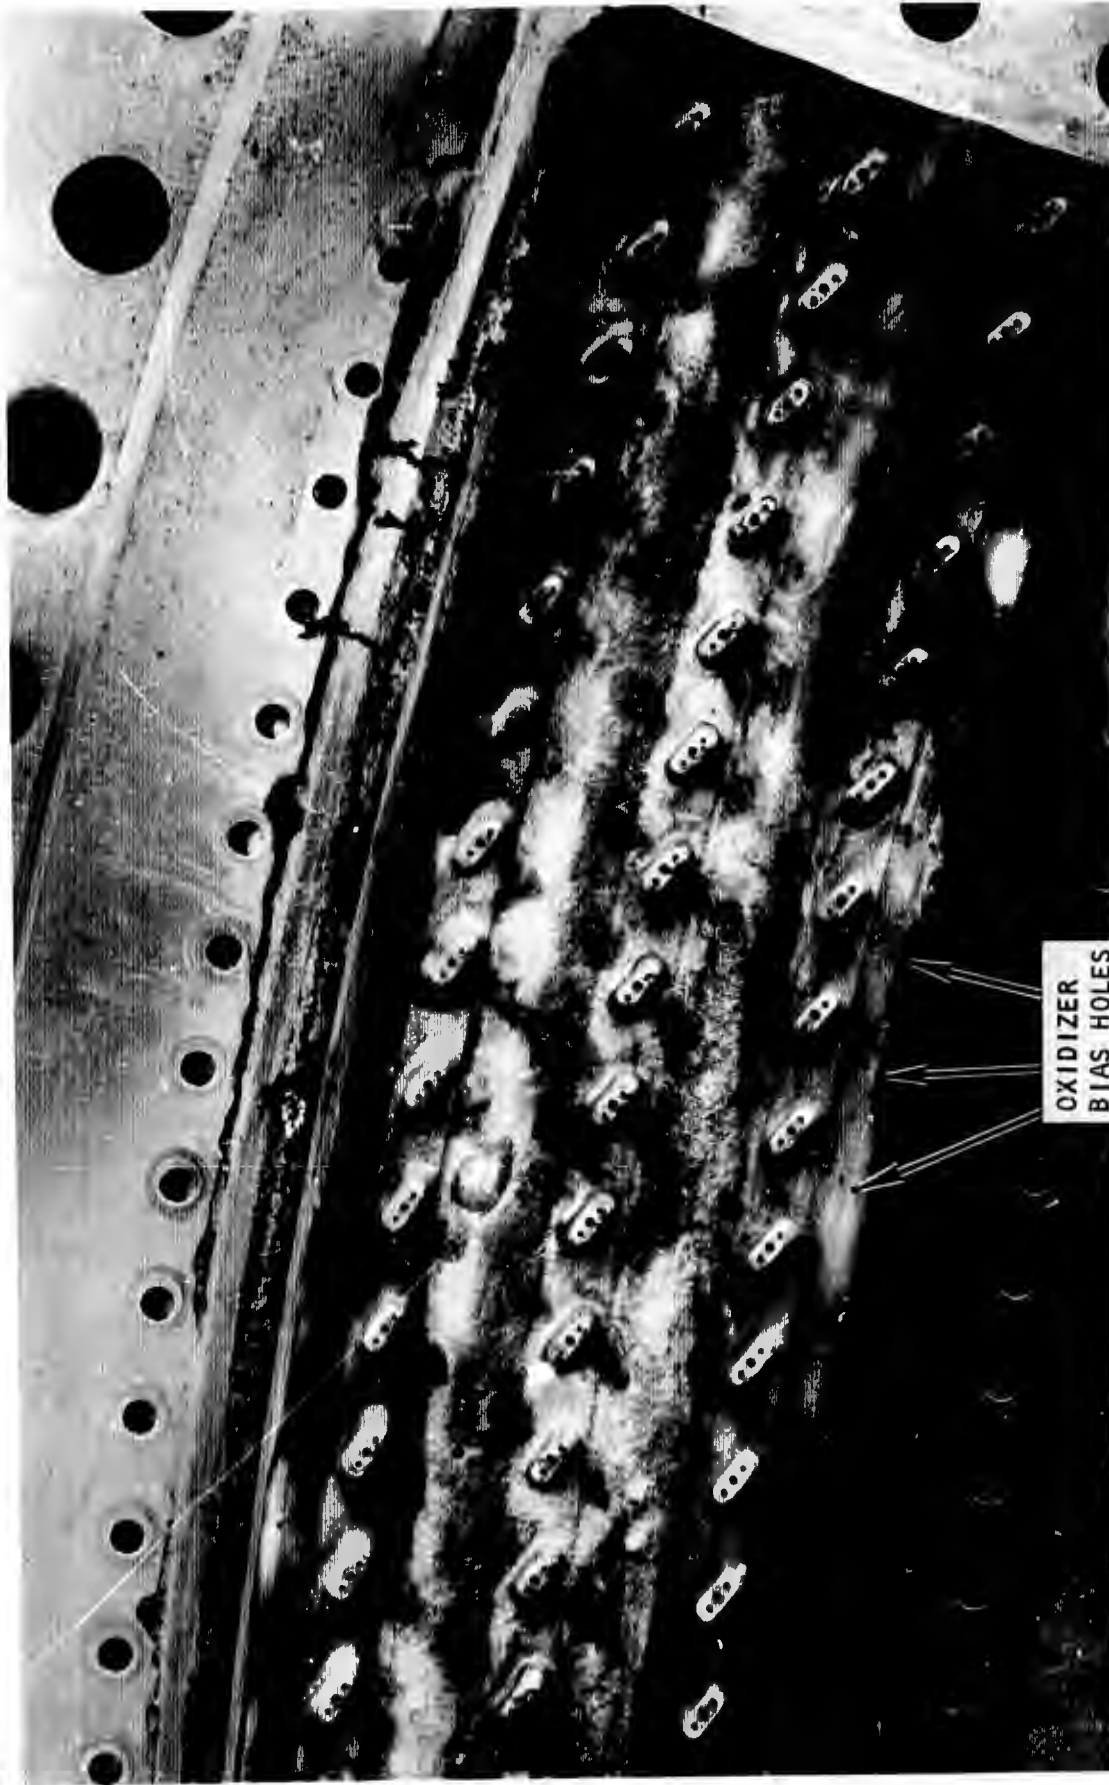
1EH45-3/24/69-C1A

Figure 67. 30-Degree Injector (U/N 1) Modified for Oxidizer Bias (Posttest 020) (U)

- (C) The completed injectors were vacuum leak checked, proof pressure checked to 11,000 psi (purge slots), flow calibrated, and cleaned according to applicable procedures.
- (C) During the test program the 30-degree brazed face injector (U/N 1) was modified to provide oxidizer film coolant orifices adjacent of the original outer row oxidizer doublets, as shown in Fig. 67. The modification was made for the test evaluation of reducing the overall chamber wall heat load by use of oxidizer film coolant. The film coolant orifice sizes were initially 0.018-inch diameter and were later enlarged to 0.021-inch diameter.
- (U) The prototype brazed-face injector design with the 0.018-inch oxidizer bias holes is shown in Fig. 68 through 70.

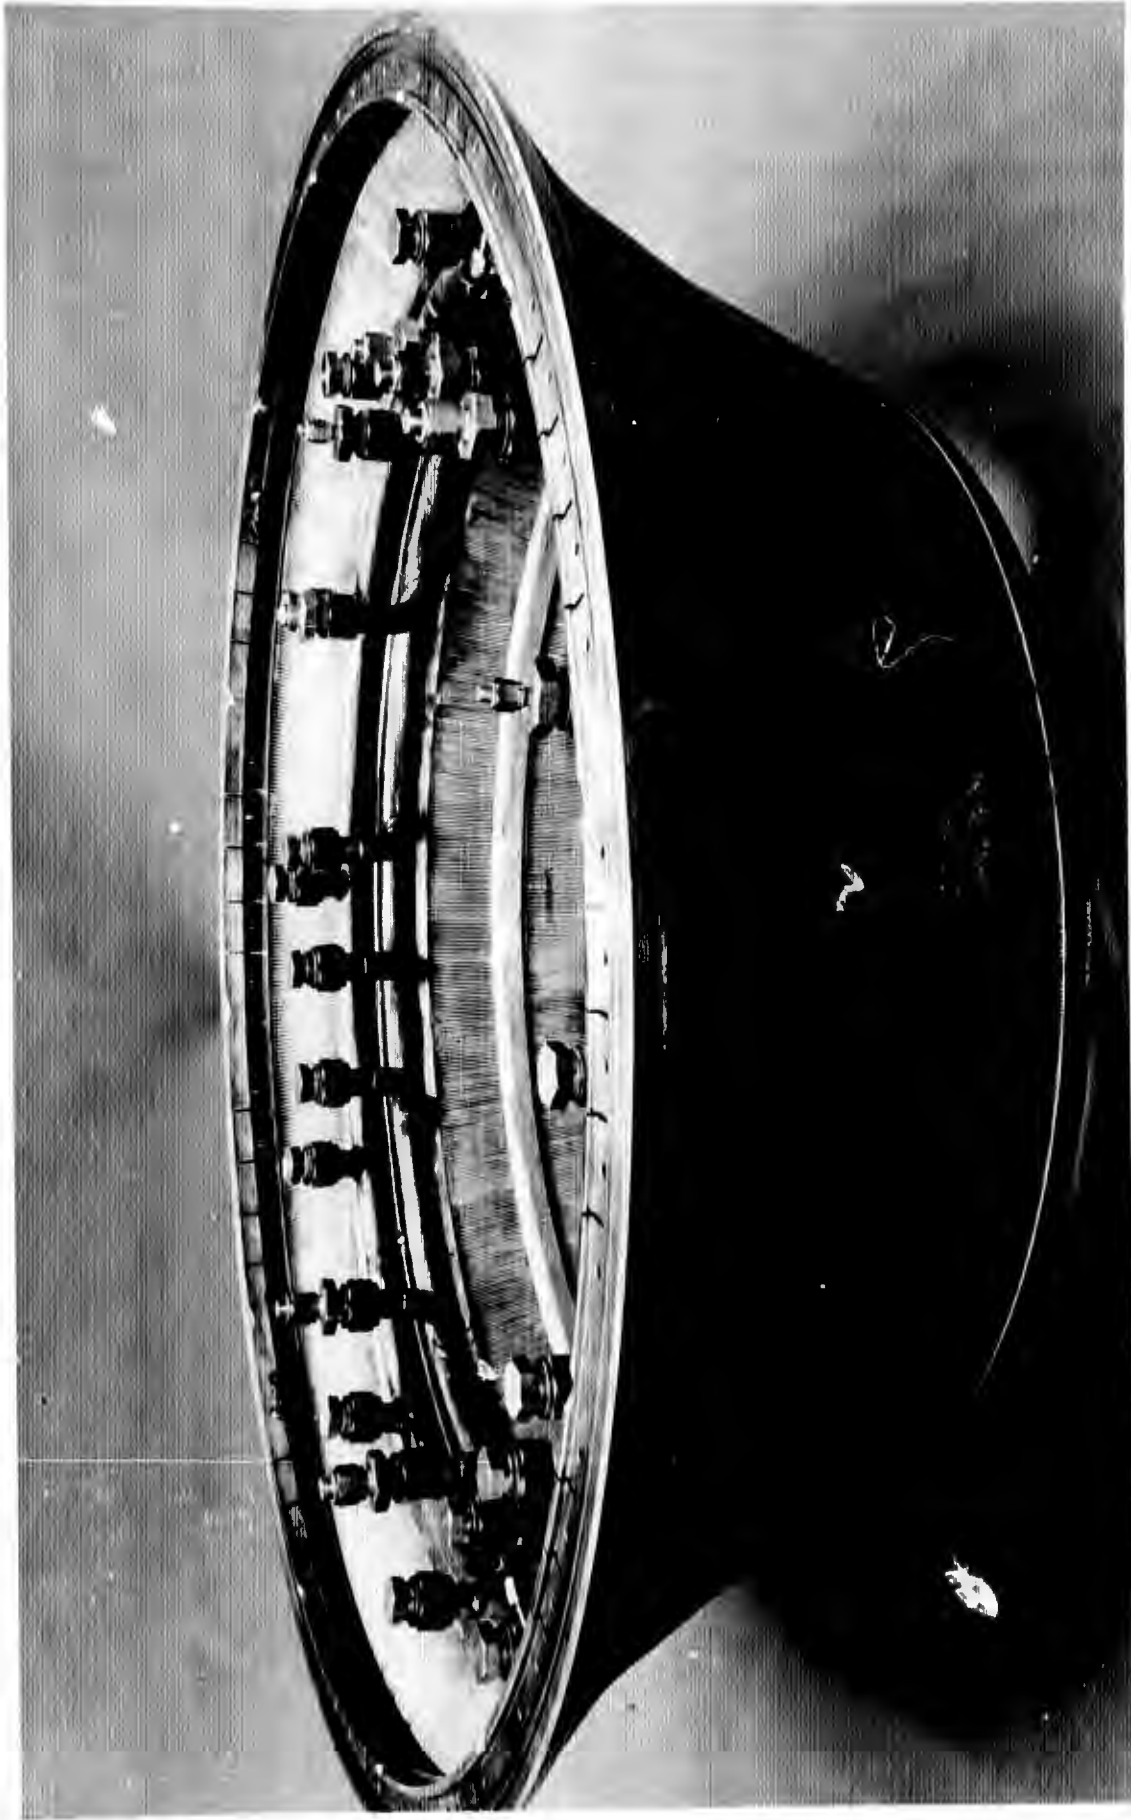
1EH32-1/30/70-C2D

Figure 139. Completed Nozzle Extension (U)

(C) The completed nozzle assembly is shown in Fig.139. The cooling circuit was basically a two-pass arrangement. Hydrogen flow from each of the segment inner bodies enters the nozzle upper manifold (Fig. 138), flows upward in alternate

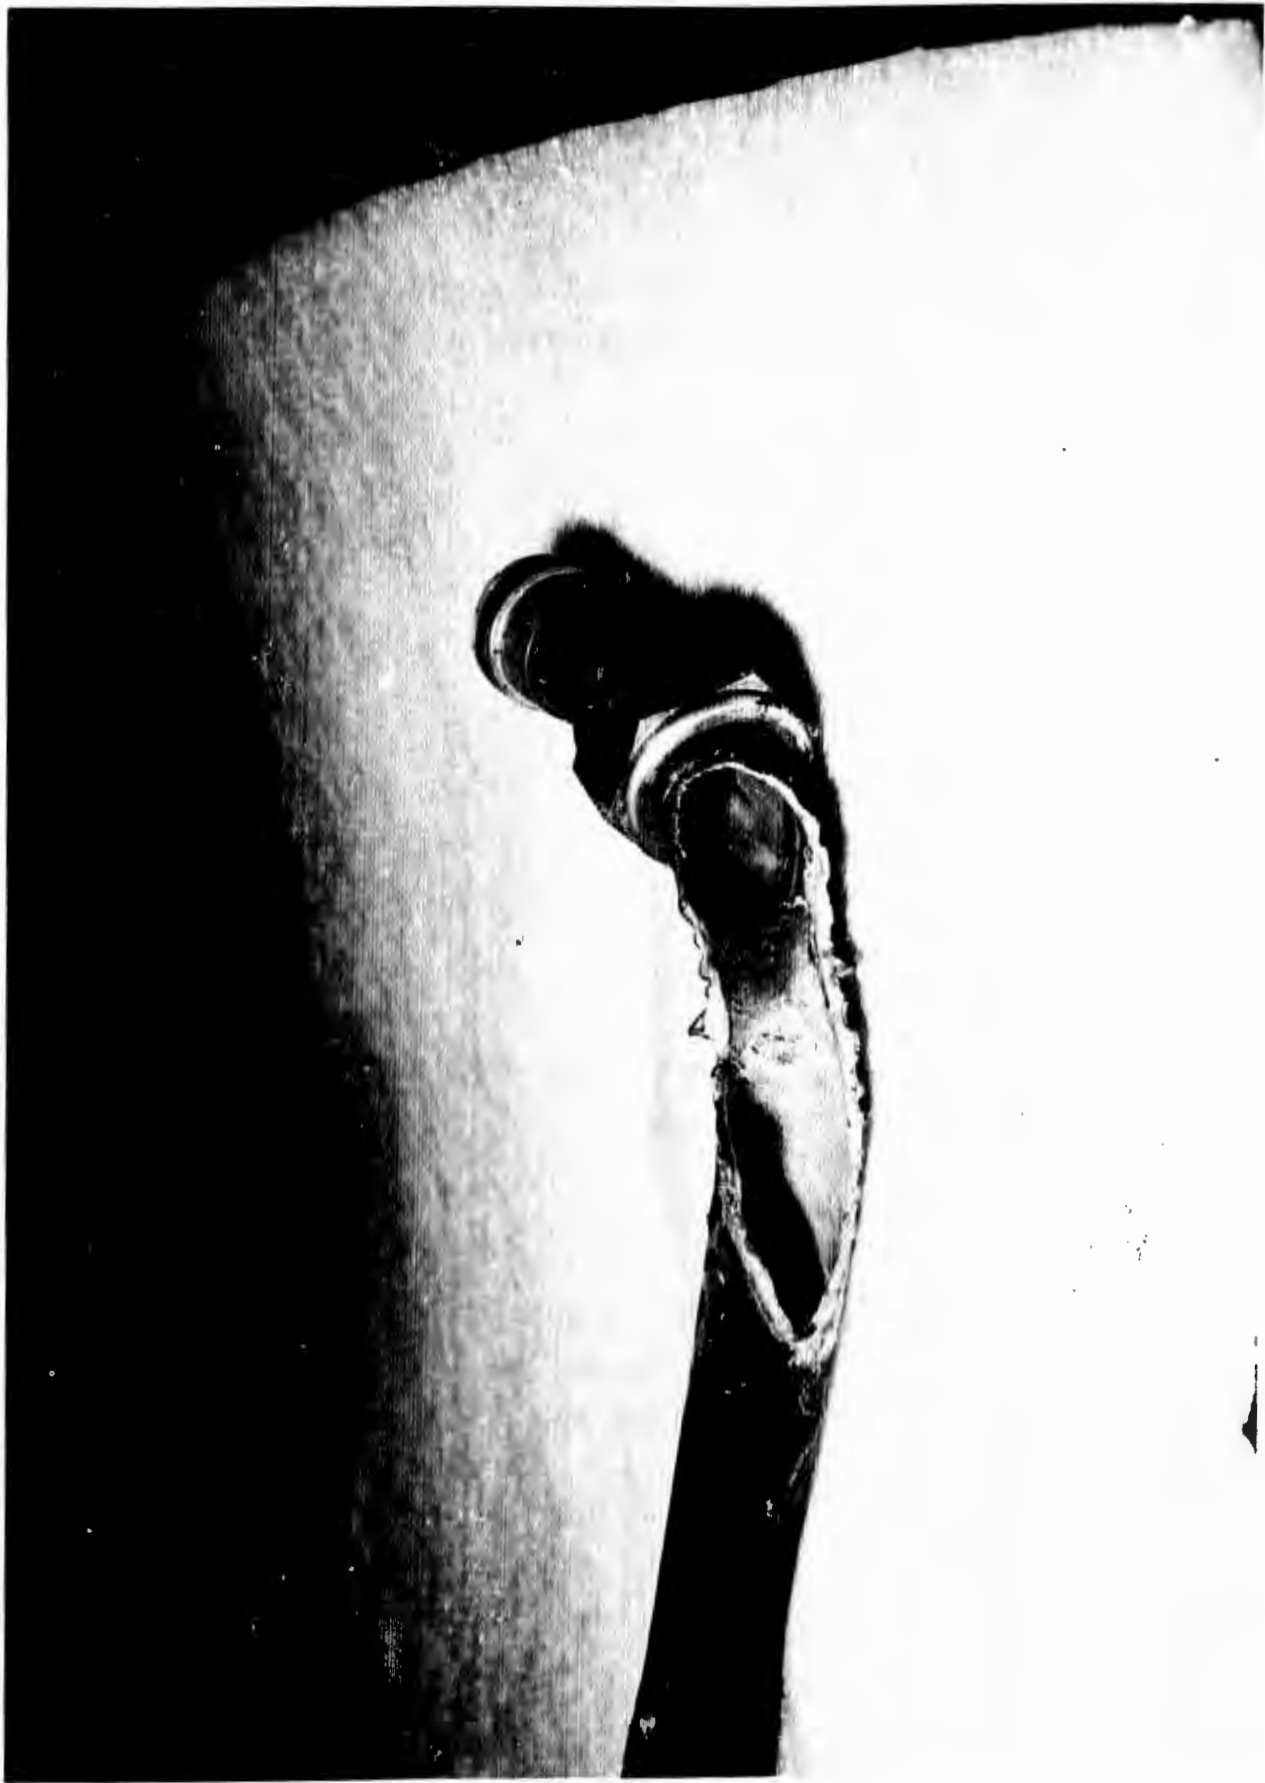
IXZ35-4/2/70-R1A

Figure 152. Facility Oxidizer Purge Tube Posttest 005 (U)

(C) The next attempted hot-fire facility activation test used a single segment assembly mounted in a new thrust mount. The test was planned for 3 seconds at 400-psig chamber pressure. The test was terminated prematurely by the automatic fire detection link cutoff device. The detected fire was a result of burnout of the oxidizer helium purge tube (Fig. 152). The tube burnout was attributed to moisture contamination. There was no segment hardware or other facility damage. Ignition and starting characteristics of the segment were smooth and normal.

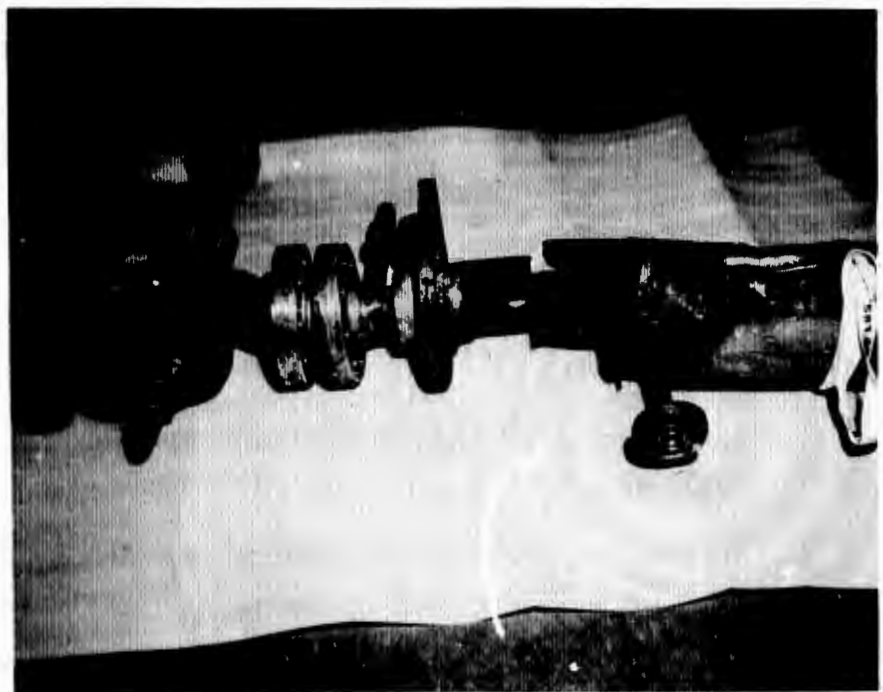
Figure 156. Main Oxidizer Valve and Inlet Line (U)

1. Internal burning of the MOV
2. Burning of the 1-inch purge check valve located in the lower half of the MOV body (Fig. 155)
3. Burnout of the 3-inch jacketed oxidizer line at its entrance to the altitude capsule (Fig. 156.) along with burning of adjacent electrical wires and control tubing

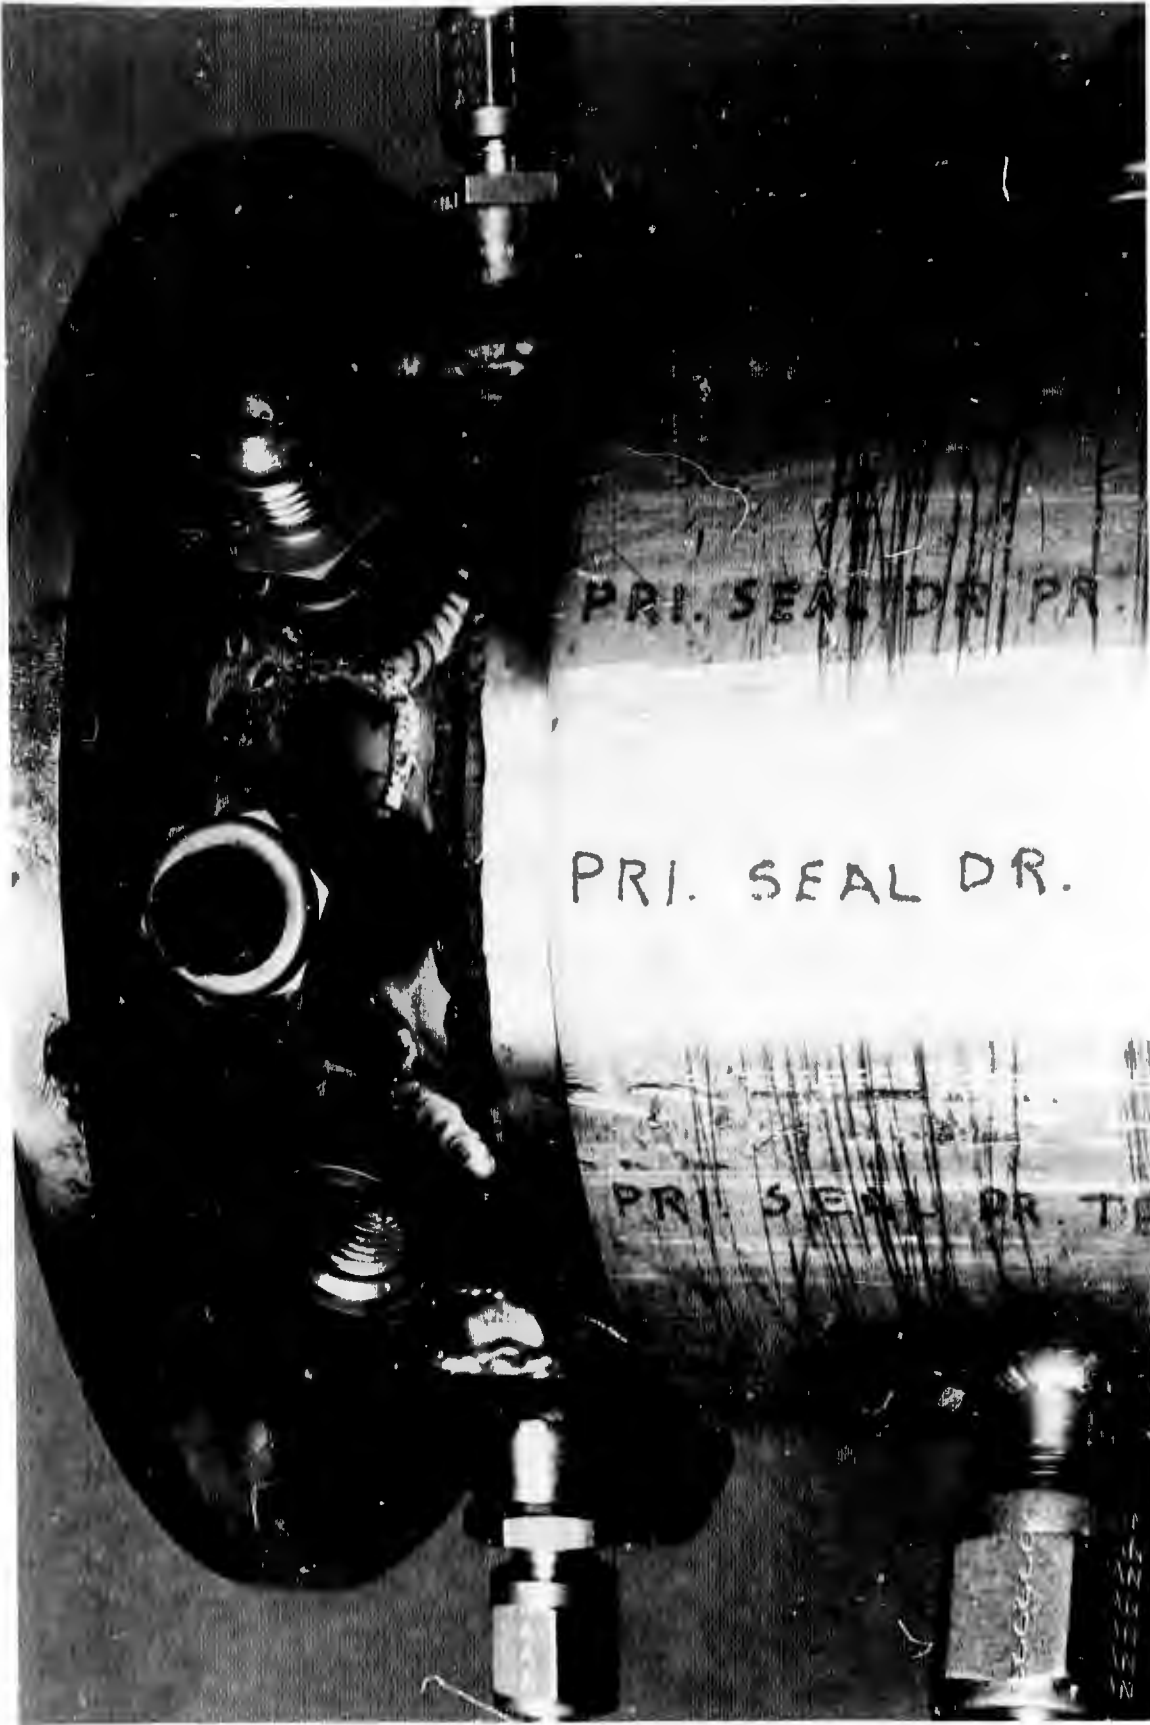
Figure 192. Main Tester Damage--View of Outer Housing Seal End (U)

(C) Analysis of the damaged hardware indicated that the fire started in the rear bearing and burned the shaft away in both directions from the bearing, finally burning a hole under the primary seal mating ring which allowed the seal and drain area to be damaged by fire. The majority of the burning occurred after cutoff while the shaft was stationary. The burning apparently continued until the available oxidizer was consumed.

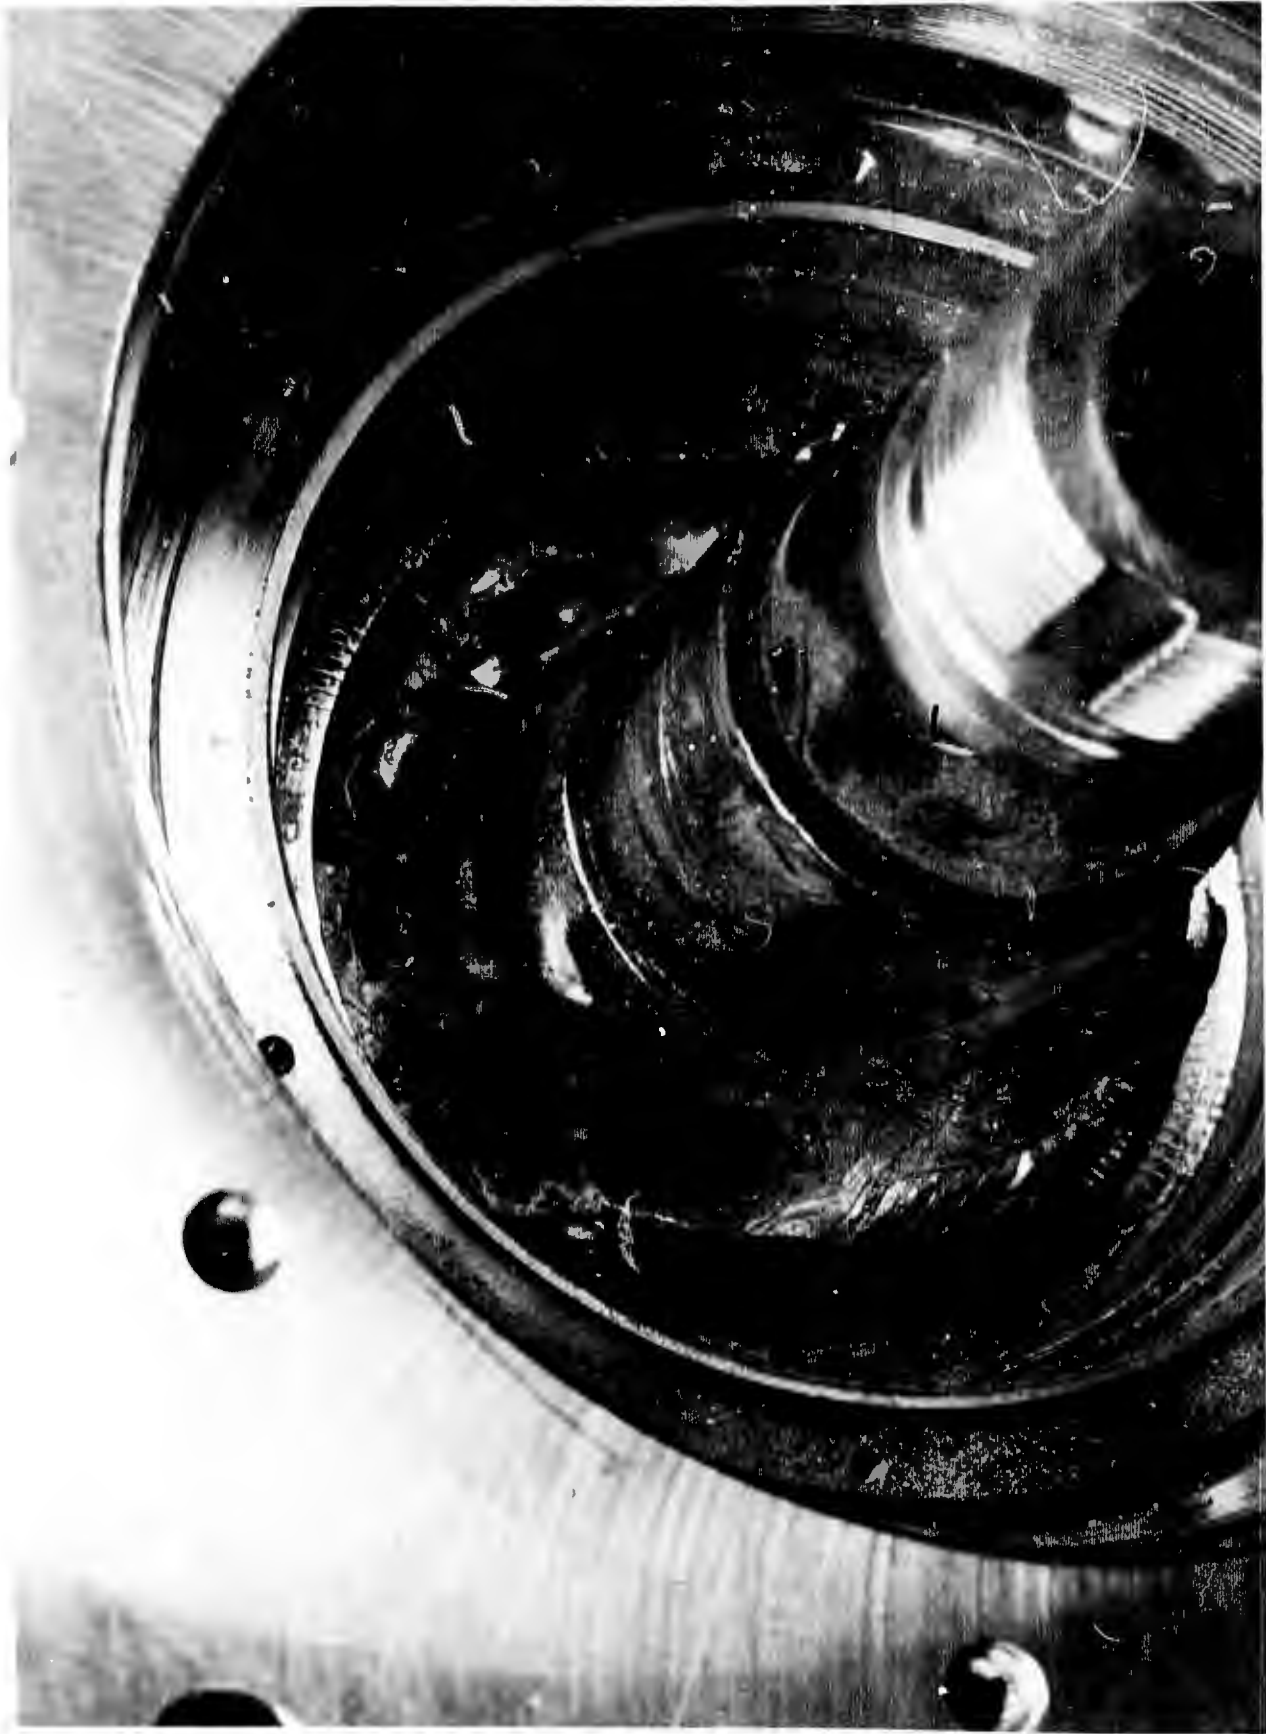
1EH95-11/20/69-C1B

Figure 193. Main Tester Damage--View of Seal Cavity (U)

(C) Posttest inspection of the tester assembly revealed that two holes were burned through the housing at the primary seal drain (Fig. 192). The shaft was locked solid (Fig. 193). There was a heavy deposit of fluoride coating in the oxidizer outlet port.

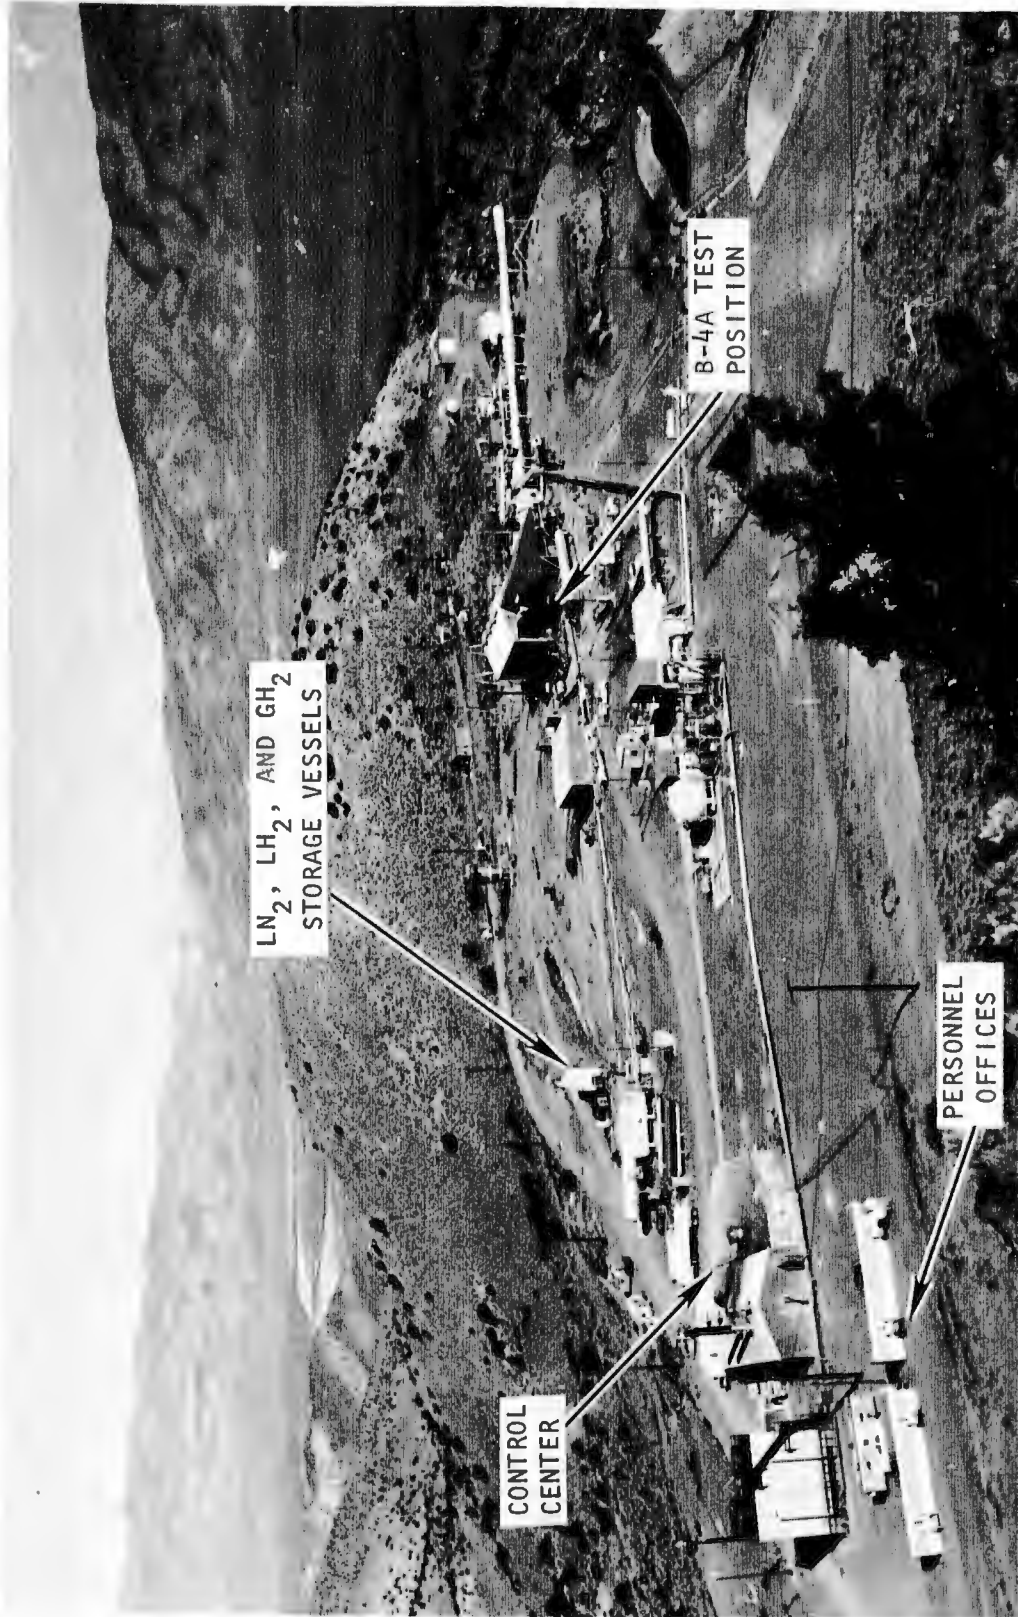
6RE11-10/29/69-R1

Figure I-5. B Area Test Facility, NFL (U)

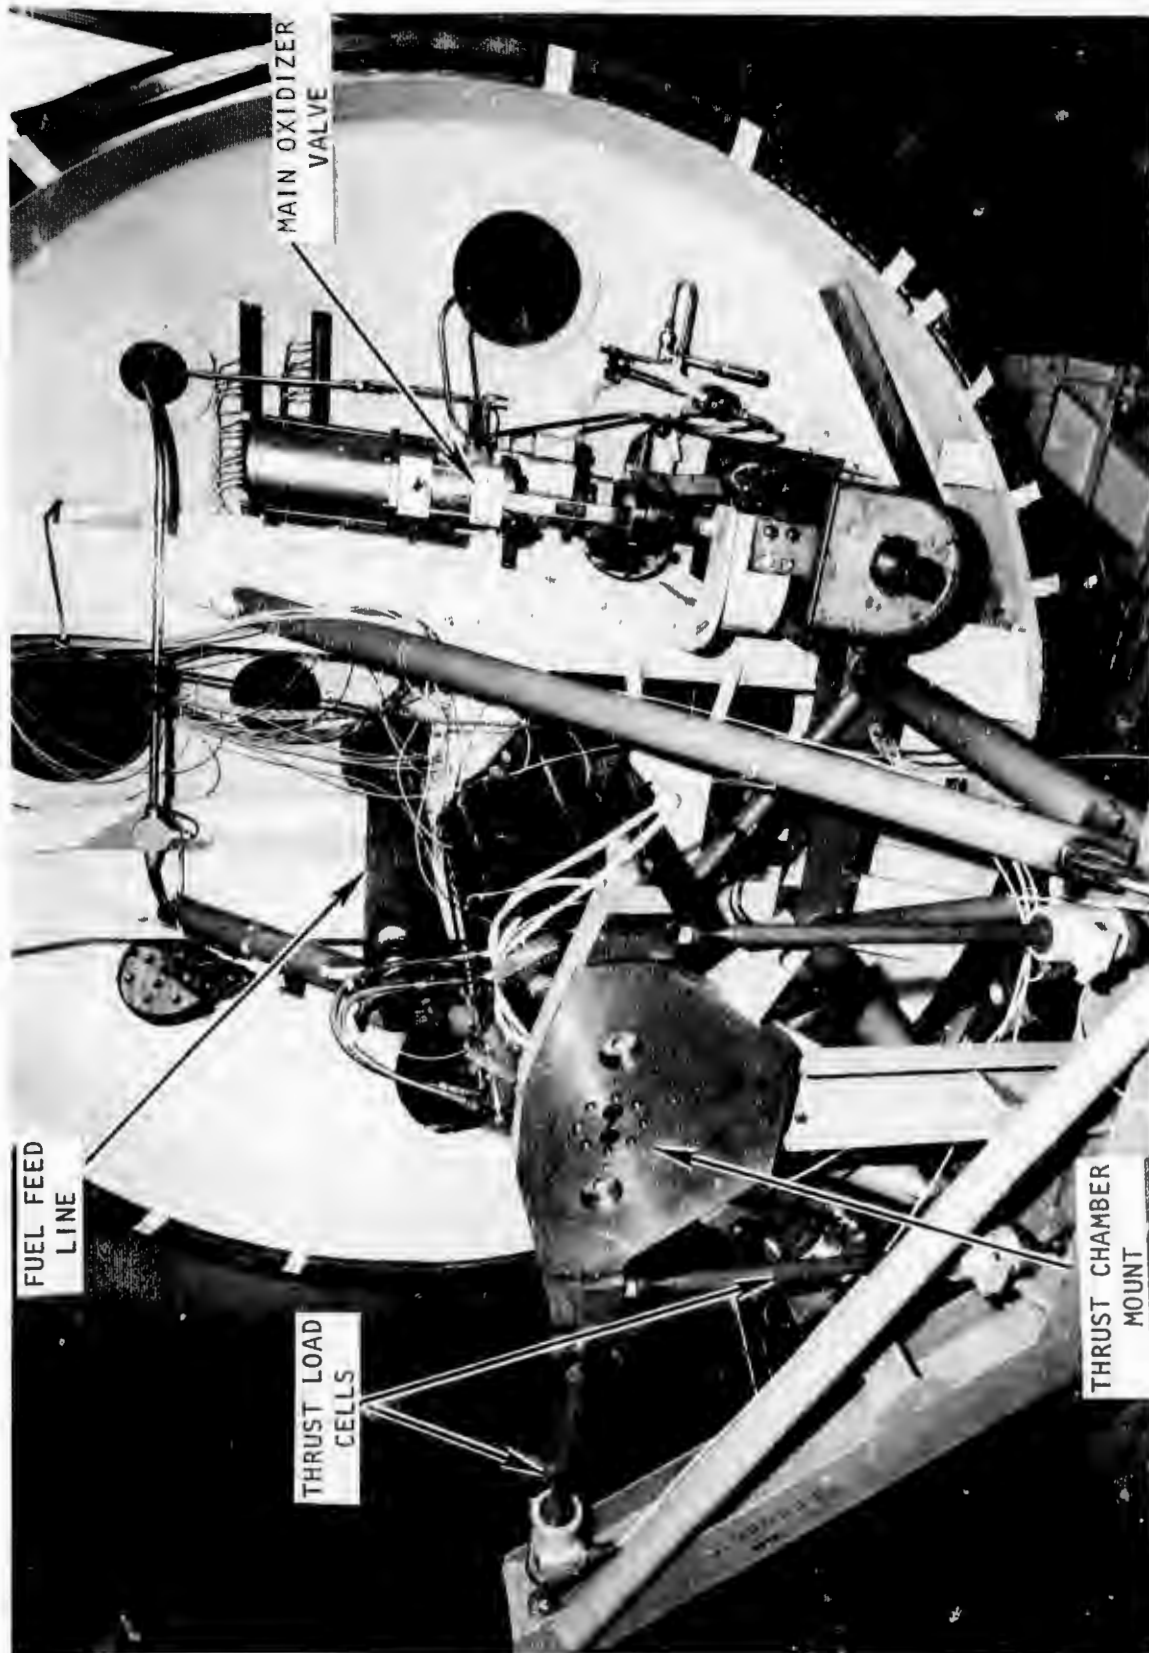
6RE36-2/4/70-R1B

Figure I-9. Altitude Capsule Thrust Mount (U)
