**LRAPP TEST BED  
ARRAY CABLE FAILURE ANALYSIS (U)**

**30 JULY 1971**

(U) This report is a diagnosis of the LRAPP Test Bed array cable failure. The high risk aspects of the Test Bed implantment that are identifiable with the array cable's properties or its handling are considered, and the particular cable properties which had major influence on the implantment are identified and their effect analyzed. Methods for retrieval of the Test Bed are then discussed and recommendations for enhancing the certainty of success for future suspended array implantments are suggested.

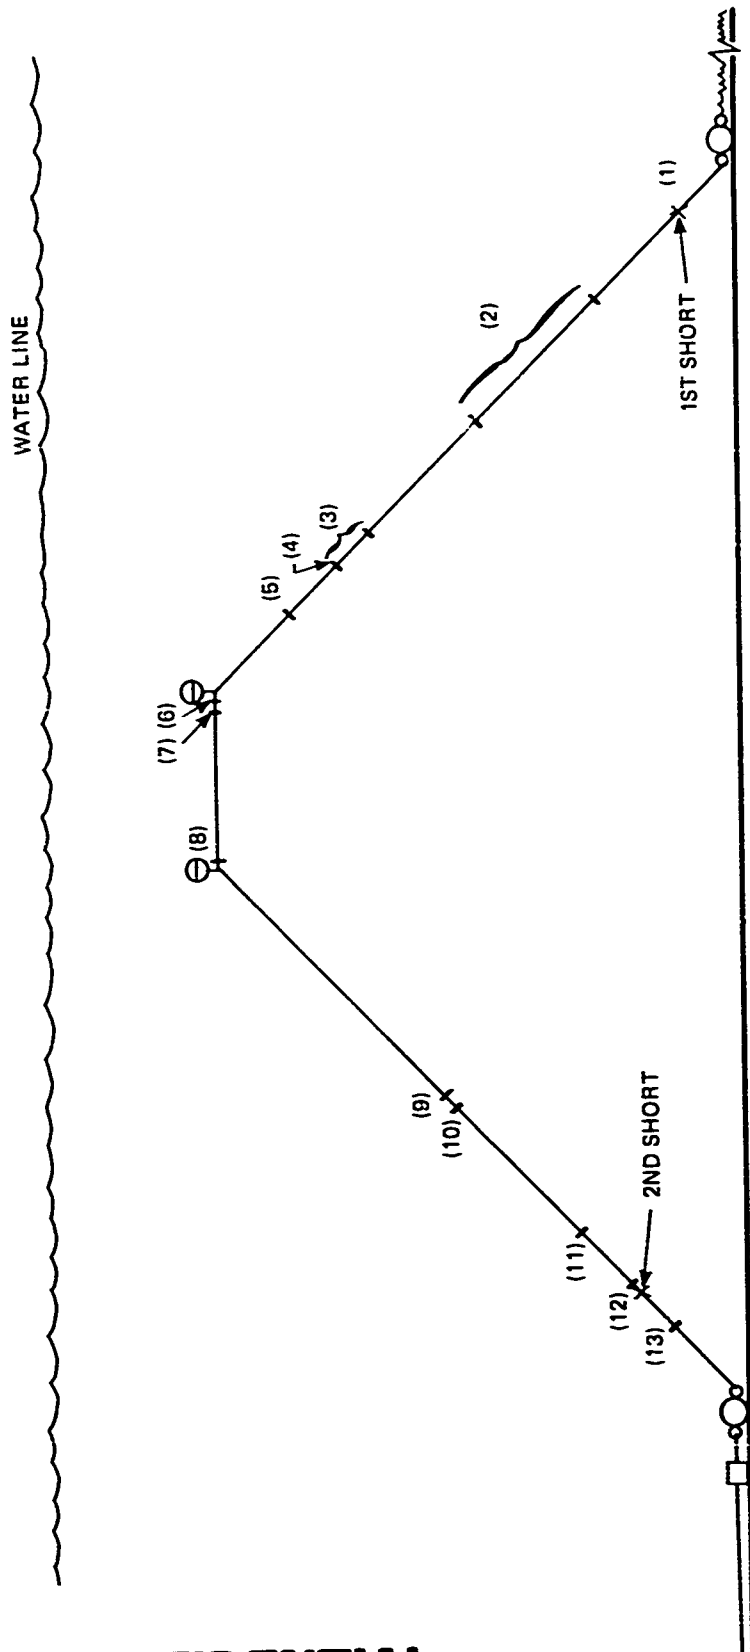
FIGURE 2. LOCATIONS OF IMPLANT IRREGULARITIES  
AND ELECTRICAL SHORTS

- (3) Between instrument packages located 11,000 ft. and 13,200 ft. above the offshore anchor. Cable was observed twisting in the tank. No further mention of this problem is made so it can be assumed that the twist distributed itself satisfactorily.

- (5) 13,230 ft. up the offshore leg at an instrument package. The array went dead electrically as this instrument package went over the drum. The electrical wire was purposely cut within the package and tested in both directions. There were no electrical faults looking shoreward. Looking seaward, a shield-to-outer-conductor short was detected, and its location was determined to be in the vicinity of the very first hockle. At this point the choices were to (a) haul back cable to the shore for repair (b) electrically terminate the array at the cut (c) proceed laying cable. The first possibility was ruled out because of the rough weather, the length of time it would take (including time to remove the glass spheres) and the lack of confidence in performing this tricky procedure successfully. The second remedy was discarded in favor of the third because the ship was heaving, cable tensions were quite high and it was only a short distance to the point where the offshore

- (7) 350 ft. inward from the offshore buoy. A kink developed in the cable. There was no measurable electrical damage so the kink was stress-relieved with 3/8" wire rope using preformed grips and turnbuckles.

- (10) 7,900 ft. up the inshore leg. A very bad kink occurred. In addition to the structural damage, the cable's electrical conductivity was broken. The entire segment of kinked cable was cut and the remaining cable ends were respliced electrically. The connecting segment was then overmolded to the armor outside diameter and taped.\* Steel wire (probably 1/2" in diameter) together with deadeye stoppers and preformed grips provided a tension bypass for that segment. Payout was then resumed.

(U) The short which eventually blanked out the entire array can be linked to at least one, and possibly three, excessive twists in the cable during payout. In particular, the diagnosed location of the short is very close to the severe twist which developed just below instrument 5H4, located 4,200 ft. up the inshore leg. In this case the cable "looked good" mechanically and checked out electrically coming out of the ship's machinery, so that not even splice rods were used. However, this particular twist may have initiated a condition that led to a short under subsequent stresses, as in the previous case discussed. Tensions in this leg just prior to inshore anchor touchdown would have been around 3,700 lbs. had this phase of the implantment truly been quasi-static. However, severe ship motion \*\* due to extremely rough weather produced dynamic cable stresses in the SDC ranging  $\pm 50\%$  about the nominal static values. Similar oscillatory stressing of the array cable inshore leg coupled with possible twisting and entangling effects due to torquing\*\*\* certainly could have aggravated a weakened section of cable to the point of electrical failure. Dynamic stressing may have been enhanced even further by in-situ motions of the inshore anchor.\*\*\*\*

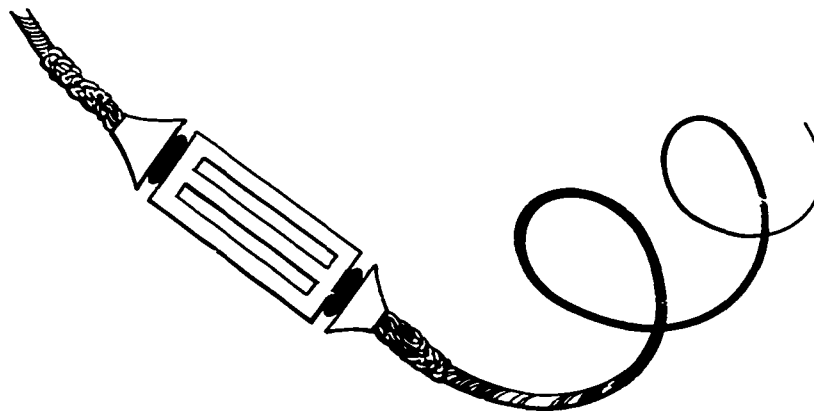
FIGURE 4. BUILDUP OF TWIST

(U) Actually, the total twists  $TX$  will not distribute itself uniformly -- it will be greatest in the vicinity of the machinery, then would decay exponentially.\* Very little twist would be propagated beyond the first 2 or 3 windings in the truck flatbed. Moreover, each instrument package, being both massive and stiff, would be a point of twist accumulation, as illustrated in Figure 4. Twisting,

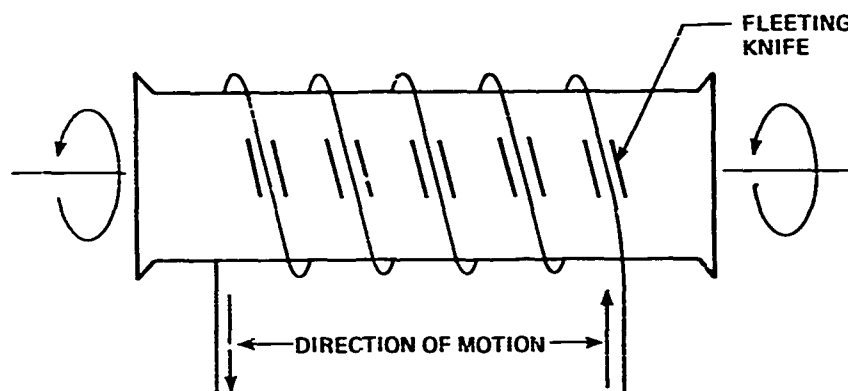
FIGURE 5. ACTION OF DRUM AND FLEETING KNIVES

(U) Now that we have come up with an explanation for the twists that fits the occurrence of events, let us hypothesize how the drum and fleeting knives actually impart the twist. The cable is wound around the drum and fleeting knives in a right hand direction (Figure 5). In order to keep the cable moving as indicated, the force of the fleeting knives must be in the vector direction of drum rotation, which is towards the left in Figure 5. Otherwise the windings

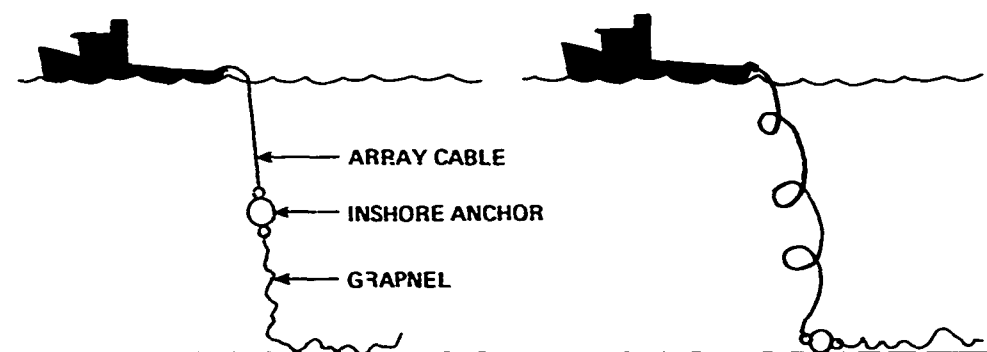
FIGURE 6. TORQUING DURING IMPLANTMENT

(U) Lowering of the offshore anchor puts the array cable in a state of torque-free tension. However, touchdown of the anchor is followed by a twist-free release of tension. With total slack in the leg, as was the case with the Test Bed, the tendency to form loops as a means of torque relaxation (as illustrated in Figure 6) was certainly there. Furthermore, since tension in

that leg eventually built up into the thousands of pounds again, kink formation was definitely a possibility.

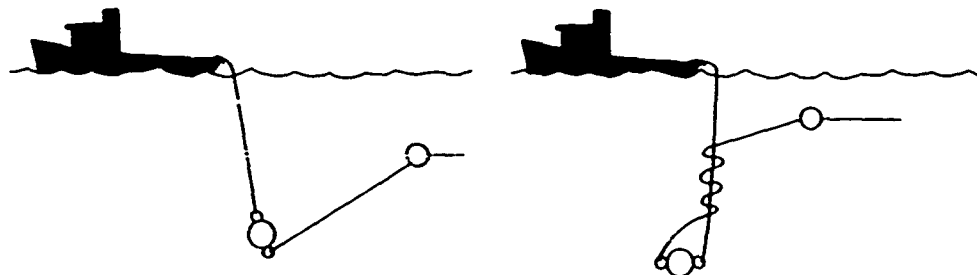
FIGURE 7. ENTANGLEMENT DUE TO TORQUING

illustrated. The consequences could be entanglement of the glass spheres, instrument cages, etc., with resultant cable stresses possibly well beyond the design range. It would be futile to attempt to construct a failure mechanism under this cycle of loading should the array have indeed torqued. However, it is sufficient to say that any cable torquing tendencies great enough to have caused entanglement during lowering would have certainly made the entire procedure unacceptable from a risk standpoint.

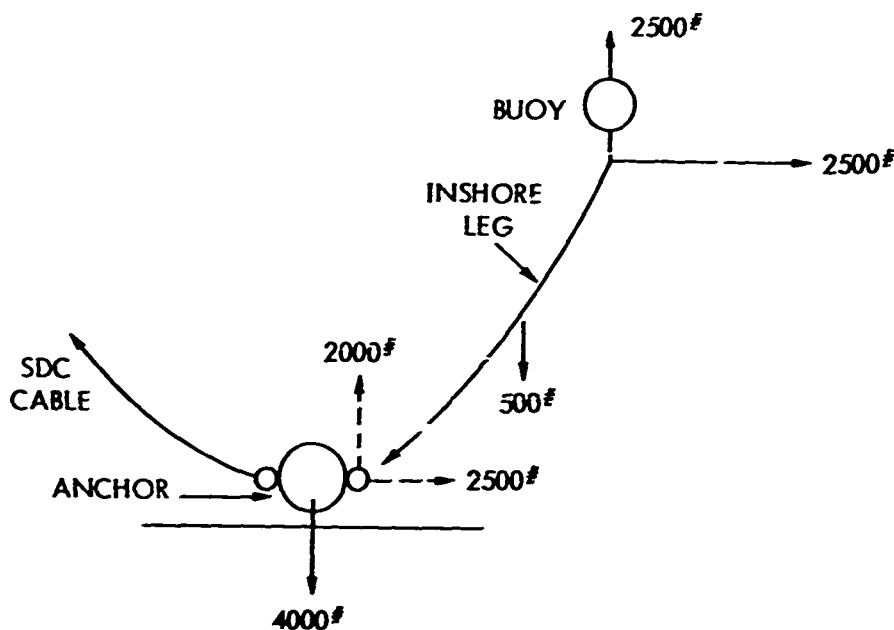
FIGURE 8. INSHORE ANCHOR TOUCHDOWN

(U) The most significant defect in the array cable implantment plan was manifested in failure to identify actual touchdown of the inshore anchor. Recall from Section 2.2 that there was no reduction in cable tension aboard ship at the SDC cable payout point corresponding to inshore anchor touchdown. In order to see why, let us consider forces on the inshore anchor just prior to touchdown. Assuming the array to be in its final configuration at this instant (Figure 8), we find from equilibrium considerations that the force of

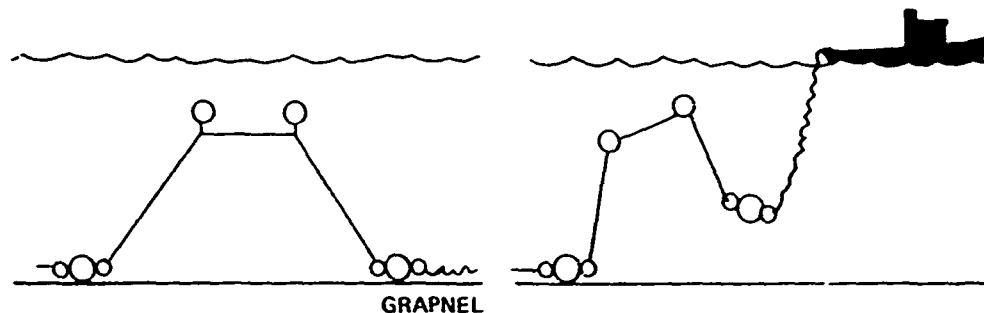
FIGURE 9. RETRIEVAL OF OFFSHORE LEG

(U) Under "optimum" positioning, the inshore leg will be vertical when the anchor is first pulled (Figure 9). The ship will then proceed shoreward

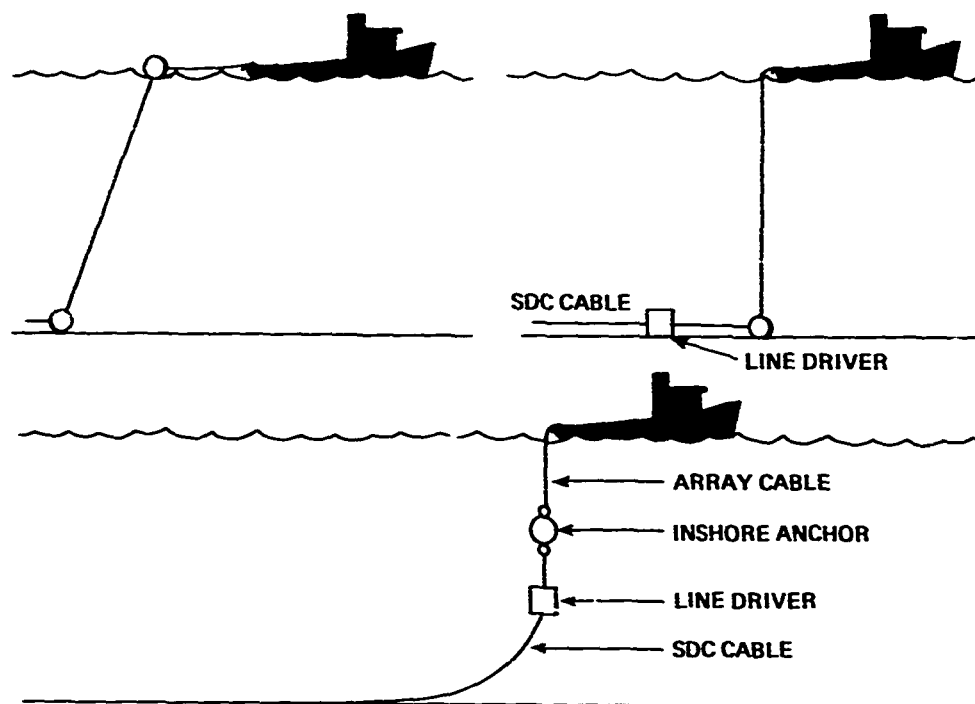
FIGURE 10. RETRIEVAL OF INSHORE LEG

at a speed which keeps this line vertical under subsequent haul-in. Static tensions for the inshore leg (neglecting drag forces) will be determined by

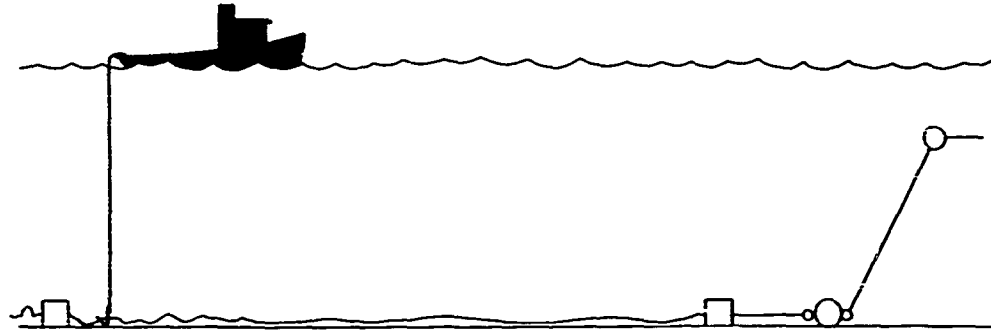
FIGURE 11. RETRIEVAL FROM INSHORE END

(U) Retrieval from the inshore end with minimal risk of damage to the SDC should begin with grappling close to shore where some slack exists (Figure 11). After cutting this cable on deck, SDC haul-in from the inshore direction commences.

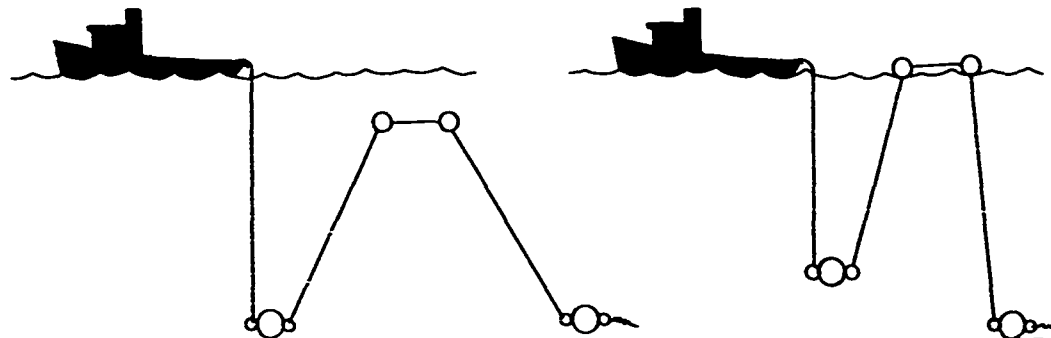
FIGURE 12. RETRIEVAL FROM INSHORE END (CONTINUED)

(U) The primary objection to this procedure is the additional effort in recovering all that SDC cable, especially if its present location is a useful one for some future effort. A second shortcoming is the excessive tension in the SDC during inshore anchor recovery. Referring to Figure 12, we observe

that the highest tension in the SDC occurs just as the anchor is pulled up. Assume the ship is positioned directly above the anchor so the weight to be lifted is  $300 + 4,000 - 2,500 + 0.517 \times 14,400 = 6,400$  lbs, plus additional

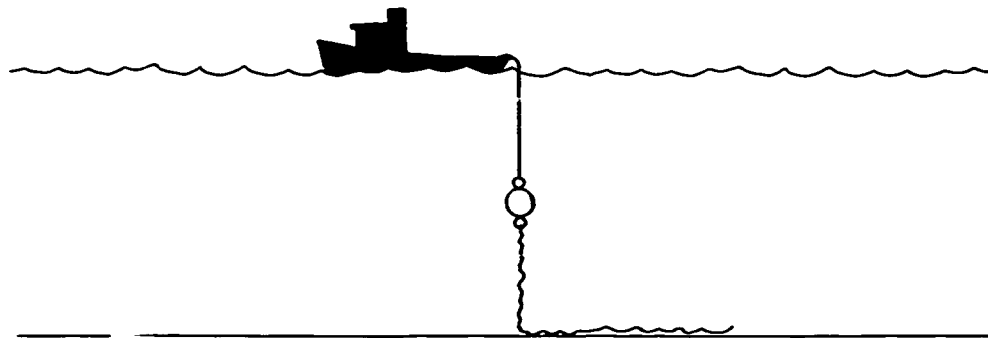
FIGURE 13. TENSIONS ON OFFSHORE LEG DURING RETRIEVAL

(U) The inshore leg can now be recovered under a very nominal range of tension -- 4,000 lbs. dropping to zero, which is important in view of its weakened condition. The horizontal leg likewise can be hauled in without any difficulty. However, tensions on the offshore leg will be considerably higher. Referring to Figure 13, we observe that the greatest static tension will occur just before the offshore anchor is retrieved, where its weight in air plus

the weight of 14,400 feet of grapnel line must be carried. Thus, the maximum static load is  $7,000 + .125 \times 14,400$ , a total of 8,800 pounds. With a dynamic amplification factor of 2, we get possible tensions of 17,600 pounds. If the cable has been weakened substantially then breakage is possible. If it breaks, we can then recover the broken piece by grappling for it from the outboard end via the stable braid. In any case, diagnostic efforts might be difficult as a result of the high tensions encountered.

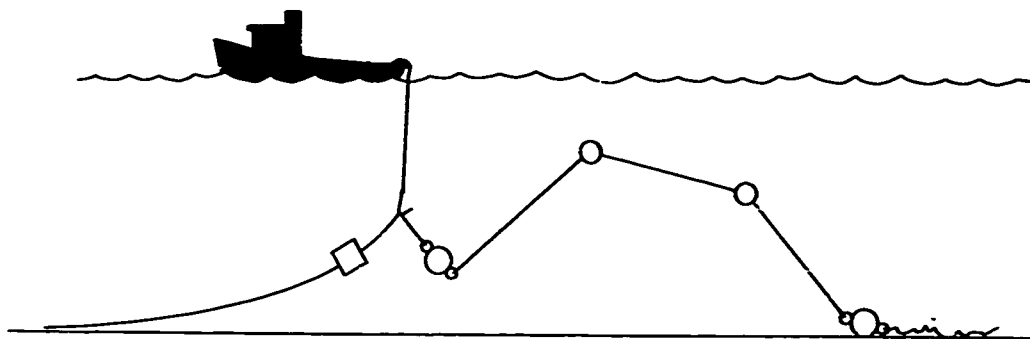
FIGURE 14. RETRIEVAL AT LINE DRIVER

- (3) Grapple for that portion of array cable lying between the inshore anchor and the line driver (Figure 14). If successful, cut the cable on deck, attach grapnel to the shoreward end for future splicing. Then proceed as described in Section 5.3. If the cable breaks before

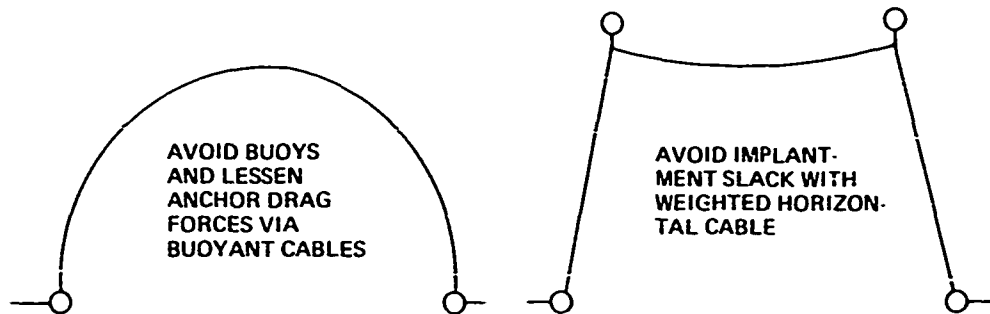
FIGURE 15. USE OF POSITIVE AND NEGATIVE BUOYANCY CABLES

give examples of how weighted or buoyant cable can help the implantment process.

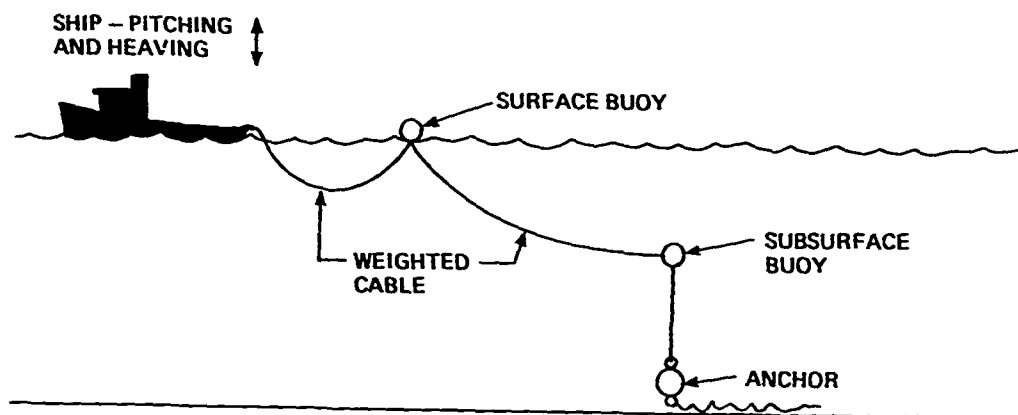
FIGURE 17. FREEZING THE IMPLANTMENT

- (17) "Freezing" the implantment. It should be possible to freeze the partially implanted array in a "safe" configuration while riding out a storm or an intolerably high sea state. Achievement of a safe configuration might require attachment of a sub-surface buoy, or of several buoys, for example. Possibly the implantment procedure should be structured so that no stage of the operation is more than, say, 1/2 hour away from a "safe" configuration, either through additional payout, haul-in, buoy attachment, or a combination of these. An example of a safe configuration is illustrated in Figure 17.

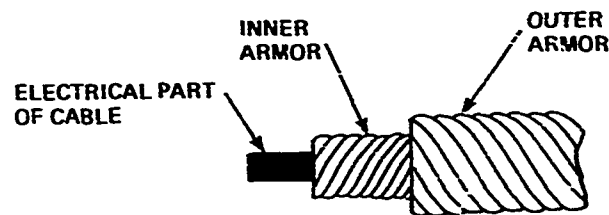
FIGURE A.1 DOUBLE ARMORED CABLE

(U) The outer winding of armor on the LRAPP Test Bed cable has a right hand lay, as shown in Figure A.1, so the words right hand twist and left hand twist

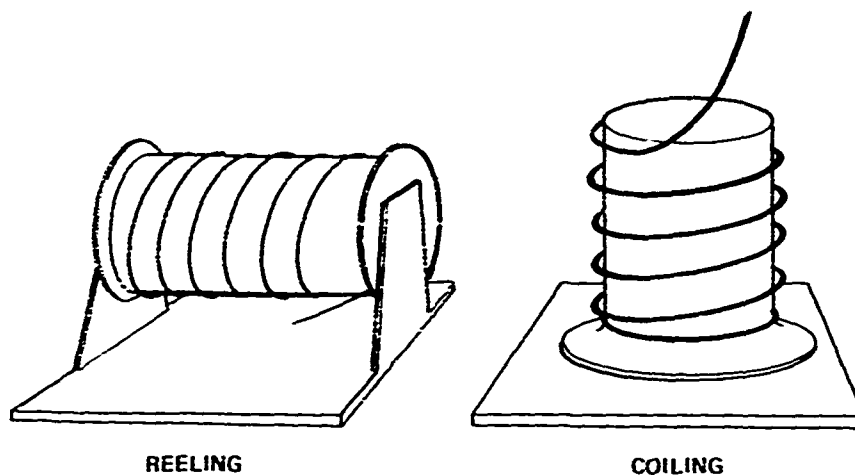
FIGURE A-2 REELING AND COILING

Reeling is pure bending, while coiling is a combination of bending and twisting. The direction of reeling is circumferential. The ultimate direction of coiling is axial. The difference is shown in Figure A.2. Likewise, cable on a reel may be unreeled, i.e., pulled off circumferentially, or it may be uncoiled (pulled off axially). The difference in the two effects may be observed by removing motion picture film from a reel by each of the two processes. Of course, the word "coil" does not necessarily imply a reel. Cable, for example, can be

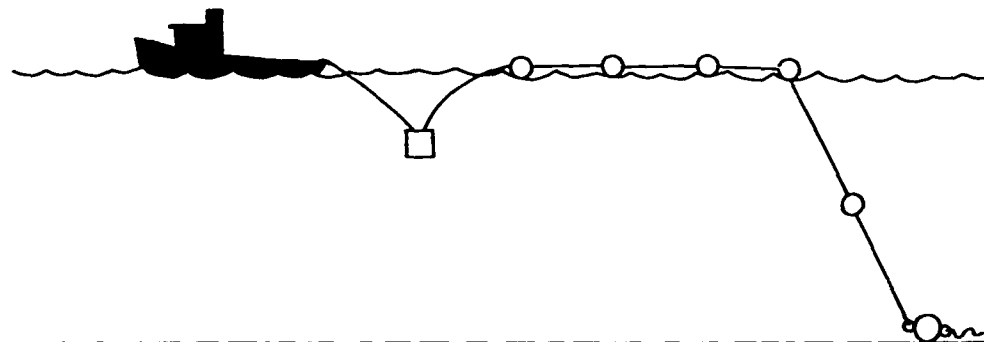
FIGURE C.2 SIX ELEMENT LUMPED MASS DYNAMIC MODEL

(U) In addition, a dynamic analysis of the array was performed for the interval between inshore anchor deployment to inshore anchor touchdown. A 6-element lumped mass model, shown in Figure C.2 at time  $t = 0$ , was programmed for the computer. The forces included array weight (or buoyancy) and the vector sum of normal and tangential drag. The masses included the actual weights in water plus the virtual mass terms.

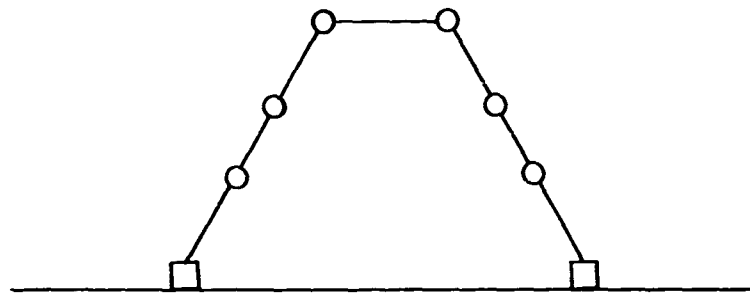
FIGURE C.3 CURRENT DRAG FORCES ON SIX ELEMENT LUMPED MASS MODEL

(U) Finally, the effects of currents on the implanted array were calculated. A six-element model was used (Figure C.3), and both in-plane and out-of-plane currents were inputted. Results showed no significant changes in array shape.

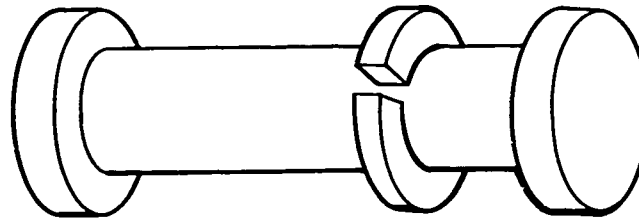
FIGURE D.1 ASSEMBLY REELS

(U) The cable segments less than 200' in length were stretched out on the floor of the plant while the larger segments were transferred onto individual 2' diameter reels which were partitioned as shown in Figure D.1. By winding

only an initial length of cable on the smaller section of reel and then switching over to the larger section, it is possible to subsequently attach connectors to both ends while the cable is still on the reel. This was indeed done for all the cable terminations.

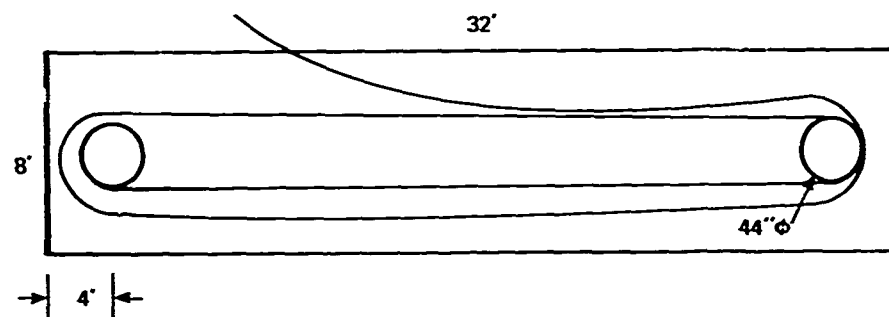
FIGURE D.5 LOADING OF ARRAY ONTO TRUCK FLATBED

(U) The array went from the tank to the building by retracing its previous path (see Figure D.5) and went from the building to the truck with the help of a 6 ft. power-driven pulley. The overall dimensions of the flatbed are shown in the diagram below. Bullnoses of 44 in. diameter were fixed at each end and

the cable was laid around the two stumps as shown in Figure D.5. Thus, the minimum circumference of cable was  $2 \times 24' + 44 \times \pi \approx 12$ , or 60 ft., while the

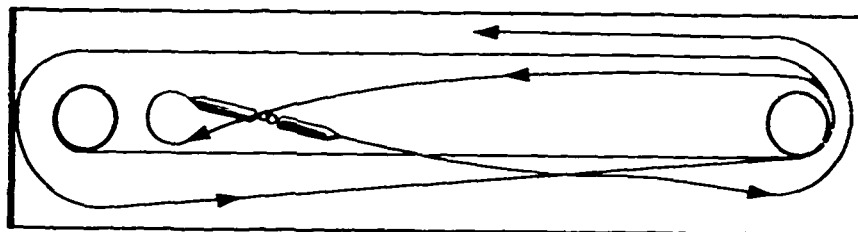
FIGURE D.6 LOOPING OF CABLE IN TRUCK FLATBED

(U) The cable laid exceptionally well in the truck with the exception of a few instances in which a cage segment had to make the sharp turn around the bullnose. Unable to bend the cage segment readily, deBell broke the counterclockwise pattern by looping the cable just before the bullnose, stretching the instrument package across the truck as shown in Figure D.6, and then continuing in a counterclockwise direction.

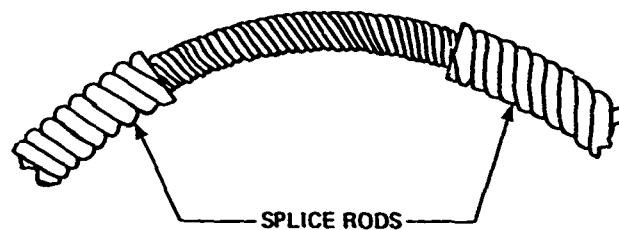
FIGURE D.7 BENT CABLE BETWEEN SPLICE RODS

(U) During loading of the array on the flatbed a short length of cable connecting two instrument packages was noticed to be bent severely because stiff

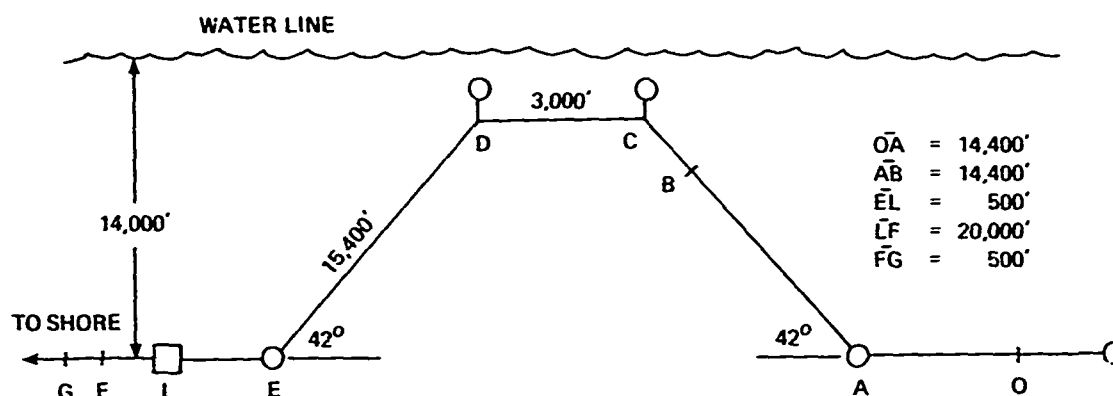
FIGURE E.1 IMPLANTED TEST BED

(U) The implanted Test Bed is sketched in Figure E.1. Details omitted are not germane to this discussion and may be found in reference (3).

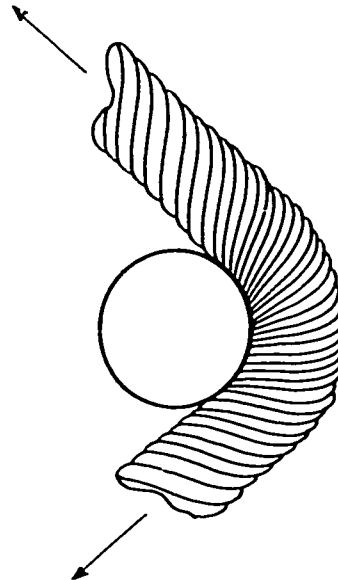
FIGURE G.5 COMBINED TENSION AND FLEXURE

(U) Combined tension and bending, as the case of a cable which is reeled, passed over a pulley or sheave, etc., can lead to the filéting effect described earlier, only at a smaller curvature. A cable's maximum allowable tensile force should be determined as a function of radius of curvature to which the cable will be bent.
