**TRECOM TECHNICAL REPORT 64-19**

**INVESTIGATION OF TERRAIN ROUGHNESS**

**May 1964**

**MIDWEST RESEARCH INSTITUTE  
Kansas City, Missouri**

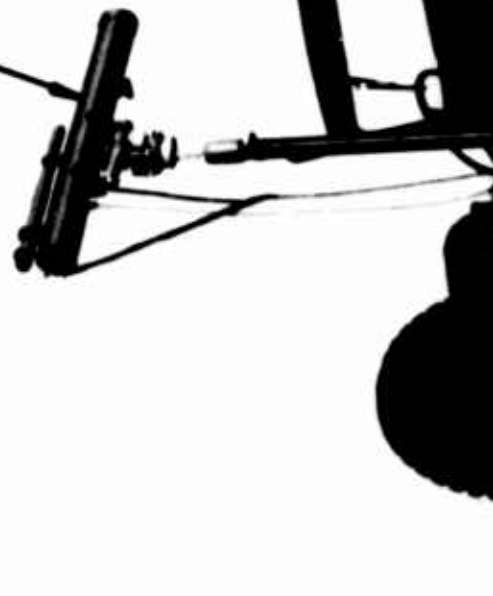
Figure 1. Terrain Profilometer System

The principle of operation of the terrain profilometer is somewhat analogous to the rod and level used in conventional surveying methods. The light-source tube, mounted on the jeep, replaces the engineer's level by projecting a collimated beam of light over the surface to be surveyed (see Figure 1). This light beam is adjusted to level, as indicated by a standard surveyor's spirit level, to establish the required reference from which measurements can be made (see Figure 2). The terrain sensor (the measuring instrument which replaces the rod) is towed over the survey path and senses the vertical position of the light beam. The distance between the surface being surveyed and the centerline of the light beam is measured every 6 inches of travel and recorded in digital form on punched paper tape.

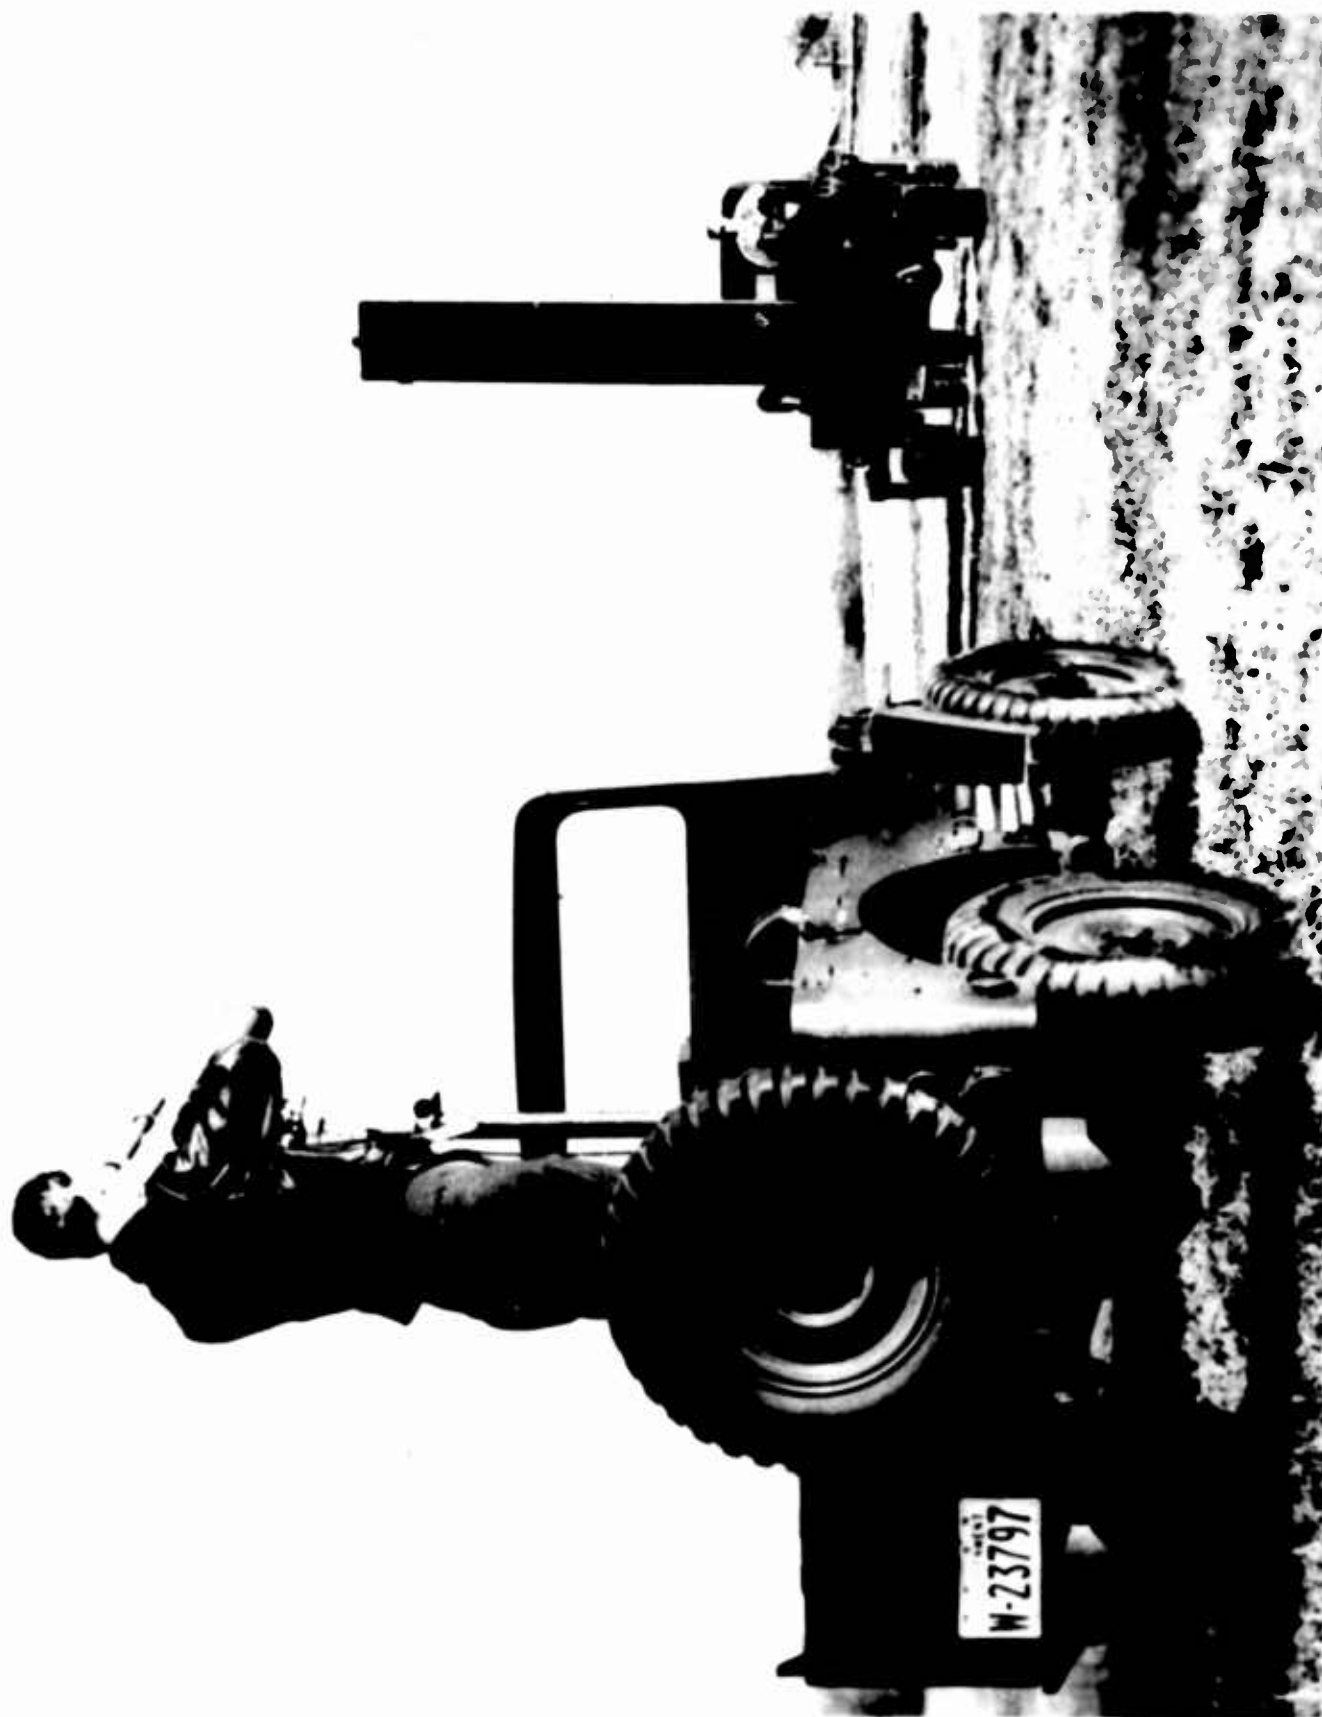
Figure 3. Desert Survey Operation

Initial consideration of the general operational requirements of the terrain profilometer system led to the design of a special trailer to support the profile sensor (see Figure 3). The trailer-mounted design permitted positioning the odometer wheel between the weight-carrying wheels to reduce the possibility of exceeding its vertical travel while in rough terrain. A trailer-mounted system further permits greater flexibility in the selection of a (towing) vehicle.

Photographs of Yuma terrain were studied to determine the dynamic loads which could be expected during the survey. A consideration of areas containing fairly large exposed rocks led to the adoption of the low-pressure Goodyear "Terra-Tire." Each tire carries a load of 500 pounds with 4-6 psi pressure. The resulting isolation of the sensor frame aided materially in maintaining the desired vertical attitude and in reducing the difficulty of keeping the light beam centered on the sensing head.

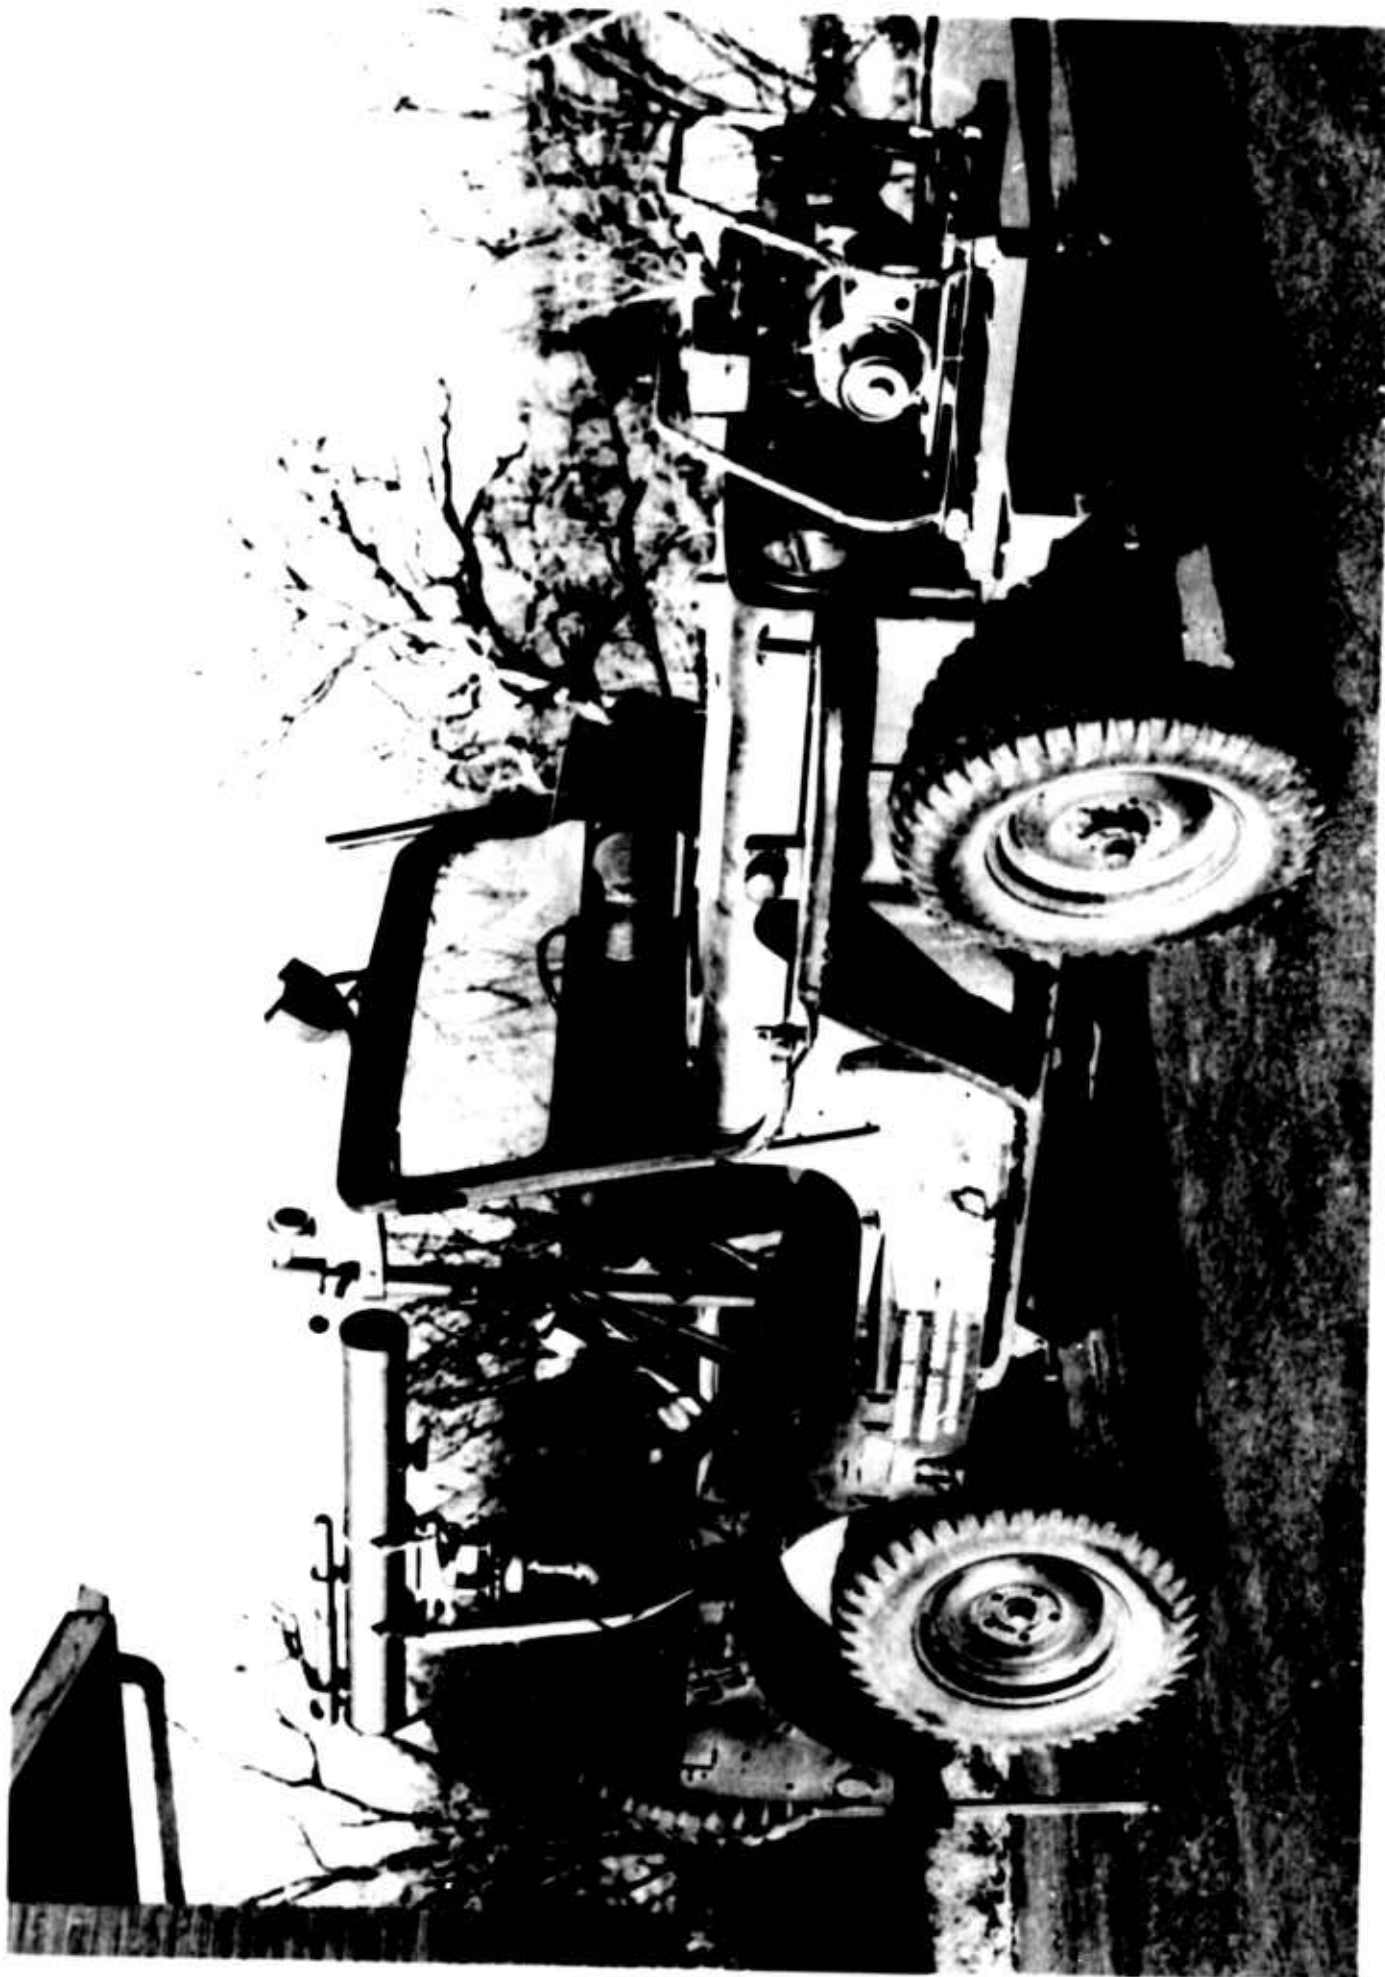
Figure 7. Light-Projector System

Several features were incorporated into the profilometer system to increase the safety, reliability, and operating convenience. The light-projector system was made more mobile by mounting the electrical power supply on a jeep and by providing high and low adjustable mounting points for the light tube (see Figure 7). A retractable hitch stand was provided to permit easy removal of the towing vehicle. Adequate clearance for storage of the tall sensor housing has presented a problem in the past. Special wheels were mounted to the trailer frame which permit the unit to be rotated to a horizontal position for ease of maintenance and handling in storage (see Figure 8). A foot-operated locking valve, which must be held open to allow flow to the reservoir, was included in the hydraulic circuit. This safety device prevents accidental motion of the sensor housing in the event that the hydraulic control column is inadvertently operated. Two clamping block assemblies are provided to lock the housing in position and to permit safe removal of the hydraulic lines and cylinders.
