# FRACTURE TOUGHNESS OF D6AC STEEL SHILLELAGH ROCKET MOTOR CASE

Technical Report AMRA TR 64-19

MATERIALS ENGINEERING DIVISION  
U. S. ARMY MATERIALS RESEARCH AGENCY  
WATERTOWN, MASSACHUSETTS 02172

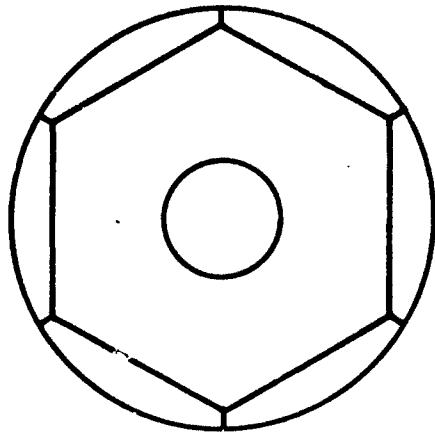
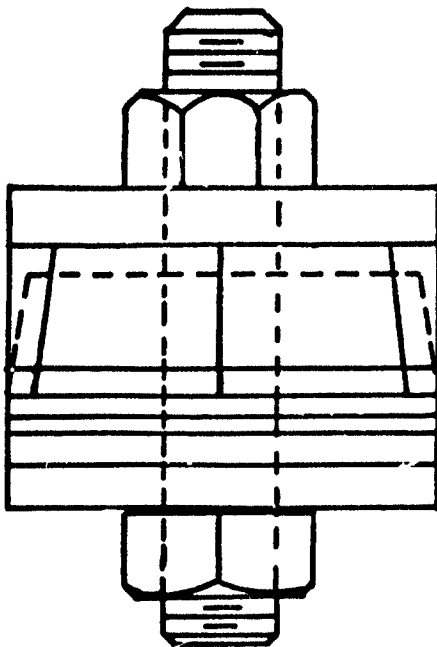
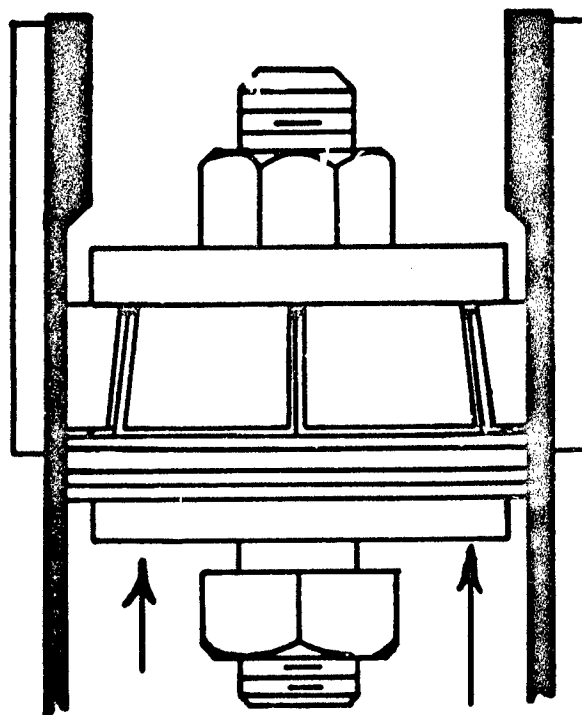
Figure 3-1

TOP VIEW OF TOP PACKING SUPPORT  
RESTRAINER AND FOLLOWER

SIDE VIEW OF TOP  
PACKING SUPPORT

CROSS-SECTIONAL VIEW OF  
ASSEMBLED PACKING

CROSS-SECTIONAL VIEW OF PACKING IN MOTOR  
CASE WITH RESTRAINING RING IN PLACE

The end closure and pressure packing design which was chosen for use at low temperatures (also used at room temperature) consisted of a top packing support, packing, and bottom packing support. The top packing support was comprised of a split-ring packing follower seated on a solid packing restrainer. The packing follower split ring was made of segments which, when in place, formed a circle with their outer faces and a concave hexagon with their inner faces. This concave hexagon fit over a convex hexagonal surface on the packing restrainer. The hexagonal design of the contact surfaces between packing follower and packing restrainer allowed some individual motion of each segment of the follower without segment cocking which would result in a leak.

Upon the application of pressure the packing restrainer is forced upward. This upward motion of the packing restrainer results in radial motion of the packing follower ring segments. To prevent yielding of the motor case as a result of the radial movement of the packing follower segments, it was necessary to use heavy restraining rings around the motor case ends.

The packing consisted of a layer of Thiokol-impregnated leather, approximately 1/8-inch thick; a layer of silicon rubber, approximately 3/8-inch thick (this material has a glass transition temperature of about -110 C, which allows it to maintain its rubber elasticity at temperatures well below other rubbery polymers); and a layer of Teflon, approximately 1/8-inch thick. This packing, with top restrainer and follower on top of it, was supported by the bottom restrainer which consisted of a simple disk. The entire assembly was held together by a rod which was locked with a nut at either end of the packing. On one packing this rod contained a center bore allowing admission of pressurizing fluid to the motor case. The end closure assembly is shown in Figure B-1. After insertion into the case, the restraining ring was placed around the case in the vicinity of the packing.
