TECHNICAL PROGRESS REPORT 381  
 NOTES TP 3674  
 COPY 1

## 624A SOLID-PROPELLANT MOTOR IMPACT TEST

**ABSTRACT.** At the request of the Air Force Systems Command, a preprototype version of the 624A motor, with a single center segment plus end closures, was impacted into a massive concrete, steel, and earth target at a velocity of 667 fps to determine the hazard potential of the motor. Photographic data showed extensive grain breakup from the impact, and blast-gage data indicated a low range of overpressure and impulse forces. Fragments of motor case were thrown to 2,500 ft, and pieces of burning propellant were thrown to 3,000 ft.

U. S. NAVAL ORDNANCE TEST STATION

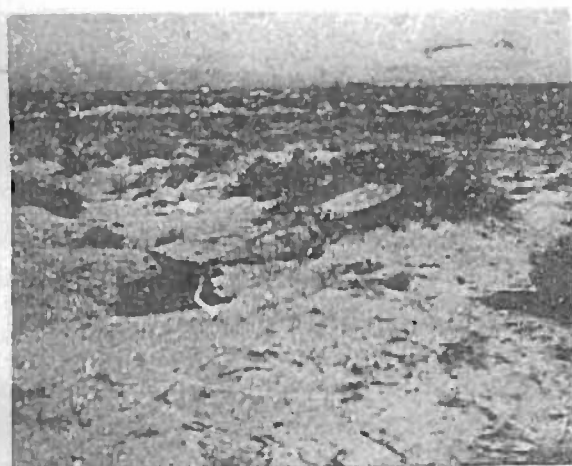
19,800' N x 1,475' E (2,400' SE of impact point)

22,100' N x 1,200' E (1,260' NE of impact point)

22,000' N x 1,200' E (1,240' NE of impact point)

19,400' N x 900' W (2,500' SW of impact point)

FIG. 19. Montage Showing Large Pieces of Debris.  
(See note on page 4, third paragraph.)

Figure 11 shows typical residue from burned propellant. The forward closure (Fig. 12) was found 270 ft beyond the target site. Figures 13, 14, and 15 show the debris to the east, west, and north of the target location; Fig. 16 shows the nozzle and other debris in the crater; Figure 17 shows the target face from the track muzzle before and after the test. Travel of some fragments was found as shown in Fig. 18. Descriptions of the fragments are keyed to the numbers in the graph. Figure 19 is a montage showing large pieces of debris found between 1,260 and 2,500 ft from point of impact (see note, page 4).
