AD617603 HYDROFOIL MATERIALS RESEARCH PROGRAM  
FINAL REPORT

PREPARED UNDER NAVY BUREAU  
OF SHIPS, CONTRACT NObs-84593  
INDEX NUMBER SF0130201  
TASK 1705

# HYDROFOIL MATERIALS RESEARCH PROGRAM

Final Report 2-53100/5R-2179

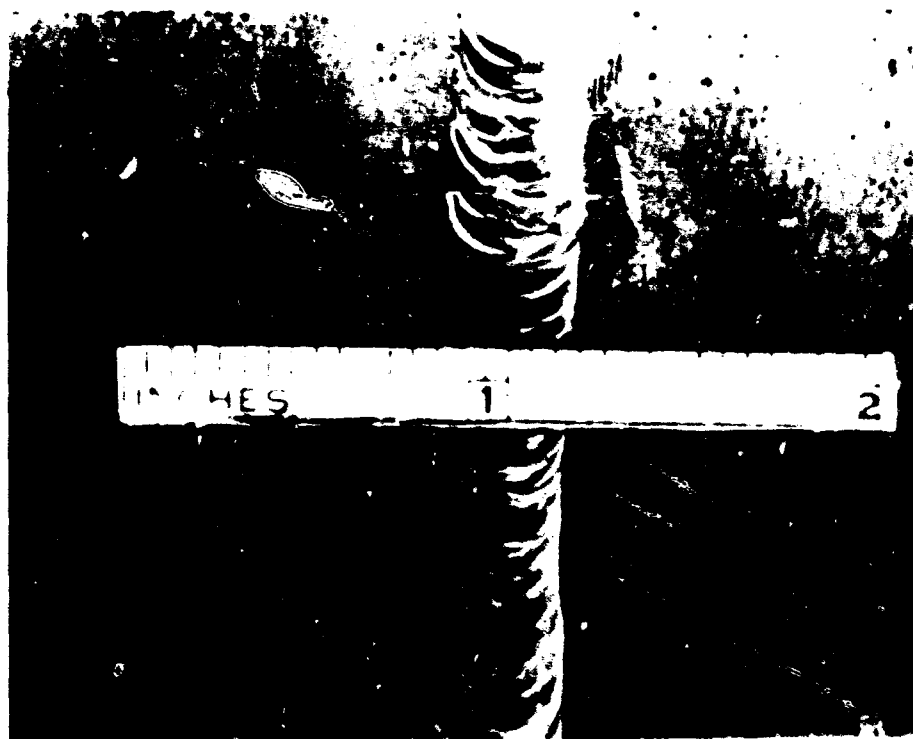
Figure 4.15 Close-up of cross-section area in right weld of Specimen shown in Figure 4.14 (Above Figure)
