TECHNICAL REPORT NO. 3-680

IMPROVED BEACH MATTING FOR U. S. NAVY AMPHIBIOUS OPERATIONS, ENGINEER TESTS JANUARY-AUGUST 1964

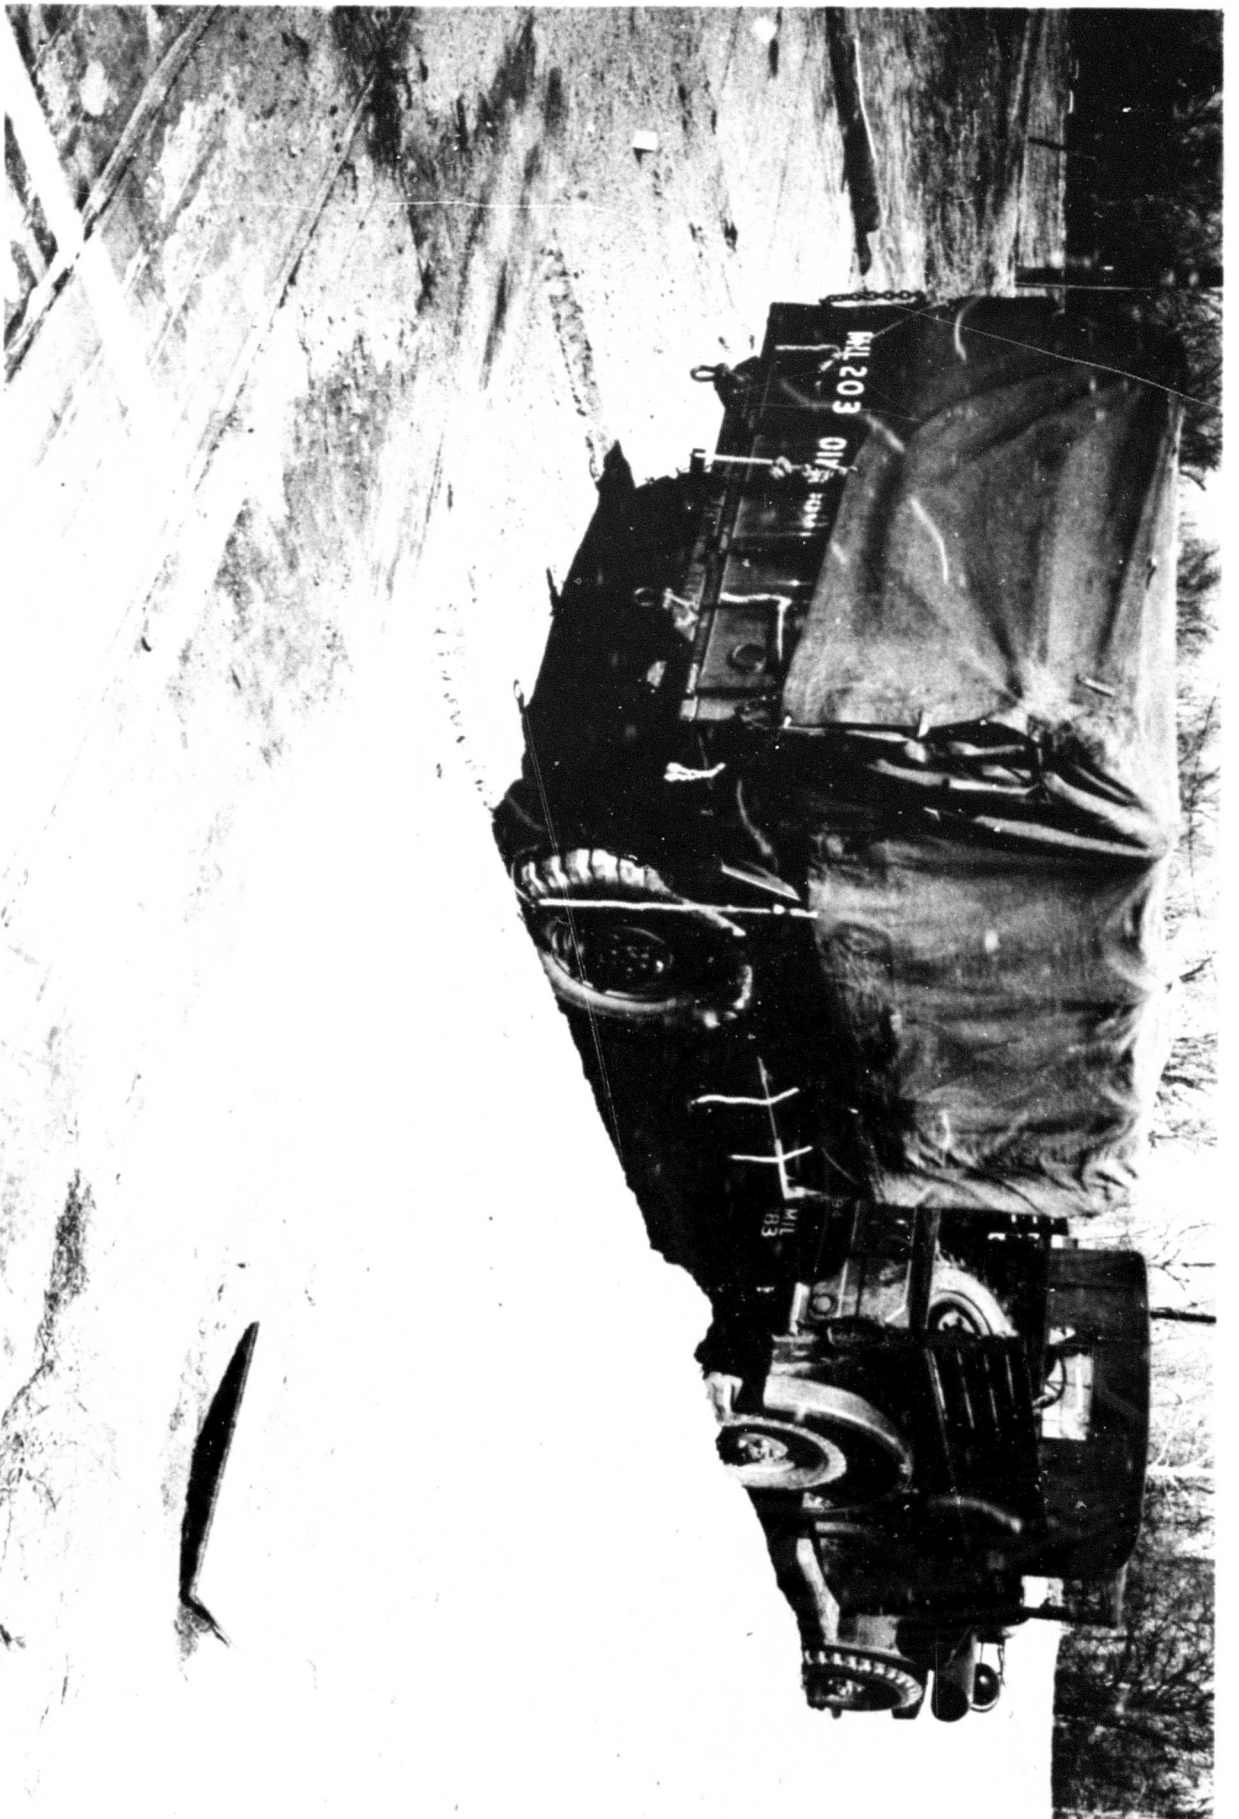
Photograph 10. M37, 3/4-ton, 4x4 truck with M101, 3/4-ton trailer immobilized on sand test section

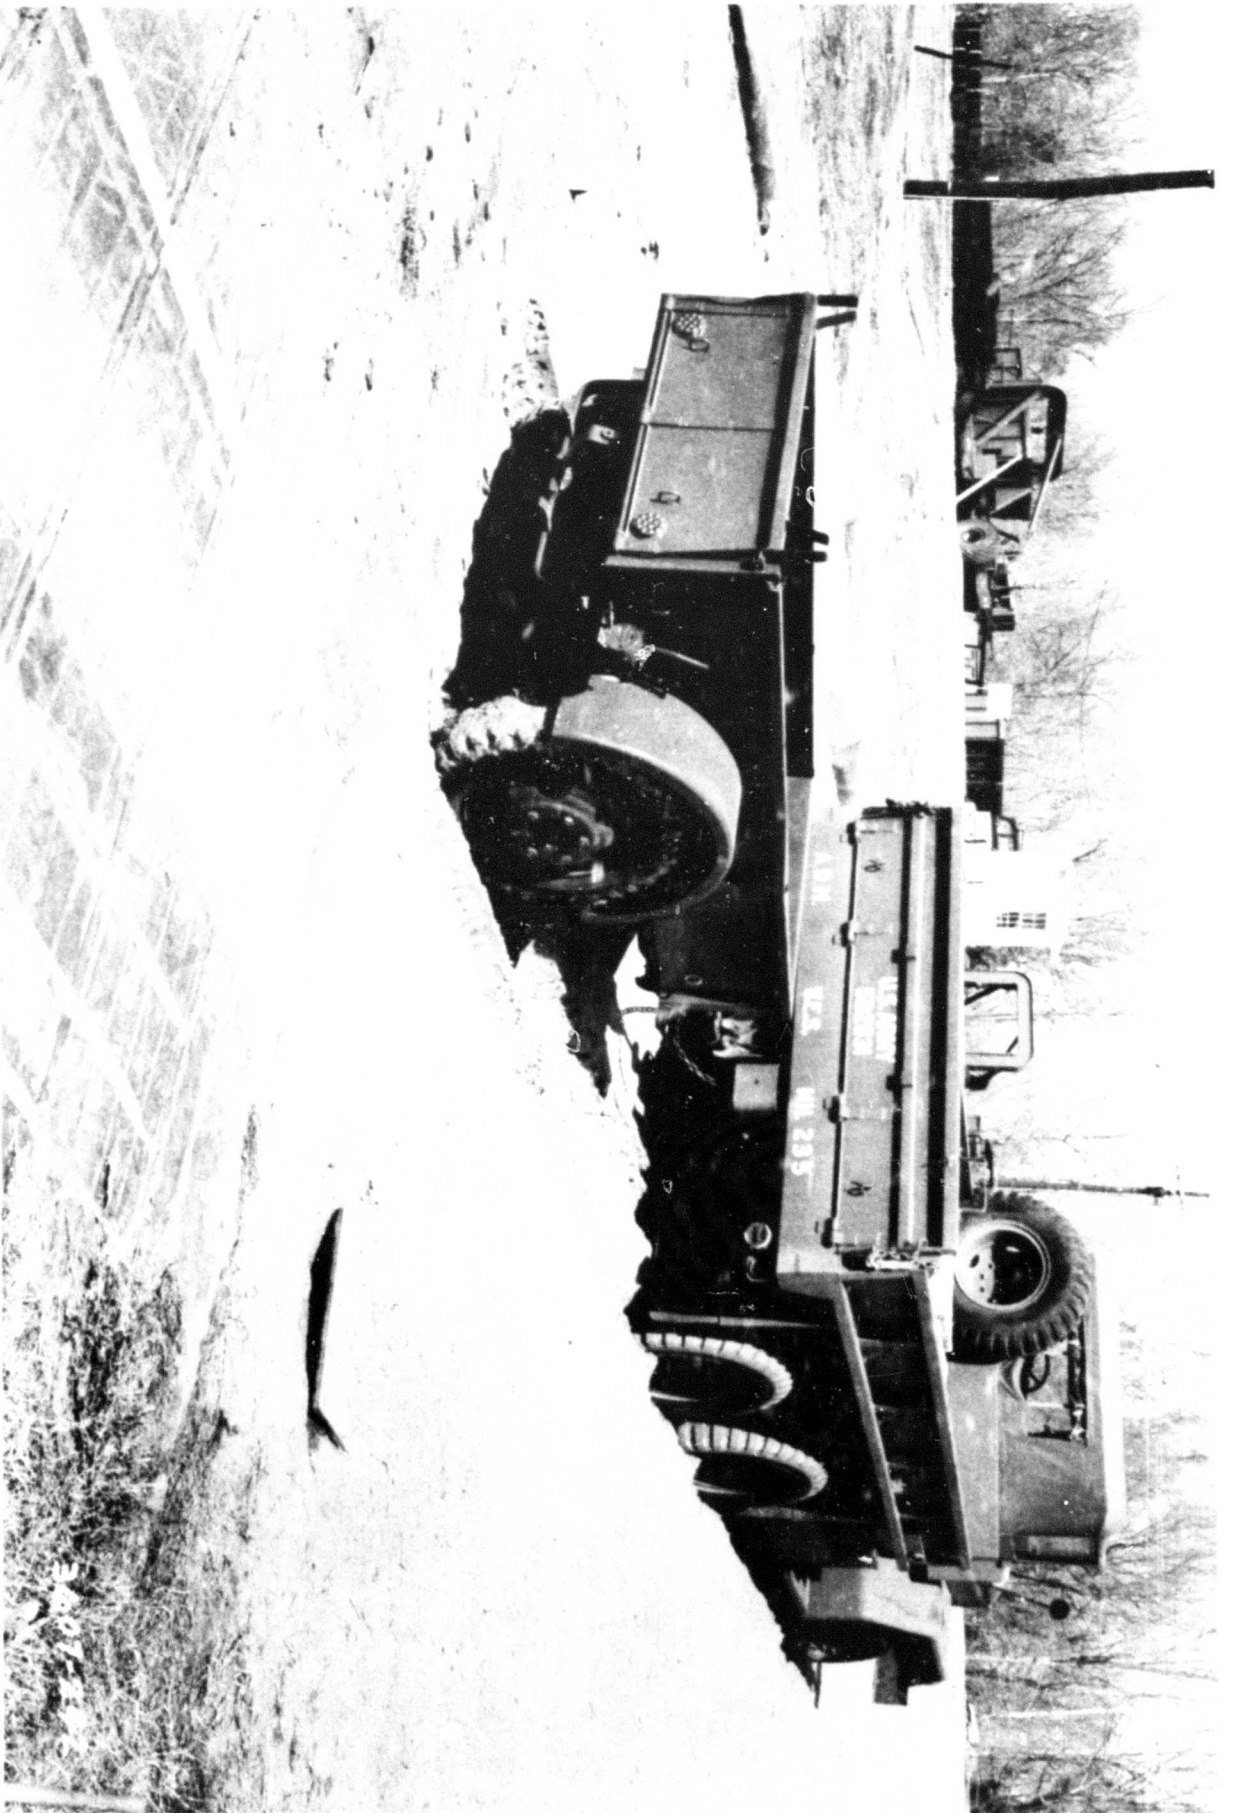
Photograph 11. M54, 5-ton, 6x6 truck with 2-W-M101, 1-ton trailer immobilized on sand test section

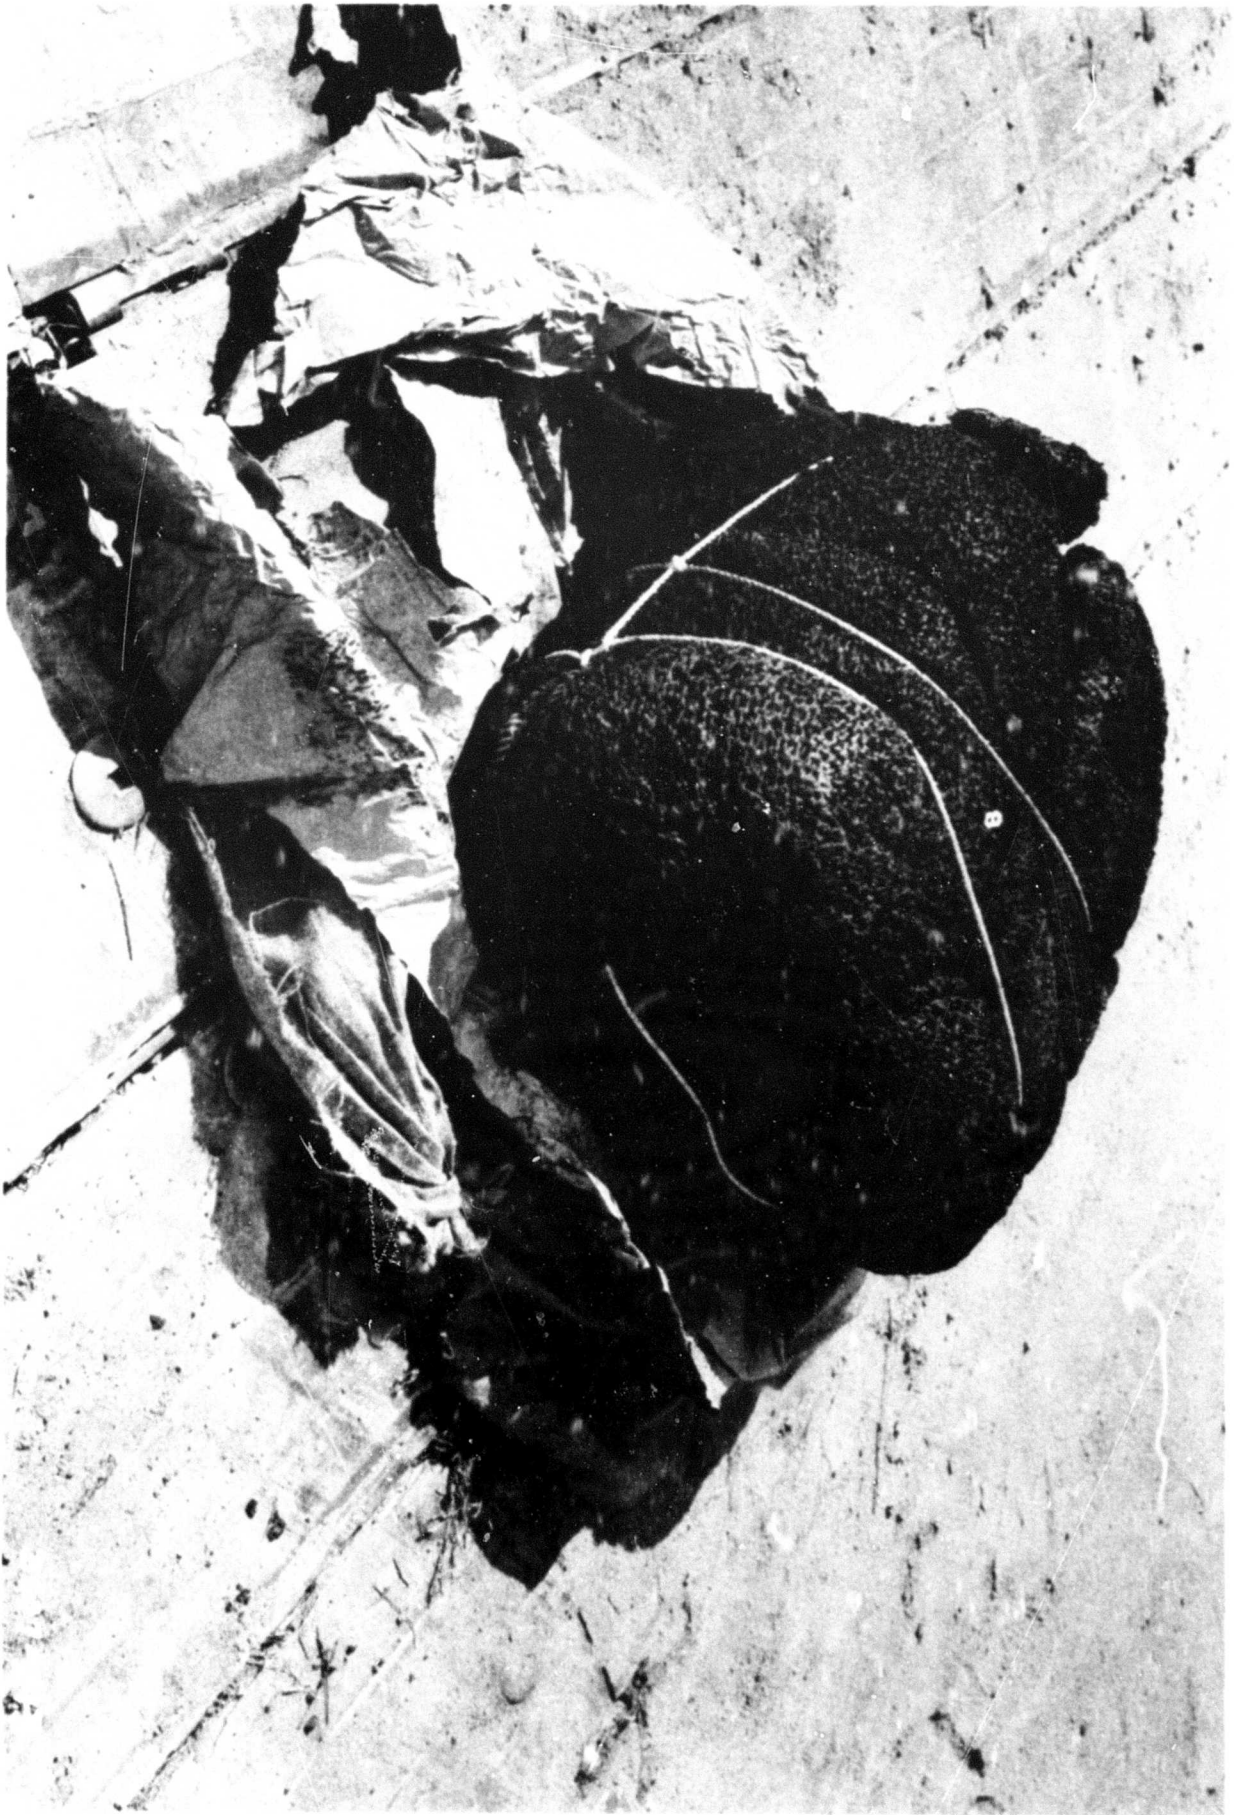
Photograph 13. Item 1 as received from manufacturer

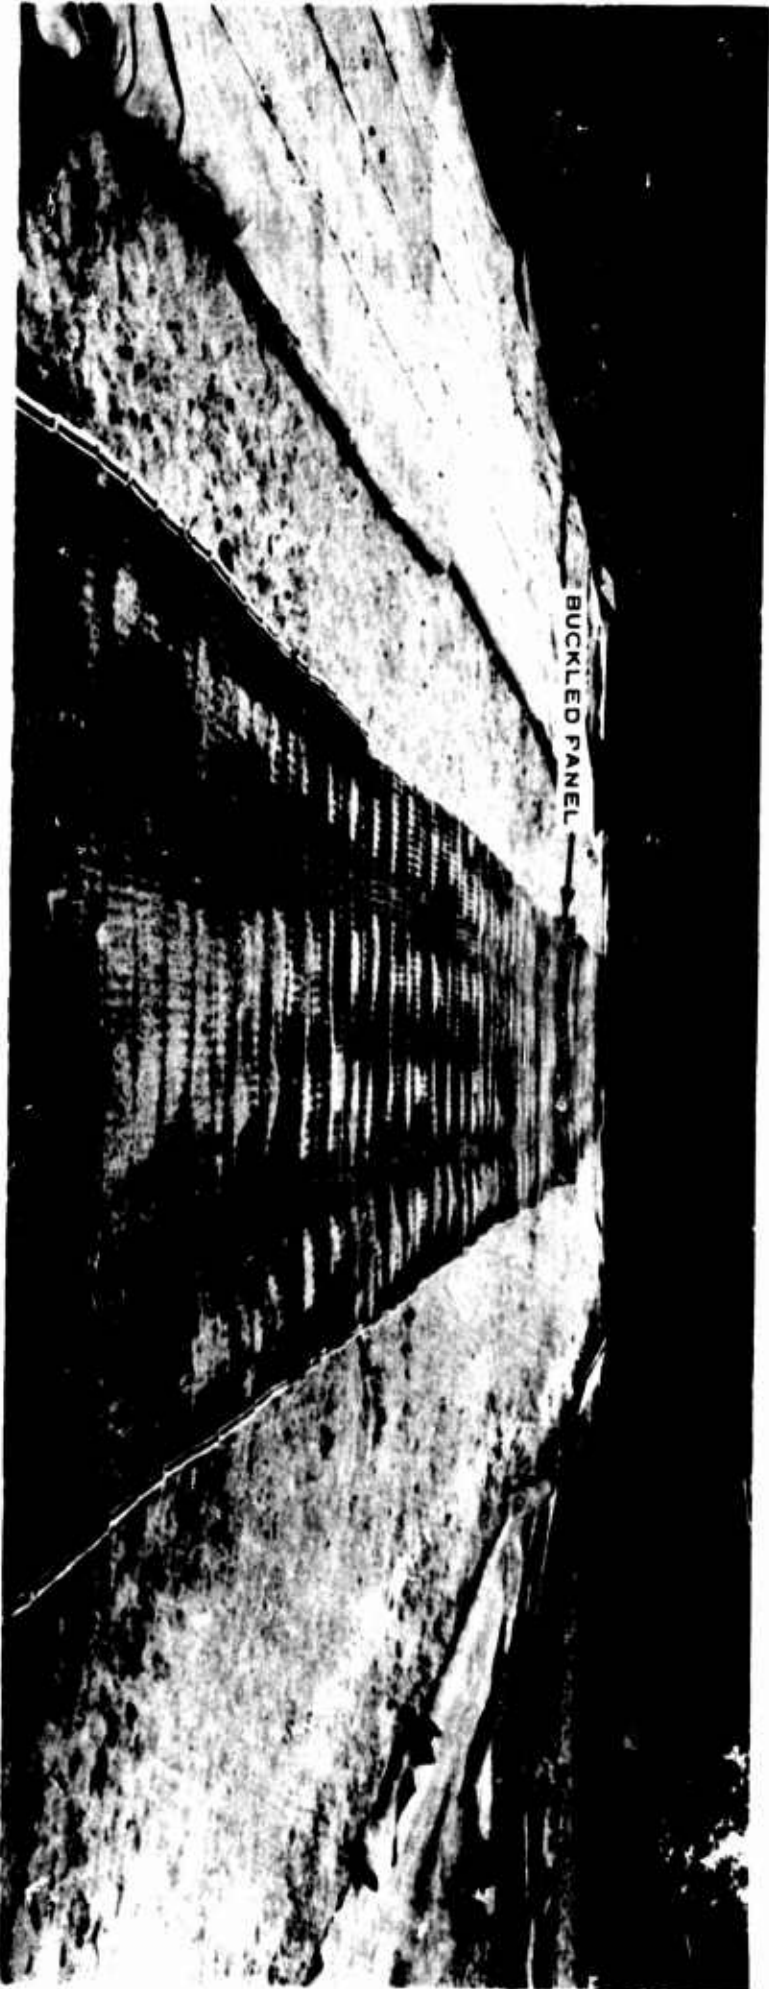
Photograph 45. Woven wire mat after initial pass of M37 truck with trailer.
Note buckled panel near upper end of test section

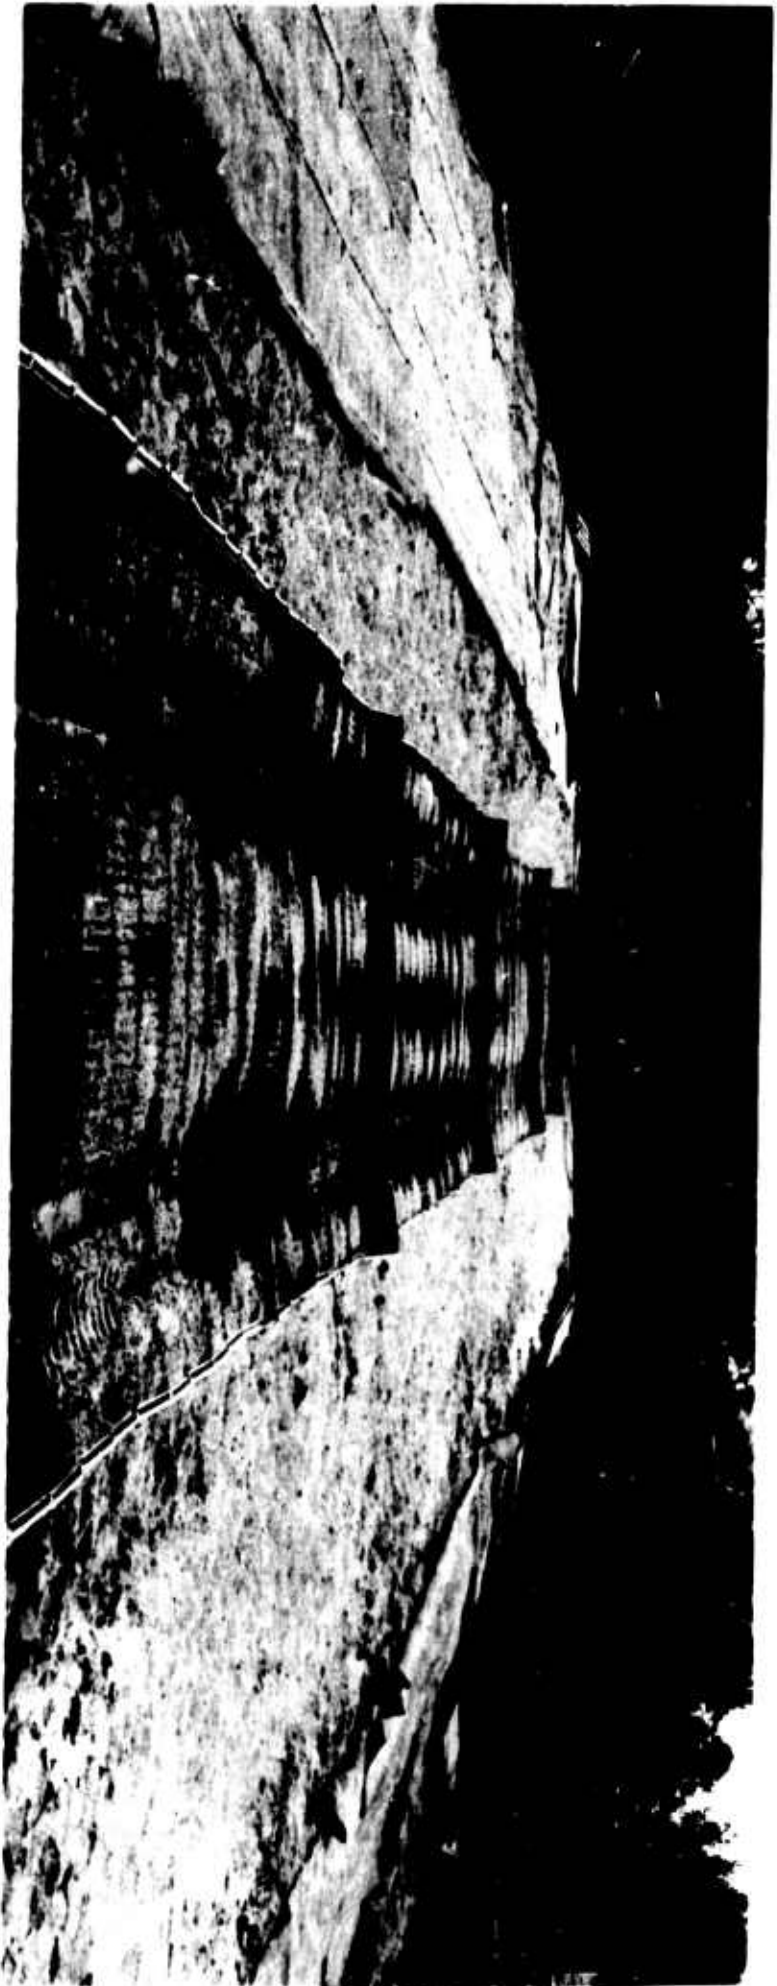
Photograph 47. Woven wire mat after initial pass of M54 truck with trailer
