Technical Memorandum 7-58

**A DYNAMIC HUMAN ENGINEERING EVALUATION
OF THE ARMORED
PERSONNEL CARRIERS T113 & T117**

August 1958

HUMAN ENGINEERING LABORATORIES

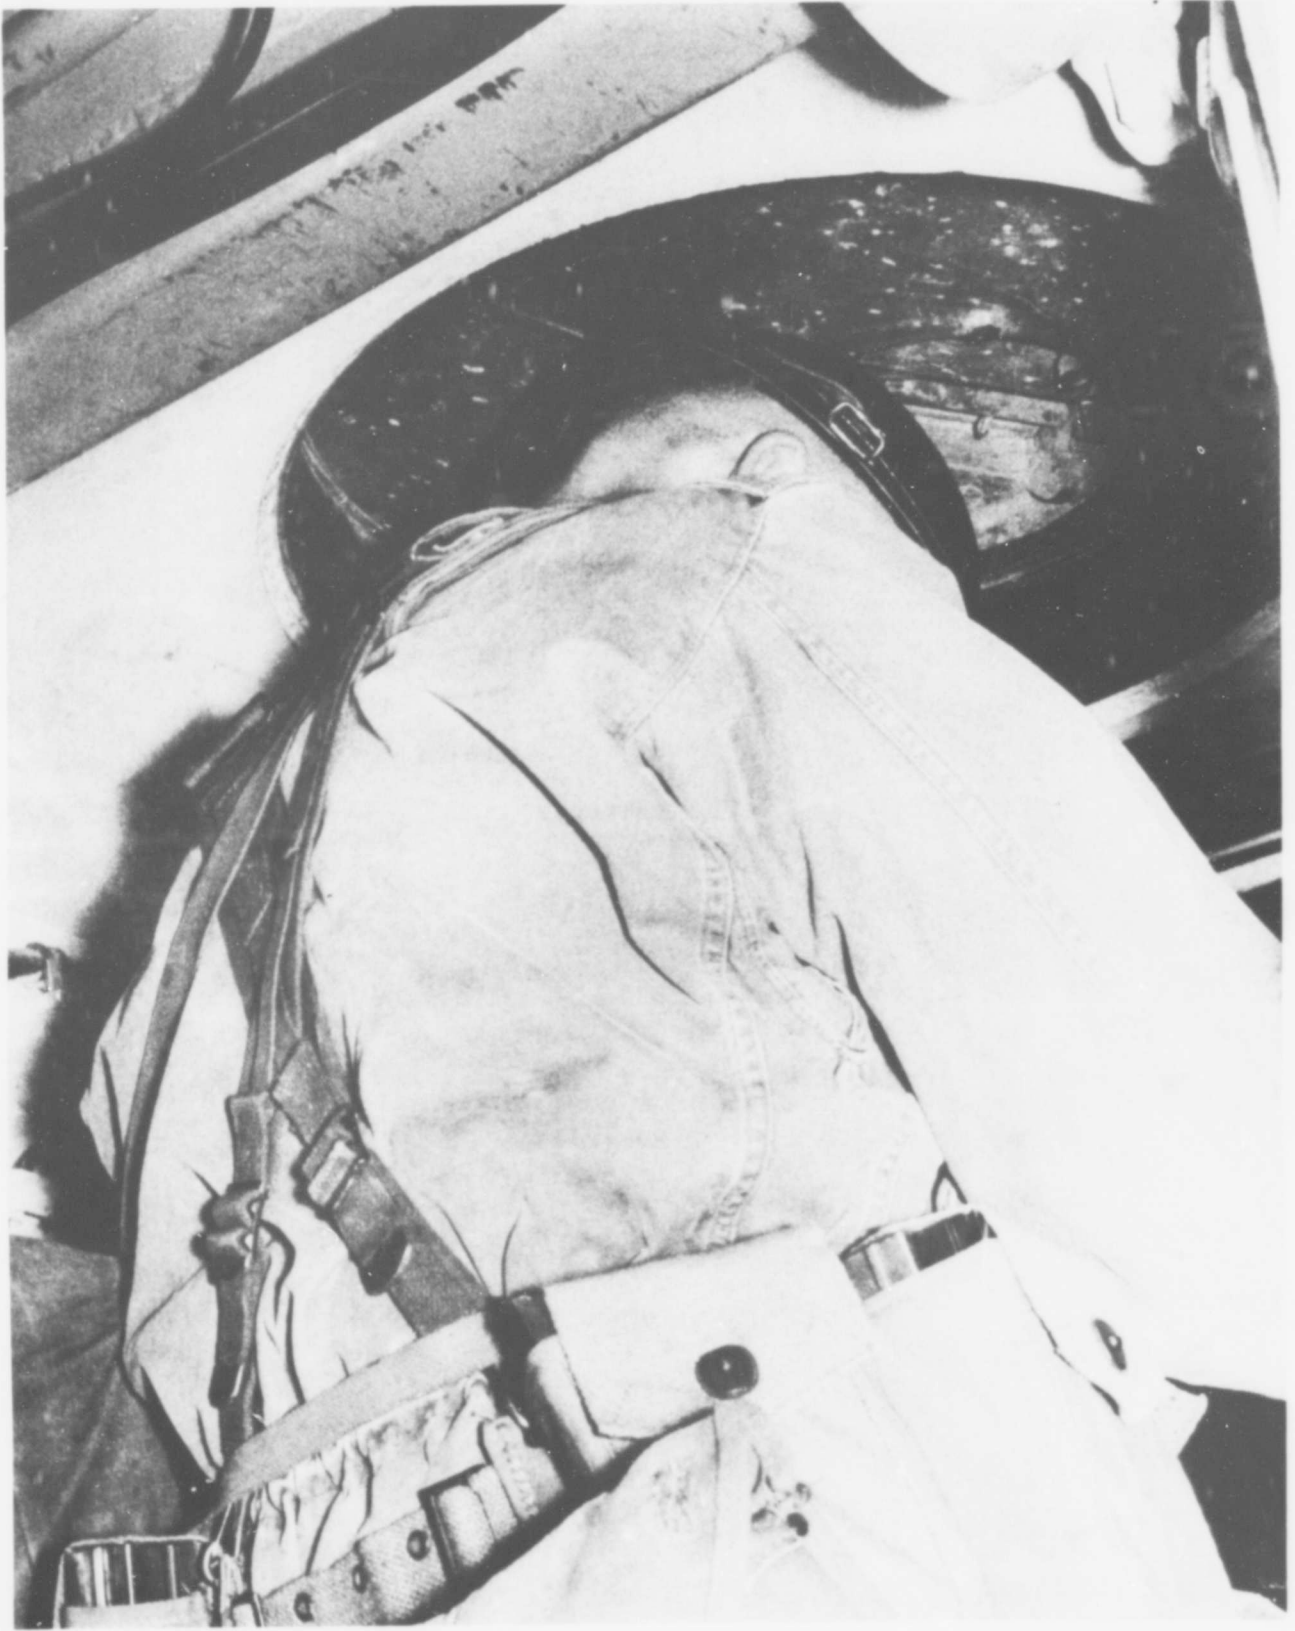
a. A driver 5' 4" was too short to operate the accelerator without becoming very fatigued when seated in the unbuttoned position. A man 6' 1" was too tall to sit in the driver's seat with a helmet in the buttoned position (Figs. 2 & 3). For further information see TM 10-57.

FIG 3. A tall driver in the "down-position" with full field equipment cannot sit properly without being in a cramped position.

- a. In order to give the tall man some head clearance in the buttoned position, the commander and driver's hatches should be dome-shaped. Also the accelerator should be designed to allow the short man to place his entire foot on the pedal, not just the tip of his toe.

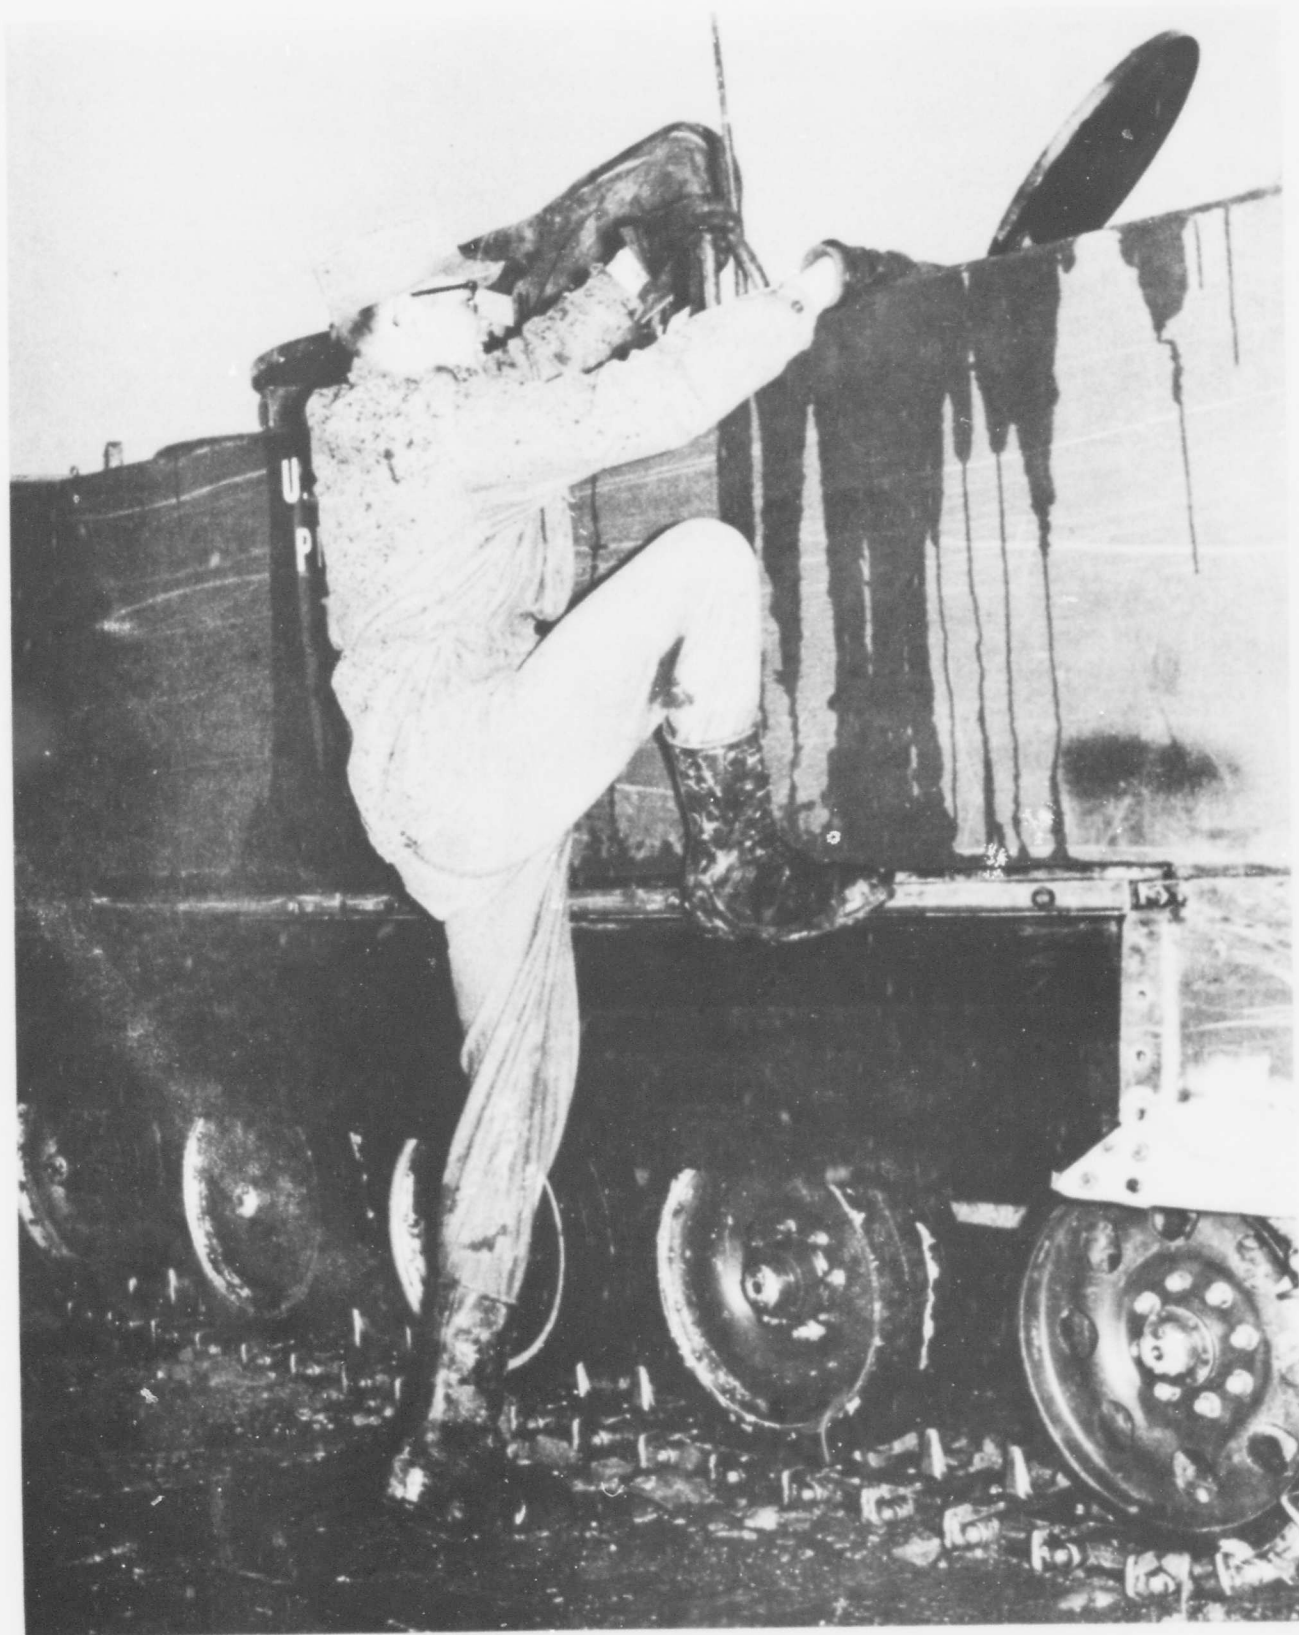
c. It was difficult for the drivers to mount the vehicles (Fig. 4).

FIG 4. Driver taking his first step to climb aboard the vehicle. Note the stretch.

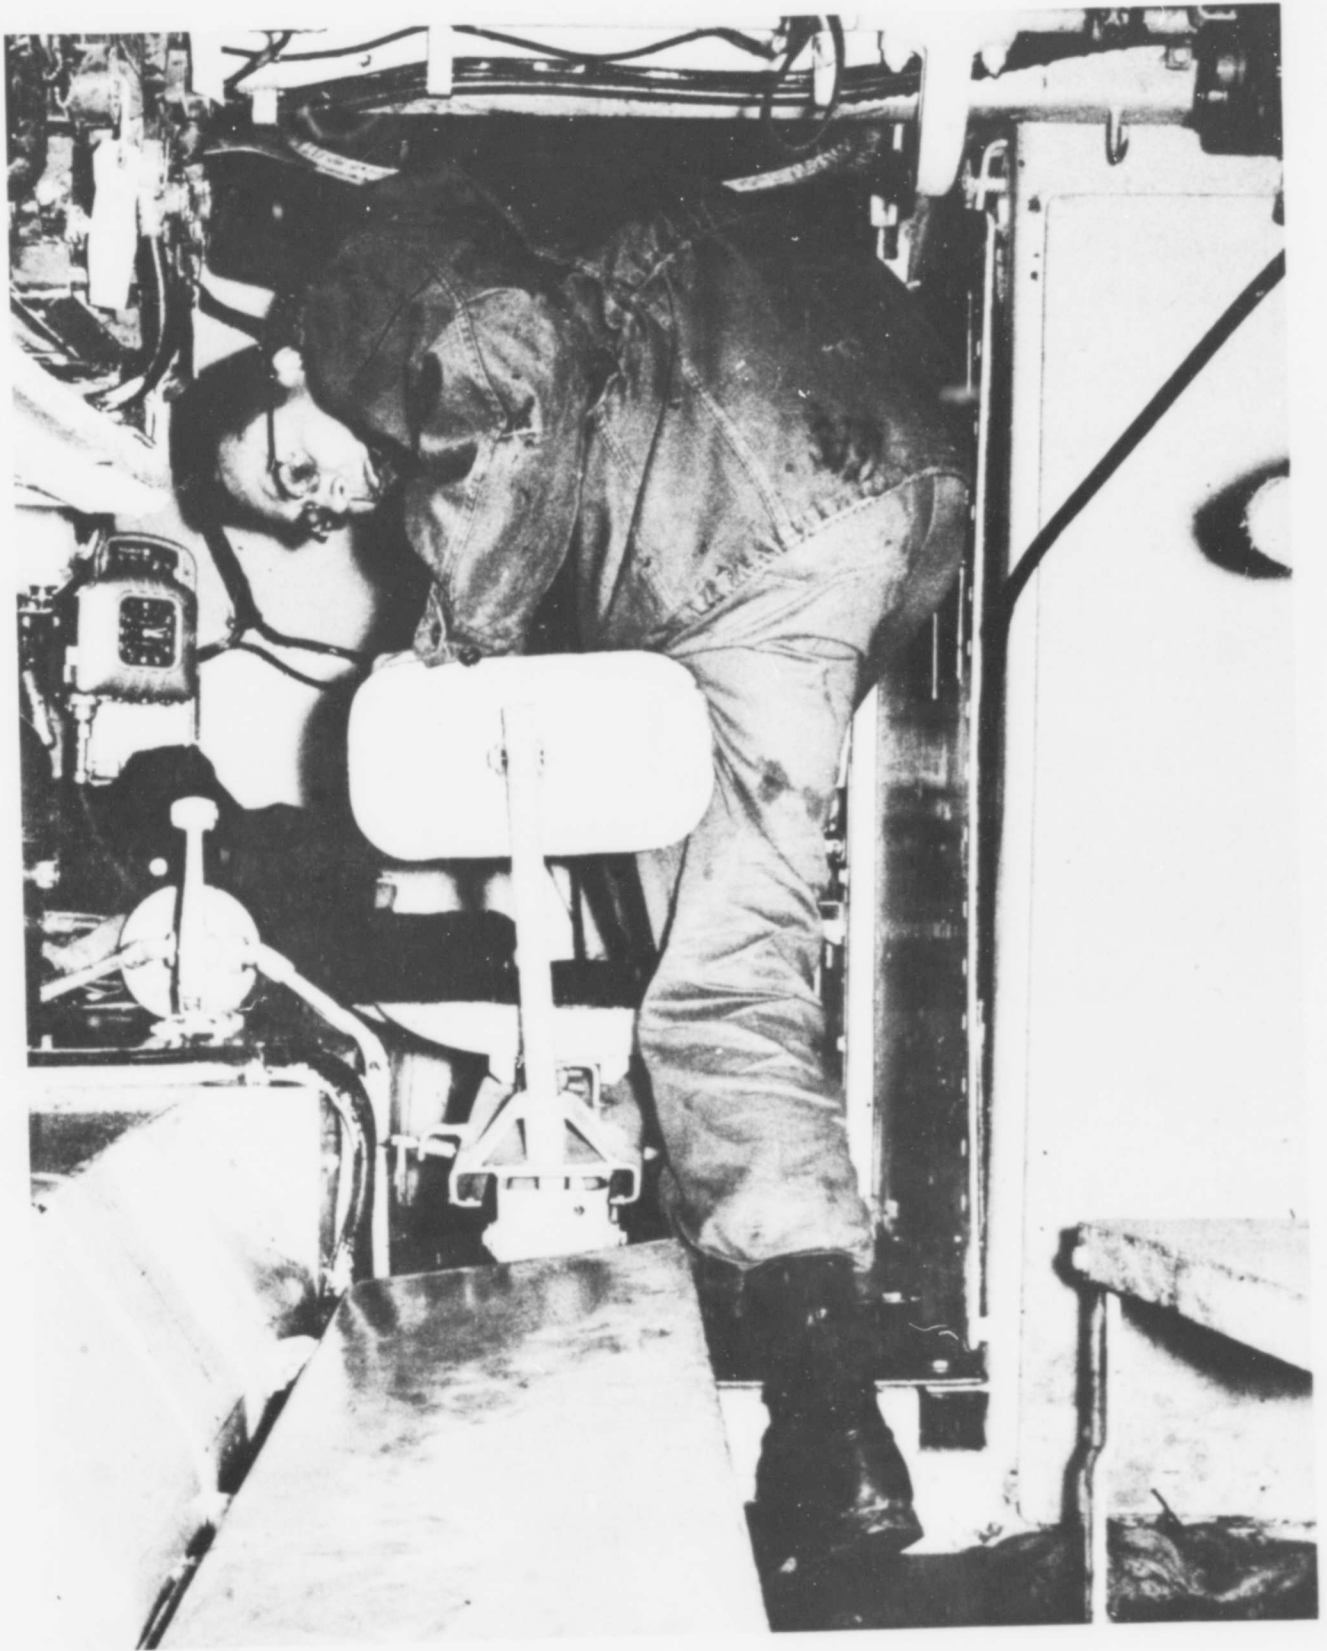
e. The driver and commander had difficulty entering and leaving their seats (Fig. 5).

FIG 5. Driver struggling to get seated.

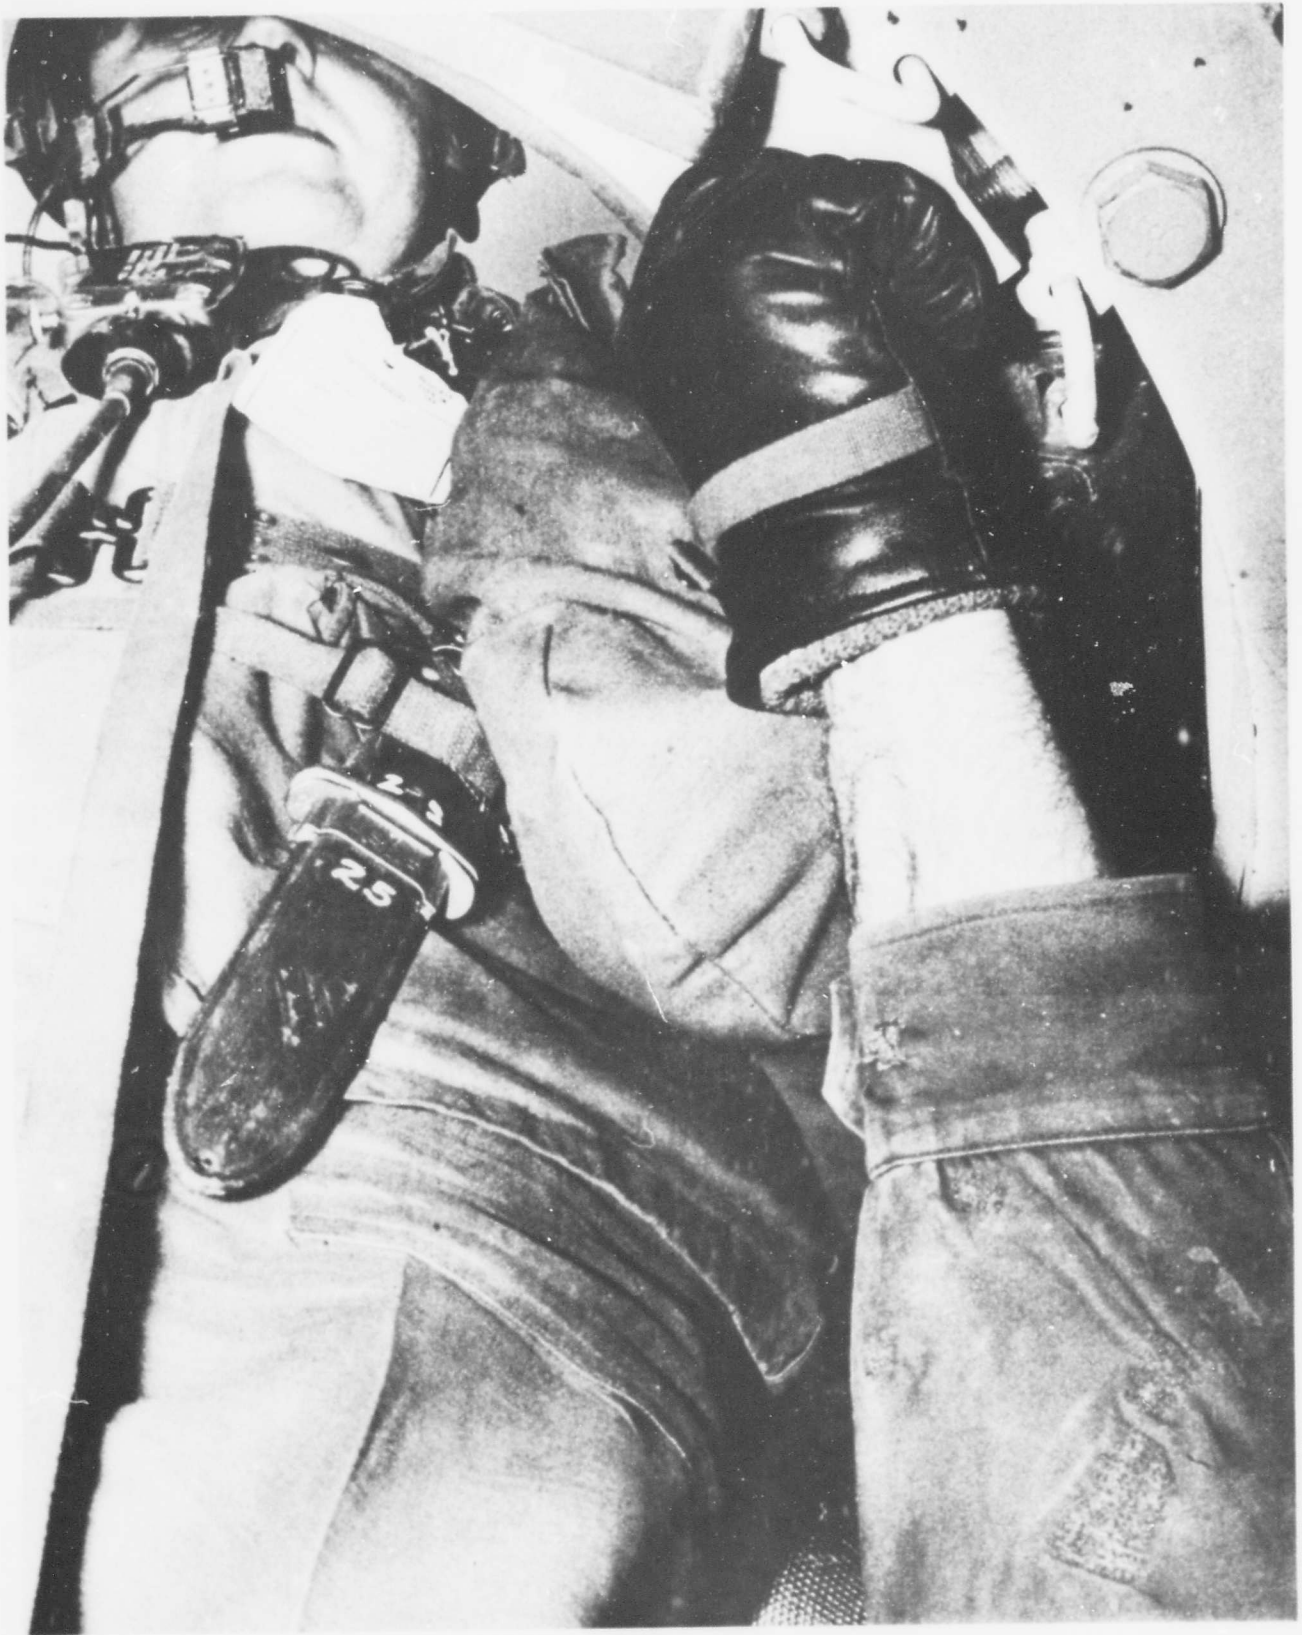
j. The T-shaped screw lock which permits the commander to turn his cupola could not be easily reached when wearing full field gear (Fig. 7).

FIG 7. While riding over rough terrain, the Commander tried to tighten the cupola. After some delay he located the cupola lock. Due to his unfamiliarity with the mechanics of the cupola lock, he unscrewed the lock. This picture shows a squad member finally coming to his aid.

- g. The T-shaped screw lock, which permits the commander to turn his cupola, should be located in the "up" position so that it can be easily reached while wearing full field gear. To prevent incorrect control movement, a lever-operated friction lock is suggested.

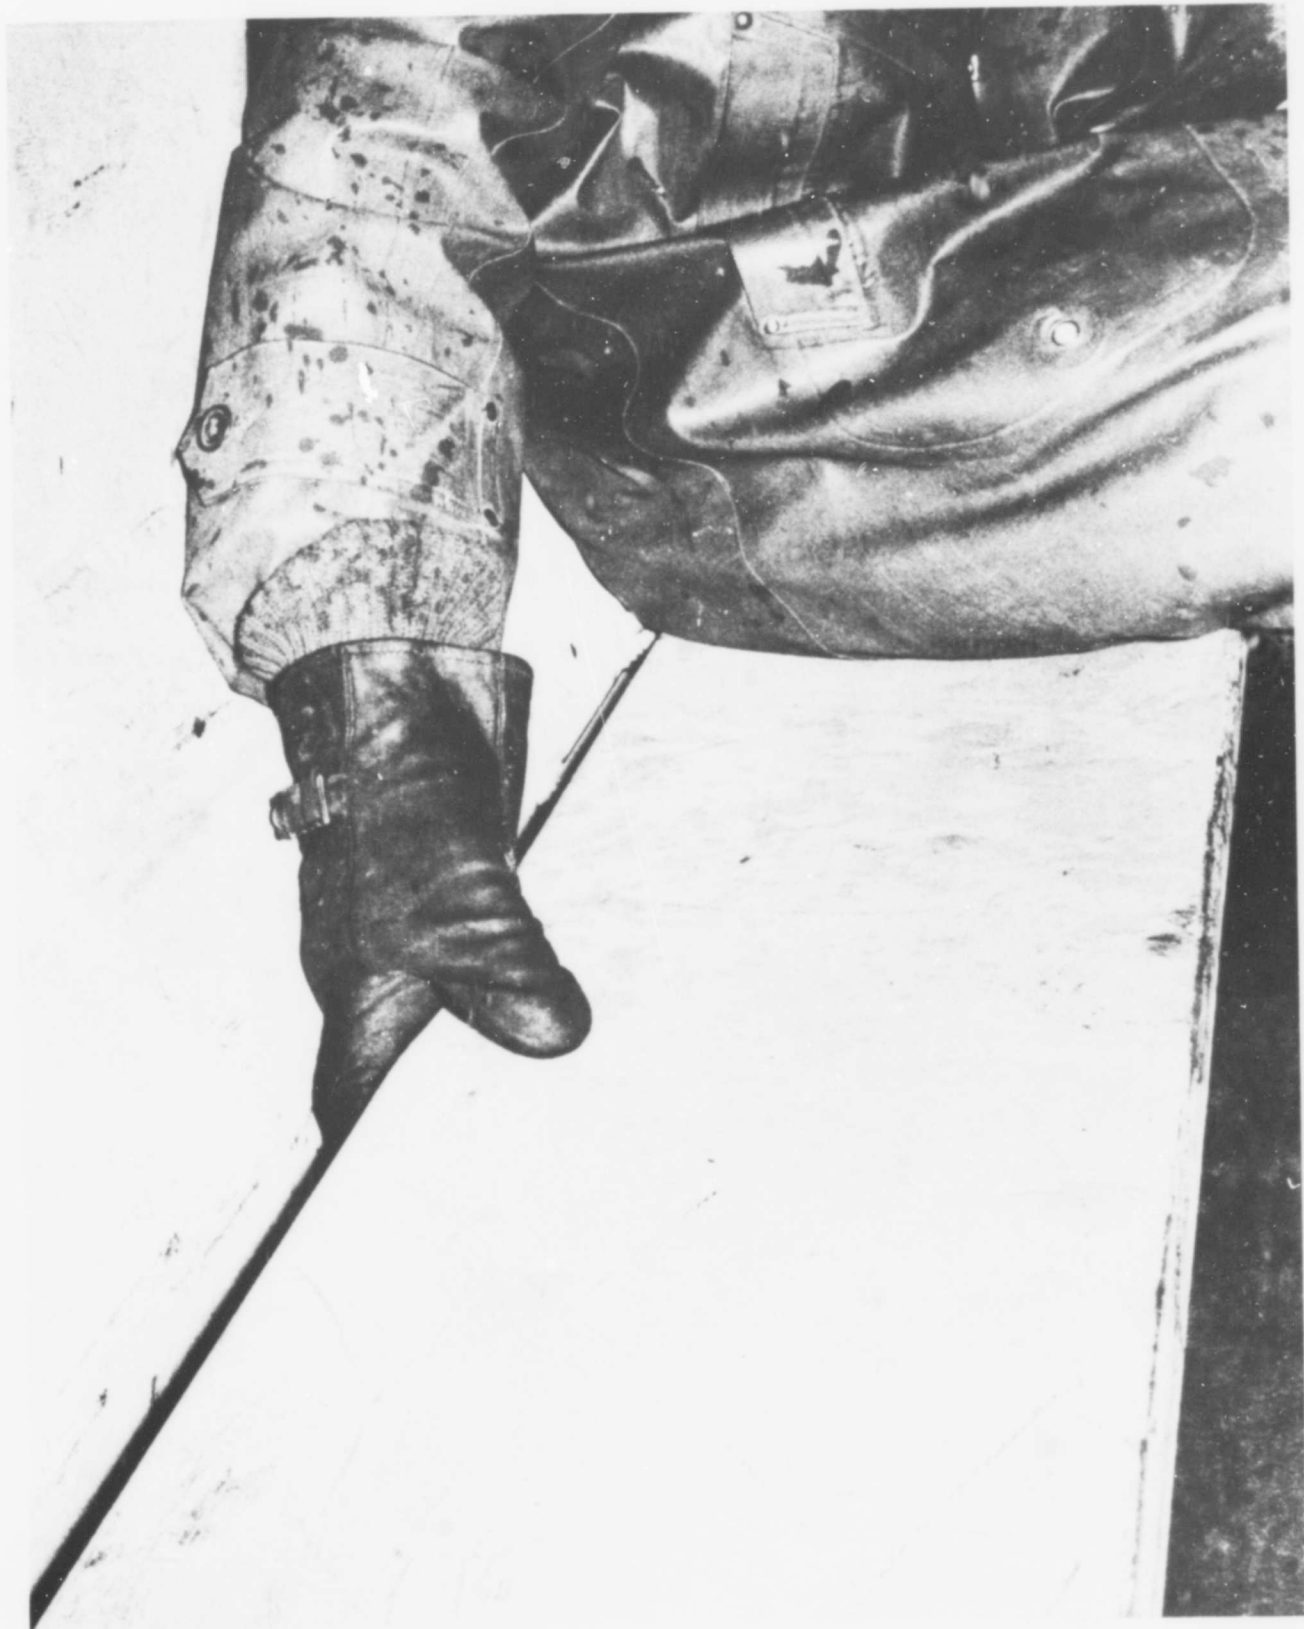
l. Shovel handles and other personal combat equipment were caught between the bench and walls of the test vehicles (Fig. 8).

FIG 8. The space between the bench and the wall in the personnel compartment is apt to catch items such as the shovel.

- i. The bench seats should fit flush to the wall of the vehicle to prevent shovel handles and other equipment being caught, thereby preventing easy egress for the squad members.

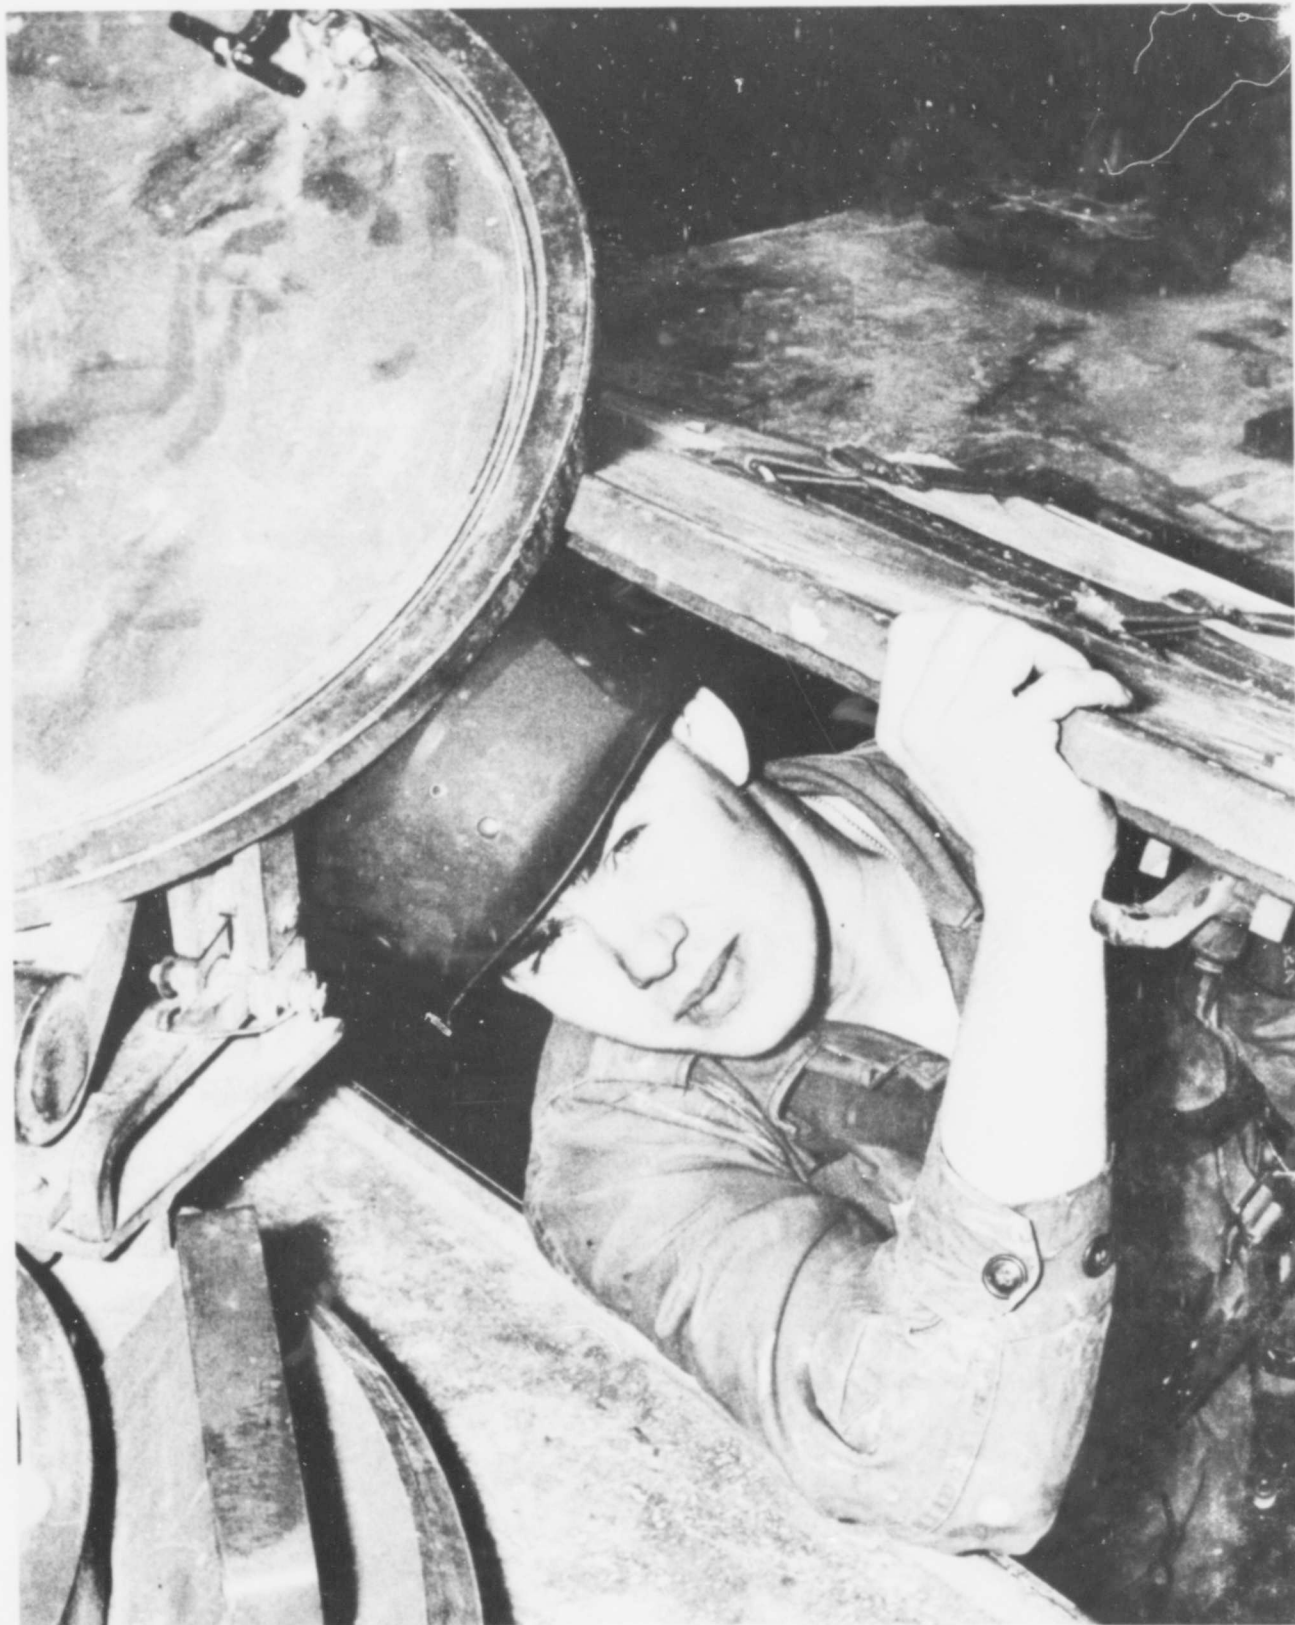
m. The cargo hatch cannot be opened while the commander's hatch is open (Figs. 9 & 10).

FIG 9. When the Commander's hatch is up the hatch blocks the cargo hatch from opening. This presents a dangerous situation in case of an emergency.

FIG 10. Another scene of the condition shown in FIG 9.

j. In the event of an emergency such as sinking, fire, or blocking of the ramp door, the cargo hatch should be able to be used as an escape hatch. The current design of the commander's hatch in the open position prevents this.

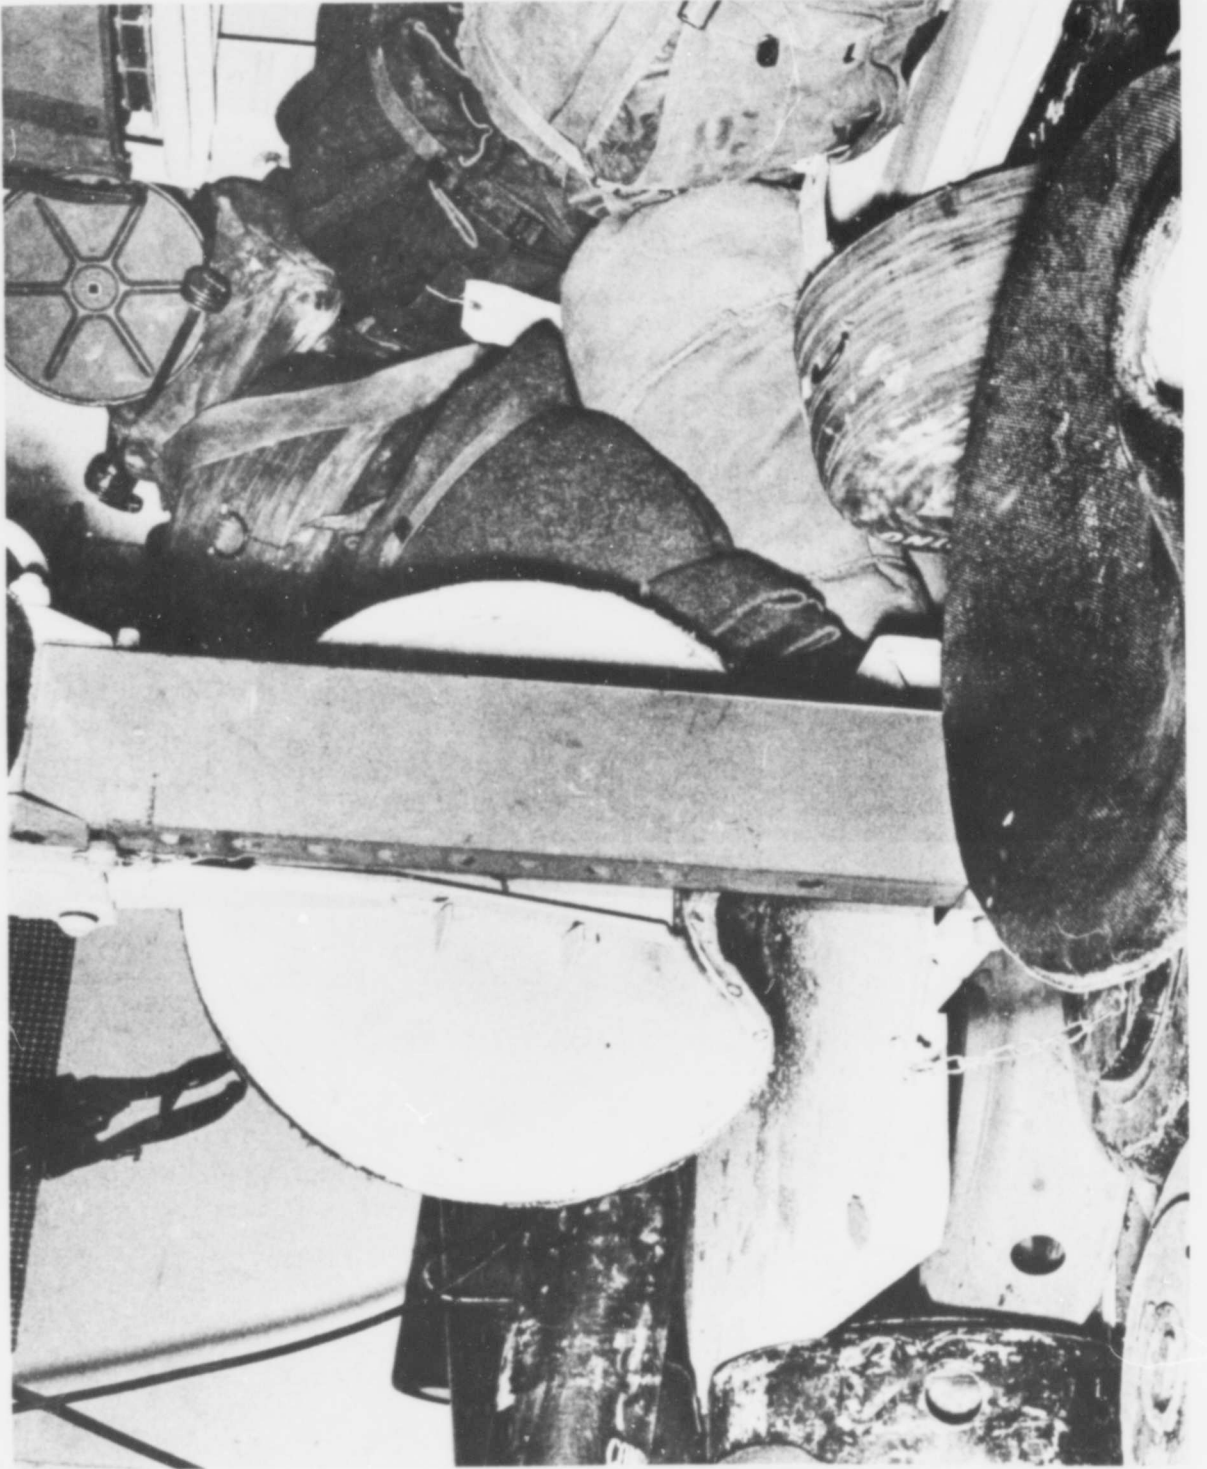
n. There was no provision for storing and securing equipment within the vehicle and, as a result, it was scattered throughout the vehicle while traveling cross-country (Fig. 11).

FIG 11. Result of a rough terrain ride with full equipment in the vehicle.

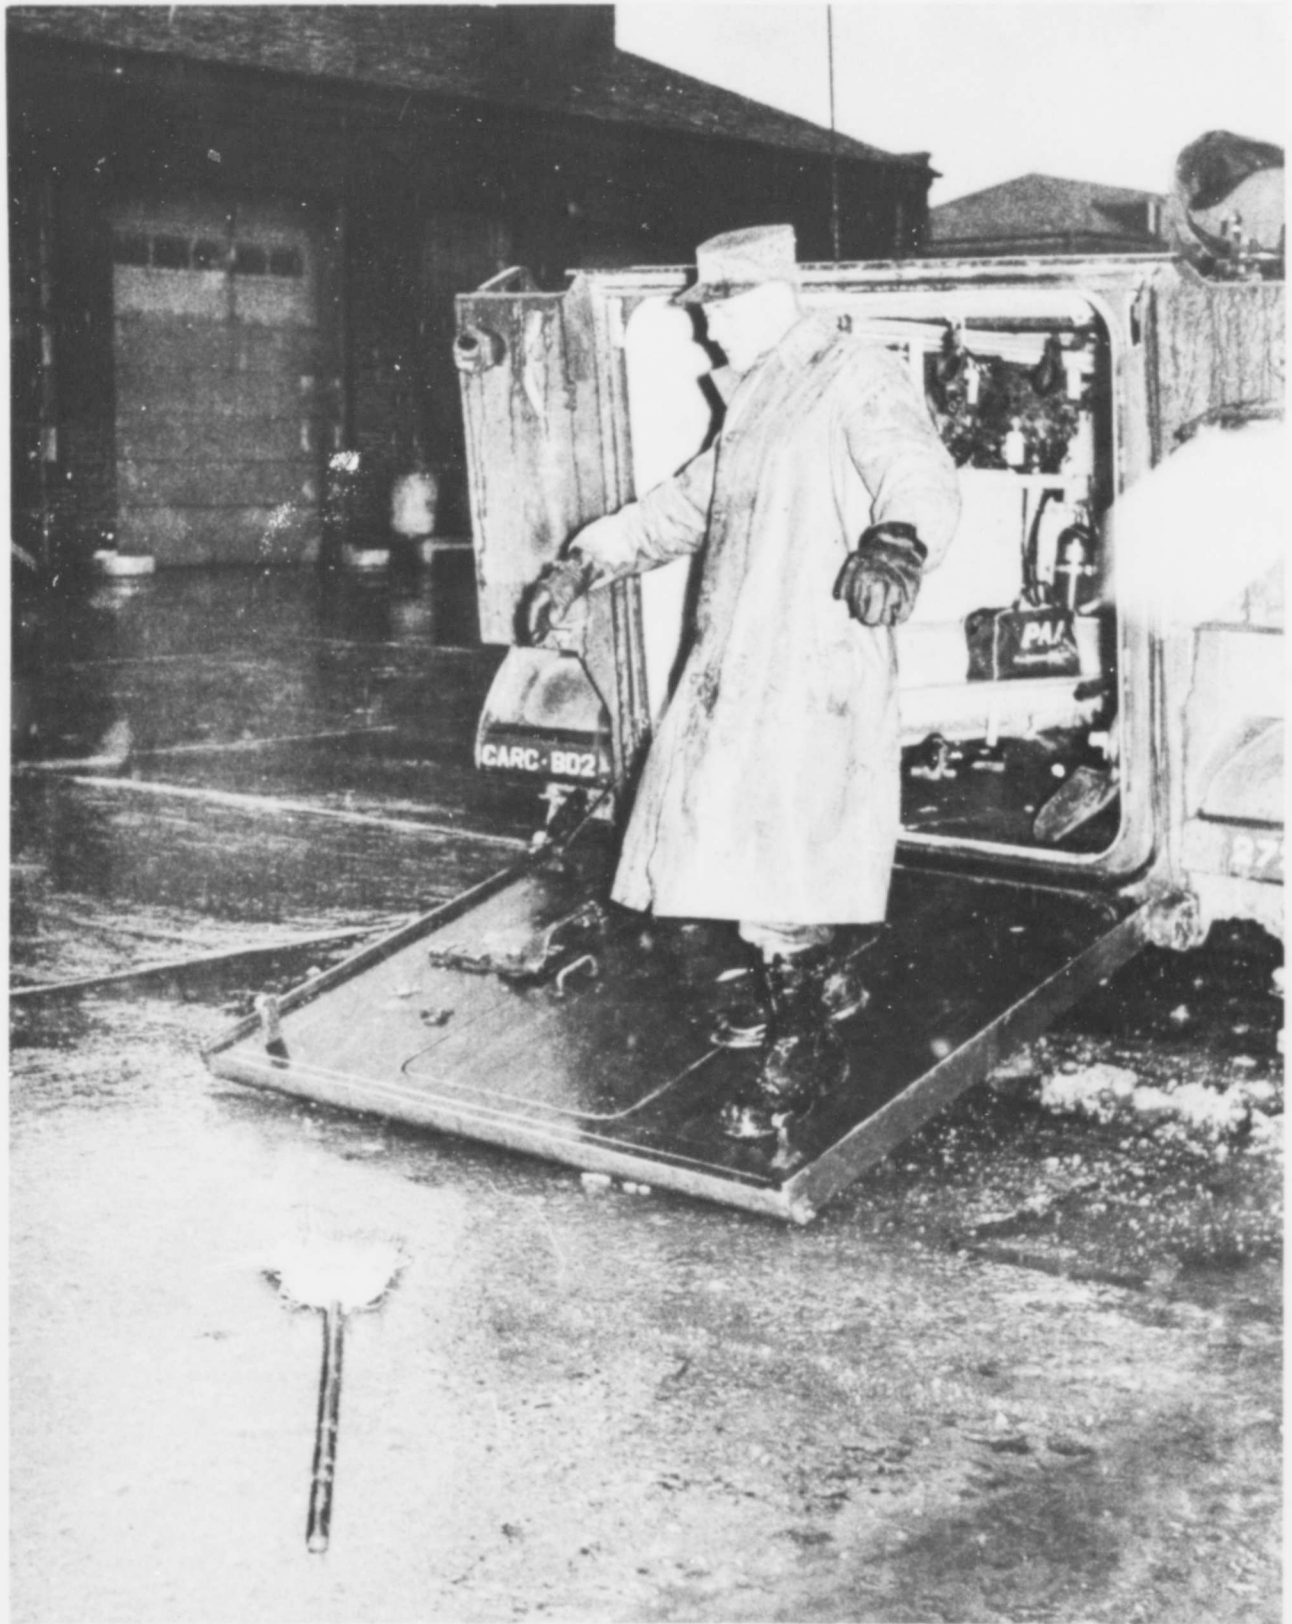
p. Men slipped on the ramp and dropped equipment when dismounting. This condition was aggravated when the ramp was wet and muddy (Fig. 12).

FIG 12. Soldier skidding on a wet ramp without any non-skid coating or horizontal bars.

m. Rungs similar to those found on the M59 ramp should be installed on the T113 and T117 ramps to prevent slipping (Fig. 16).

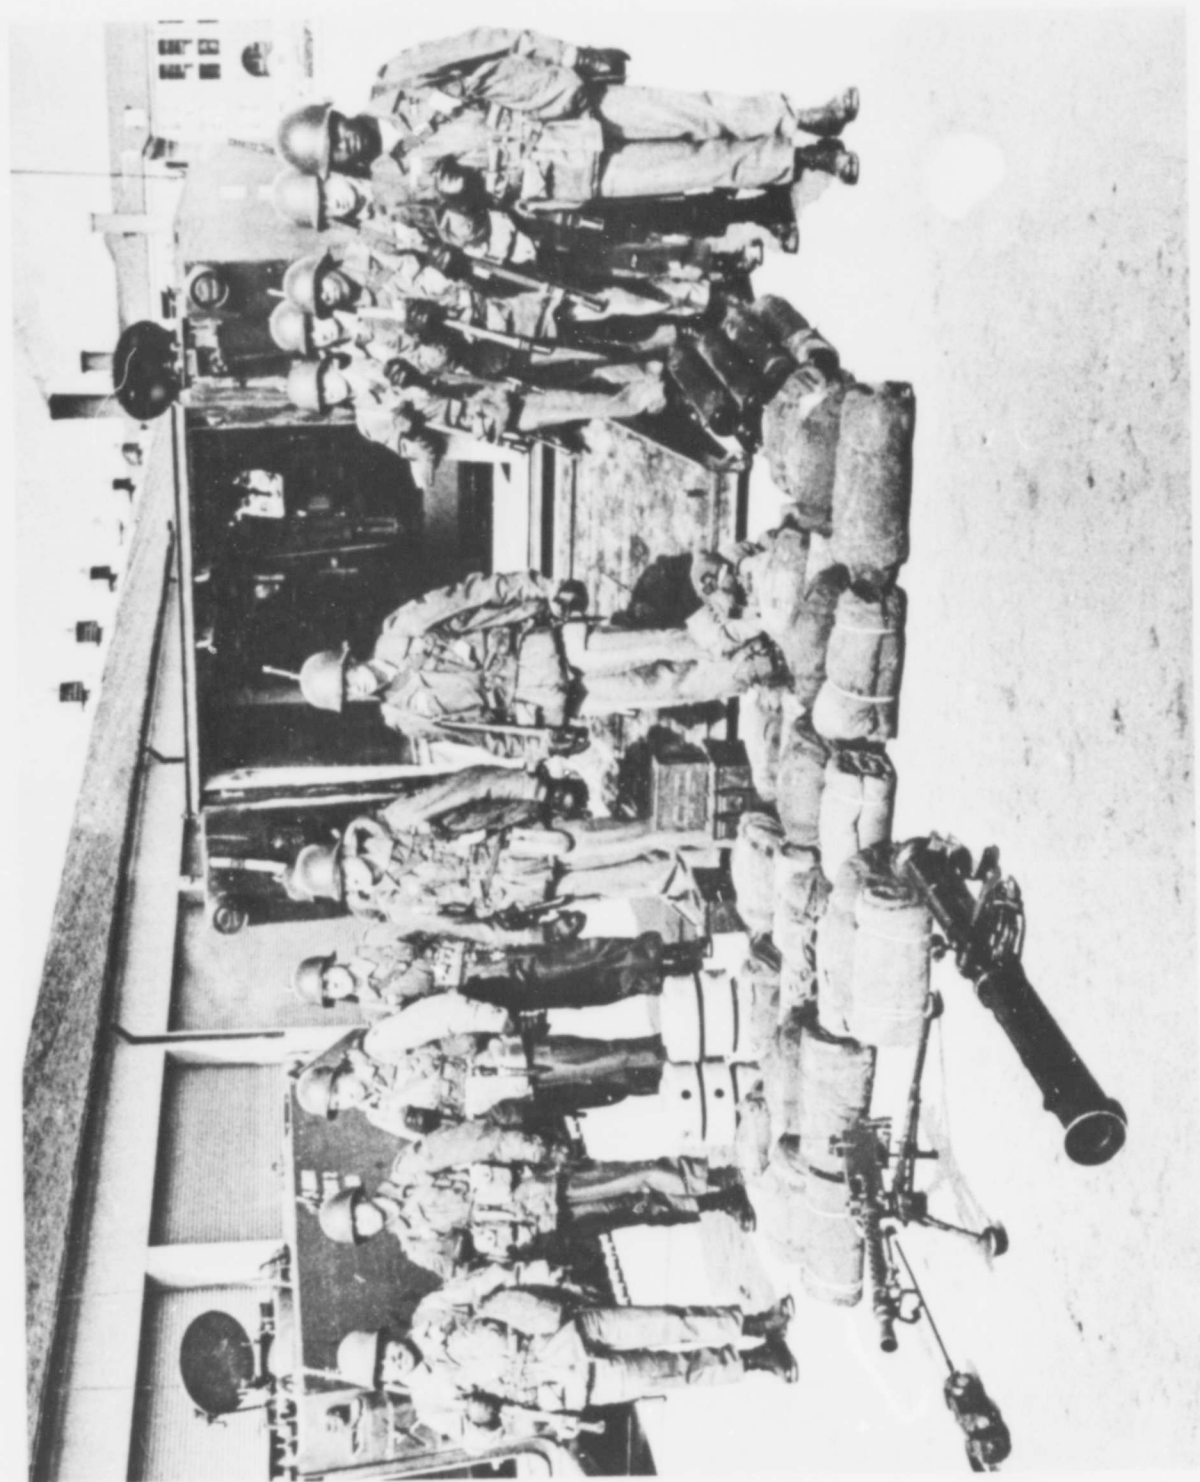
q. There was insufficient storage space for OVM and squad equipment (Fig. 13).

FIG 13. Vehicle shown with its full complement of personnel plus their TO&E equipment.

k. Racks, straps, and labels for all OVM, and redesign of current dead space, should be incorporated for better equipment stowage (Fig. 13).

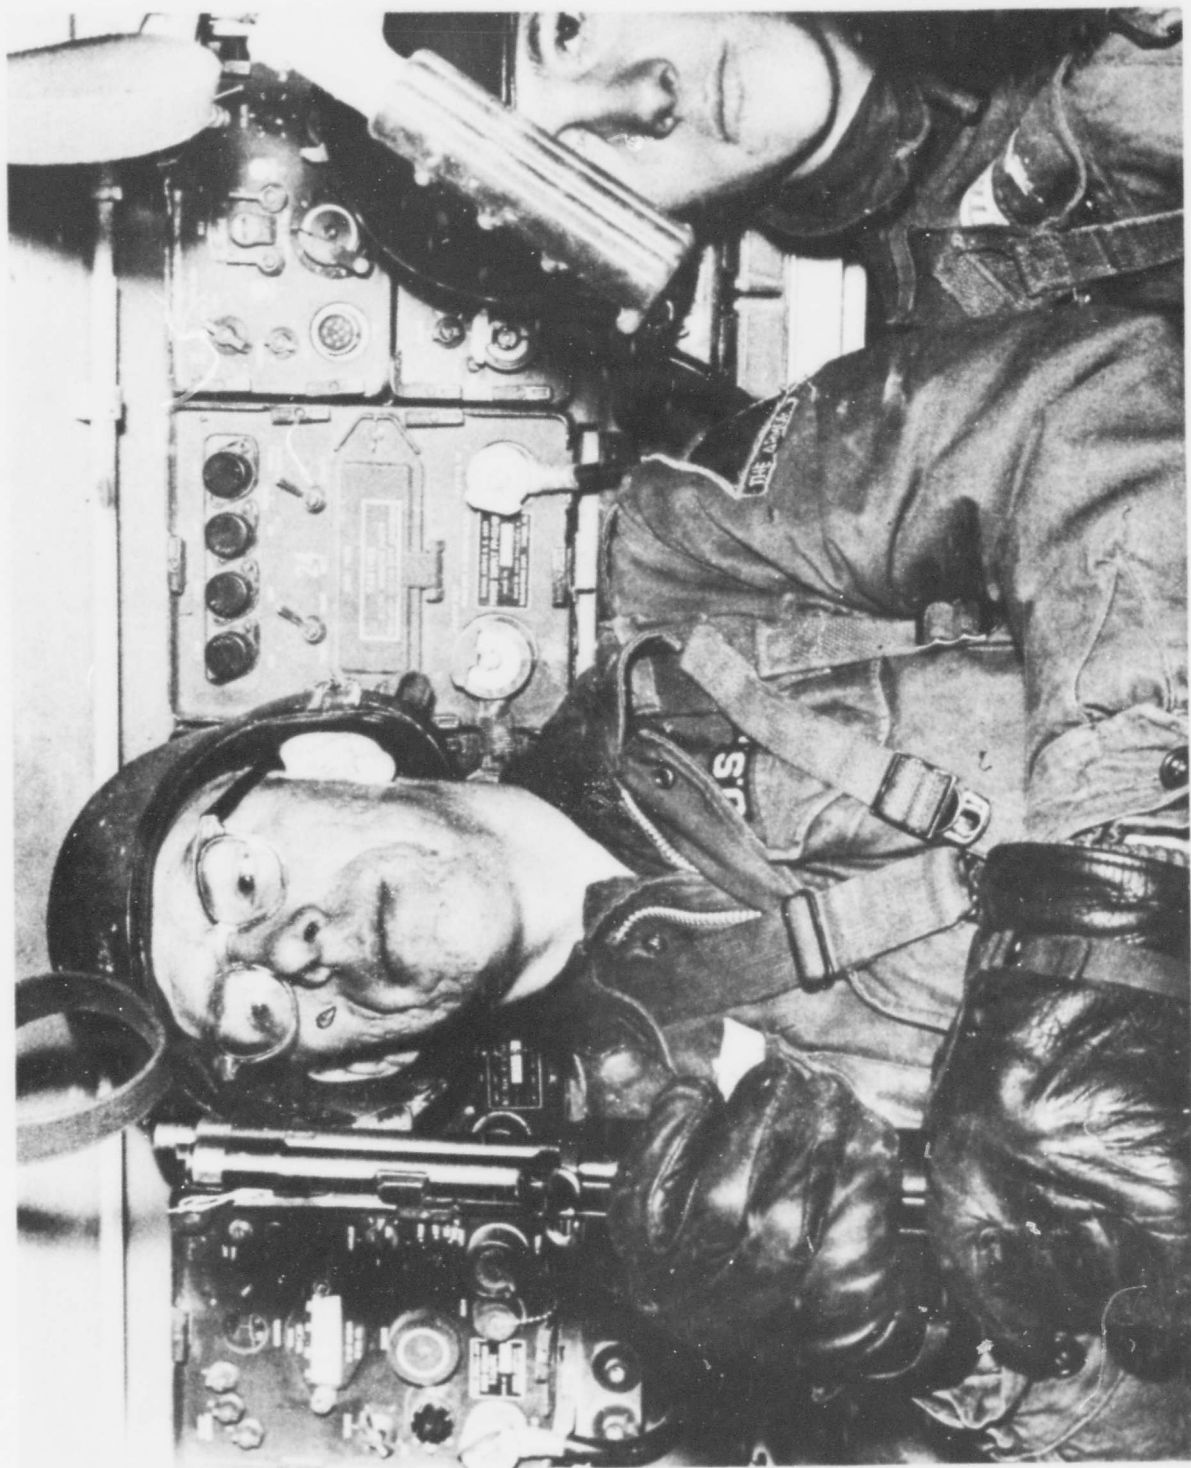
r. The radio channel on which the vehicle commander was receiving his orders was inadvertently changed by a crew member who brushed against the controls (Fig. 14).

FIG 14. The soldier seated directly in front of the radio, blocks the radio controls from the Commander, and his helmet frequently disrupts the controls.

- e. A "U"-shaped hand grip placed on the wall in front of the commander would provide him with a means of bracing himself in the buttoned position.
- f. The radio should be made more accessible to the commander by relocation or some means of remote control. The radio controls should have locking qualities to prevent inadvertent movement by crew members. Rounding the edge of the radio case would prevent the possibility of injury to personnel.
