Technical Memorandum 7-58

**A DYNAMIC HUMAN ENGINEERING EVALUATION
OF THE ARMORED
PERSONNEL CARRIERS T113 & T117**

August 1958

HUMAN ENGINEERING LABORATORIES

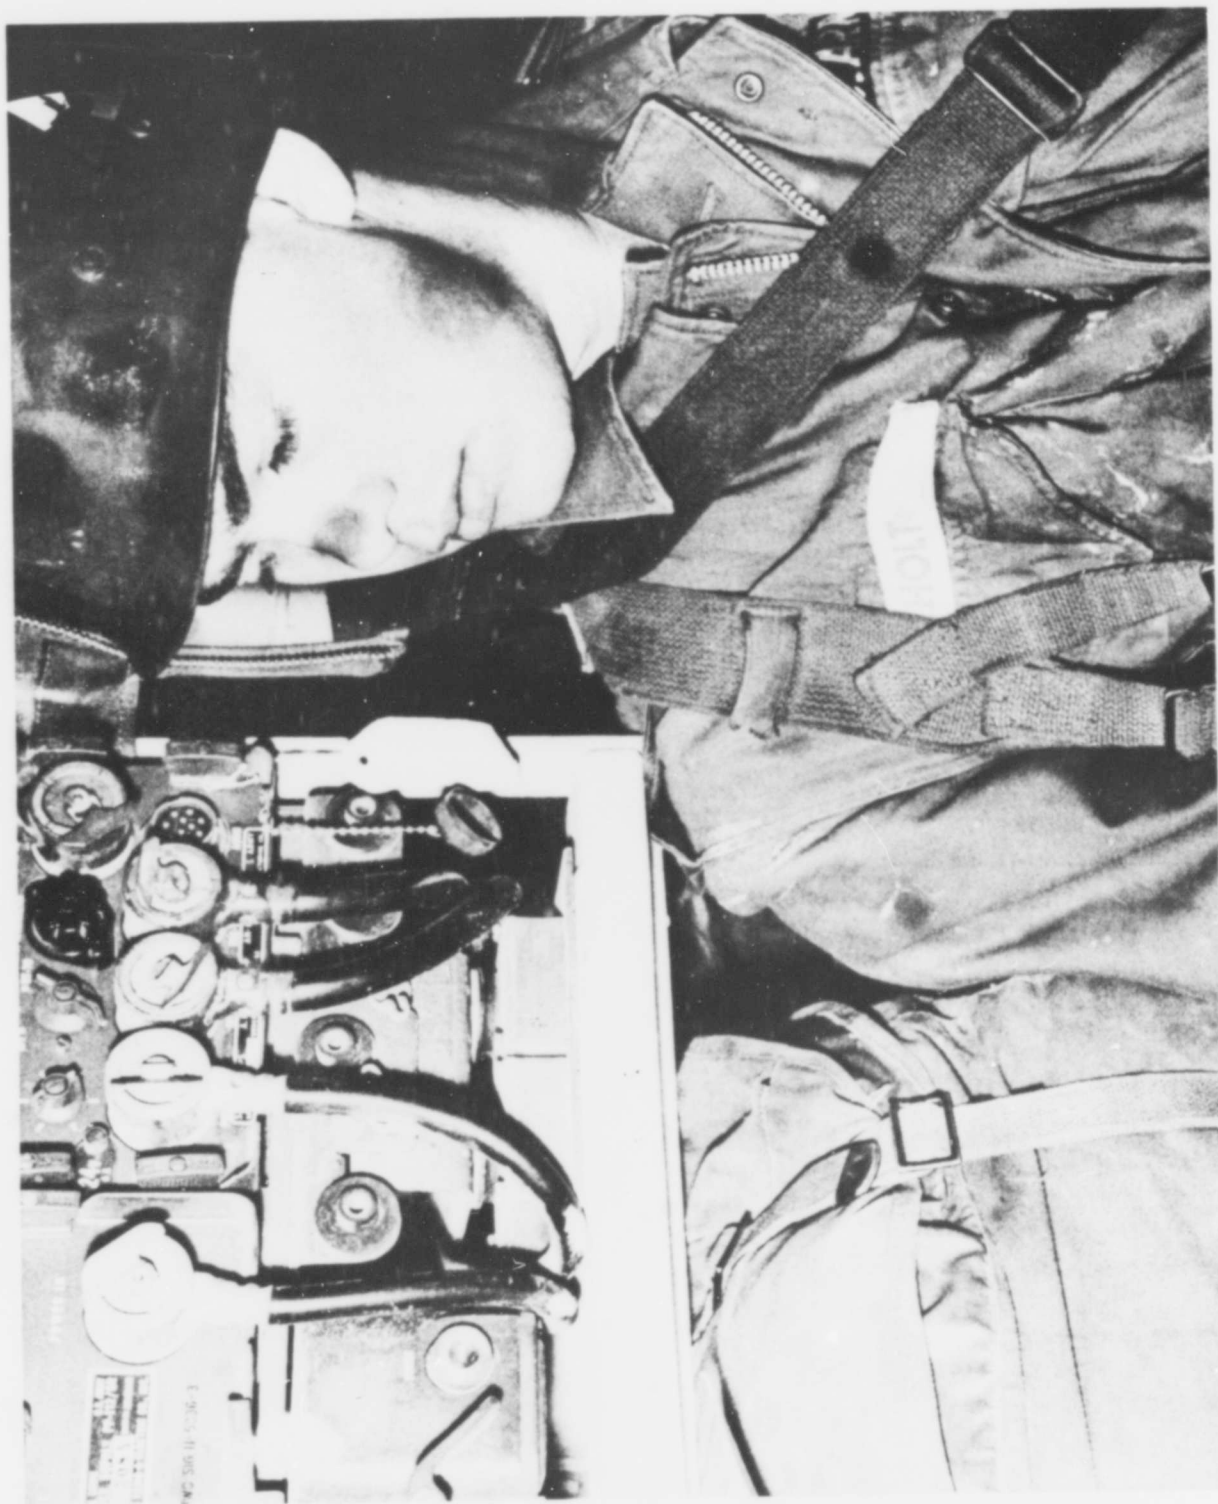
s. The corner of the radio jutted into the shoulders of the men sitting next to it (Fig. 15).

FIG 15. The proximity of the soldier's shoulder to the edge of the radio is hazardous.

- e. A "U"-shaped hand grip placed on the wall in front of the commander would provide him with a means of bracing himself in the buttoned position.
- f. The radio should be made more accessible to the commander by relocation or some means of remote control. The radio controls should have locking qualities to prevent inadvertent movement by crew members. Rounding the edge of the radio case would prevent the possibility of injury to personnel.

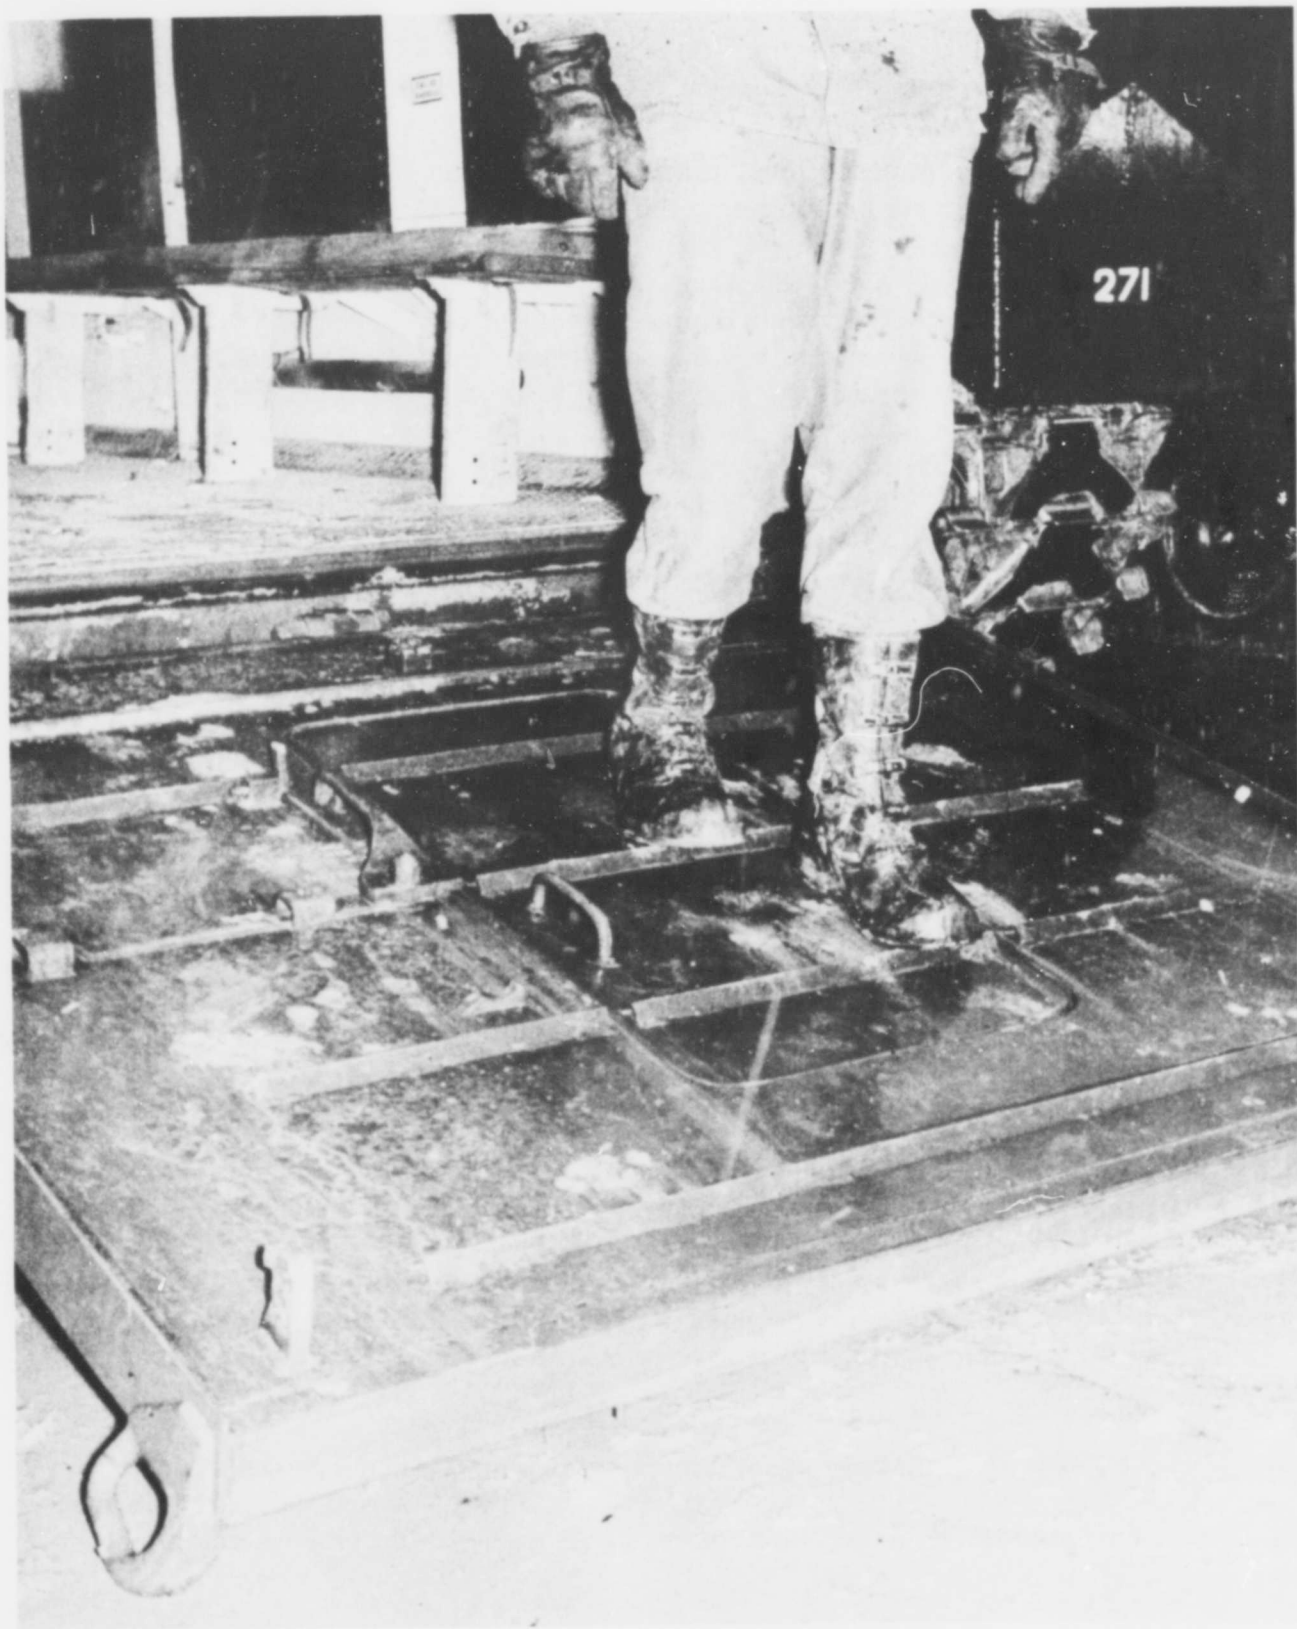
FIG 16. Picture of the horizontal bars on the ramp.

m. Rungs similar to those found on the M59 ramp should be installed on the T113 and T117 ramps to prevent slipping (Fig. 16).
