Technical Report 1674-TR

FIELD LOAD TEST OF COLLAPSIBLE  
CANVAS LINER FOR SHALLOW TUNNELS

7 June 1961

U S Army  
Engineer Research And  
Development Laboratories

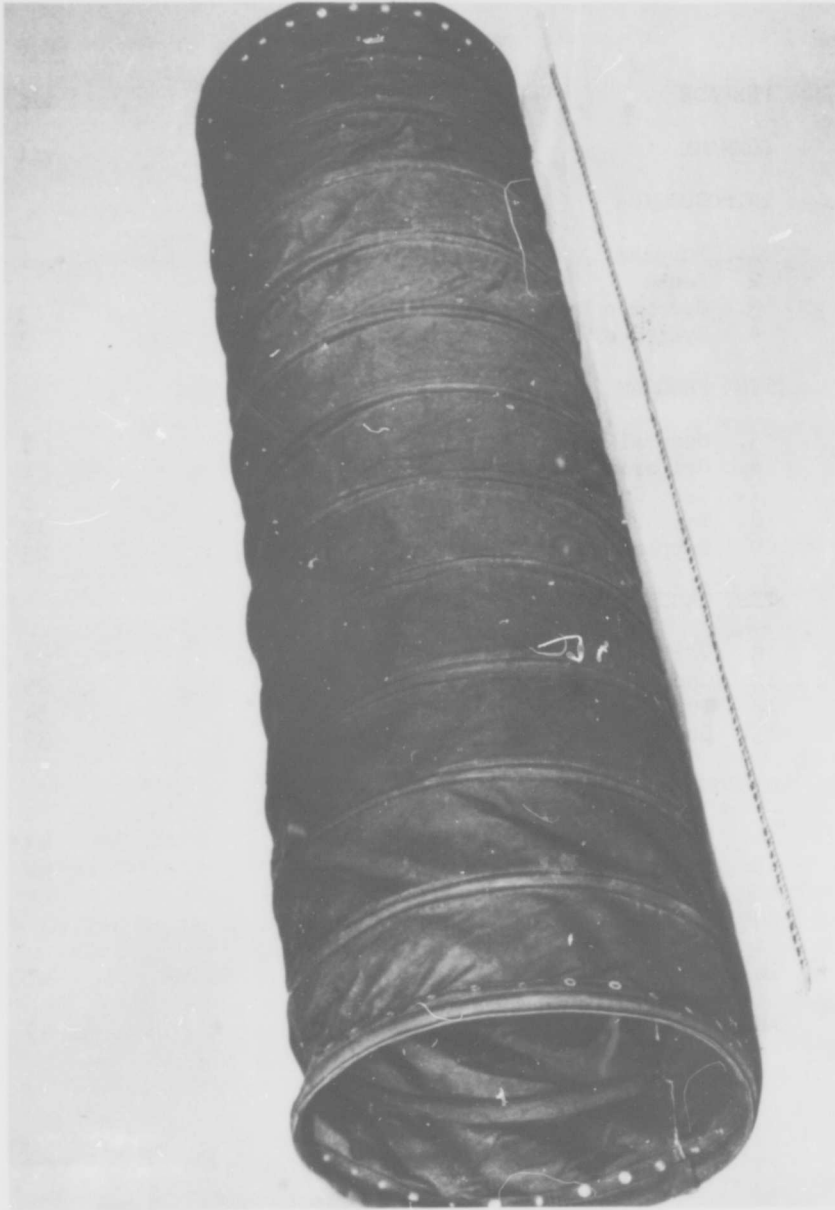
F7465

Collapsible canvas liner for shallow tunnels.

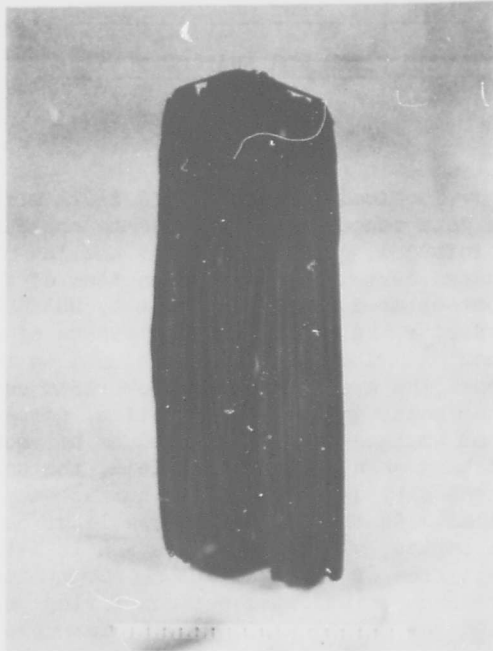
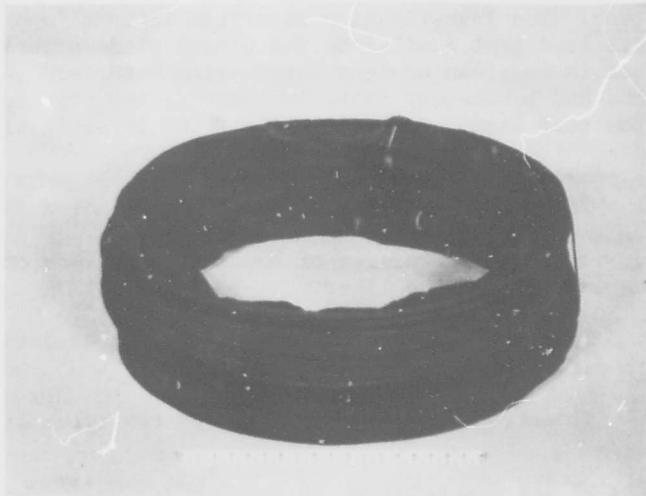
Fig. 1. Collapsed liner.

3. Specimen Description. The liner consisted of three components. A cotton duck fabric was sewn in a cylindrical envelope 30 inches inside diameter and 10 feet long. When collapsed, the liner makes a package approximately 34 inches in exterior diameter and 10 inches in height (Fig. 1). The envelope was held in shape by steel rings pocketed at 10-inch intervals in cotton webbing affixed to the fabric by cotton thread. At each end of the liner on the interior edge of the first web pocket, brass grommets were installed on approximately 3-inch centers around the circumference of the envelope for anchorage purposes. The canvas material used in the fabrication of the envelope was type I, No. 4, hard-texture cotton duck, vat-dyed olive drab shade No. 7, mildew-resistant treated, 72 inches wide, conforming to requirements of Federal Specification CCC-C-419, "Cloth, Cotton, Duck, Unbleached, Plied Yarns (Army and Numbered)." The webbing used to attach the rings was dyed to match the No. 7 shade of olive drab, mildew-resistant and water-repellent treated, type III, heavyweight, 2-inch, 2.65 ounce per linear yard, conforming to the requirements of Military Specification MIL-W-530B, "Webbing, Textile, Cotton, General Purpose, Natural or in Colors." The cotton thread used for all sewing was heavy thread, glazed, type III B, 5-ply, ticket No. 10/5 conforming to Table VI, Federal Specification V-T-276d, "Thread, Cotton." The seams and machine stitching used in the fabrication of the liner were in accordance with Federal Specification DDD-S-751. All sewing was done with stitch type 301, commonly known as the lock stitch, 6 to 8 stitches to the inch.

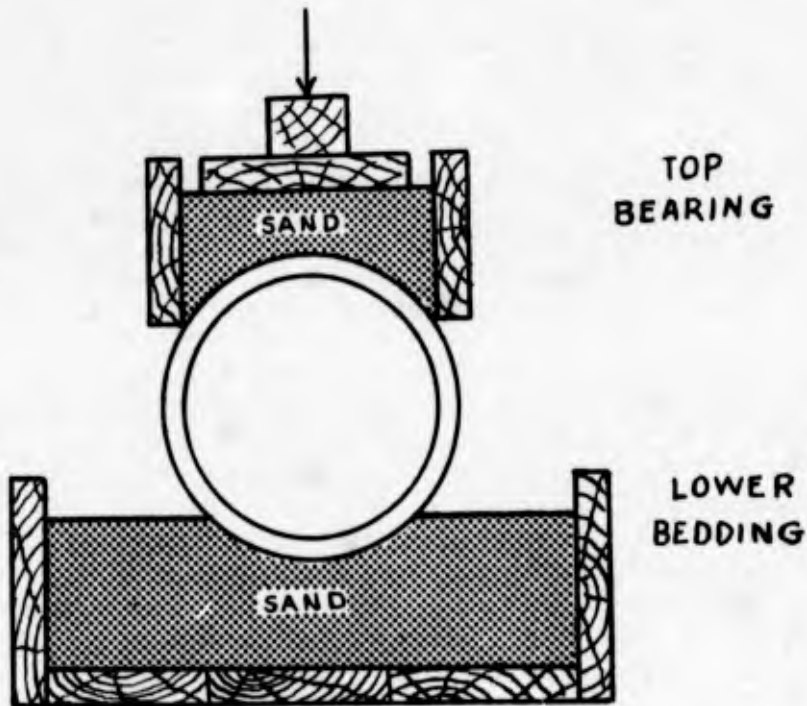
Fig. 2. Sand-bearing installation for testing of pipe.

5. General. Two widely recognized tests for the determination of supporting strength of conduit are the Sand-Bearing Method (Fig. 2) and the Three-Edge Bearing Method. Both of these methods are described in applicable ASTM specifications and are considered equally acceptable. The sandbox test is based on simulation of the conditions found in a trench. A distinct advantage which the sandbox test has over the three-edge test is that the former presents direct results. Results of the three-edge test can be made applicable for comparison with actual trench loads only when adjusted by a factor based on bedding conditions. Since means were readily available to construct a sandbox and only one liner was to be evaluated, the sand-bearing method was selected to obtain the required data.

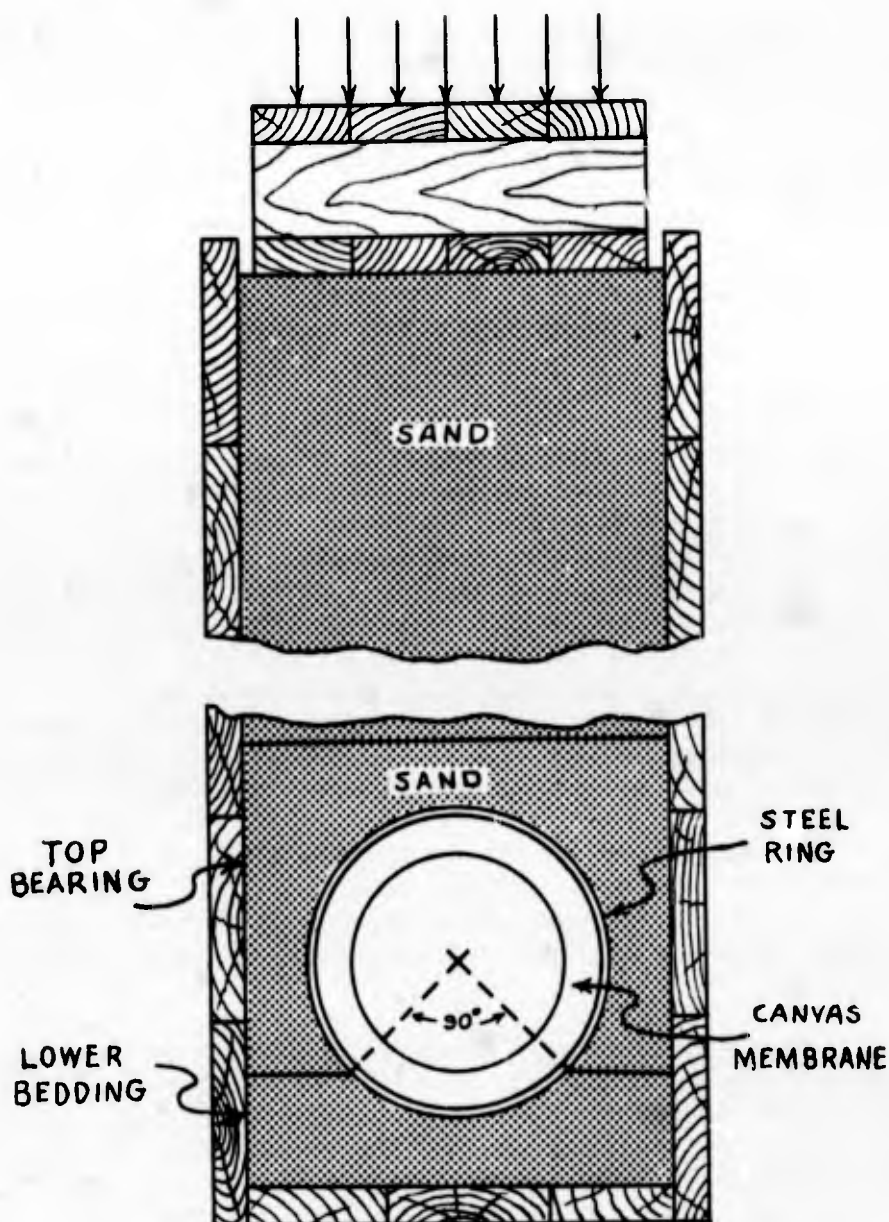
Fig. 3. Sand-loading installation for testing of liner.

7. Test Installation. A schematic diagram of the test installation is shown in Fig. 3. The site selected for construction of the sandbox was at the base of a vertical 6-foot-high embankment to facilitate loading arrangements. On level grade, two 2-by-10 wooden stringers 12 feet long were laid with 42-inch, center-to-center spacing. Across these sills were placed nine 2-by-4 floor joists about 48 inches long with the seven interior joists on 18-inch centers. Wedges were placed under these members for any necessary leveling of floor or plumbing of walls. A solid flooring of one-by-sixes was next placed on the joists. Longitudinal wall panels made up of seven 2-by-4 studs 12 feet long and initially sheathed to a height of 6 feet were set up and nailed to the joists. A double 2-by-4 stud was used at the center of the walls.

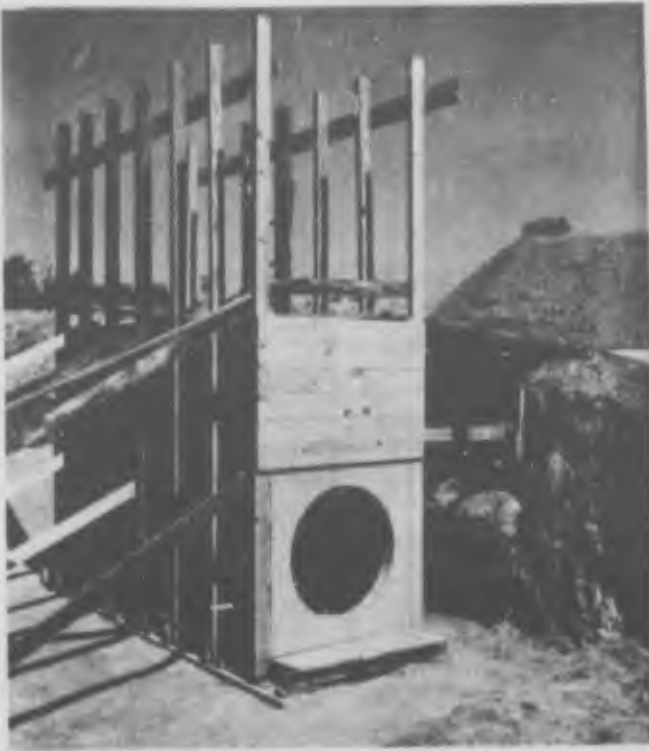
Fig. 4. Provisions  
for wall height  
extension.

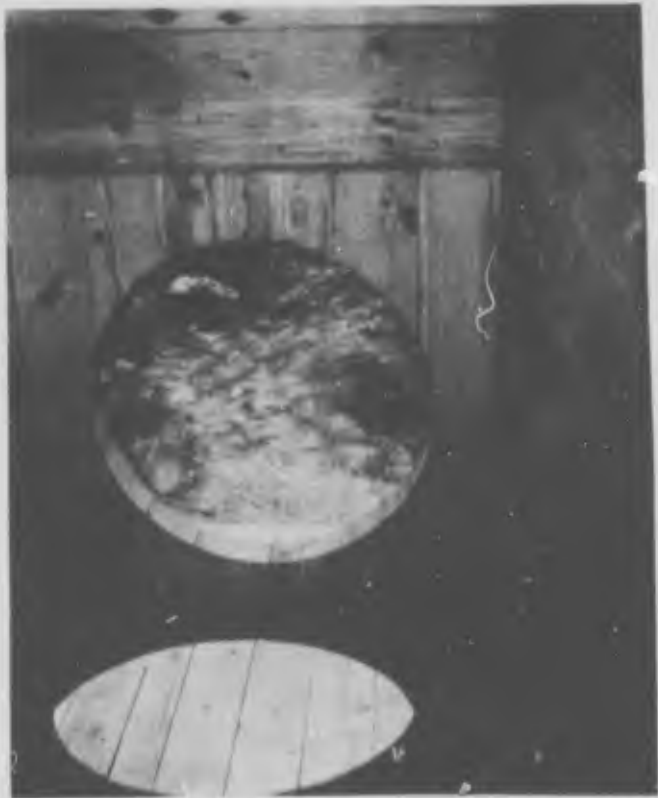
Fig. 5. Anchorage  
bulkhead was fabri-  
cated of 6 three-by-  
eights 42 inches  
long.

The anchorage method resolved to secure the liner under loading consisted of a 42-inch-square bulkhead made up of 6 three-by-eights held together by a 3/4-inch-thick exterior plywood panel. A 31-inch-diameter opening was cut from the center of each bulkhead. Above the bulkheads, the ends of the box were sheathed by one-by-sixes nailed to the end studs of the walls. Figures 4 and 5 illustrate these construction features. The anchorage bulkheads were framed in place both inside and outside the box.

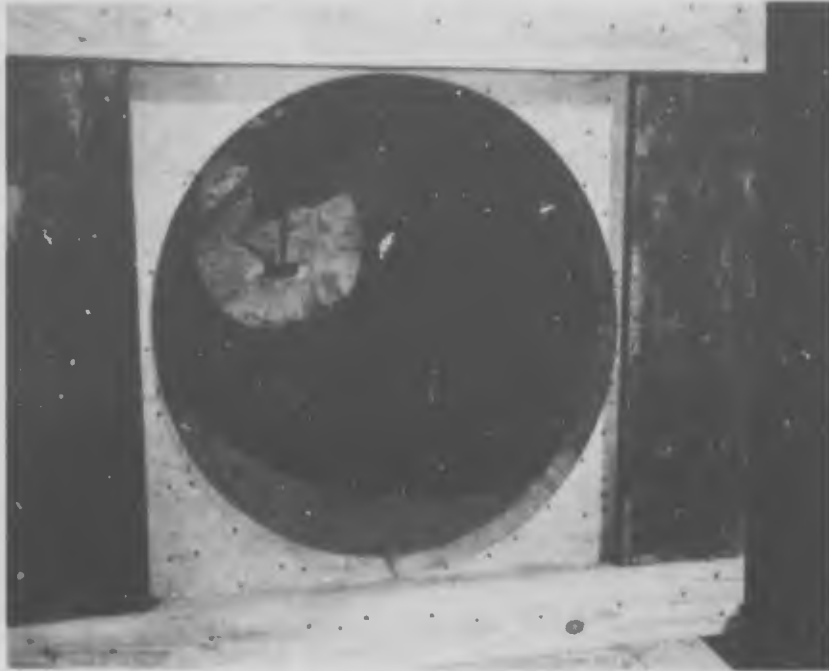
F8079

Fig. 6. Lower bedding shaped to fit barrel of liner.

Before the liner was anchored, a lower bedding of sand about 6 inches in depth was placed in the box and shaped to fit the barrel of the liner with reasonable closeness for a width of more than 50 percent of the liner breadth (Figs. 6 and 7). The sand was a clean hand aggregate reasonably free from soft or flaky particles, salt, alkali, organic matter, or other extraneous substances and contained less than 3 percent clay. The material was well-graded from coarse to fine all passing a No. 4 (4,760-micron) sieve and less than 5 percent passing a No. 100 (149-micron) sieve. Moisture content of the sand averaged about 12 percent during the time of the test.

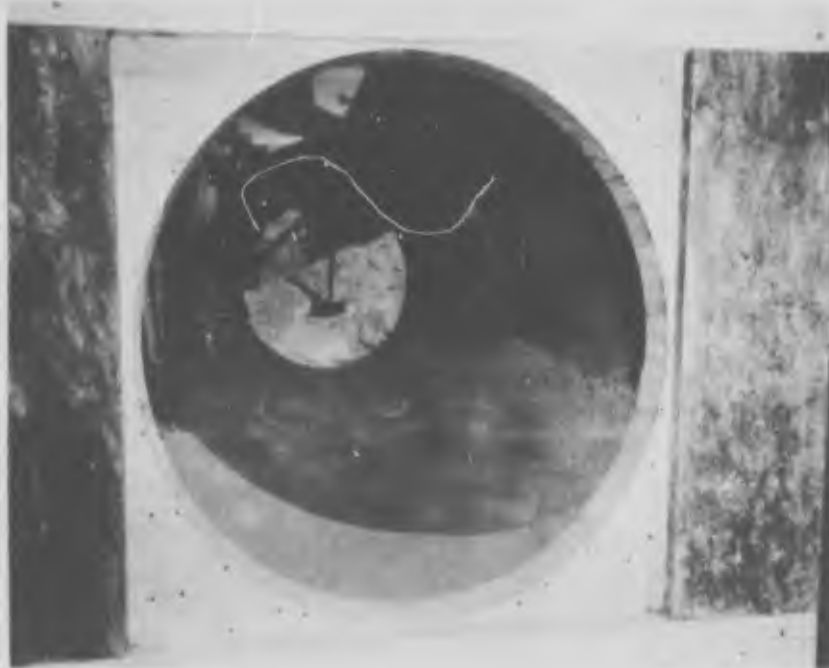
F8080

Fig. 7. Lower bedding hand tamped beneath the haunches of liner and between walls to a height above the bottom quadrant points of the barrel.

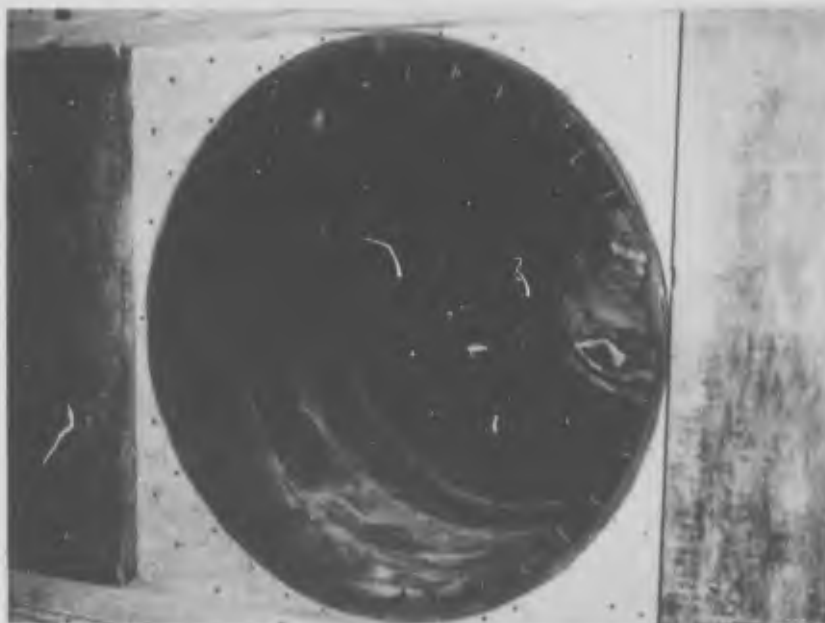
F8092

Fig. 8. Liner was secured to bulkhead by means of screws and washers through grommets affixed to liner.

Upon completion of the lower bedding, the liner was anchored to each bulkhead (Fig. 8) through grommets by means of washers and screws. The liner was stretched taut (Fig. 9) with all rings positioned vertically and all ring joints oriented on the horizontal diameter (Fig. 10) to one side of the vertical axis.

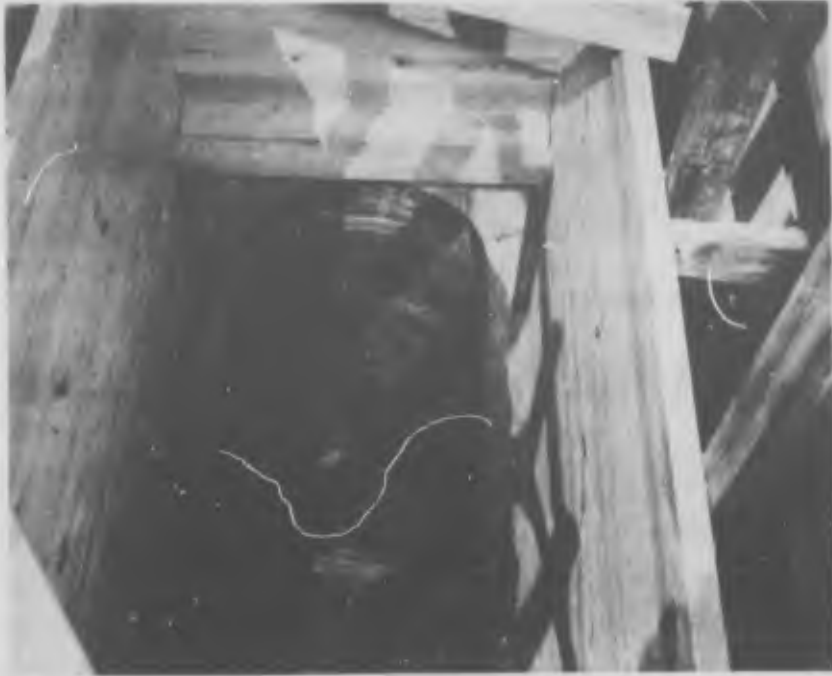
F8081

Fig. 9. Interior framing of bulkhead.

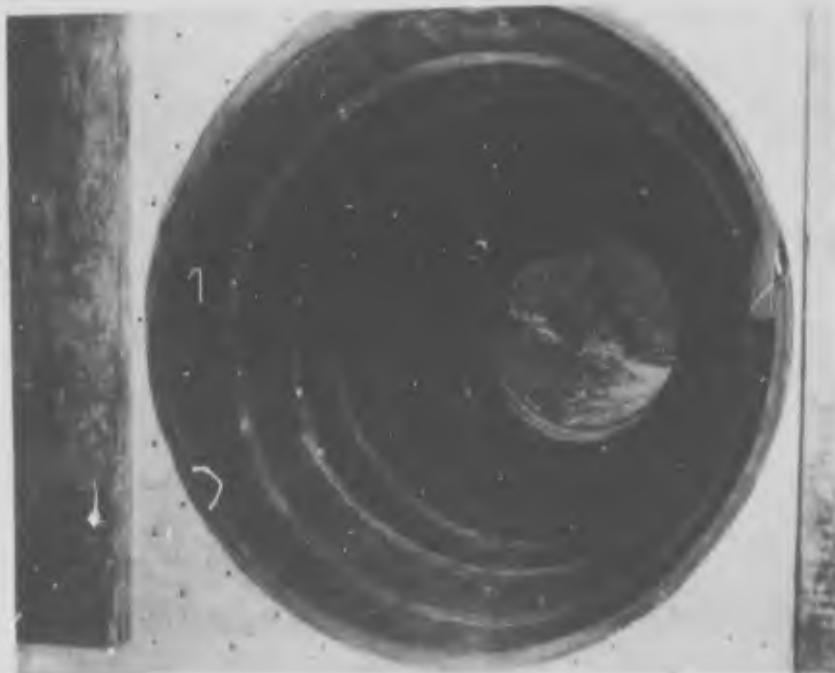
F8090

Fig. 10. Ring joints oriented on horizontal diameter to right side of vertical axis; excess webbing covering joints.

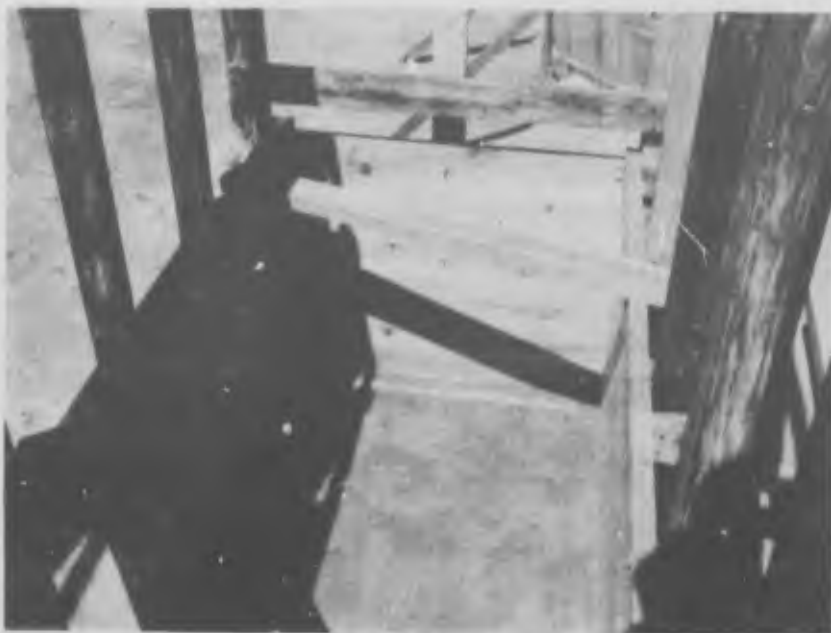
F8077  
Fig. 11. Sand in top bearing struck off level at an elevation  
6 inches above liner crown.

After the liner was secured in place, the space between the walls and the liner (6 inches on each side) was filled with identical sand material as lower bedding in layers of 6-inch maximum depth to a height of about 6 inches above crown of the liner (Fig. 11). Compaction was accomplished by hand tamping. Interior bulging of canvas between rings was tamped from inside the liner to remove all slackness from the fabric and to aid surrounding sand in supporting the rings in a vertical position (Fig. 12).

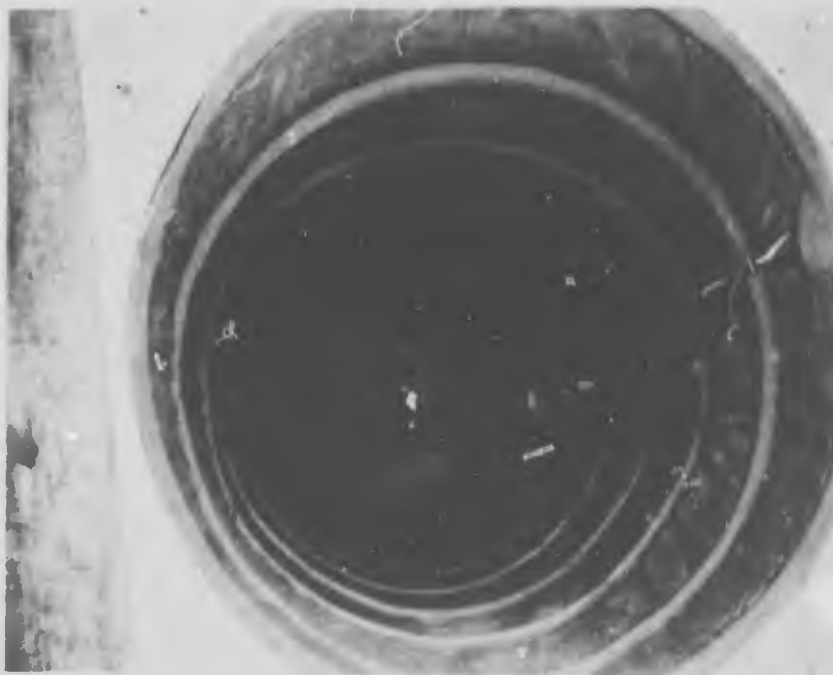
F8091  
Fig. 12. Liner in place with all rings vertical and covered  
with top bearing material.

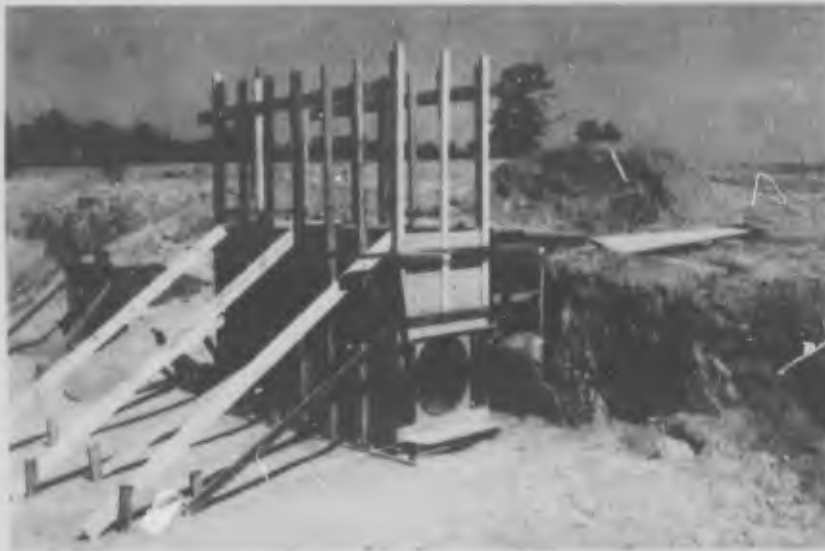
F8078

Fig. 13. Sandbox prepared for test loading; height of walls about 6 feet.

The upper surface of the sand was leveled off after the bearing fill was completed. Wall struts and braces were placed about 4 and 6 feet above floor grade (Fig. 13) to avoid appreciable bending from side pressure of the sand load. A timber collar made up of two-by-fours encircled the walls.

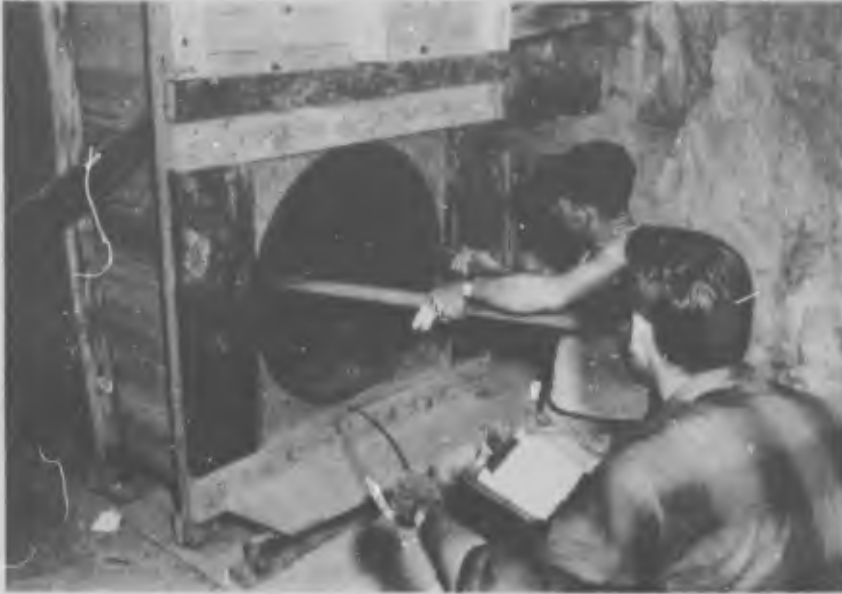
F8083

Fig. 14. Five-foot-length, field-constructed calipers inserted into liner to determine deflections.

Test measurements were to be made of both vertical and horizontal deflections at 1-foot fill height increments above the crown of the liner. Figures 14 and 15 show the method used to determine these deflections.

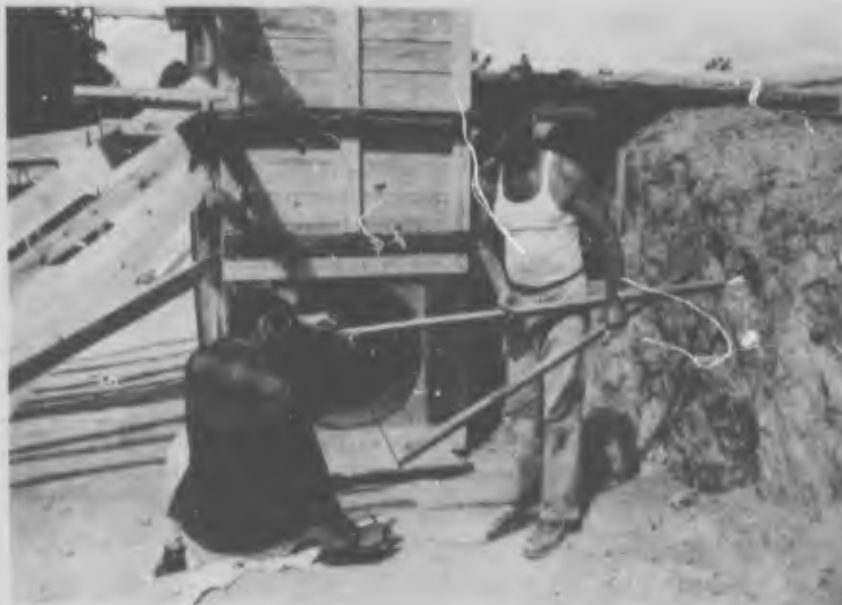
F8095

Fig. 15. Spread of calipers measured to nearest 1/8 inch.

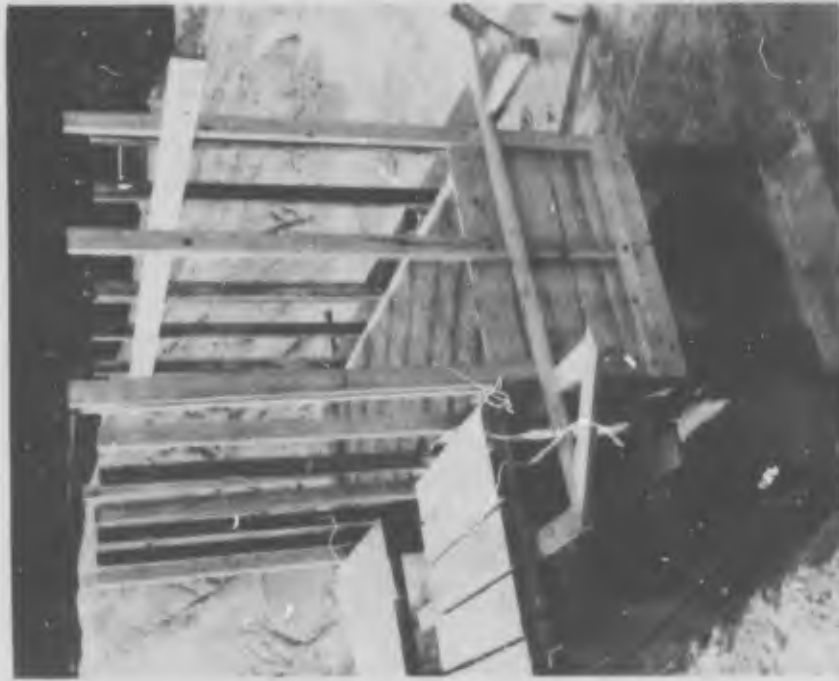
F8073  
Fig. 16. Test load reaching initial 6-foot height of sandbox; height of fill over crown of liner is 3 feet.

On Friday, 25 September 1959, the fill height above the crown of the liner had reached the 3-foot level (Fig. 16), the extent of the original height of the wall panels. At this time, no appreciable deflections were noted or recorded. Since the liner was still intact, the wall height of the sandbox was increased from 6 to 8 feet with an additional timber collar, and the remaining sand supply was exhausted (Fig. 17). Liner deflections were recorded at the 4- and 5-foot levels.

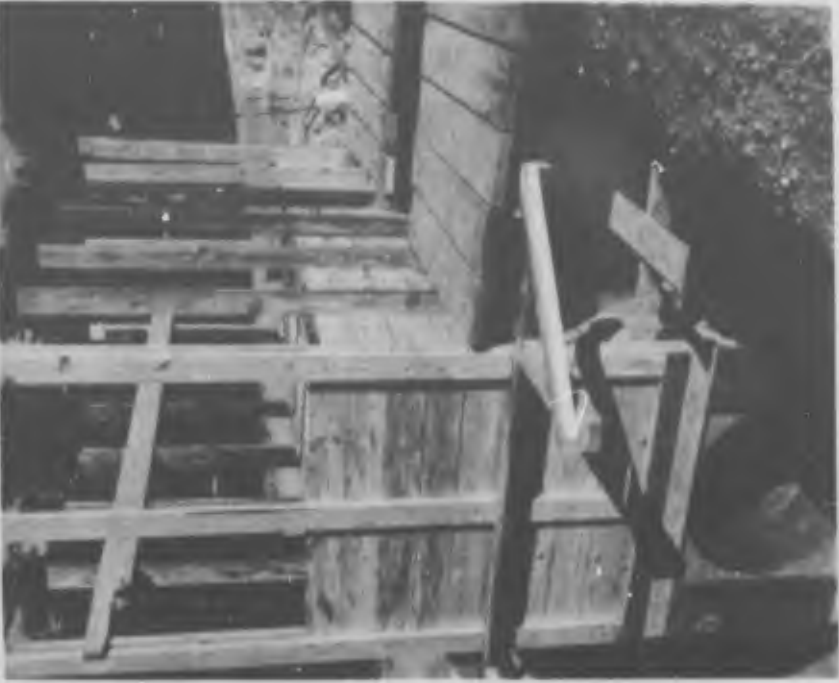
F807C  
Fig. 17. Initial height of sandbox extended to 8 feet; height of fill over crown of liner is 5 feet.

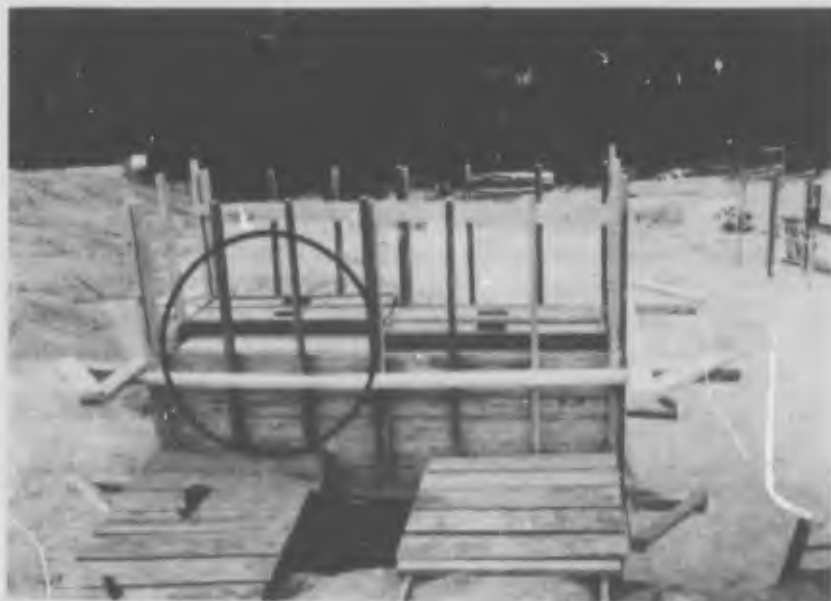
Fig. 18. First 2-ton surcharge (note left corner of timber top bearing plate).

The next test measurements were made on Monday, 28 September 1959, at which time 1,000-pound lead weights were substituted for the sand material. The surcharge was applied to the liner through a rigid top bearing plate. The plate was made of heavy timbers and was capable of reasonable uniform distribution of the test load without significant bending. The plate covered the upper surface of the sand fill completely except for a 2-inch clearance around the perimeter to permit free movement. A 20-ton crane was used to place the lead weights on the bearing plate. As each four weights (2 tons) were placed on the plate, deflection measurements were taken. The surcharge condition and deflections in the rings are shown in Figs. 18 through 26.

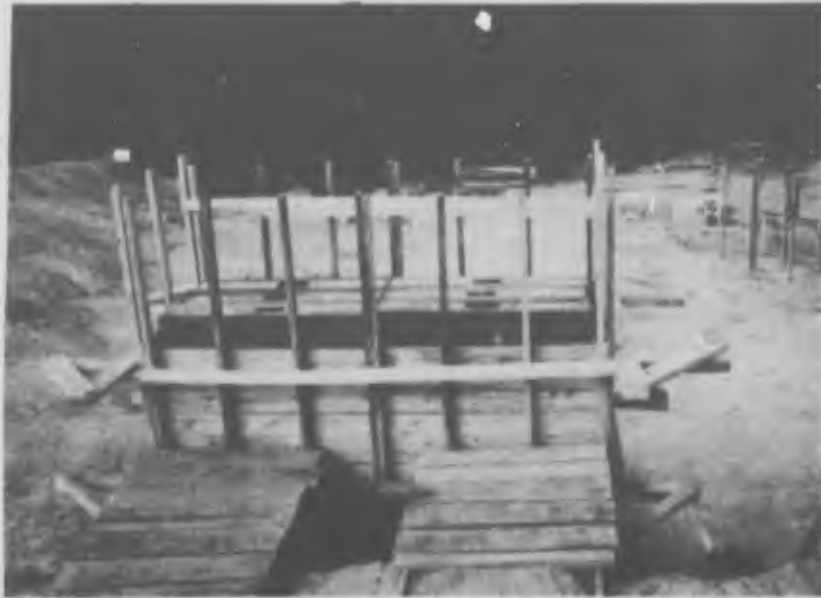
F8075

Fig. 19. Six-ton surcharge covering complete surface of sand fill (note levelness of weights).

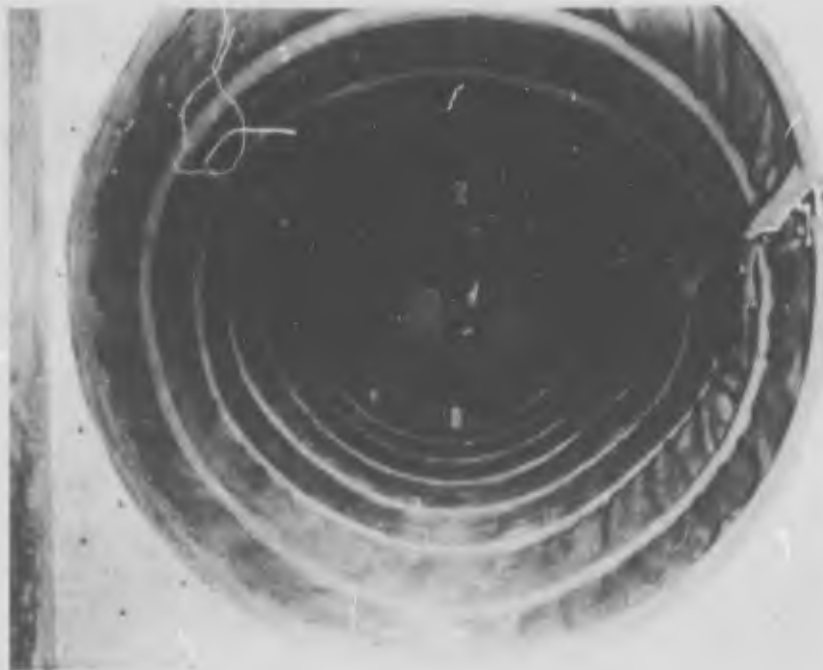
F8084

Fig. 20. Ring deflections at 6-ton level (note testman in background taking vertical deflection measurement of Ring No. 6)

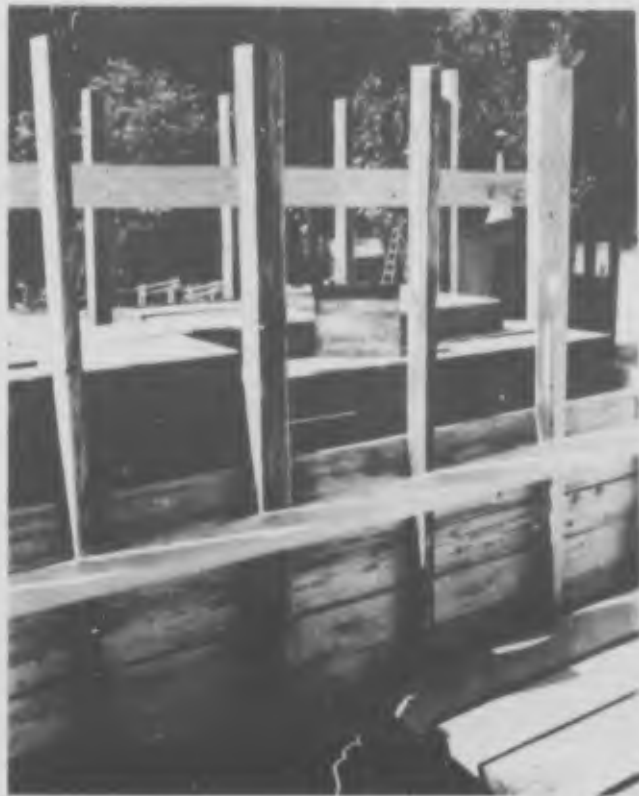
Fig. 21. Test load at 8-ton surcharge level.

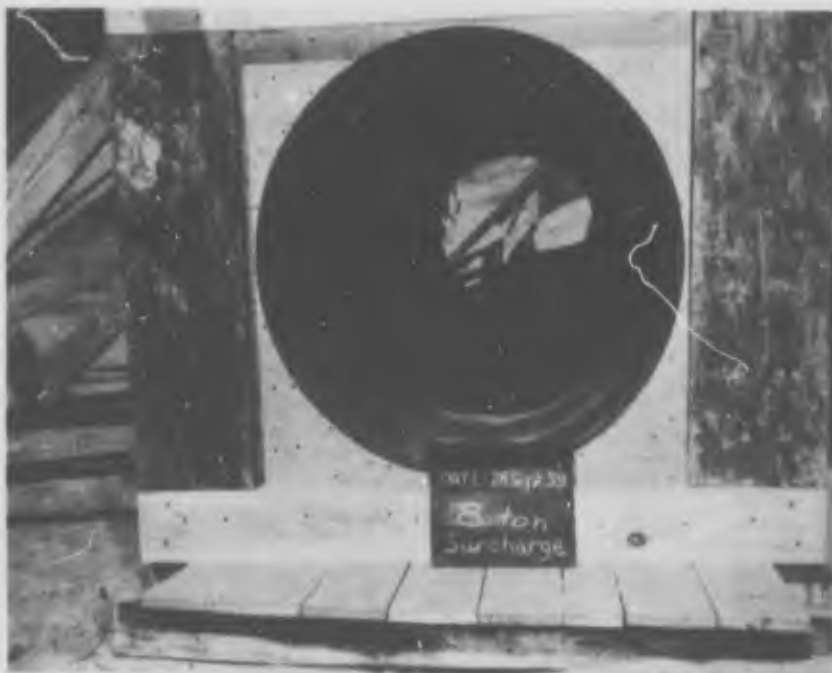
Fig. 22. Ring deflections from south end of liner at 8-ton level (Ring No. 1 in foreground).

small differential settlement of these members. Re-examination of Figs. 22, 26, and 27 indicates the extent of this settlement.

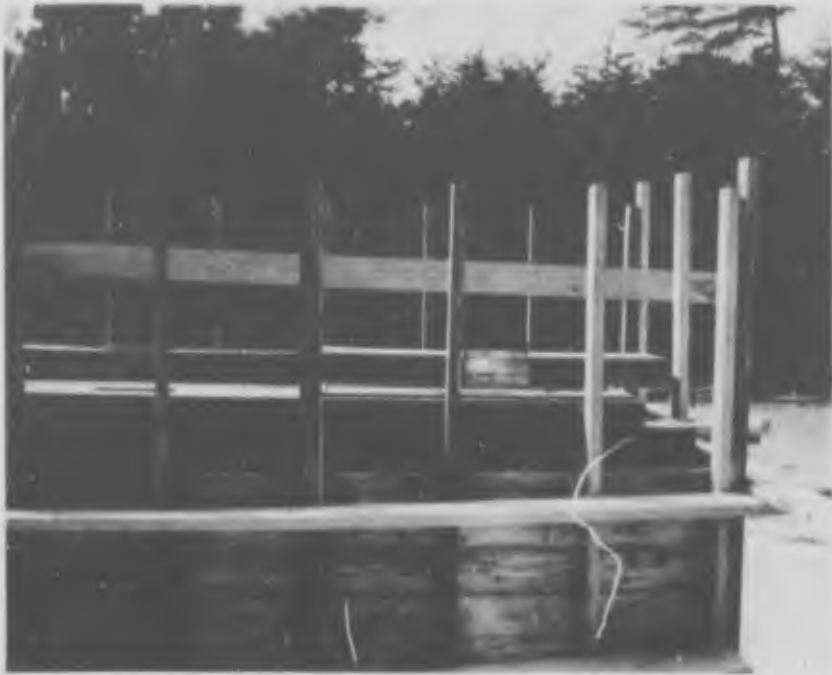
F8093

Fig. 23. Test load at 10-ton surcharge level.

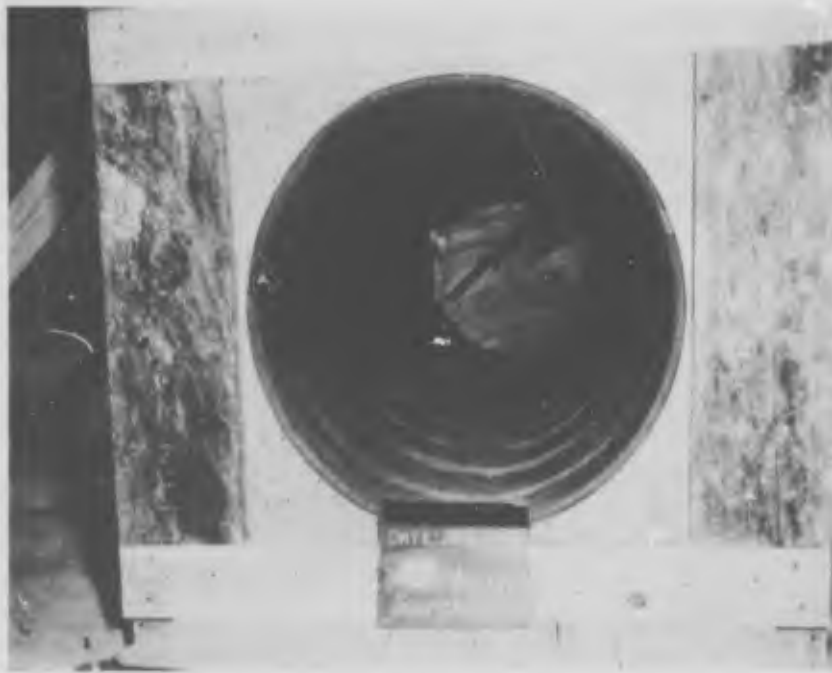
F8087

Fig. 24. Ring deflections from south end of liner at 10-ton level.

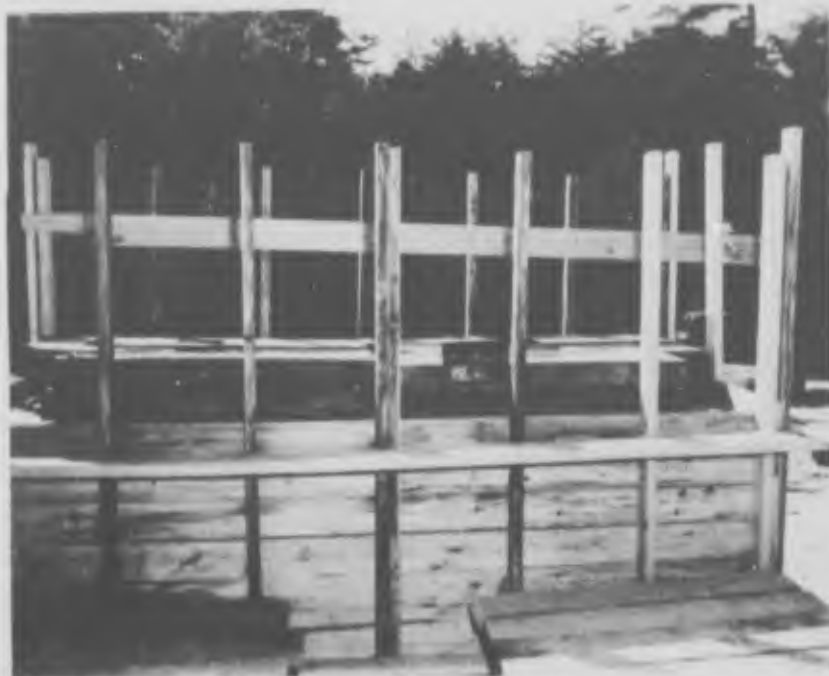
F8094

Fig. 25. Test load at 12-ton surcharge level.

end of the sandbox. This is shown in Fig. 25; the right side is lower than the left.

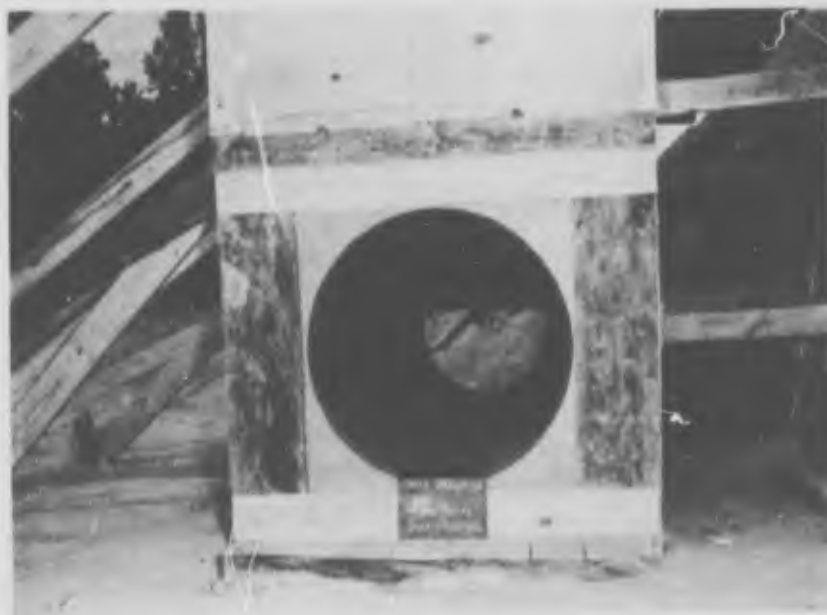
F8082

Fig. 26. Ring deflections from south end of liner at 12-ton level.

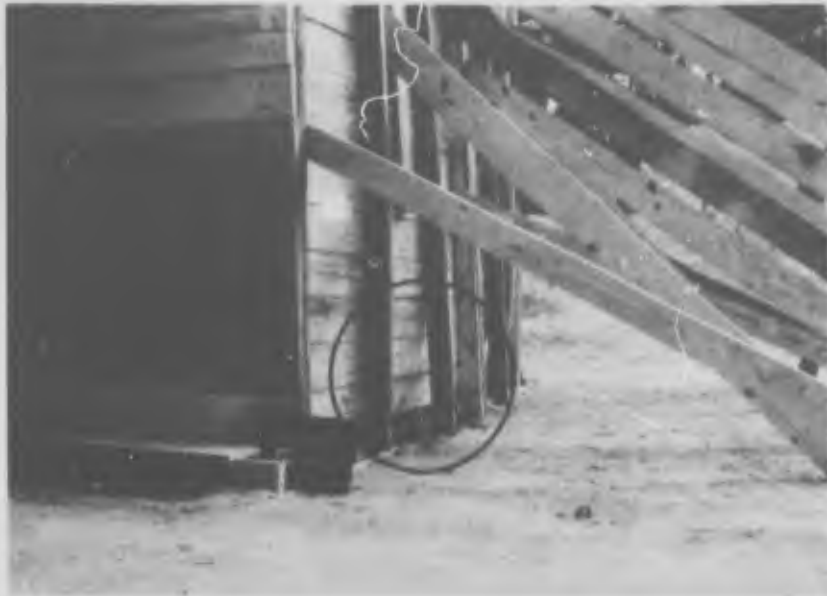
F8089

Fig. 27. North end of sandbox (note condition of wall panel studs).

of one wall indicated that the sandbox was failing. Two studs were splitting, and four studs had sprung away from the 1-by-6 sheathing (Figs. 27 and 28). Several jury braces were erected to sustain the wall panel to resist further lateral pressure. Indications were that failure of the wall panel would occur with the addition of another increment of the test load. Such was not the case; before the last 1,000 pounds of the 2-ton increment (13½-ton level) could be placed, the wall panel abruptly gave way (Figs. 29 through 32). As each 1,000-pound weight was applied, a hurried observation was made of the ring deflections. At the 13½-ton level, it was not noted that the rate of deformation was any greater than observed in previous examinations. In fact, approximately 10 minutes elapsed after the last weight had been applied before the wall failed. Another lead weight was being applied when failure of the sandbox took place.

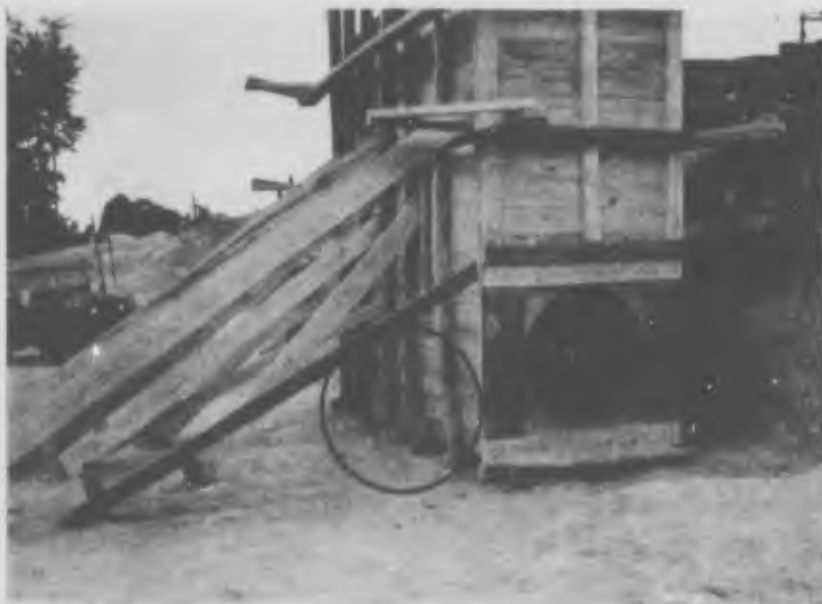
F8085

Fig. 28. South end of sandbox at 12-ton surcharge level (note splitting of wall studs and addition of jury braces).

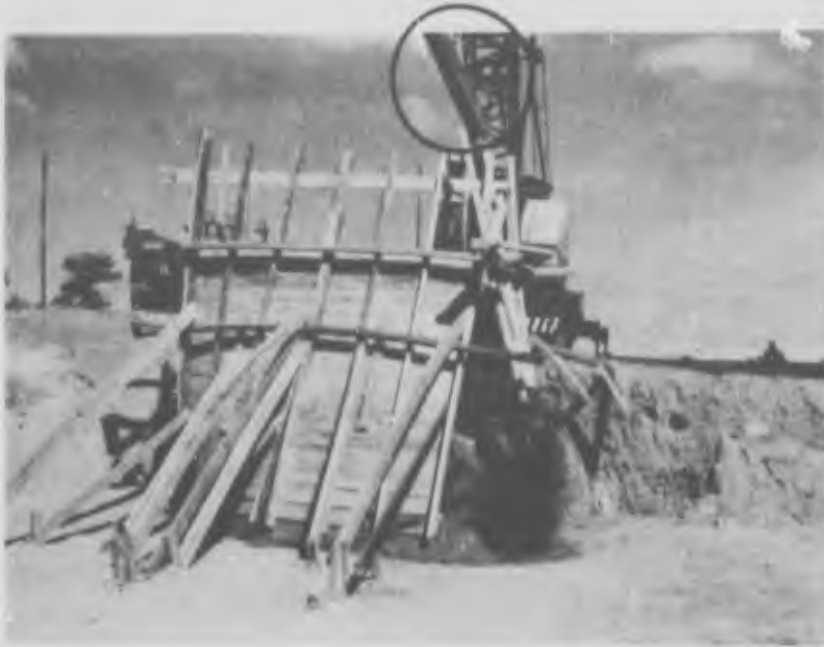
Fig. 29. Failure of sandbox at  $13\frac{1}{2}$ -ton surcharge level (note additional 1,000 pounds being applied). F8069

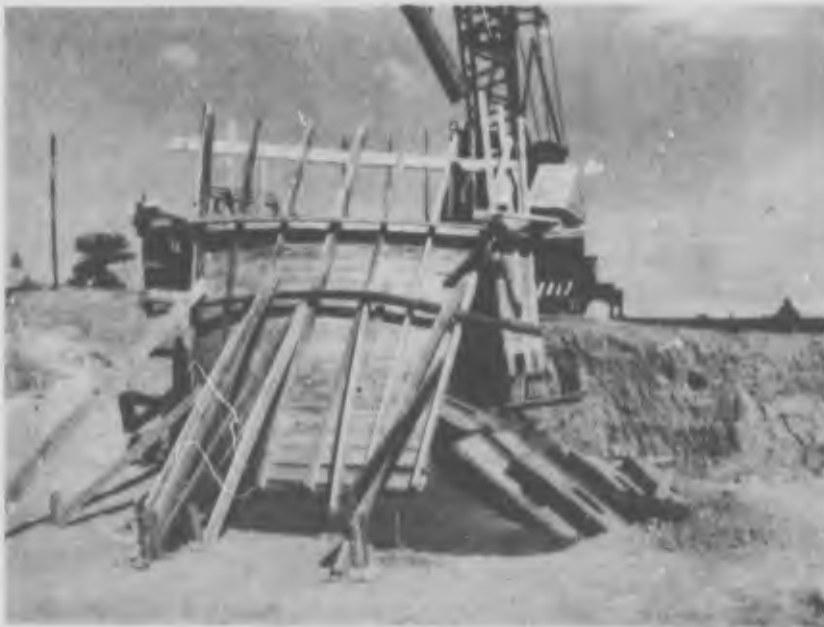
Fig. 30. Collapse of wall with lead weights crashing down. F8074

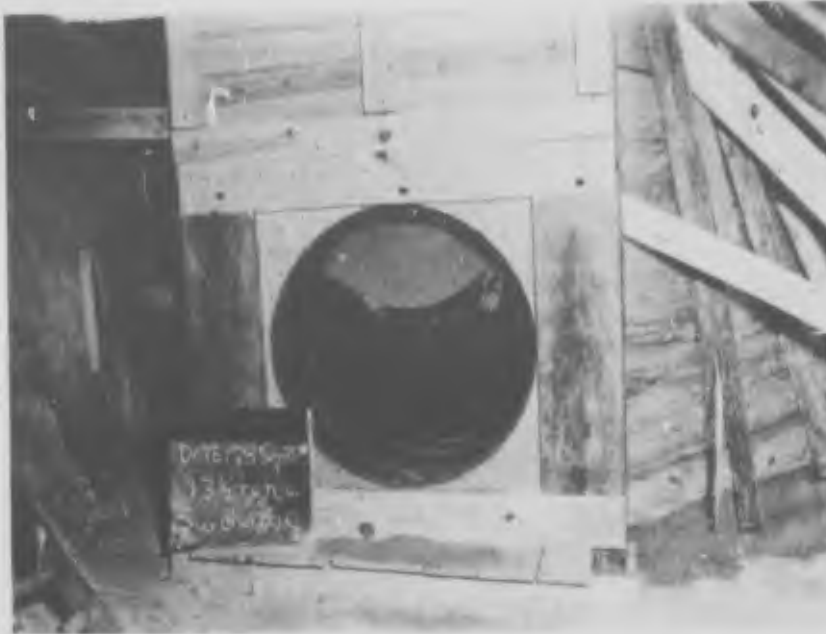
F8096

Fig. 31. Liner damage viewed from north end after sandbox failure; Ring No. 13 intact.

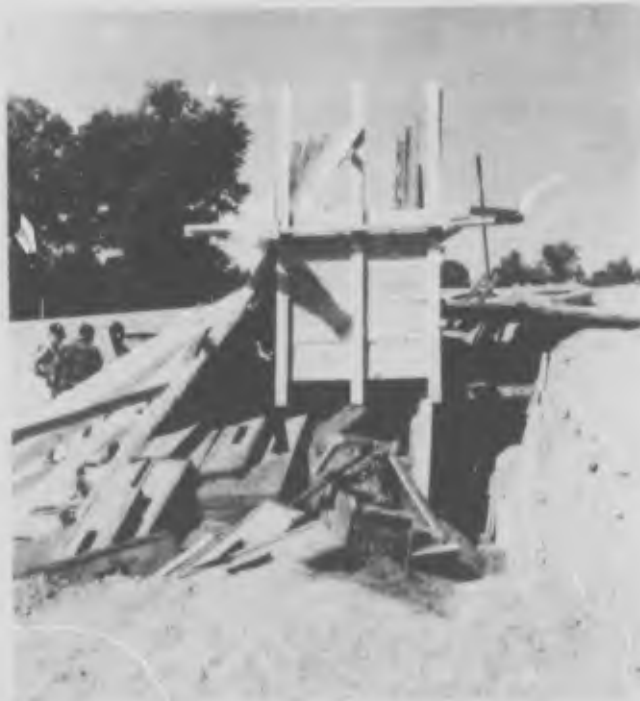
F8072

Fig. 32. Test installation viewed from south end after collapse of wall panel; Ring No. 1 buried under debris.
