Technical Report 1674-TR

FIELD LOAD TEST OF COLLAPSIBLE  
CANVAS LINER FOR SHALLOW TUNNELS

7 June 1961

U S Army  
Engineer Research And  
Development Laboratories

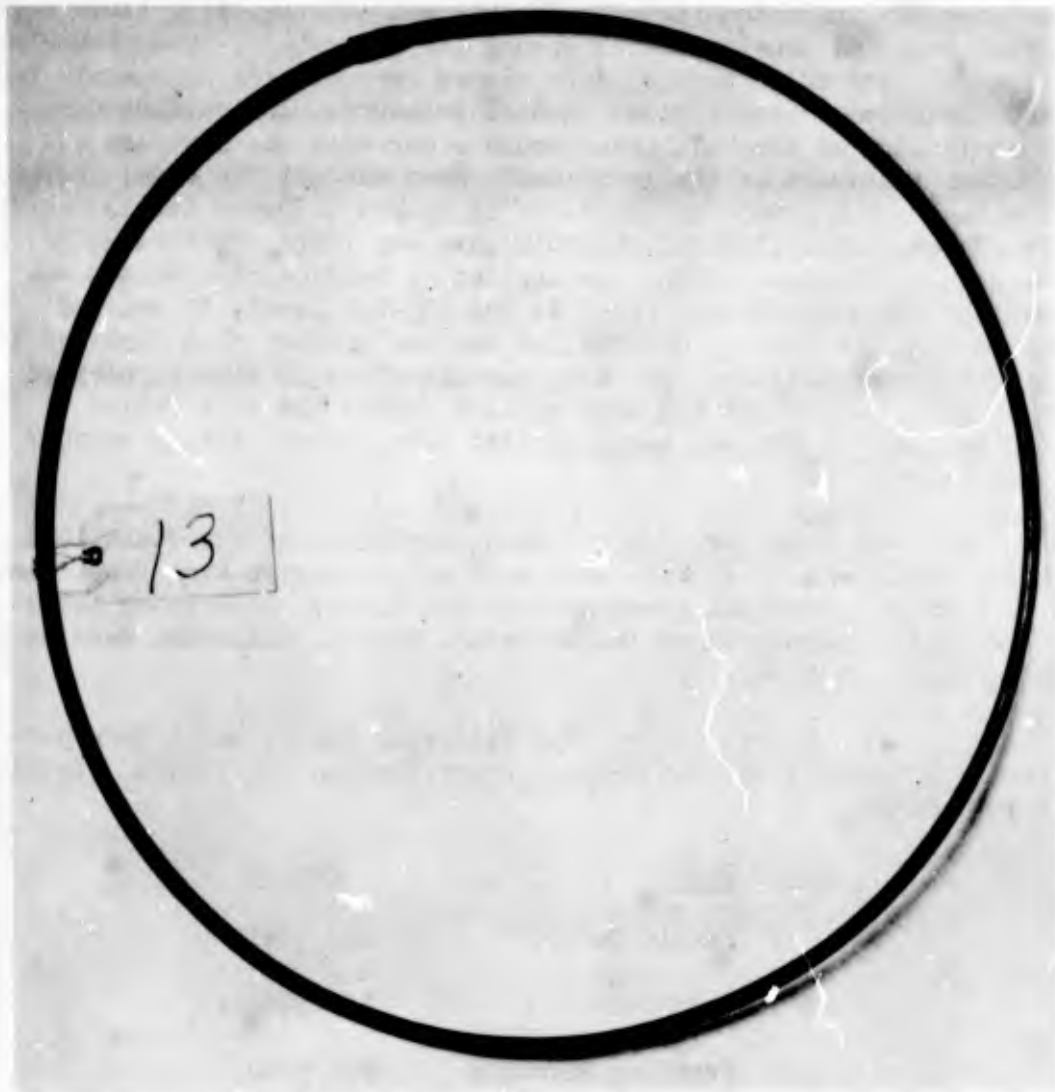
G3491

Fig. 33. Near-perfect condition of Ring No. 13 used for supplementary testing.

b. Compressive Ring Test. A compressive ring test was made of Ring No. 13 (Fig. 33). This particular ring was salvaged after failure of the sandbox. The near perfect condition of the ring was attributed to the function it performed as an anchorage ring. Ring No. 13 was more representative of the type of ring used in the liner.

The ring test was performed on a 300,000-pound-capacity Universal Testing Machine. With the connecting joint oriented on the horizontal diameter, the ring was loaded progressively in increments of 20 pounds until the vertical diameter was reduced by 90 percent. The vertical and horizontal deflections were to be measured at each successive load increment; however, due to an oversight the horizontal deflection measurements were not taken. The horizontal measurements were, therefore, computed by Data Processing and Statistical Services Branch, Technical Service Department, USAERDL.

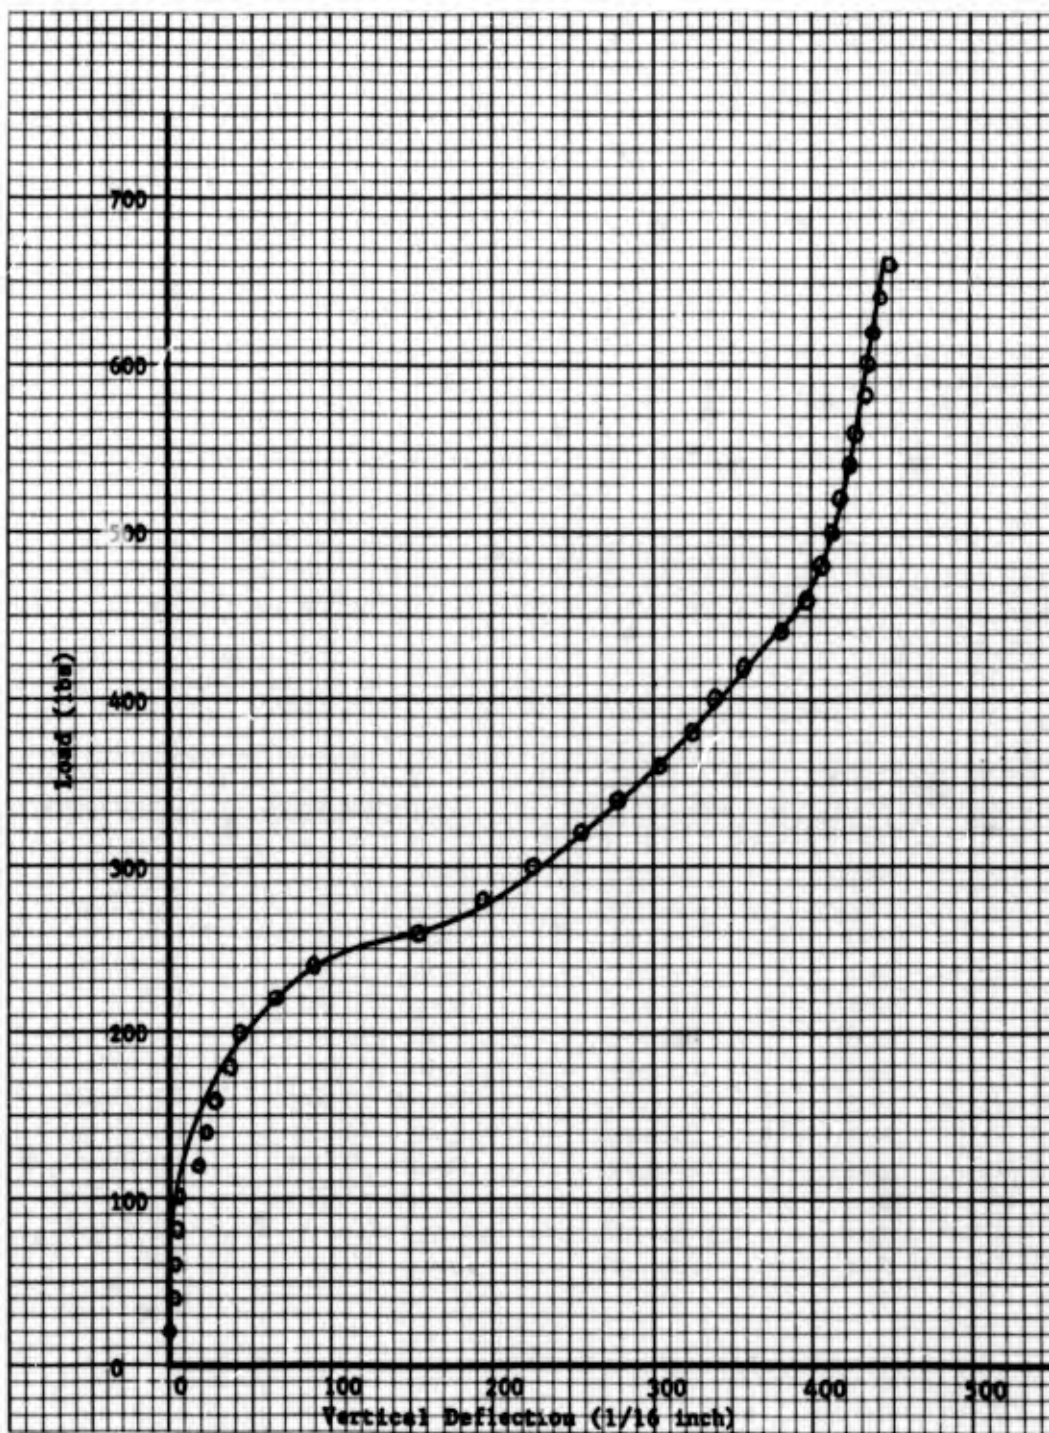
Fig. 34. Vertical deflections vs load as measured in ring compression test.

Test results of the ring compression test performed in the laboratory appear in Table VII. The portion of data pertaining to vertical deflections has been used to construct a deflection versus load graph (Fig. 34). Since the increase in horizontal diameter is nearly the same as the decrease in vertical diameter, the graph of this function is not shown.

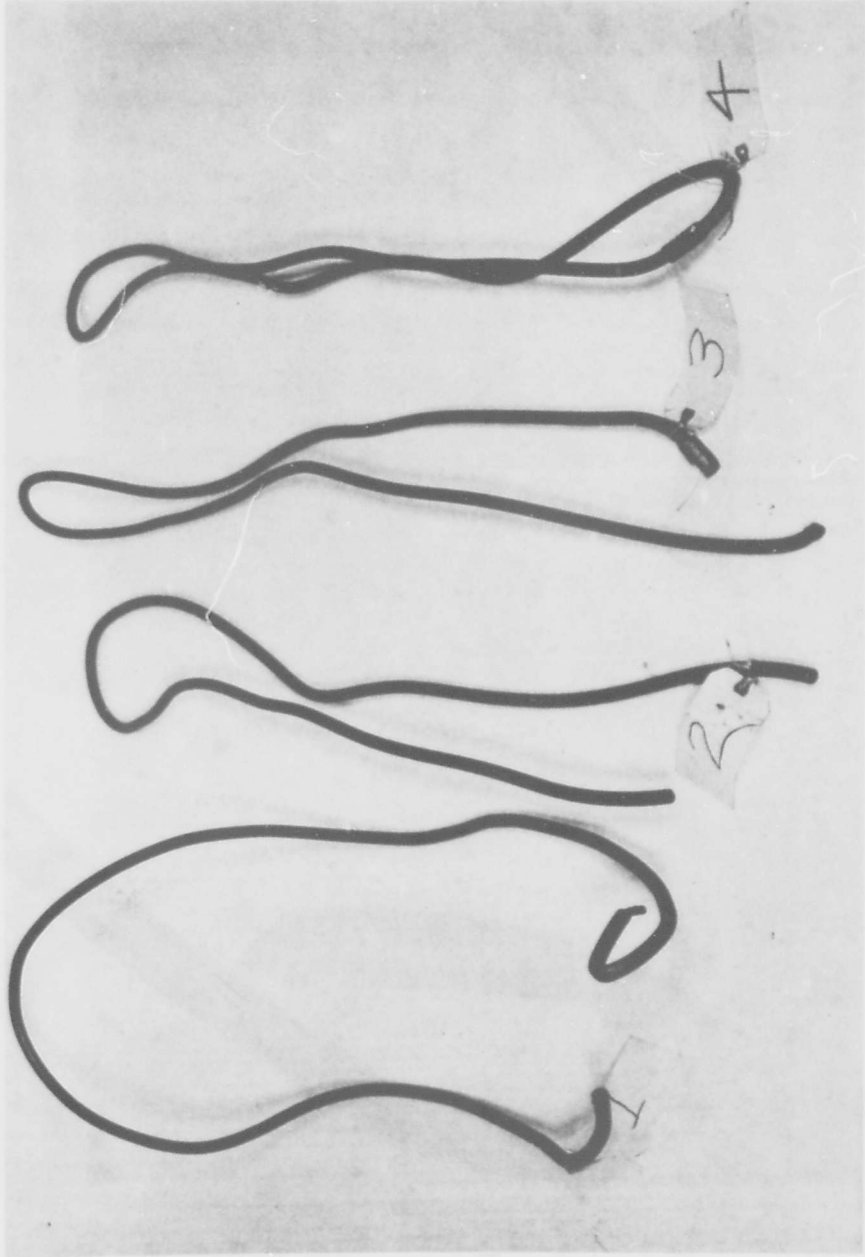
G3492

Fig. 35. Representative failures of rings and joints.

12. Types of Ring Joint Failure. Table IX summarizes the ring joint data gathered in field load test. Figures 33 and 35 through 39 illustrate the effect of the two types of joints on ring performance.

Throughout the entire laboratory test of Ring No. 13, the connecting joint showed no signs of failure. Figures 35 through 39 illustrate typical joint failures; this data is summarized in Table IX. It was believed that the failure of the Allen screws to stay in place in the ring joints was due to the inability of such thin material to retain screws and to the variation in workmanship of the handmade rings. With one exception, Ring No. 9, all the short fillet joints were intact. It is apparent that the length and angle of edge fillet welds are critical. A better joint connection is indicated for pipe rings.

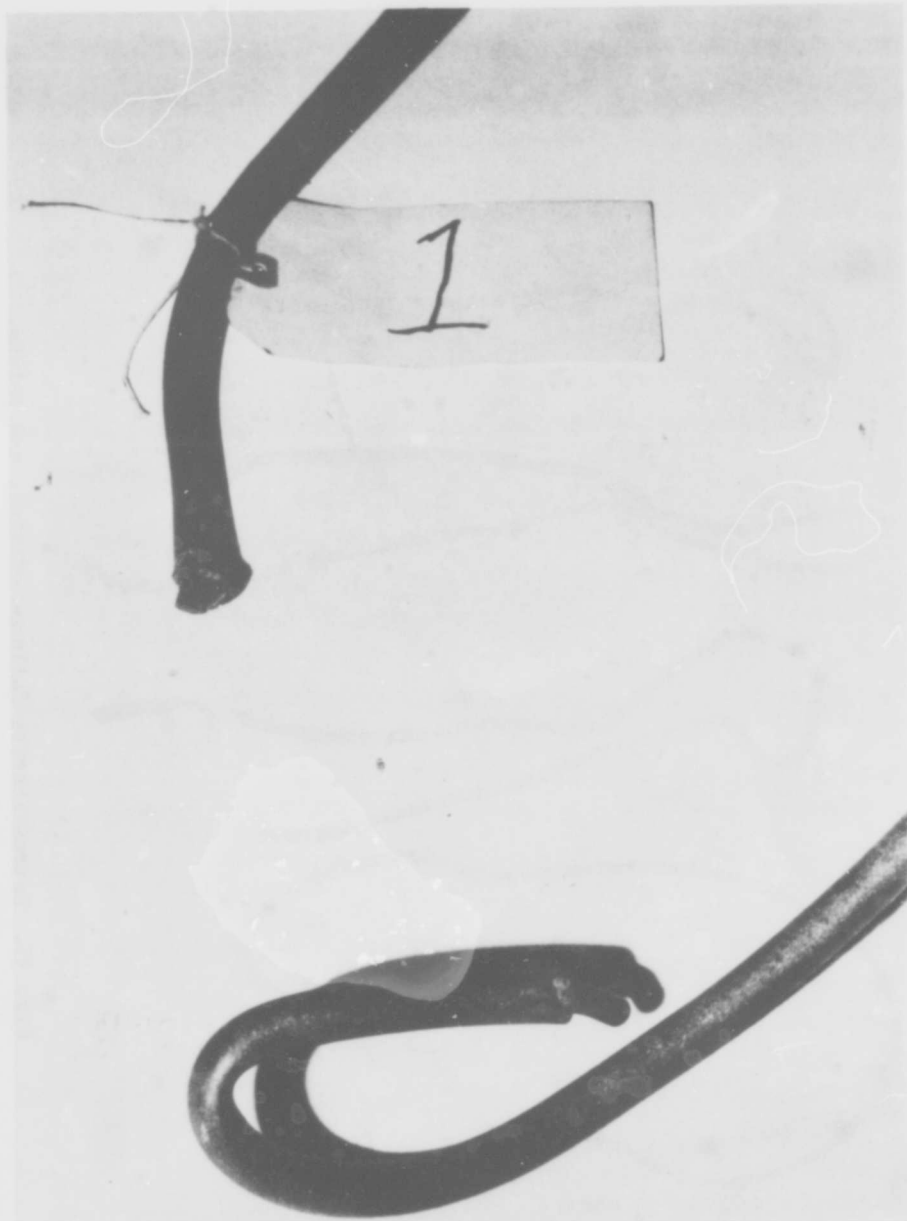
Fig. 36. Ring No. 1 joint failure caused by inadequate edge distance and thickness of pipe wall. G3494

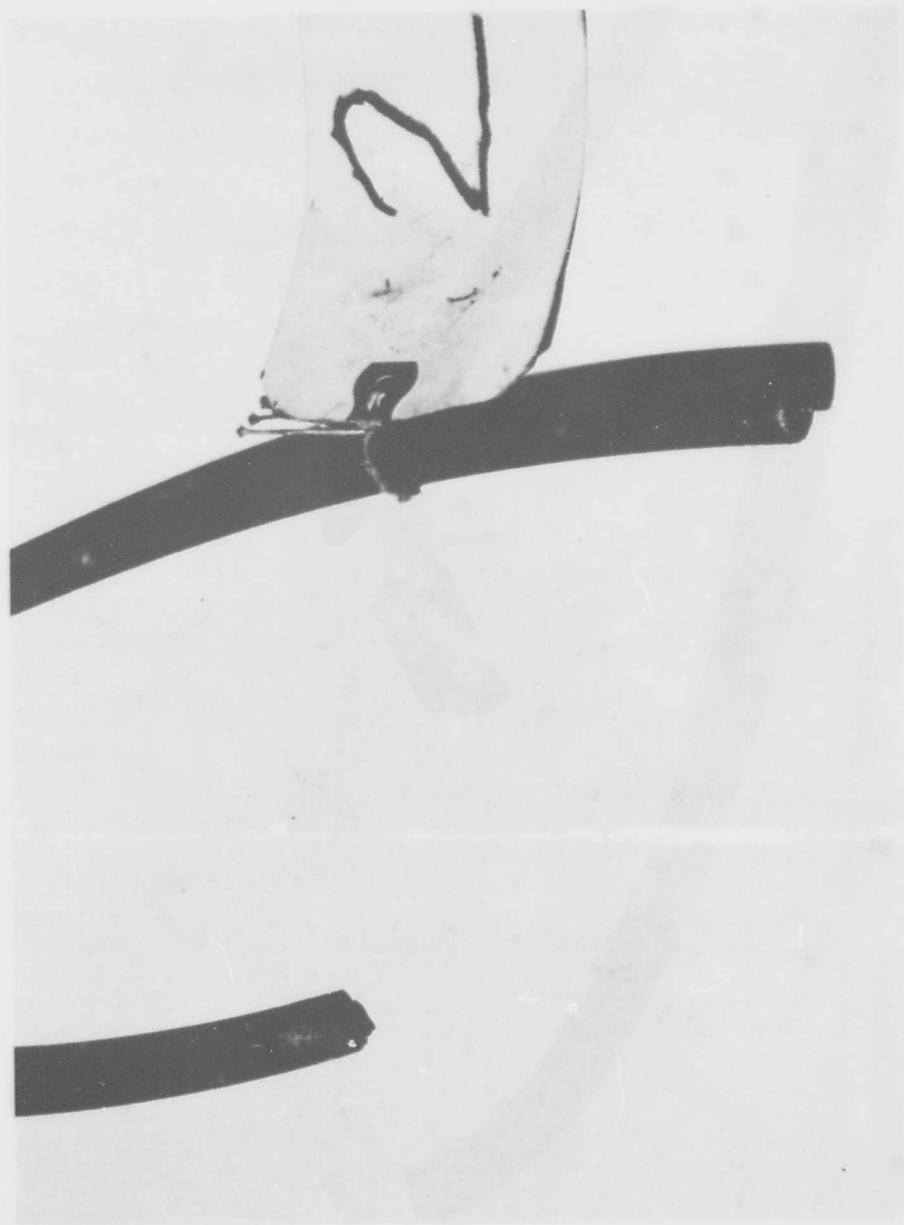
G3495

Fig. 37. Ring No. 2 joint failure caused by excess bending stress in pipe insert.

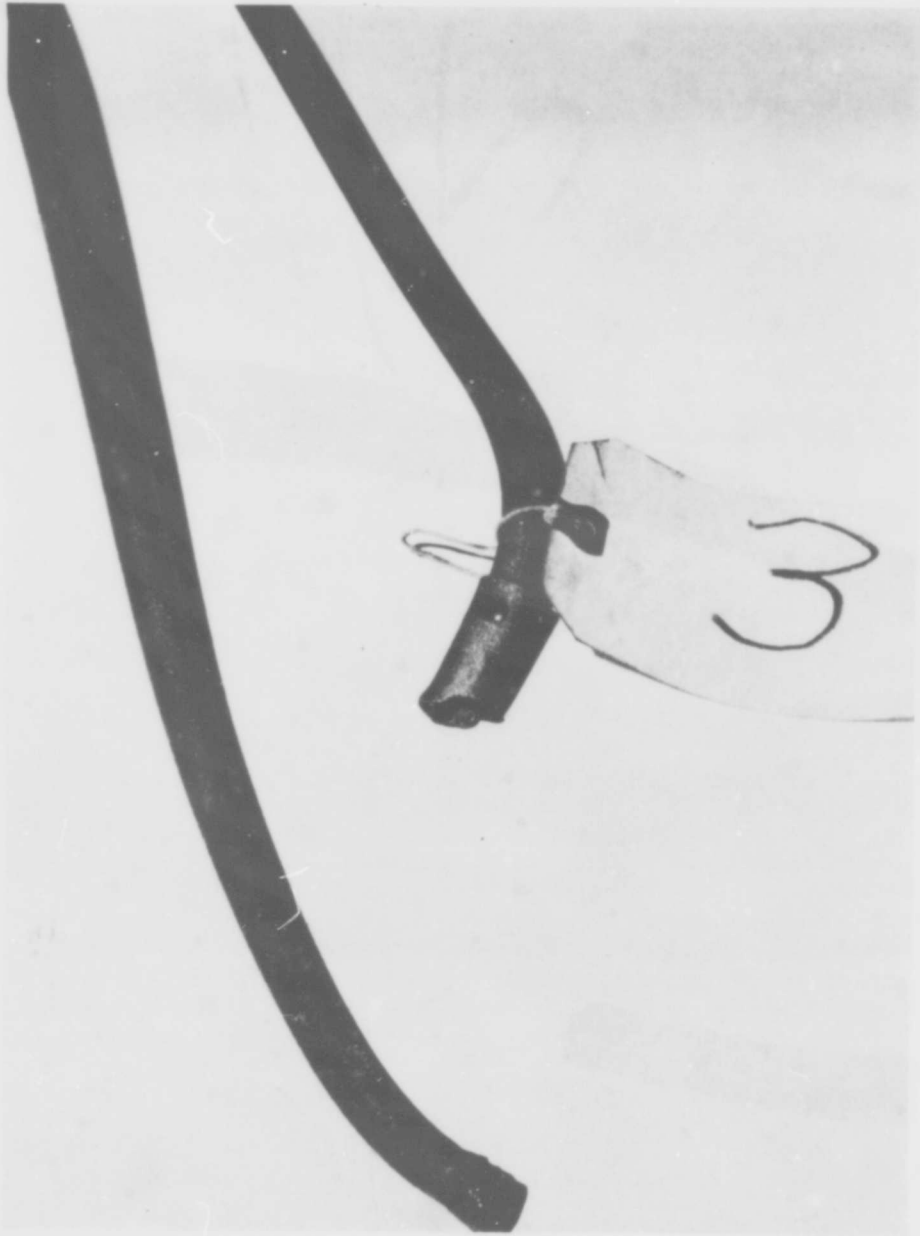
Fig. 38. Ring No. 3 joint failure caused by inadequate thickness of rod coupling wall (note short fillet weld). G3493

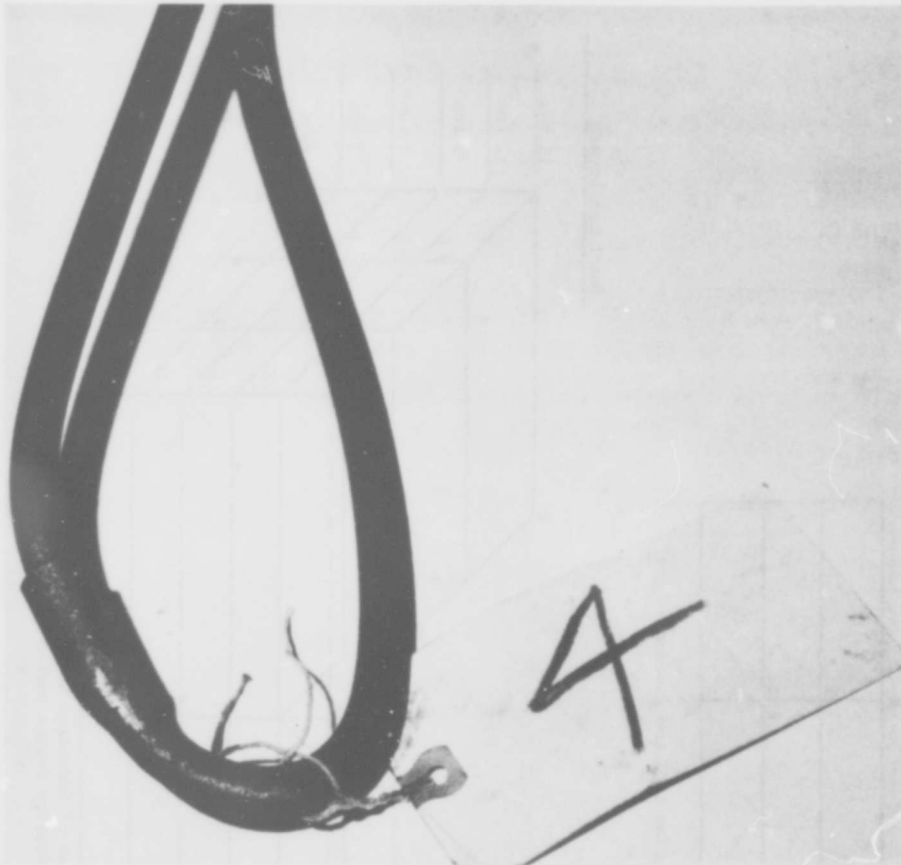
Fig. 39. Ring No. 4 joint intact (note long fillet weld). G3496

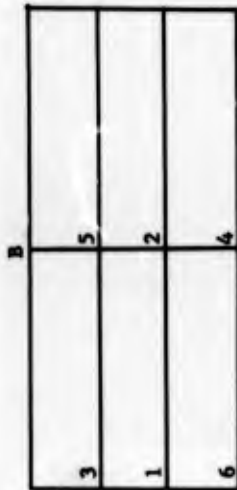
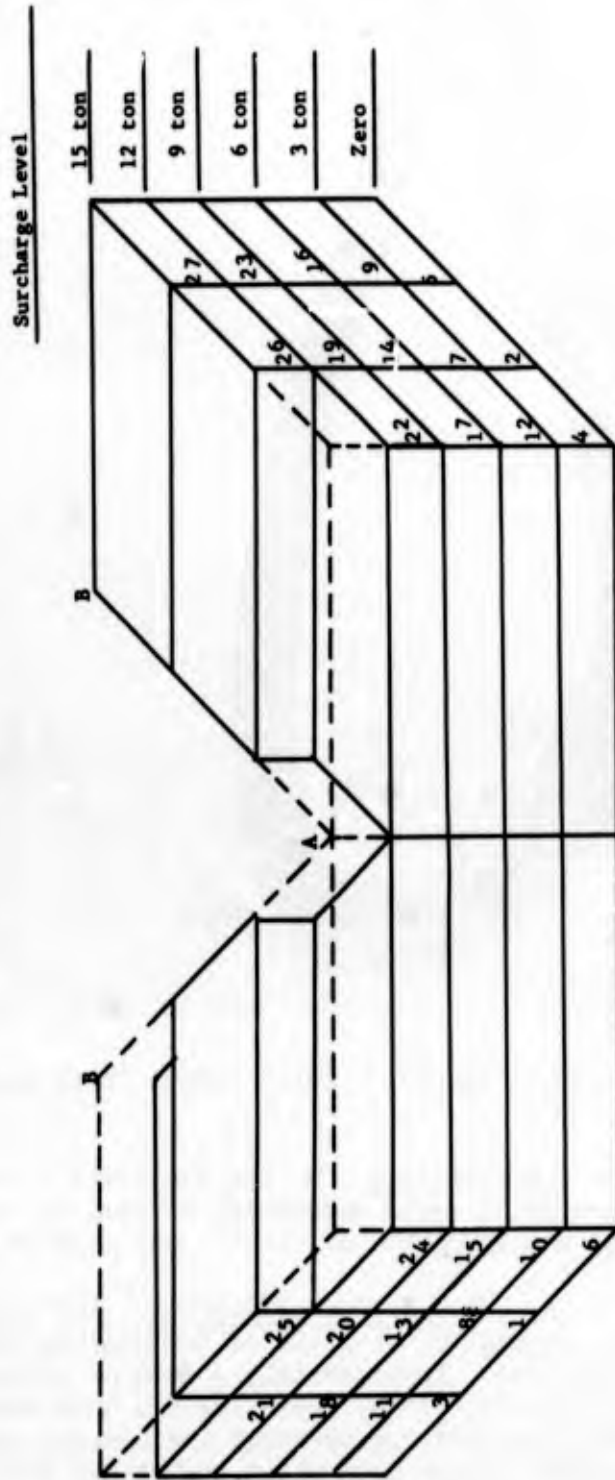
Fig. 40. Surcharge loading diagram.

a. Plan of 3 ton Surcharge Level

b. Isometric view of Surcharge Loading with rotation about "A". Numbers denote number of 1000 lb weights.

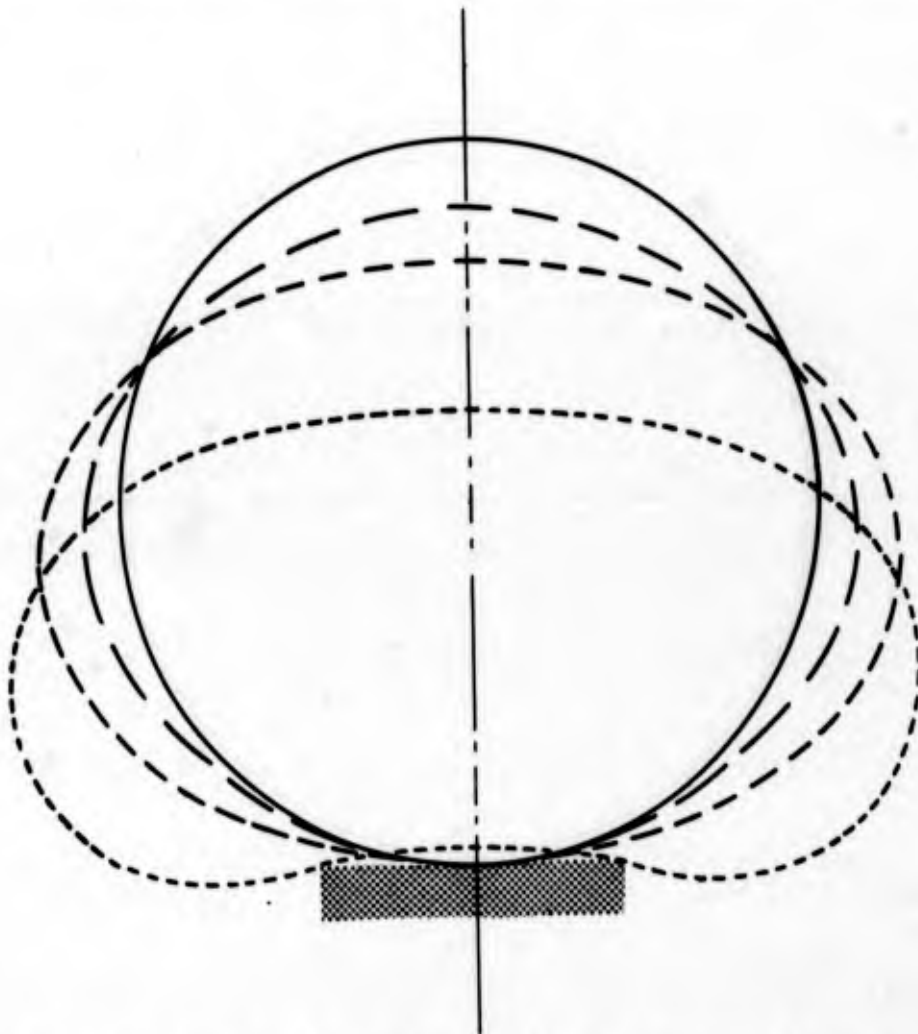
Fig. 41. Stages of ring deformation in compression test.

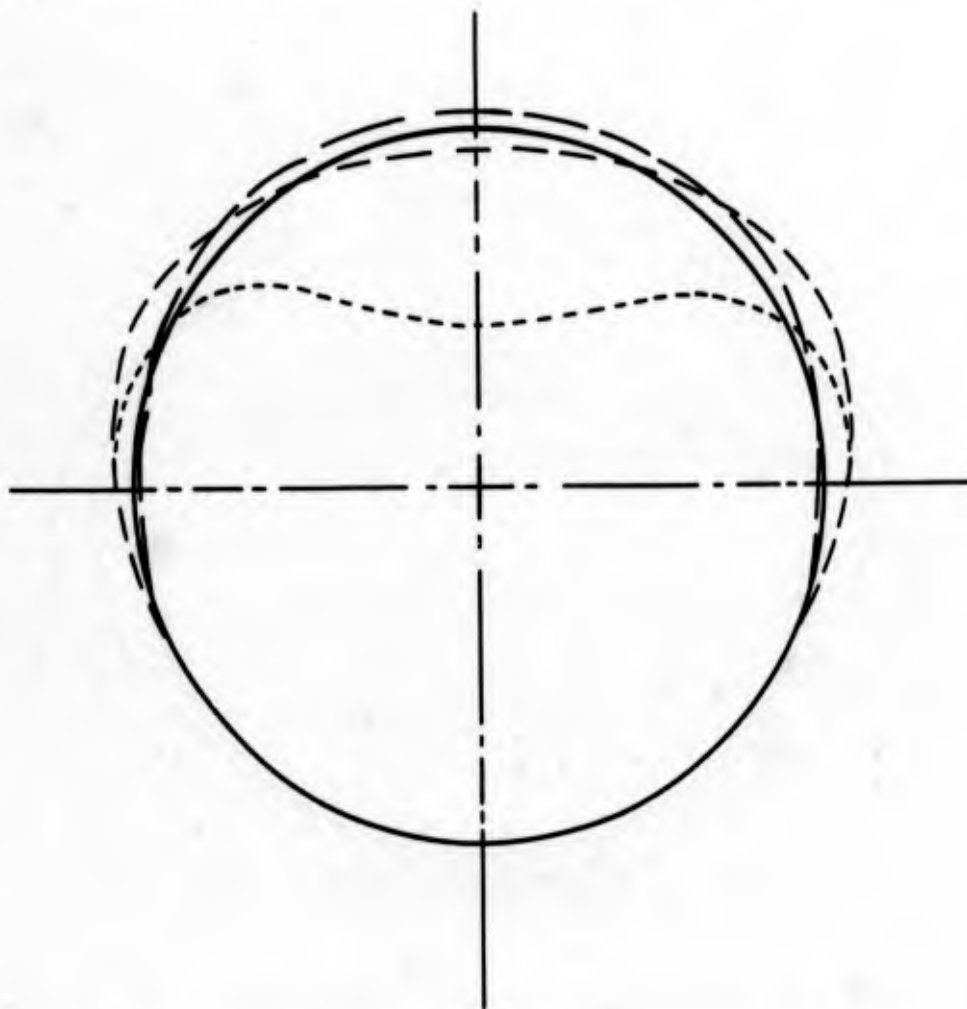
Fig. 42. Stages of ring deformation in field load test.

c. Configuration of Rings under Loading. One point of interest noted in the field load test was the manner of deformation taken by the steel rings. Prior to the field test, it was thought that the rings would take a shape similar to those taken by Ring No. 13 (Fig. 41) in the laboratory test, flatter and flatter ellipses. This did not occur; instead, the rings took the shape illustrated in Fig. 42 (attested by Figs. 12, 20, 22, 24, and 26). Indications were that most of the deformation of the rings took place above the horizontal axis. Ring deformations in these figures are greatly exaggerated by the bulges encountered between rings. These bulges greatly restricted the vertical clearance and seriously hampered passage through the liner.

reduce considerably the load over the liner. The bulges in the cotton fabric, the negative horizontal deflection recorded in Table V, and the ring configurations attained as shown in Fig. 42 are indications of the stiffness or compactiveness of the side fills. Measurements of the horizontal diameter of the liner taken during placement of the side fills would have shown more vividly this pinching-in of the rings which was not neutralized until considerable sand load caused resumption of original horizontal diameter. This occurred slightly above the fill height of 4 feet. The configuration of the rings in the field load test did not correspond to the laboratory ring test because of the restraining force of the side fills to the flexing of the rings. Since this transverse flexing action was limited, the liner could only draw minimal support from the surrounding side fills in distributing the stresses peripherally. Instead, the external pressures were concentrated through the vertical axis causing premature buckling of the top of the rings. Deformation upward of the bottom of the rings, below the horizontal axis, was of little consequence.
